**ACCIDENT**

<b>Aircraft Type and Registration:</b>	Skyranger Nynja 912s(1), G-CGWL	
<b>No &amp; Type of Engines:</b>	1 Rotax 912ULS piston engine	
<b>Year of Manufacture:</b>	2011 (Serial no: BMAA/HB/601)	
<b>Date &amp; Time (UTC):</b>	9 December 2017 at 1233 hrs	
<b>Location:</b>	Plaistow Farm Airfield, Hertfordshire	
<b>Type of Flight:</b>	Training	
<b>Persons on Board:</b>	Crew - 1	Passengers - None
<b>Injuries:</b>	Crew - 1 (Fatal)	Passengers - N/A
<b>Nature of Damage:</b>	Aircraft destroyed	
<b>Commander's Licence:</b>	Student Pilot	
<b>Commander's Age:</b>	58	
<b>Commander's Flying Experience:</b>	39 hours (of which 28 were on type) Last 90 days - 10 hours Last 28 days - 4 hours	
<b>Information Source:</b>	AAIB Field Investigation

**Synopsis**

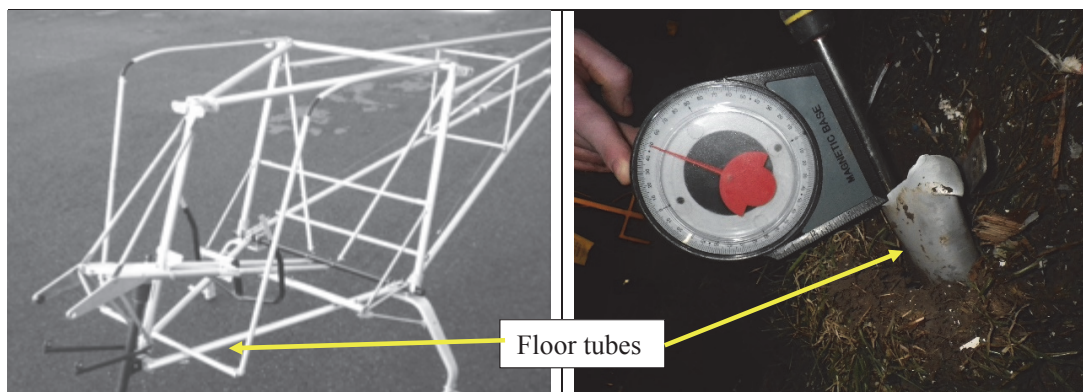
**Figure 1**

From the impact marks, it was established that the aircraft struck the ground on a heading of 140° (M). Both wings were level and there was no evidence of the aircraft rotating or spinning. The aircraft structural tubes supporting the engine mountings had failed during the impact and the floor tubes had been driven into the ground at an angle of 50° to the horizon (Figure1). There was a significant amount of oil in the area of the engine and two of the three propeller blades had broken off and were lying next to the hub. There was also a strong smell of fuel in and around the aircraft.

Floor tubes driven into the ground

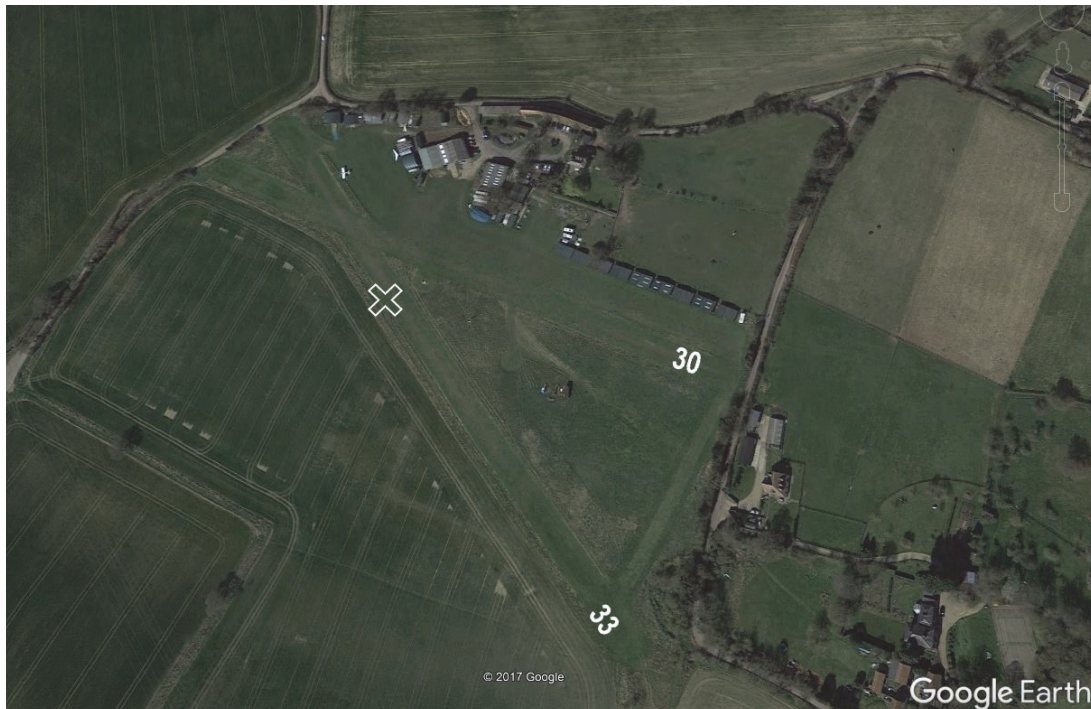
**Figure 8**

The aircraft had struck the ground within the airfield on Runway 15/33 (Figure 8), approximately 130 m from the threshold of Runway 15. Prior to the arrival of the AAIB, the aircraft had been moved several metres and the wreckage disturbed by the first responders.

Plaistow Farm Airfield, Runways 12/30 and 15/33 with accident site marked
