AAIB Bulletin

10/2018

ACCIDENT

Aircraft Type and Registration:	AS350 B3e Ecureuil, G-MATH	
No & Type of Engines:	1 Turbomeca Arriel 2D turboshaft engine	
Year of Manufacture:	2016 (Serial no: 8274)	
Date & Time (UTC):	5 May 2017 at 0830 hrs	
Location:	Wycombe Air Park, Buckinghamshire	
Type of Flight:	Training	
Persons on Board:	Crew - 2	Passengers - 1
Injuries:	Crew - 1 (Fatal) 1 (Serious)	Passengers - 1 (Serious)
Nature of Damage:	Extensive	
Commander's Licence:	Commercial Pilot's Licence (Helicopters)	
Commander's Age:	45 years	
Commander's Flying Experience:	5,747 hours (of which 579 were on type) Last 90 days - 53 hours Last 28 days - 17 hours	
Information Source:	AAIB Field Investigation

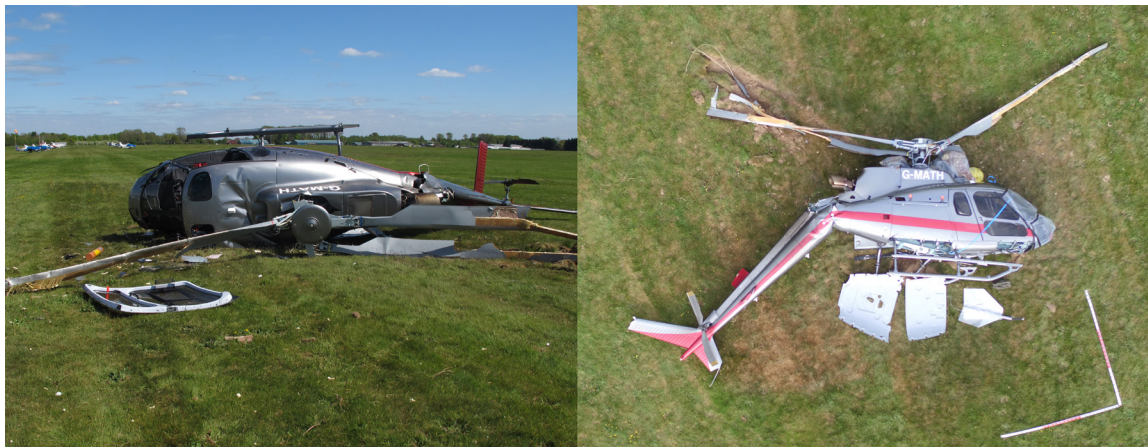
Figure 1

The accident site was located within the airfield boundary, about 200 m north of the centre of Runway 06/24. The helicopter had struck the ground on its left side with little forward speed (Figure 1). The ground impact marks showed that the main rotor blades had struck the ground first when the helicopter was in a near 90° left bank, and the damage to the blades was consistent with them being powered. The tail boom had failed as a result of the inertia loads of the impact but there was no damage to the tail rotor. The fuselage came to rest on a heading of 019°(M).

G-MATH accident site

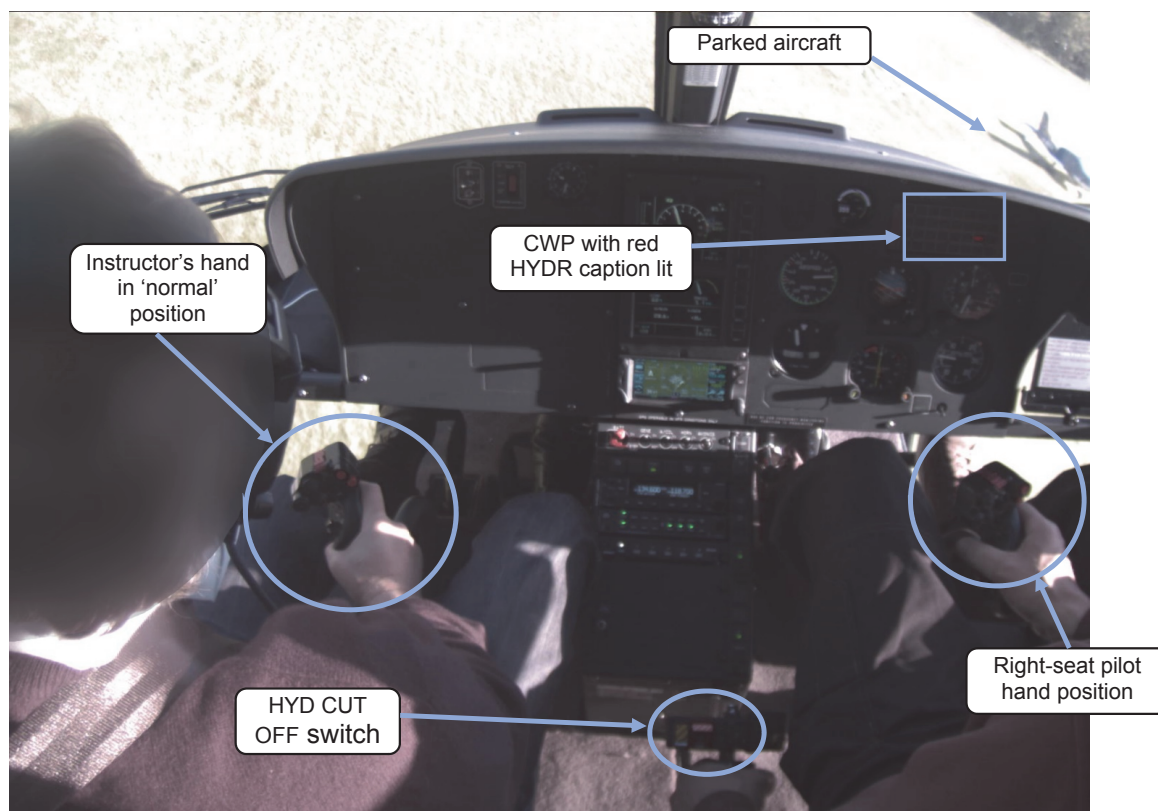
Figure 4

The instructor applied left and forward cyclic, left pedal and raised the collective, producing a corresponding increase in FLI. Indicated airspeed and altitude began to increase as the helicopter pitched nose-down and rolled left. The left roll was initiated at a height of approximately 20 ft agl and reached 30° at approximately 47 ft agl. Throughout the initial stages of the second go-around, the right-seat pilot's hands and feet were still on the controls but his grip on the cyclic was seen to loosen (Figure 4).

Second go-around showing right-seat pilot with hands and feet on the controls (instructor's head has been blurred).

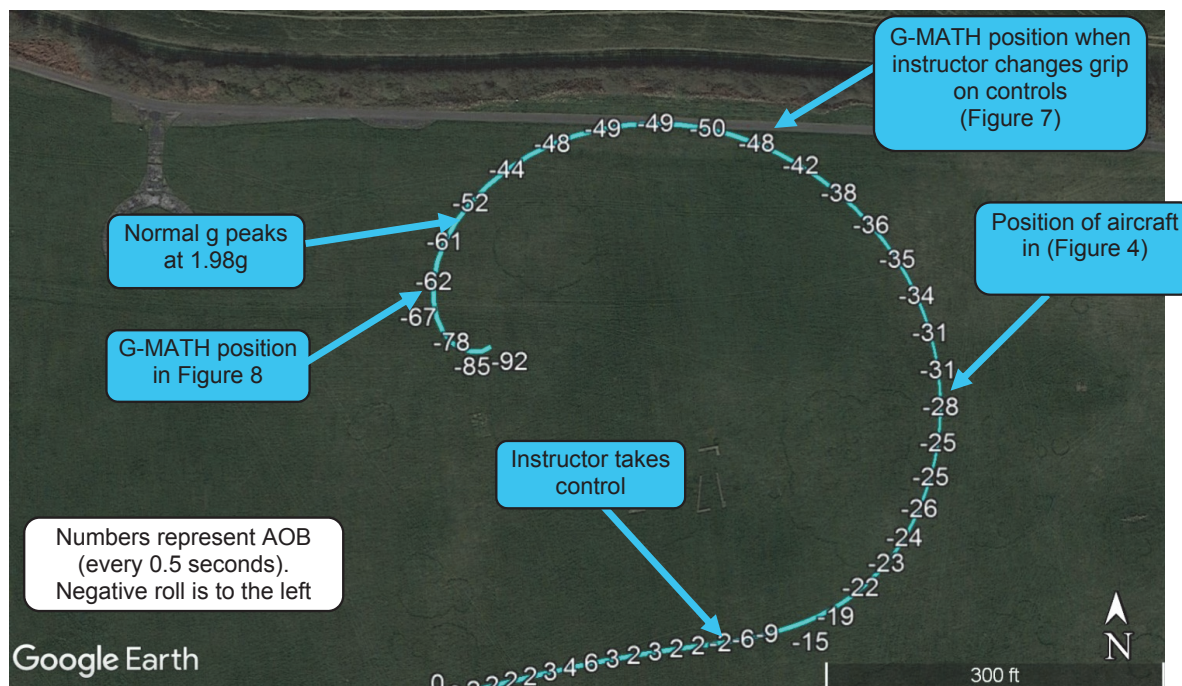
Figure 6

In the final stages of the second go-around (Figure 6) the AOB increased to 50° left and the helicopter pitched down to -19° over four seconds. (The view from the cockpit video and recorded position at this point showed the helicopter was just inside the airfield boundary hedge). The recorded height was 64 ft agl.

G-MATH final go-around manoeuvre showing AOB

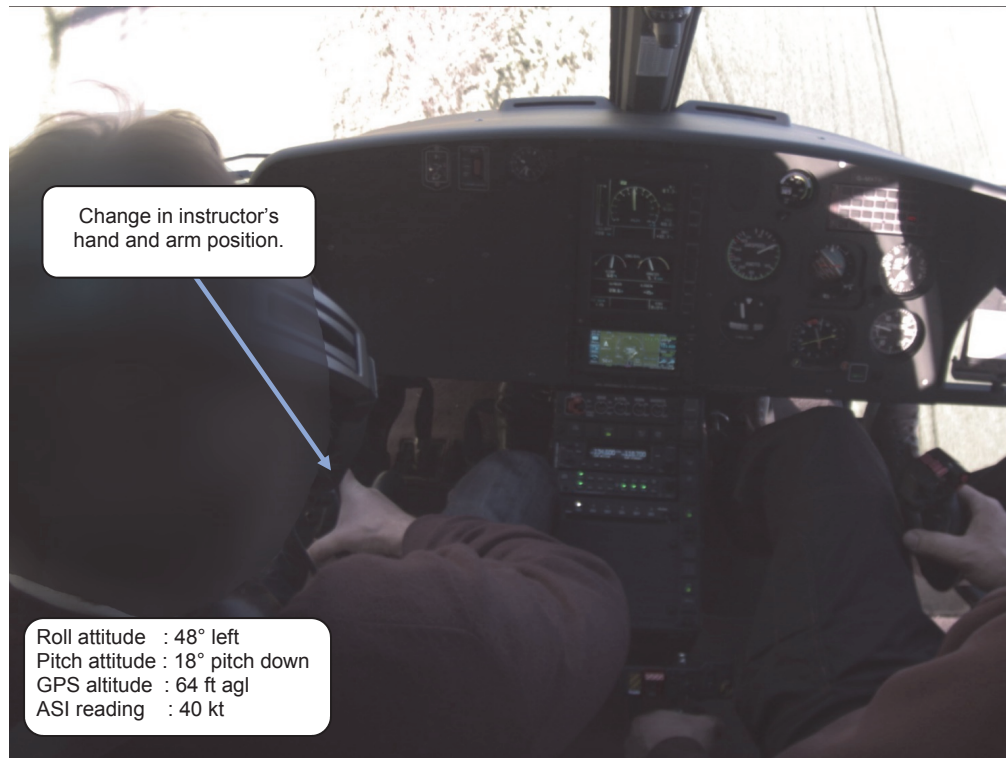
Figure 7

G-MATH at 0832:54 hrs during second go-around showing changed grip for instructor (compare with Figure 4). (Instructor's head has been blurred)

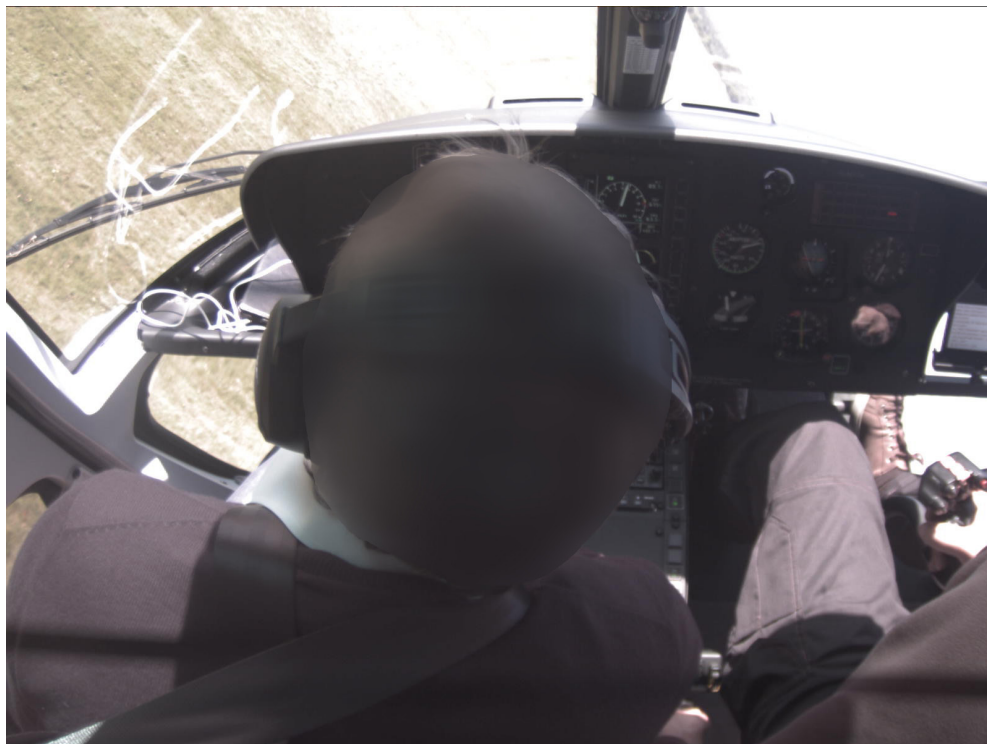
Figure 8

After the instructor's grip on the cyclic had changed, his body also leant to the right (Figure 8) and for the final 3 seconds prior to the accident, obscured the Vision 1000's view of the right collective lever and the position of the hydraulic cut-off switch on the end of the right collective. The view of the CWP was not obscured and the red HYDR light remained illuminated until the end of the recording.

G-MATH at 0832:58 hrs during second go-around showing instructor's right lean (62° AOB). (instructor's head has been blurred)

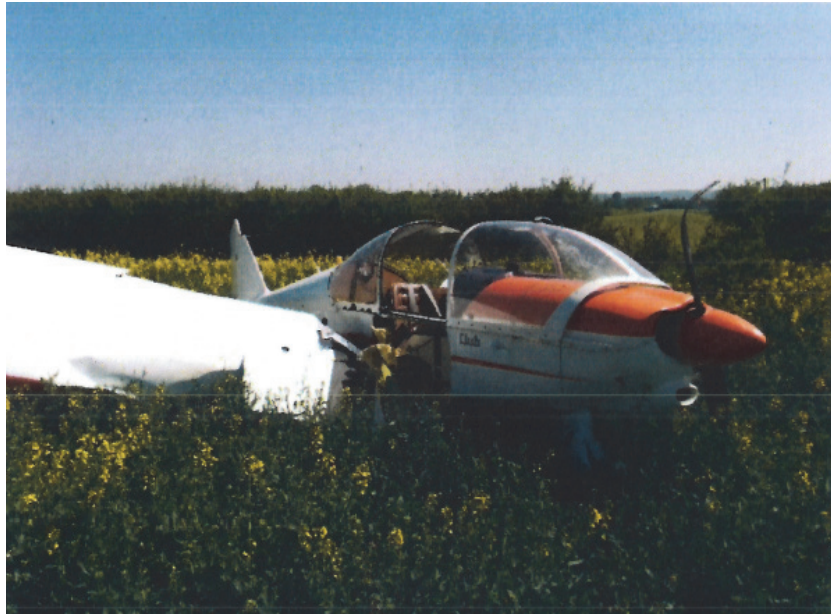
Figure 1

The pilot decided to use Runway 29, although it would involve a slight tailwind, as it would be away from buildings close to the threshold of the runway. After completing his checks, the pilot commenced the takeoff roll. The aircraft reportedly reached an airspeed of 40 kt approximately 400 m along the runway, but its acceleration did not continue as expected. The aircraft collided with a 2 m (6.6 ft) high hedge at the far end of the runway at an estimated airspeed of 45 kt. (The rotate speed for this aircraft is 49 kt and the best climb angle speed is 62 kt.) Both occupants, who were wearing four-point harnesses, were uninjured and able to vacate the aircraft unaided. The aircraft was substantially damaged, (Figure 1).

General view of the aircraft post-accident

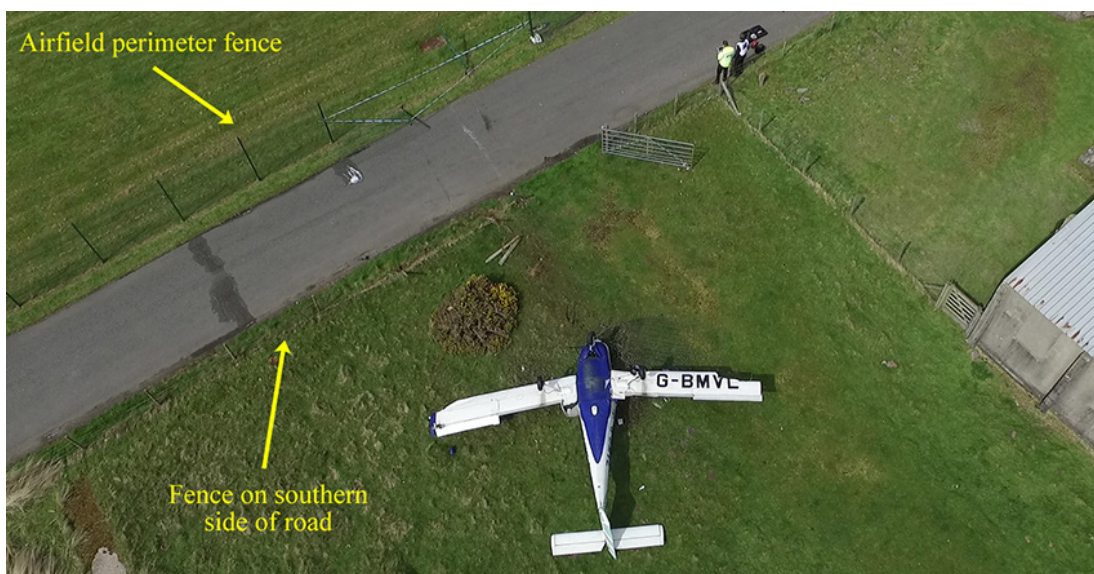
Figure 2

View of accident site from police drone (Picture courtesy of North Wales Police)

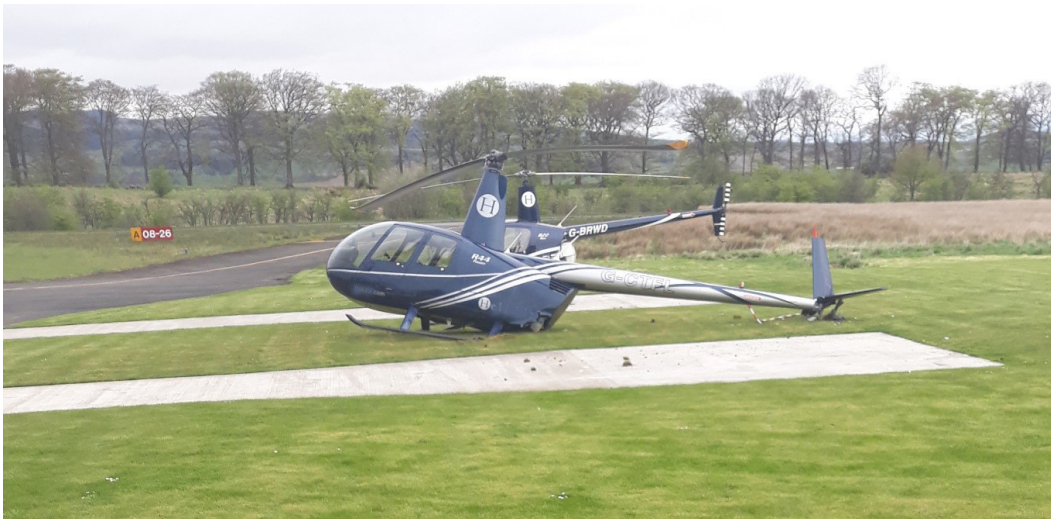
Figure 2

The pilot of G-CTFL heard a bang and recalled that his helicopter pitched nose-up and right, so he made a forward cyclic control input to return towards the helipad and lowered the collective lever. He then realised the helicopter was pitching nose-down so he moved the cyclic stick aft, but the tail struck the ground, before the helicopter bounced forward off its skids, towards the R22. The pilot stated that he reacted by making a left cyclic stick input, but that the rotor blades then struck the ground and the helicopter vibrated violently, so he lowered the collective lever fully. G-CTFL landed heavily in a nose-up attitude, near the R22, with its tail resting on the ground (Figure 2).

G-CTFL after the accident, facing towards Apron A, with the R22 visible behind, on the northern helipad, and with loose debris in the foreground

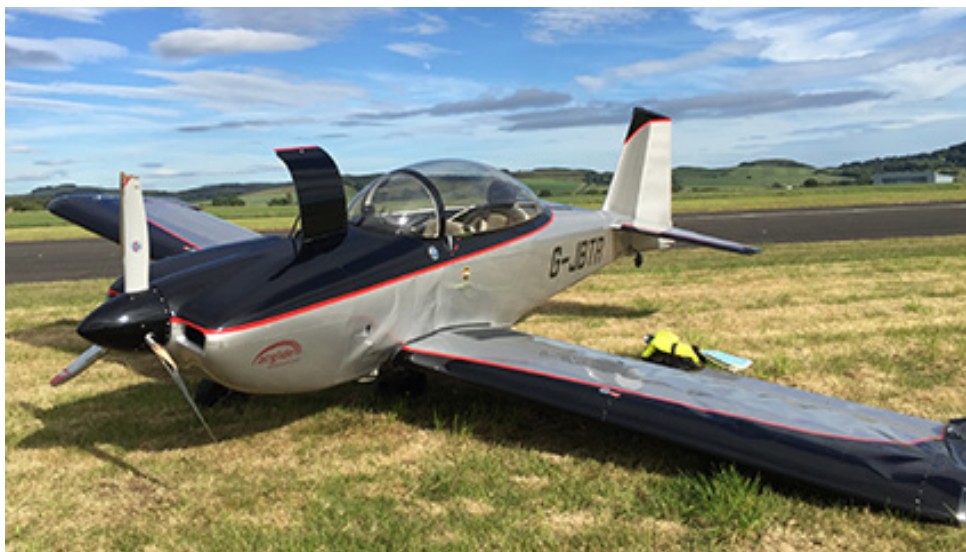
Figure 1

The aircraft slid sideways and as it left the paved surface, moving at a groundspeed of approximately 40 kt, the left main landing gear collapsed, causing the left wing and the propeller to strike the ground. The occupants vacated without difficulty after the aircraft came to rest, orientated on a northerly heading (Figure 1).

G-JBTR showing evidence of damage to the propeller, the fuselage and the left wing

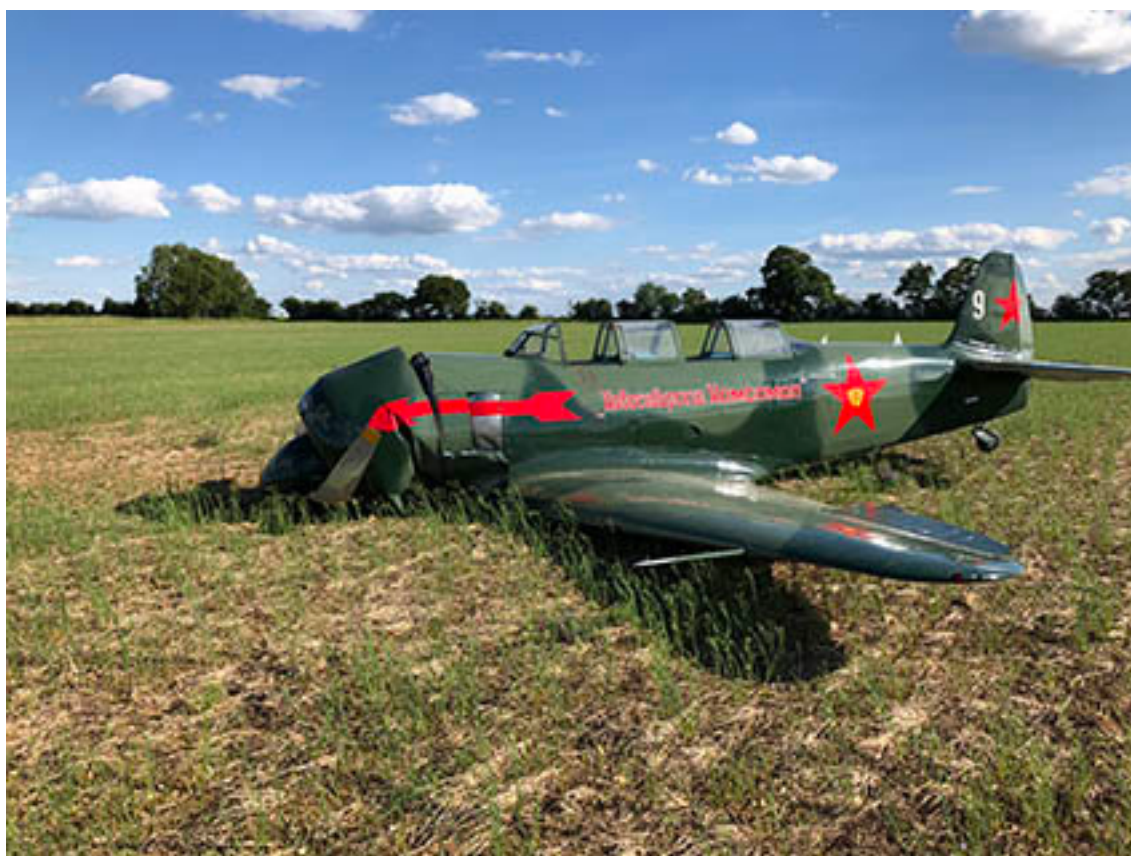
Figure 1

Accident site
(photograph provided by pilot)

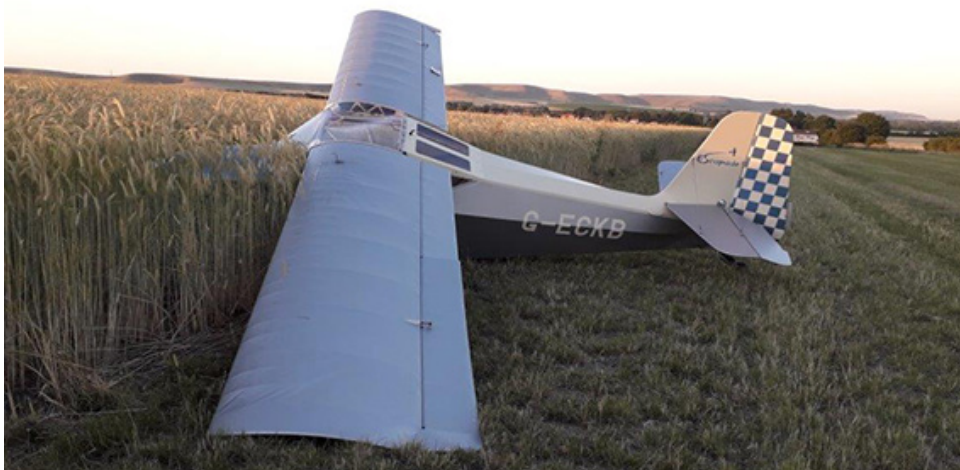
Figure 1

While on final approach the aircraft sank in turbulence, and this alarmed the passenger who then, inadvertently, restricted the control stick from being moved rearwards. Consequently, the pilot could not prevent the aircraft from descending rapidly, and the left main landing gear detached in the ensuing ground contact with the grass runway. While this occurred the passenger was instructed to allow the pilot freedom to move the control stick and, after a single bounce, the pilot landed the aircraft on its right main landing gear and tailwheel. However, as the airspeed reduced, the aircraft settled onto its left wingtip and slewed left, before coming to rest at the edge of grain crop which adjoined the runway (Figure 1).

G-ECKB resting on its left wingtip at the edge of the grain crop

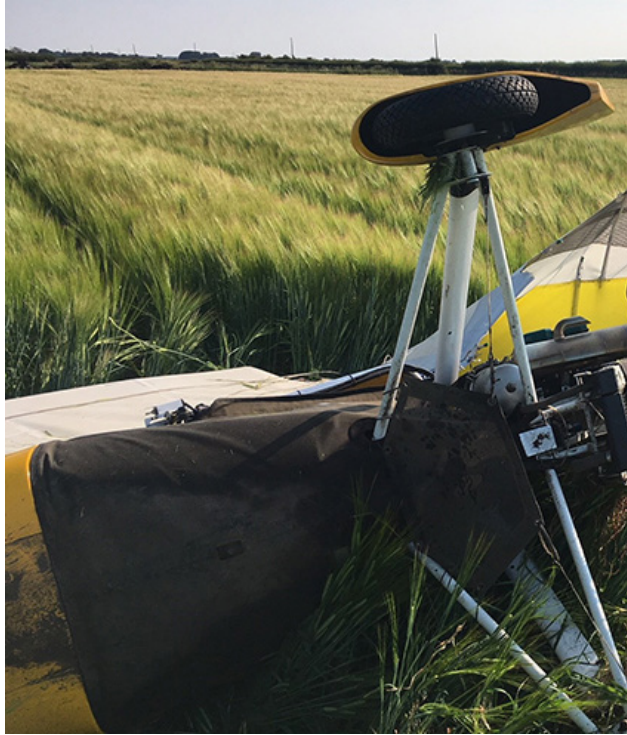
Figure 1

G-CGSO on its side after the accident
