AAIB Bulletin

12/2018

BAE Systems (Operations) Ltd ATP	SE-MHF	14-Dec-17	3
BAE Systems (Operations) Ltd ATP	SE-MHE	14-Feb-18	15

Aircraft Type and Registration:	BAE Systems (Operations) Ltd ATP, SE-MHF	
No & Type of Engines:	2 Pratt & Whitney Canada PW126 turboprop engines	
Year of Manufacture:	1989 (s/n 2013)	
Date & Time (UTC):	14 December 2017 at 0606 hrs	
Location:	On approach to East Midlands Airport	
Type of Flight:	Commercial Air Transport (Cargo)	
Persons on Board:	Crew - 2	Passengers - None
Injuries:	Crew - None	Passengers - N/A
Nature of Damage:	None	
Commander's Licence:	Airline Transport Pilot's Licence	
Commander's Age:	29 years	
Commander's Flying Experience:	2,089 hours (of which 1,854 were on type) Last 90 days - 82 hours Last 28 days - 29 hours	
Information Source:	AAIB Field Investigation

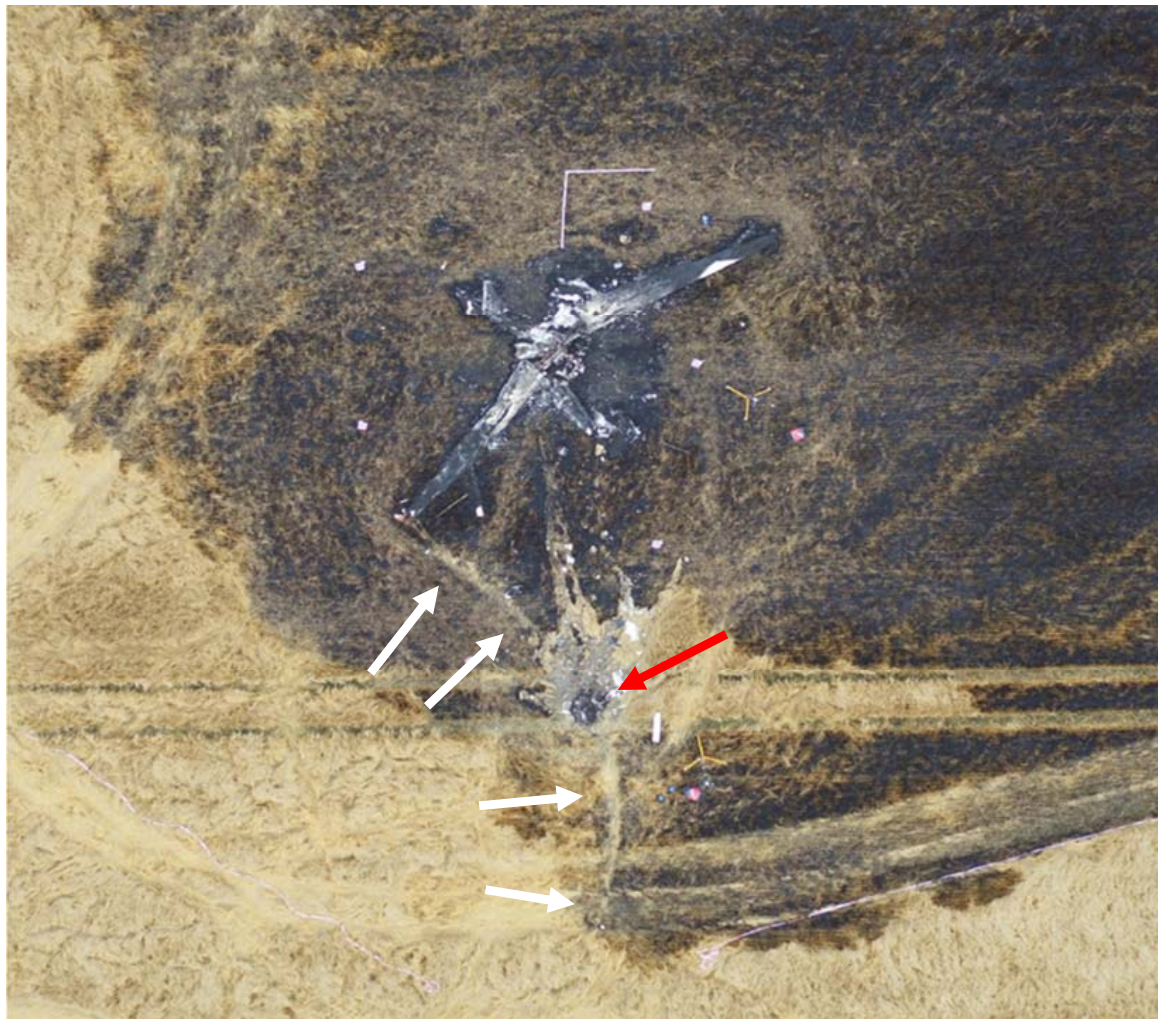
Figure 2

Aerial photo of accident site
(white arrows indicated curved impact marks from wing leading edges;
red arrow indicates engine impact location)

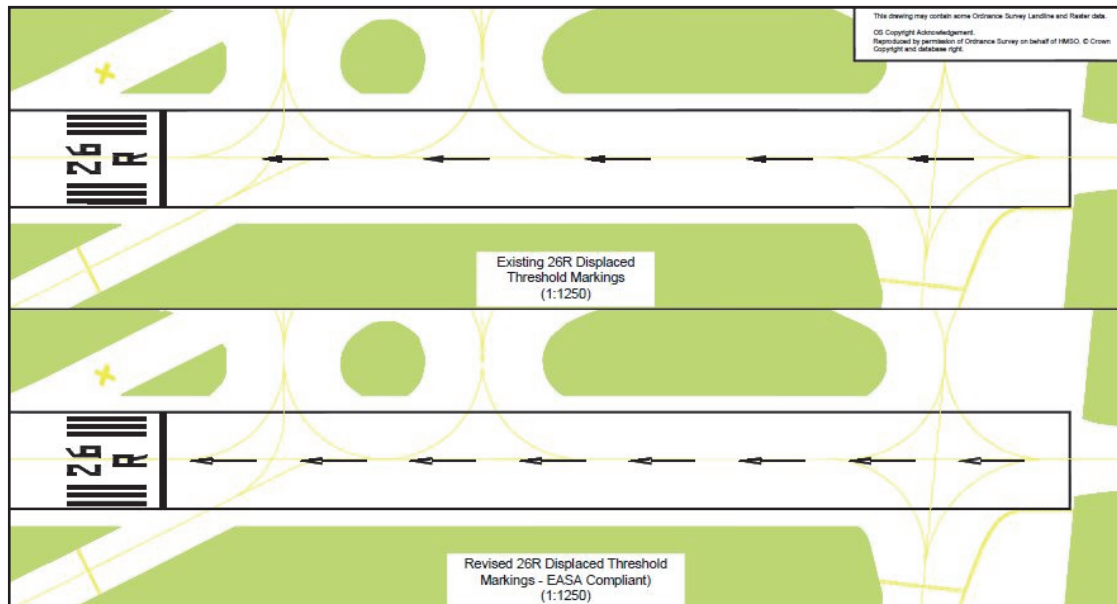
Figure 8

Revised markings Runway 26R
