AAIB Bulletin

4/2016

Published 14 April 2016

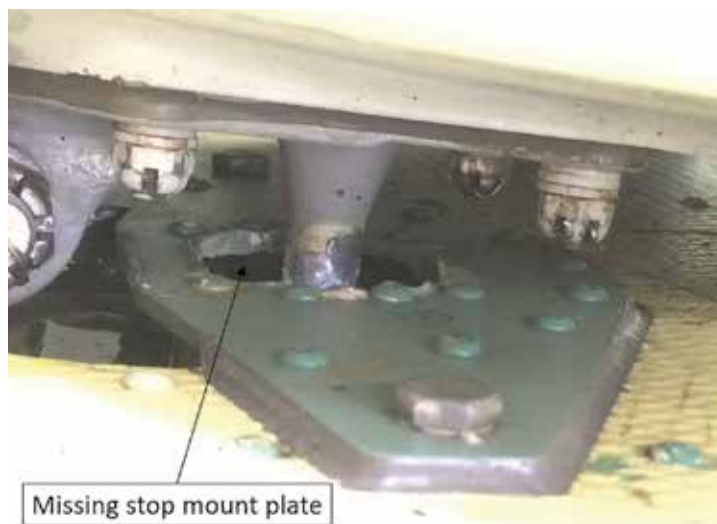
Figure 2

Amongst the photographs the pilot sent by email were images of the transmission drag pin and stop mount, and the main transmission driveshaft, forward coupling and isolation mount. The maintenance manager examined the photographs and, when looking at the stop mount support plate (see Figure 2), he did not see any damage or cracked paint on the domed heads of the attachment rivets. Furthermore, he did not see any disturbance of the sealant between the stop mount support and the fuselage upper deck. He observed that the drag pin attachment hardware appeared undamaged, as did the drag pin itself, apart from some loss of paint on the side of the pin. This, in his experience, was not an abnormal condition. He did not notice the absence of the stop mount plate, which had detached.

Pilot's photograph of damage to transmission drag pin and stop mount assembly

The transmission drag pin had made heavy lateral contact with the stop mount plate and the rivets attaching the stop mount plate to the support plate had failed in shear, releasing the stop mount plate which was found lying loose beneath the support plate. The drag pin's paint finish had been abraded, revealing the bare metal surface beneath.

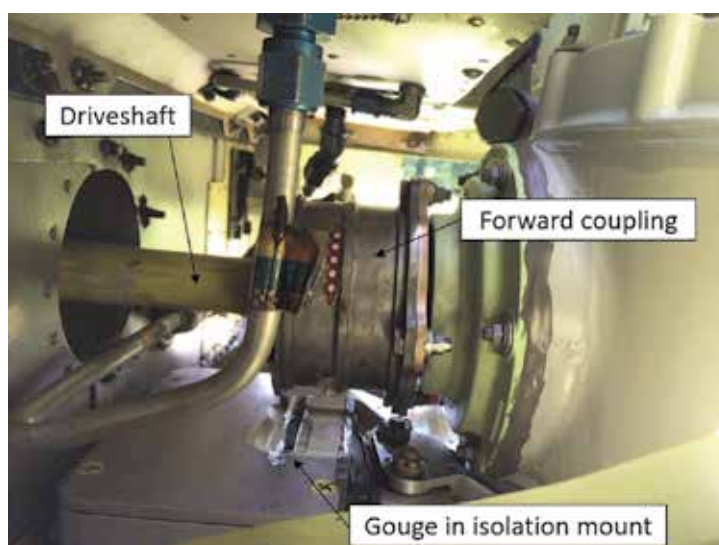
Figure 3

When looking at the driveshaft area (see Figure 3), the maintenance manager observed that the dots on the red temperature indicator stickers, on the forward driveshaft coupling, were white, indicating that the coupling had not been overheated excessively. He noted a gouge in the isolator mount top plate, which was similar in his experience to previous B206 heavy landing events, but he did not ask the pilot to measure the gouge depth and did not refer to the AMM for allowable damage limits. The pilot advised the maintenance manager that the mast was “free to move left and right” and photographs taken by the pilot showed no visible contact marks on the main rotor pitch links or the mast cowling. The maintenance manager verbally approved the helicopter to fly back to Biggin Hill Airport for further examination at the owner's maintenance facility, and no defects were recorded in the helicopter's technical log either before or after these flights.

Pilot's photograph of damage to isolation mount

states that the maximum allowable depth of damage to the isolation mount top cover plate is 0.080" (2.0 mm). The top cover plate thickness is 5.2 mm.

One of the required checks is to inspect the isolation mount for any contact with the main rotor driveshaft coupling and, if the isolation mount is damaged beyond permitted limits, to overhaul the main driveshaft. The Bell 206 Component Repair and Overhaul Manual

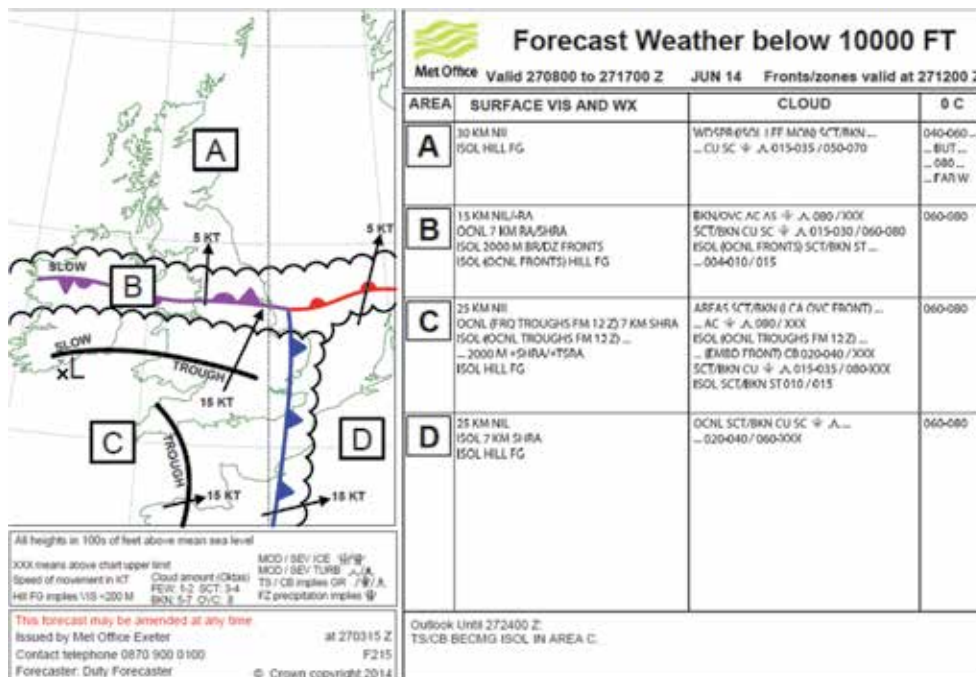
Figure 4

F215 valid for flights between 0800 hrs and 1700 hrs on 27 June 2014

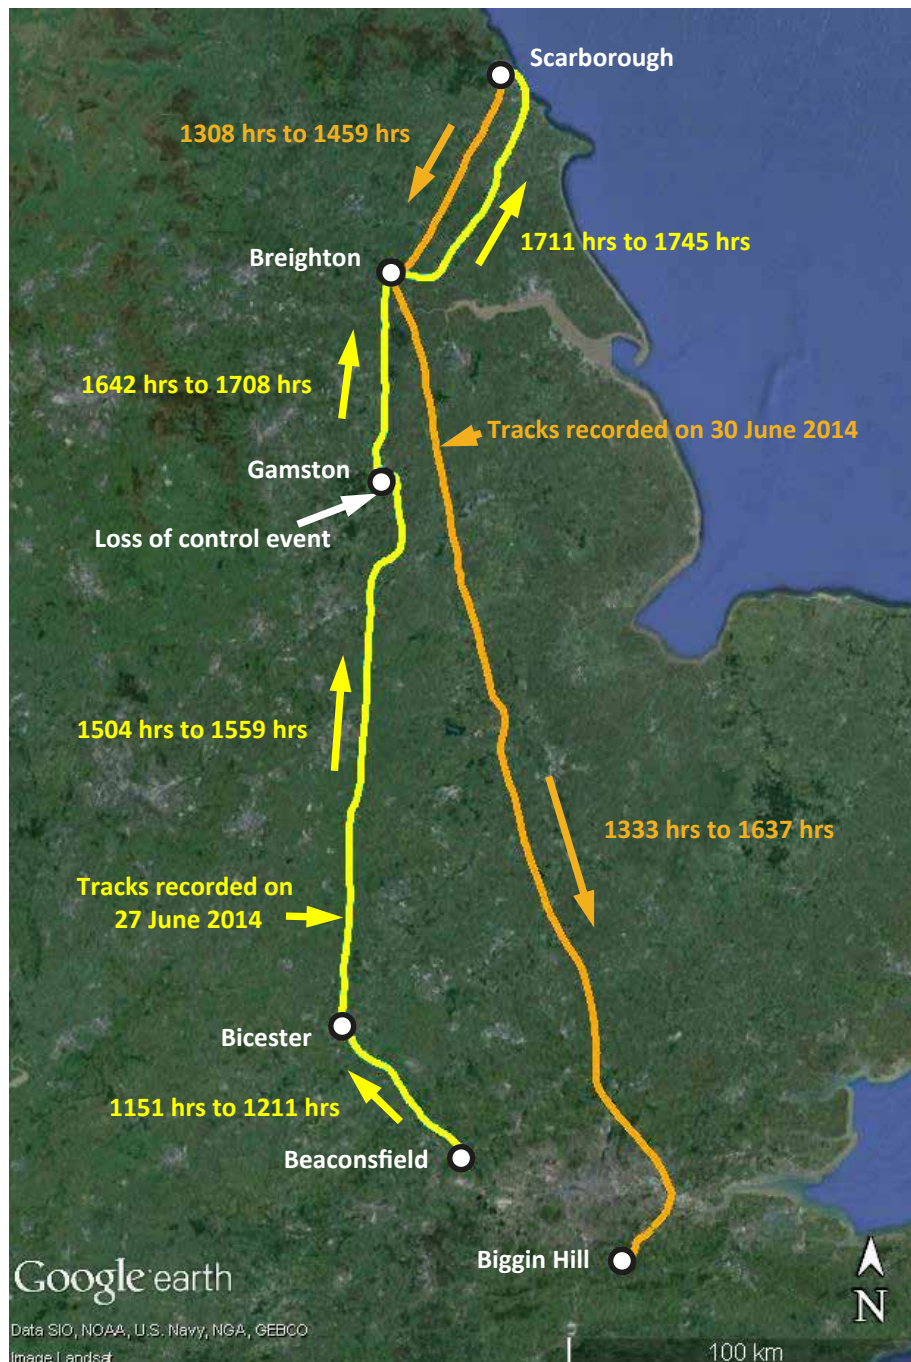
Figure 5

The pilot was using an iPad navigation application during the four flights on the day of the event and the two return flights three days later. The application recorded tracks for all these flights (see Figure 5).

Tracks recorded on the iPad for 27 June 2014 and 30 June 2014

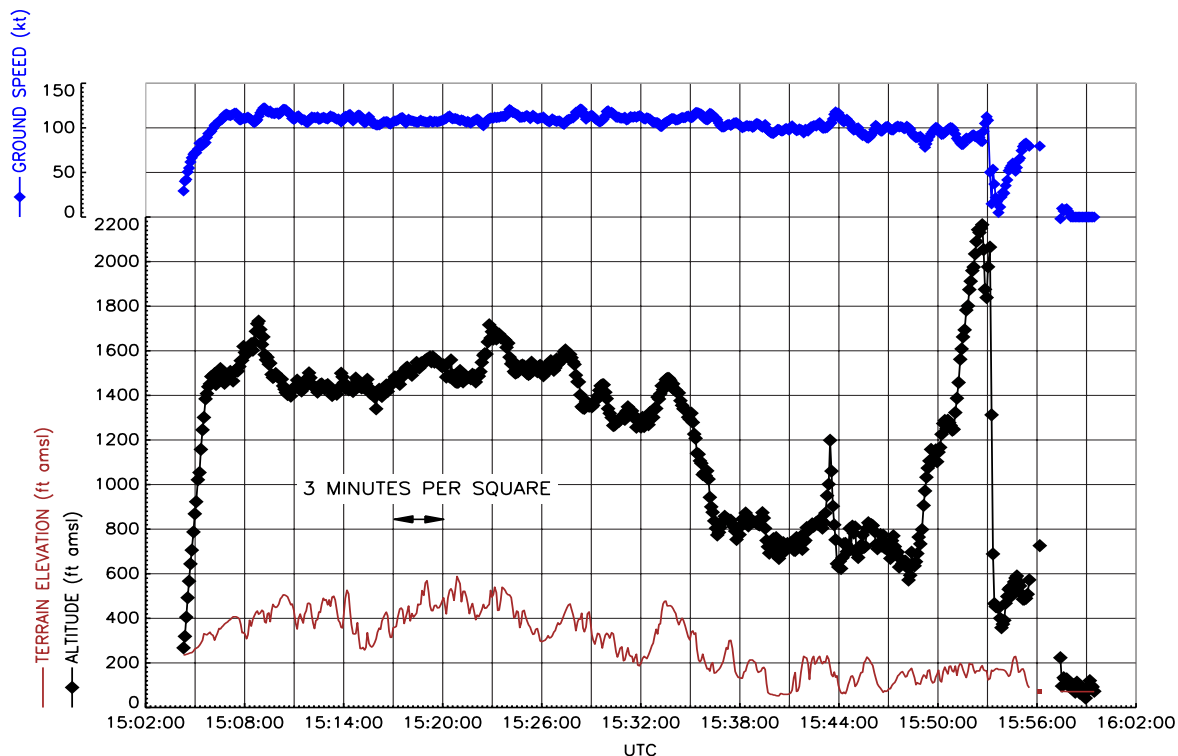
Figure 6

The flight from Bicester (see Figure 6) started at 1504 hrs on 27 June 2014. The helicopter initially tracked north at a height of approximately 1,000 ft agl. At 1533 hrs, it descended to approximately 600 ft agl, before descending further to approximately 400 ft agl. After this, the helicopter climbed to a height of approximately 2,000 ft agl over a four-minute period.

Flight from Bicester to Gamston

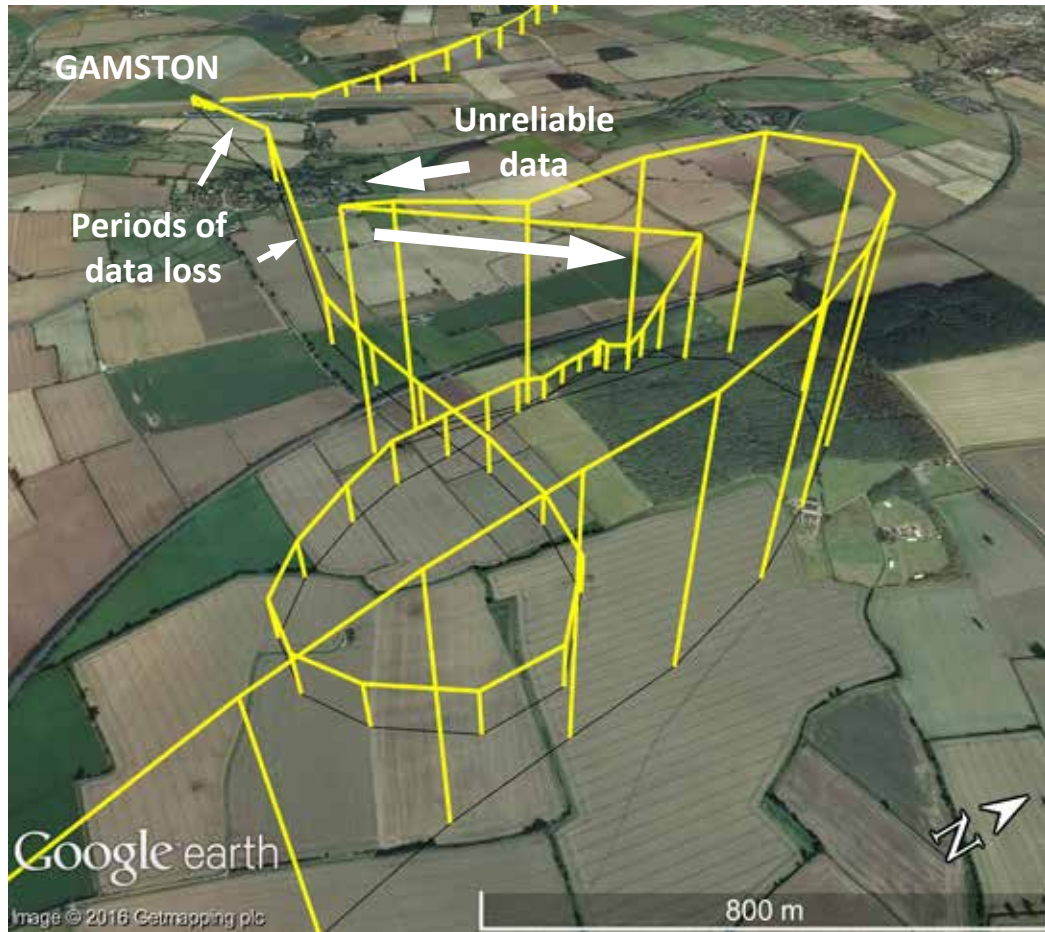
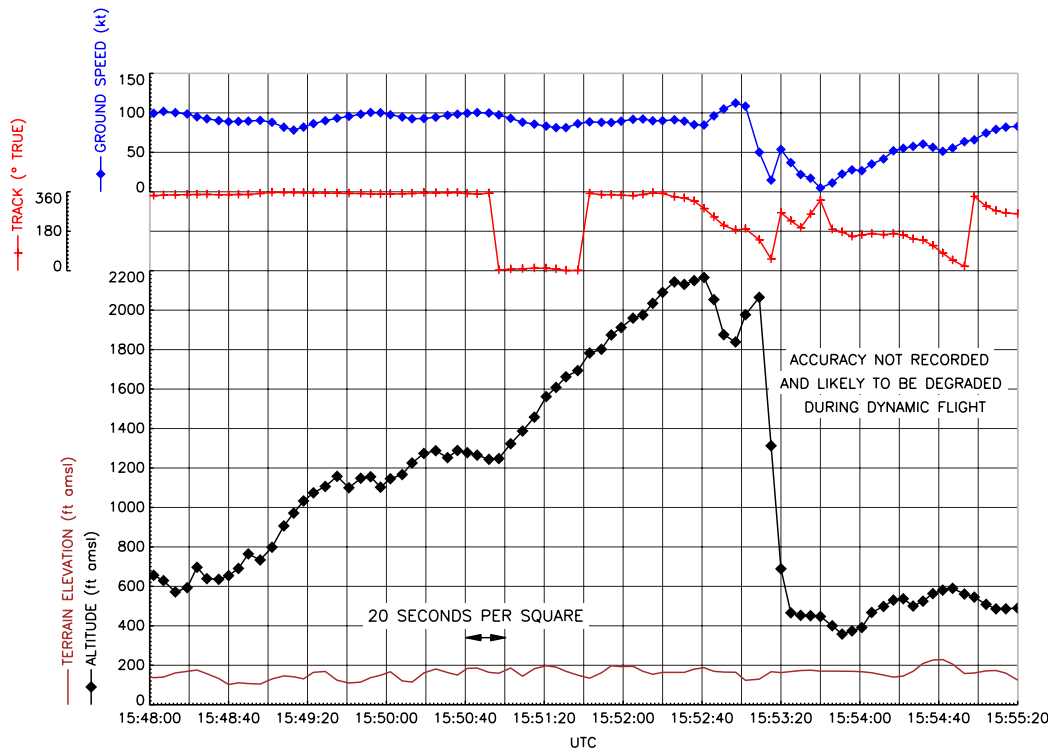
Figure 7
Loss of control

On reaching this height, the helicopter began a turn to the left, achieving a track change of 90° in approximately 20 seconds, and a descent was initiated (see Figure 7). As the data becomes less reliable under dynamic situations, it could not be used to accurately assess the dynamic manoeuvres that followed.

The highest rate of descent indicated by the data was 6,000 ft/min but this is unlikely to be accurate. The data indicated that the helicopter then flew level at a height of approximately 300 ft agl but with a reducing ground speed. The helicopter then descended further, the speed increased and the helicopter then climbed again. After control was regained, the aircraft proceeded to Gamston Airport.

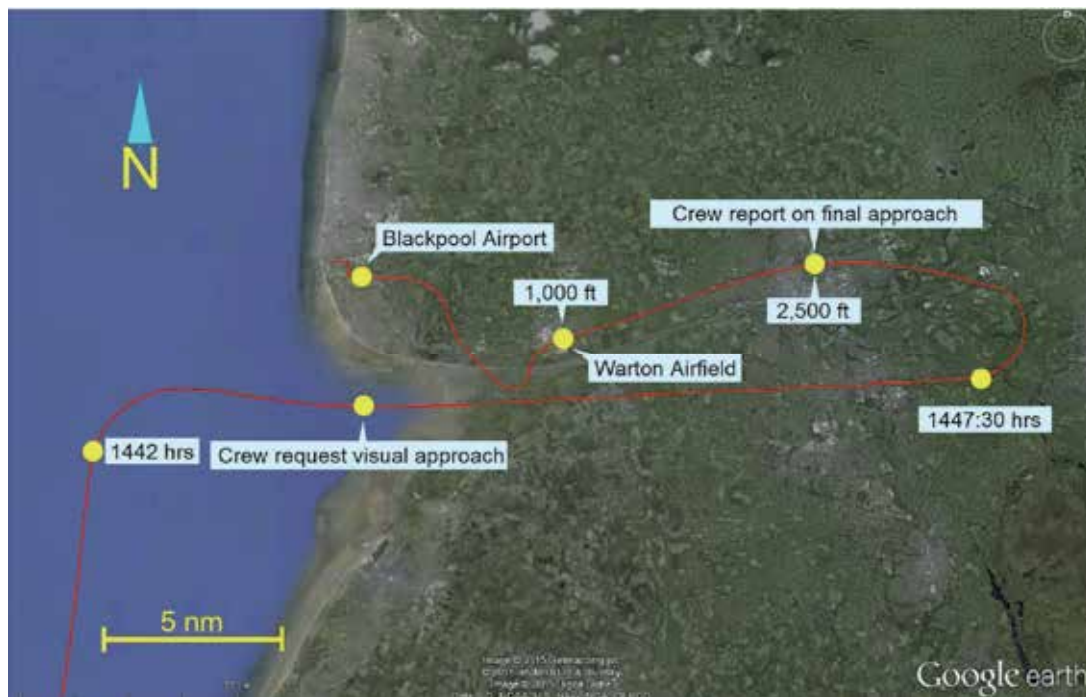
Figure 1

The aircraft started a right turn, initially towards the 'BPL', an NDB located at the airfield. However, the turn continued until the aircraft was on an easterly track (Figure 1), heading directly towards the POL VOR (33 nm east of BPL). At 1443 hrs, Blackpool ATC requested the range of the aircraft from the BPL, the reply was "THIRTY EIGHT MILES INBOUND PAPA OSCAR LIMA". This was acknowledged by ATC.

Radar track of approach to Blackpool Airport (altitudes amsl)

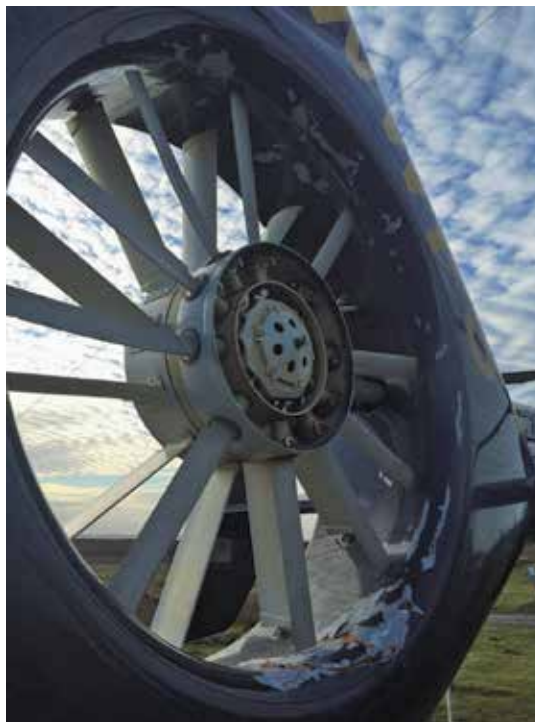
Figure 2

It was discovered that the fenestron unit on the tail of the helicopter had been significantly damaged. The hub cover had detached and was found distorted and lacerated (Figure 1). Also, a damaged piece of metal, measuring approximately 20 cm square, was found nearby. The pilot concluded that this had been sucked into the fenestron duct, hitting the hub cover. The hub then detached and one, or both, of these metal objects appeared to have been ingested by the fenestron fan. The duct surface was deeply cut, the paintwork was badly scraped and the fan blades bore signs of foreign object damage (Figure 2).

Damaged fenestron duct with hub cover missing
