FINAL REPORT

AAIU Synoptic Report No: 2009-010

Aircraft Type and Registration:	McDonnell Douglas MD-83, G-FLTM
No. and Type of Engines:	2 x Pratt & Whitney JT8D-219
Aircraft Serial Number:	53052
Year of Manufacture:	1990
Date and Time (UTC):	16 August 2007 @ 23.34 hrs
Location:	Santry Cross, near Dublin Airport
Type of Flight:	Public Transport
Persons on Board:	Crew – 6 Passengers – 112
Injuries:	Crew – Nil Passengers – Nil
Nature of Damage:	None
Commander's Licence:	Airline Transport Pilot's Licence (Aeroplanes), issued in Croatia
Commander's Details:	Male, aged 42 years
Commander's Flying Experience:	5,077 hours, of which 2,626 were on type
Notification Source:	Station Manager, Dublin ATC
Information Source:	AAIU Field investigation

SYNOPSIS

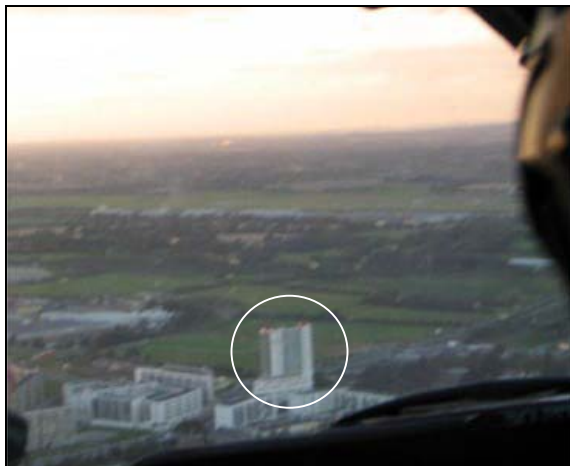
Photo No. 1:
16-storey building at Santry Cross
(under daylight conditions)

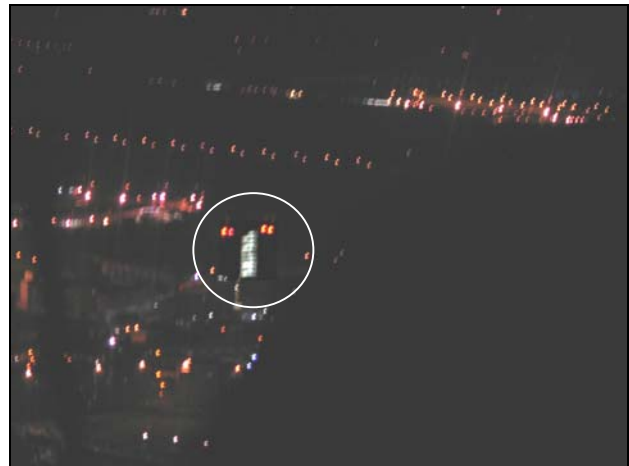
Photo No. 2:
16-storey building at Santry Cross
(under night conditions)

It was readily apparent to the Investigation that under night conditions, the lighting on the 16-storey building at Santry Cross, resembled the approach lighting on RWY 34. It was also evident that, under night conditions, the approach lighting can be difficult to identify due to extraneous lighting from the city environs on this approach. **Photo No. 4** illustrates the visual picture of the approach, at a distance of 5.5 nm to RWY 34, with the Hotel and Approach lights both visible. As this distance from the runway, the PAPI’s indicate all red as the aircraft is below the visual profile.

11. On becoming visual, under clear night conditions, the Flight Crew misidentified the lighting of the 16-storey building as being the approach lighting for RWY 34.

1. The fixed red obstacle lighting on the roof of the building, together with the white internal lighting, resembled the approach lights of the landing runway when viewed from the approach path.
2. The failure of the Flight Crew to follow Company Standard Operating Procedures.
3. Poor CRM of the Flight Crew.
4. Communication with Maintenance Crews on RWY 10-28 distracted the AMC at a crucial time during the approach, while the AMC was the sole occupant of the Tower.

2. That the IAA reviews the suitability of obstacle lighting as installed on the 52 metre-high building situated at Santry Cross, Dublin (**SR 17 of 2007**). The IAA responded as follows: *'The Authority accepts Safety Recommendation SR 17 of 2007. We have reviewed the lighting scheme installed on the 52m high hotel at Santry Cross and have been in contact with the Building Management Company to have the lights changed from fixed red obstacle lights to flashing red obstacle lights. The lighting has been operational in flashing mode since Monday, 8 October 2007'.*

The two *interim* Safety Recommendations (**Section 1.19.4**) made to the IAA were put in place without delay - the modification of the obstacle lighting to flashing red from 8 October 2007 reduced the risk of misidentification re-occurring as the PAPI indicators either side of the runway always appear as a combination of white/red, but steady lights.

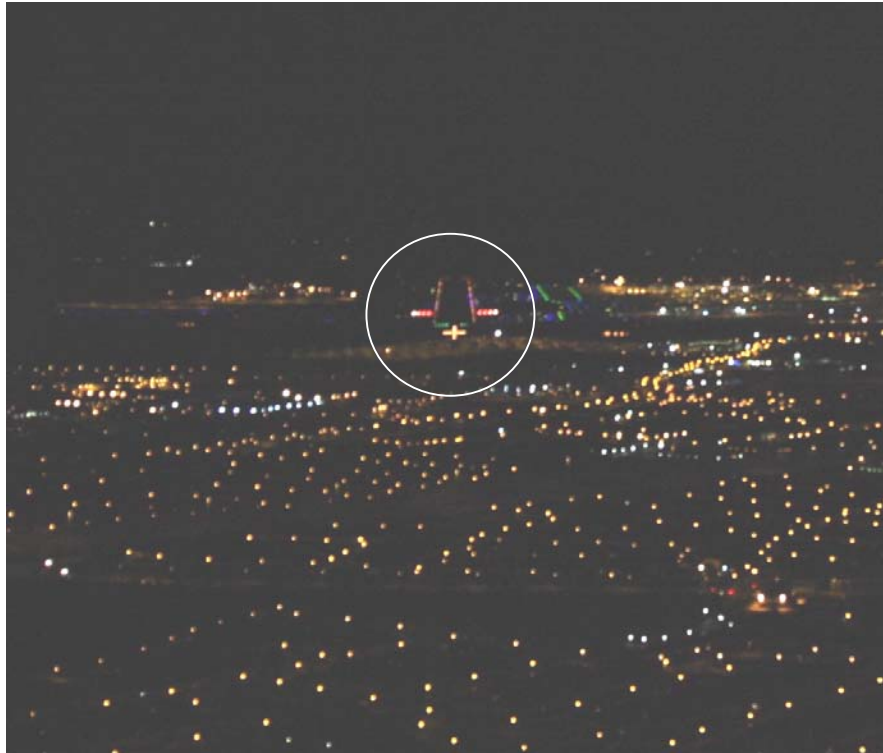
Photo No. 3 shows the RWY 34 Approach lighting as it would appear to an aircraft on finals. The aircraft is now on a 3-degree visual descent path, with guidance to the Pilot being provided by PAPI, indicating white/red either side of the RWY.

Photo No. 3: RWY 34 approach lights at 3 nm to the RWY

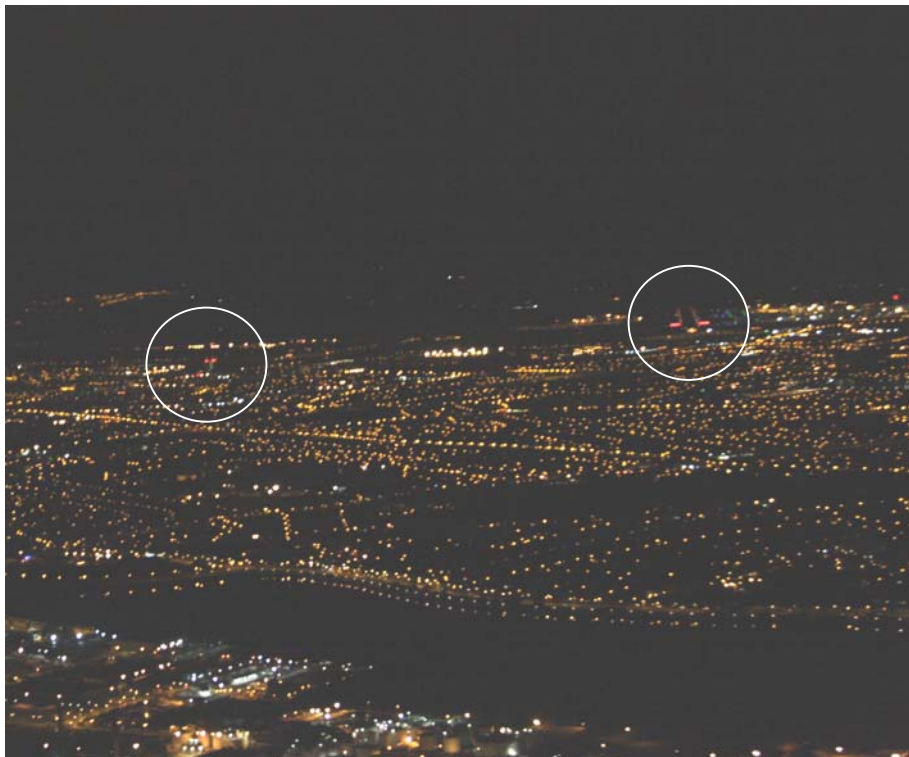
Photo No. 4: View of the RWY 34 approach at 5.5 nm to touchdown, with the Hotel building at Santry Cross indicated on the left of the photograph.

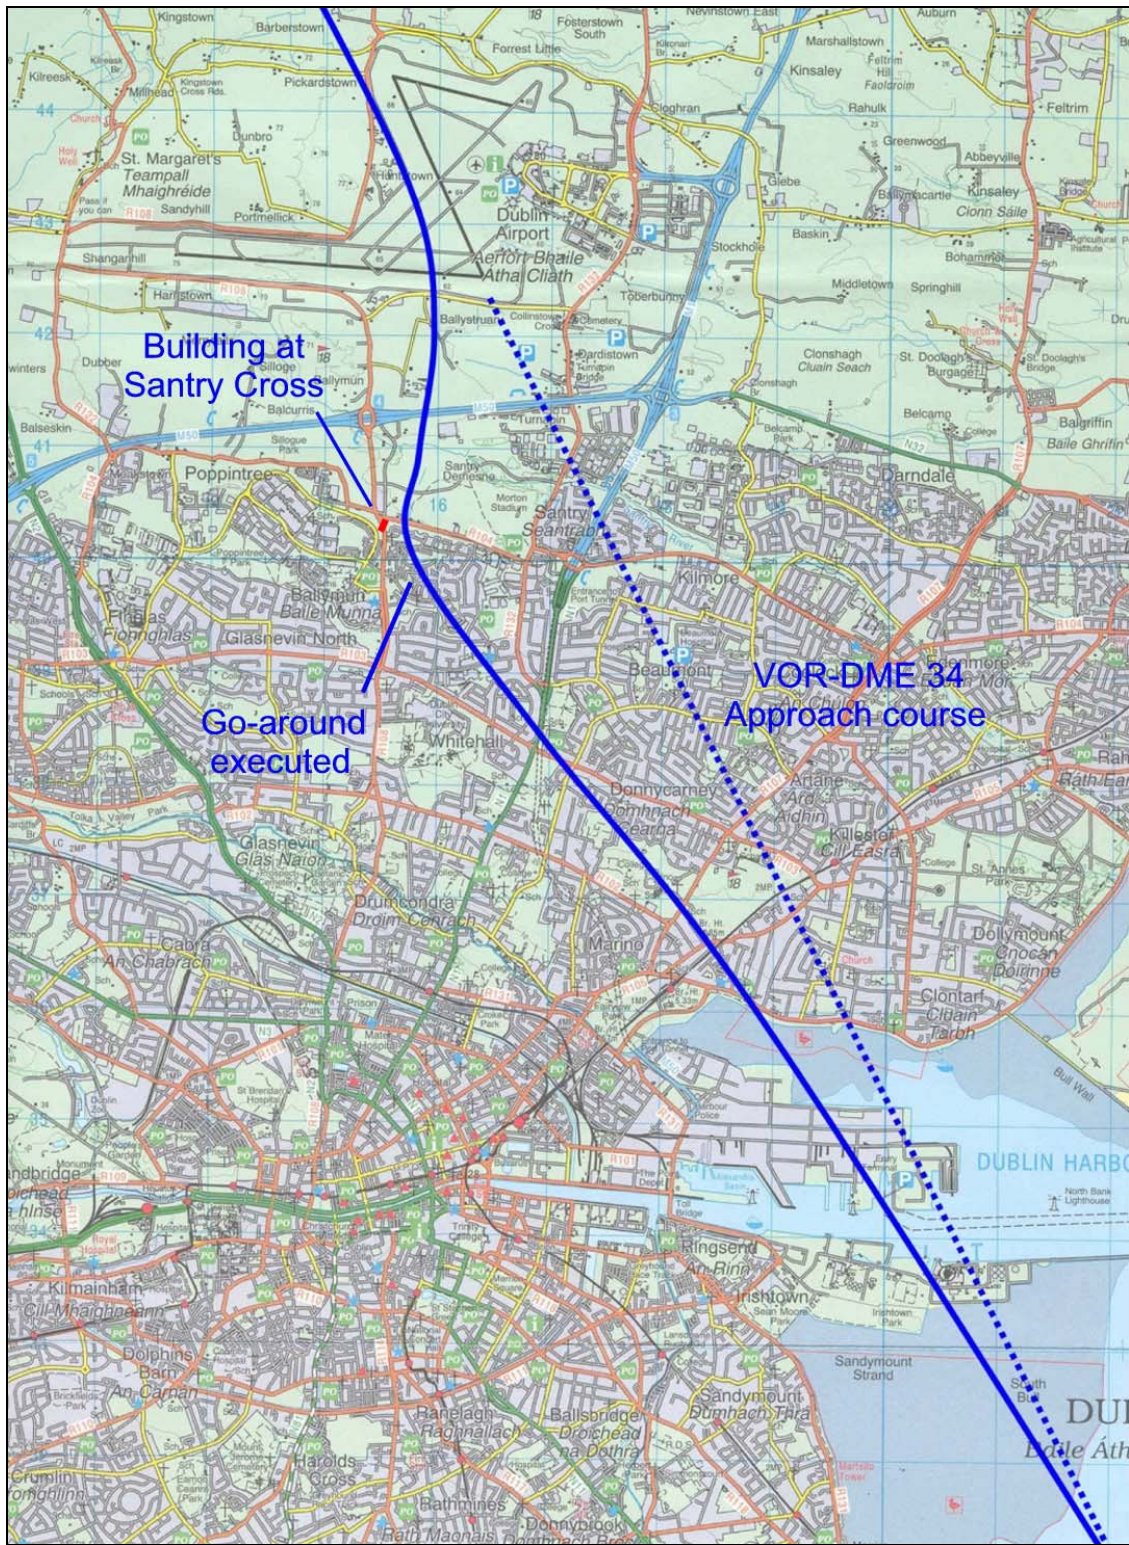
Flight track of FLT344E

The aircraft began to deviate from the final approach course at 4.8 miles from the runway threshold. At this point the aircraft was at 2,000 ft and a speed of 130 kts. At 1.3 miles the MSAW on the Radar screen activated. Passing 1,100 ft the aircraft turned further left tracking directly towards an obstacle identified as a 16-storey Hotel situated at Santry Cross. Radar information confirmed the aircraft had descended to below 600 ft AMSL before the go-around was executed. The aircraft continued to descend until instructed to turn and climb by the AMC in the Tower. At the point where the go-around commenced, the aircraft was approximately 520 metres (1,706 ft) from the building and 61 metres (200 ft) above it.

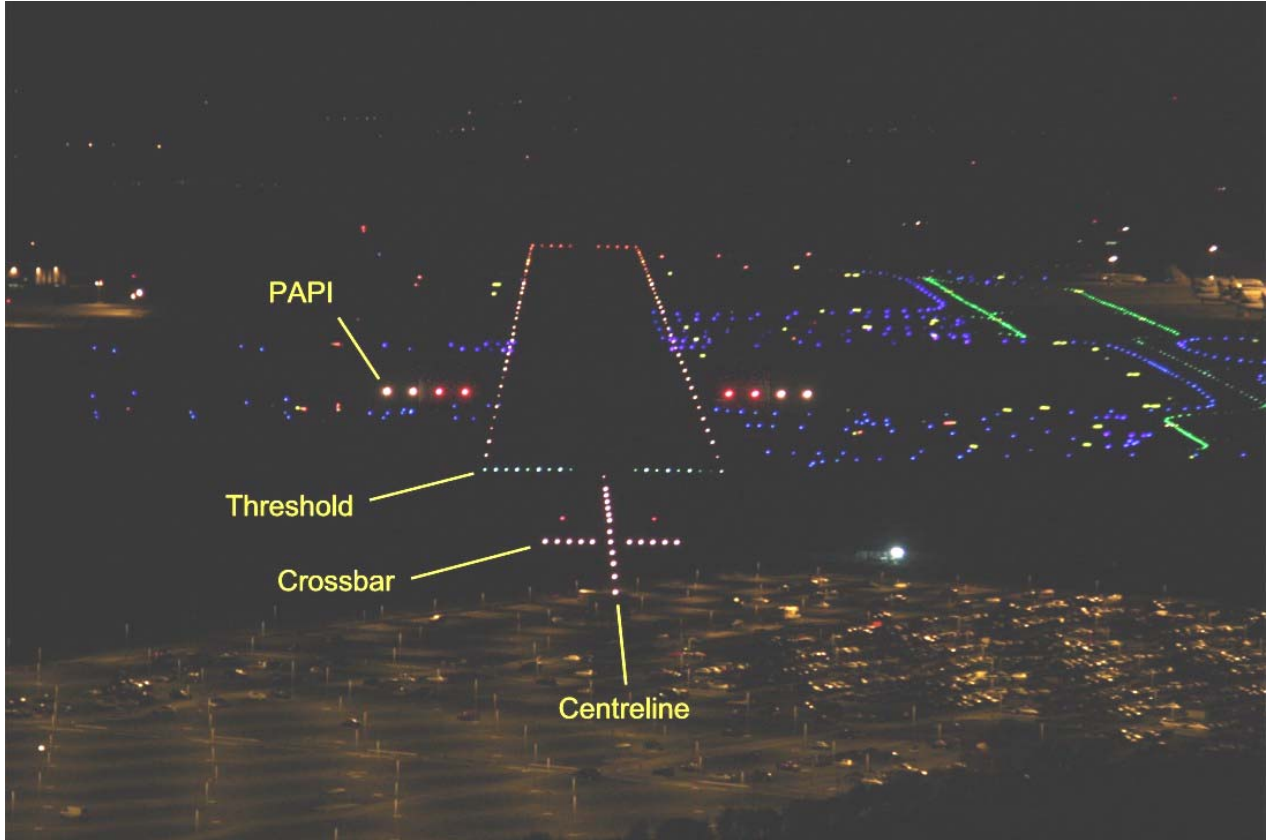
Detailed view of RWY 34 and Simple Approach Lighting System

The Investigation found that due to the extraneous lighting from the city environment, the approach lighting was not easy to identify at a distance. It is possible for ATC to increase the lighting brilliance, but this would be much too bright for Flight Crews completing the final approach and landing flare. Because the approach lighting, and by association the runway, are not easy to identify, it is therefore all the more important to complete the Instrument approach as per the procedure which brings the aircraft as close as possible to the landing position with due regard for centreline tracking and obstacle clearance. Had this procedure been followed, the aircraft would have in a position to land and the runway in full and clear view at 700 ft, the MDA. Even in poor weather, where the runway may not be visible at this height, a go-around is the mandatory action.

Detail view of the RWY 34 Simple Approach Lighting System.

The approach lights consist of a centreline of white lights with one crossbar. Threshold lighting is green in the direction of landing aircraft with white runway edge lights. Taxiway lights are blue. In the visual profile, the PAPI's should appear as pairs of white and red lights either side of the runway. From a distance, however, the PAPI's indicate all red as the aircraft is normally below the final approach profile of 3 degrees.
