ACCIDENT

(Aerospatiale) Eurocopter
AS 350B1, EI-IHL

Ballynacally, Co. Clare
Ireland

12 July 2007

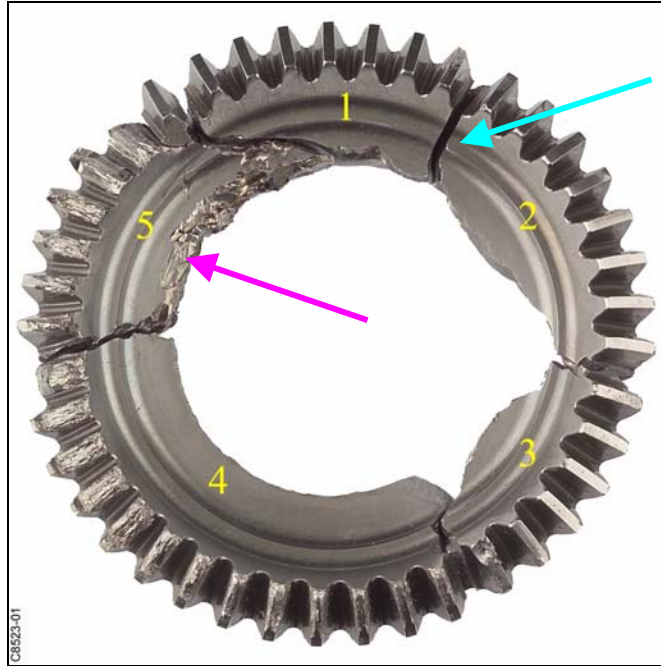
Modules M02, M03 and M05 were then removed. This allowed Module M01 to be disassembled, which revealed that the 41-tooth Bevel Gear had disintegrated (**Photo No. 1**). The fragments were photographed and loose metallic fragments preserved for examination.

Photo No. 1: Bevel Gear fragments recovered from Module M01

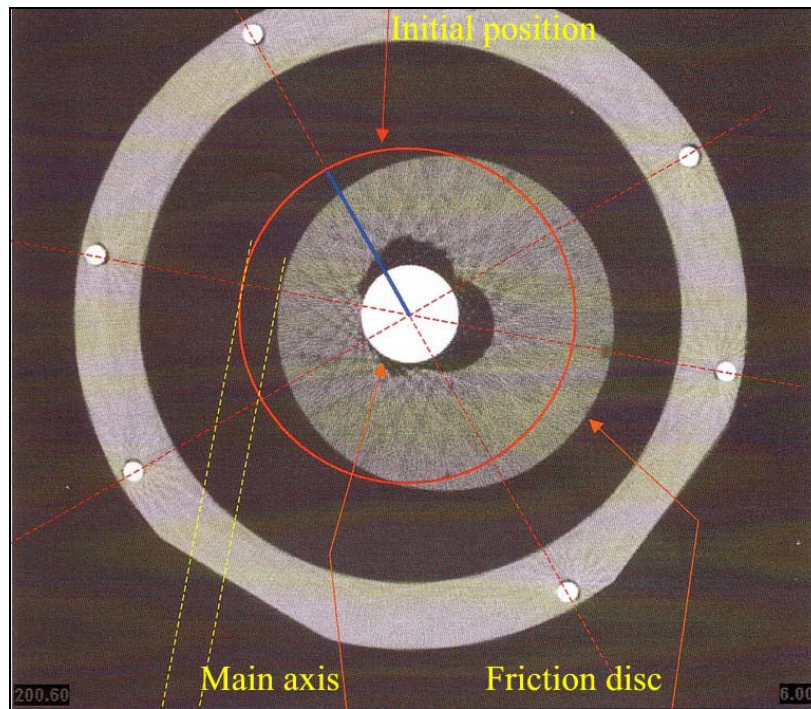
A visual inspection of the Starter-Generator revealed the friction disc of the damping system to be off-centre. To ascertain the extent of the offset, a series of cut-views using Tomography were carried out using equipment from TomoAdour Cie. This testing did not require any dismantling of the Starter-Generator. The source detector set was moved in 0.6 mm steps over a distance of 12 mm length parallel to the rotor shaft axis. Images were extracted in the range 5.40 mm to 6.60 mm and made available to the Investigation. The image in **Photo No. 2** shows a cross-cut of the Starter-Generator, with the rotor shaft at the centre appearing as a white disc. Surrounding the rotor shaft, in grey, is the friction disc. Note the damage to the centre of the disc and the displacement from its normal position, indicated by the red circle. The damping plate was found to be approximately 7.2 mm off-centre.

Photo No. 2: Image of damaged Starter-Generator friction disc

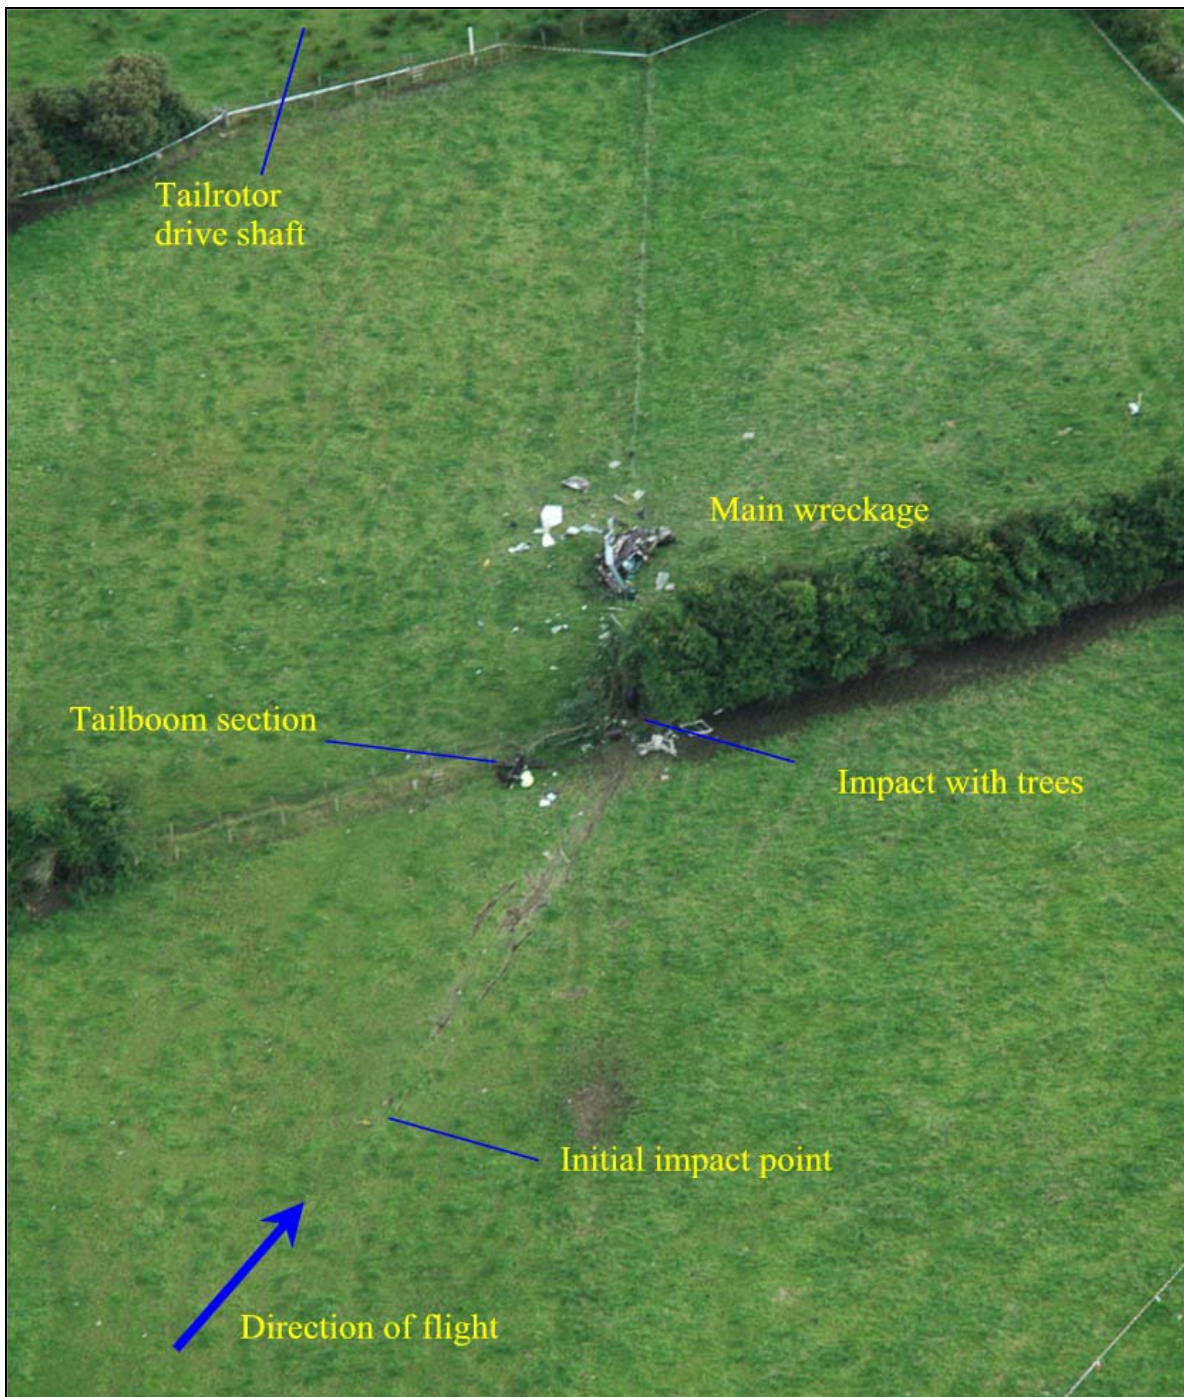
The wreckage, except for the aft tail boom structure, was concentrated in a single area. A trail of witness marks and pieces of structure revealed that the helicopter impacted heavily, at speed, on its main landing skids. The underside of the helicopter was severely damaged during the impact sequence. Sloping terrain to the right of the impact line showed evidence of two main rotor blade strikes. The helicopter continued forward with a considerable velocity and impacted into a hedgerow, which contained a line of mature trees. This impact resulted in the disintegration of the entire front cockpit of the helicopter. The wreckage pattern included the windscreen centre support, windshield transparency pieces, both main doors and panels, together with numerous charts and loose items from the cockpit. The aft section of the tail boom including the entire tail rotor assembly was sheared off. The wreckage, still with considerable momentum, was then propelled into an adjoining field where it came to rest, in an almost upright position, approximately 10 metres from the tree impact. A section of the tail rotor drive was found approximately 58 metres further on from the main wreckage (**Appendix B**).

Photo B3: Aerial view of impact point and wreckage (*GASU Photo*)

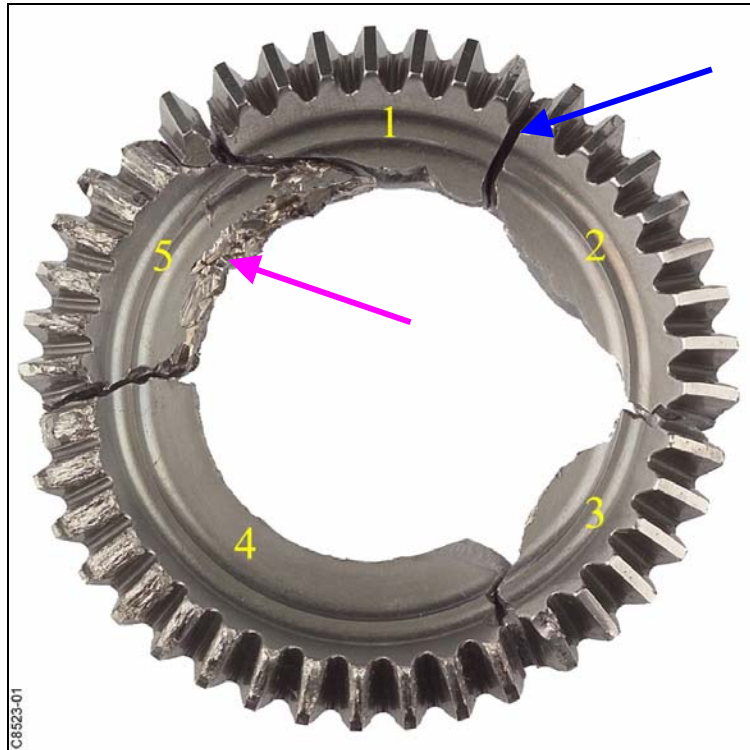
Photo C4: Identification of Bevel Gear sectors

initial fracture on tooth space bottom land (blue arrow) and area of web showing indications of alternate bending (magenta arrow)

The observation of the 41-tooth Bevel Gear shows that the web fractured in five sectors. The fracture path between the web occurs mainly in the web fillet radius (see **Photo C4**).

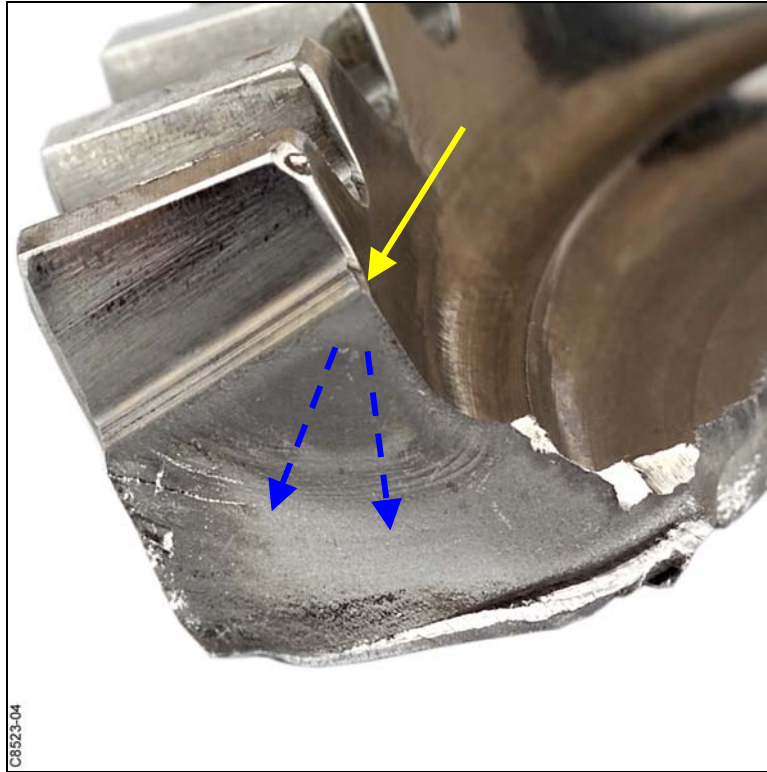
Photo C5: Macrographic observation of Sector 2

The crack origin region is indicated in yellow, the direction of propagation is indicated in blue.

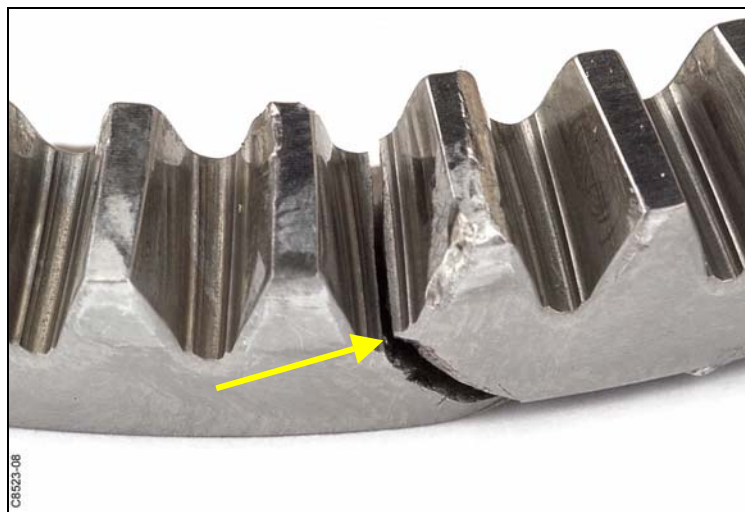
Photo C6: Crack initiation between Sectors 1 and 2 consistent with maximum stress on starting

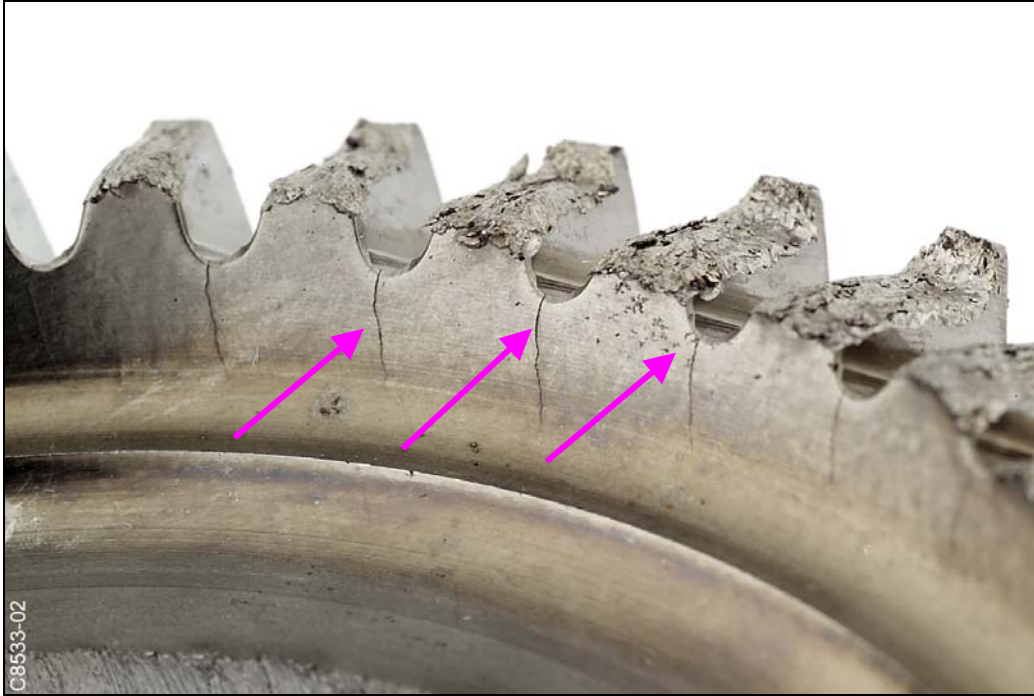
Photo C7: Macrographic observation of Sector 5

Note the presence of secondary cracks on almost all the tooth space bottom lands.

The crack origin region is in the bottom land fillet radius, slightly offset on the starting flanking side. Heavy damage of the tooth tips resulting from the overlapping of the teeth with those of the 23-tooth gear after gear meshing was lost. The direction of the primary crack indicates that this was propagated during the starting cycle.

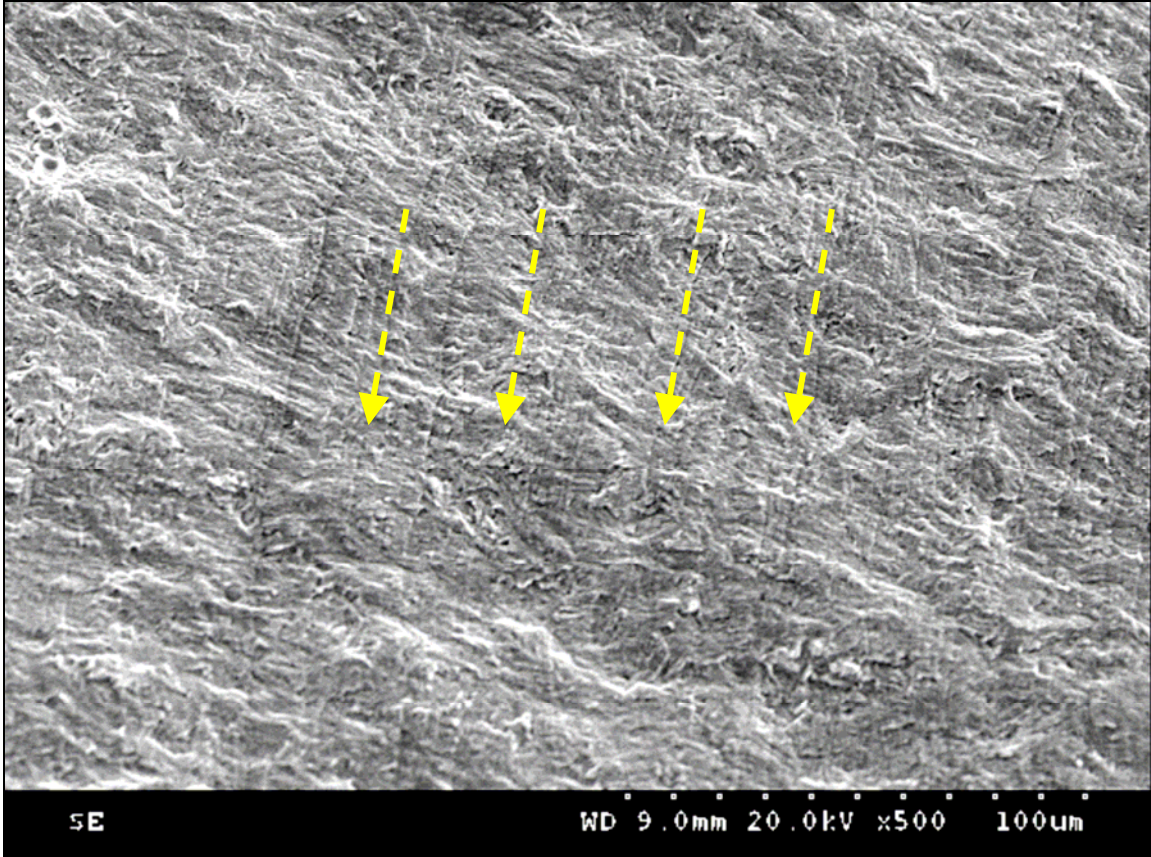
Photo C8: Fractographic examination of Sector 2, indicating presence of fatigue striations

The fractographic observation under the Scanning Electron Microscope (SEM) of the fracture surface in sector 2 shows a fatigue propagation pattern.

The observation of the fracture surface shows two opposite lunulae that are typical of exposure to alternate bending stresses and of a progressive cracking process.

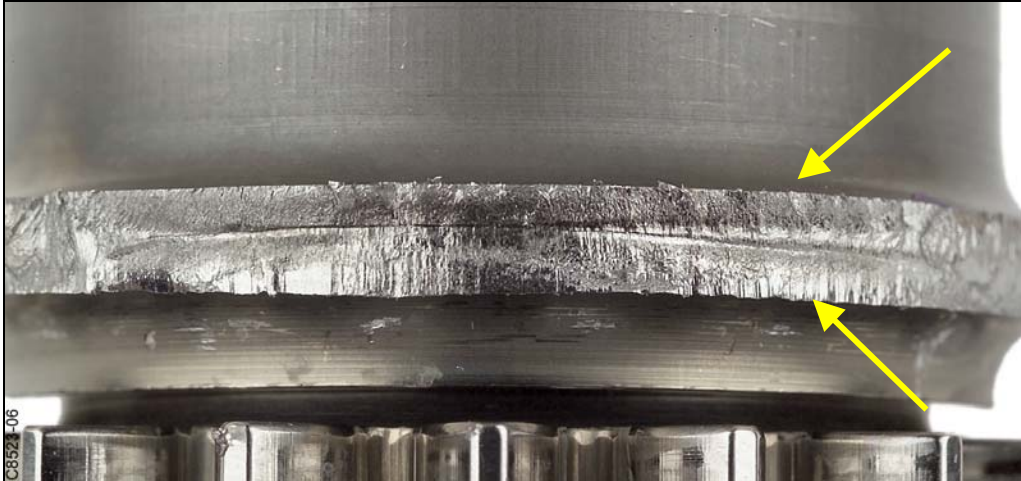
Photo C9: Fractographic examination of the fracture surface on Sector 5, indicating the crack origin regions at the end of the fillet radii.

The fractographic examination of the fracture surface on sector 5 located on the rim confirms the fracture under alternate bending stress. The crack origin regions are located at the end of the fillet radii between the hub and the web. No metallurgical anomaly was observed in the crack origin regions.

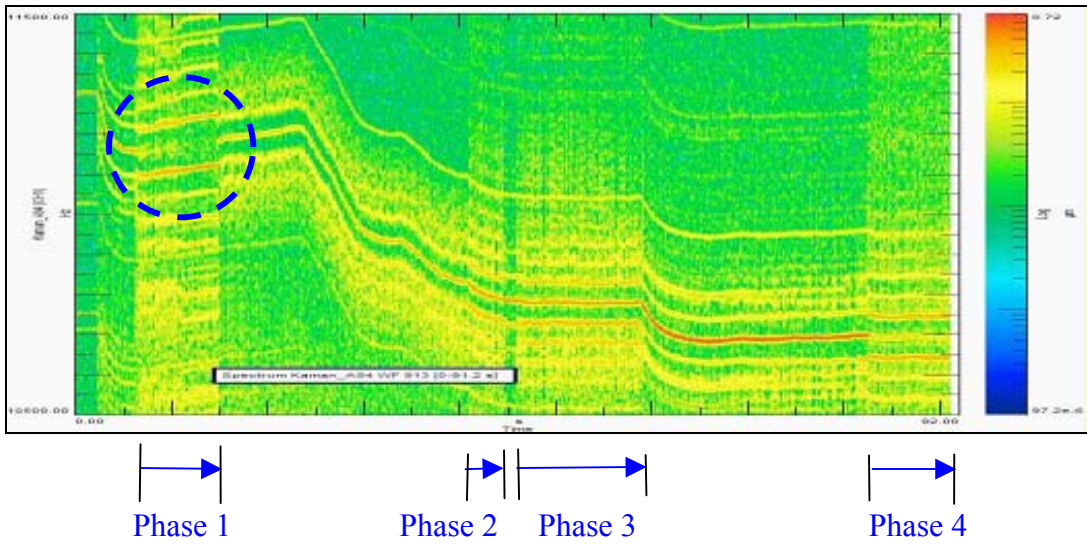
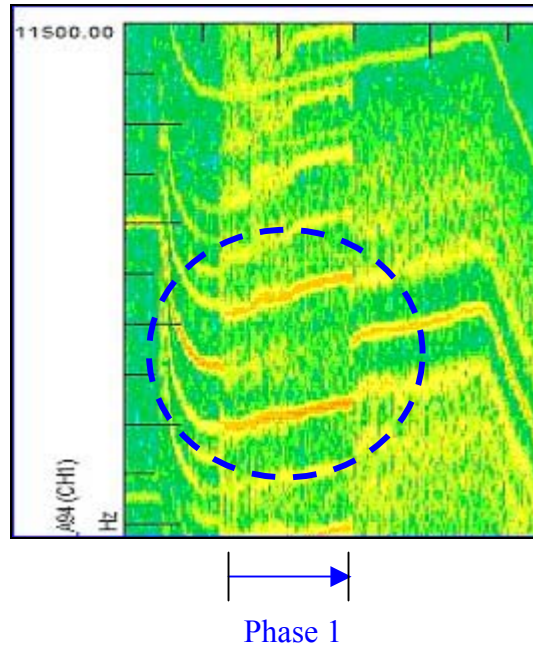
On the 41-tooth gear similar sidebands appear around order 41 with a particularly remarkable phenomenon; the attenuation of order 41 signature (**Figure E8** and **Figure E9**) or even, in certain cases, the disappearance (in **Phase 1**) of order 41 signature and replacement by sidebands (see **Figure E10** and **Figure E11**). This means that during this phase, the gear no longer meshes at its typical teeth passage frequency but at the frequency of the sidebands, which indicates gear flapping.

Figure E9: Order 41 frequency (+ sidebands) measured at the A94/Gear Z41 speed and position sensor (for an N1 variation between 68.4% and 64.6%)

Figure E10: Periodic loss of Order 41 response in Phase 1 (Indicates Gear flapping and meshing anomaly)

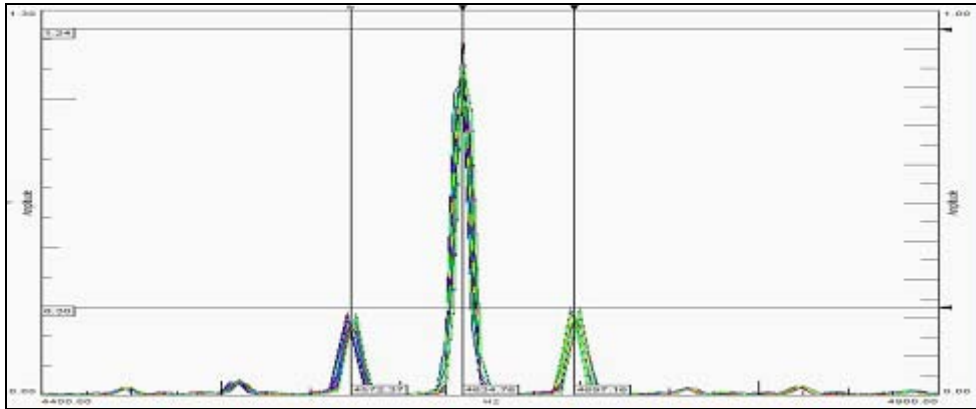
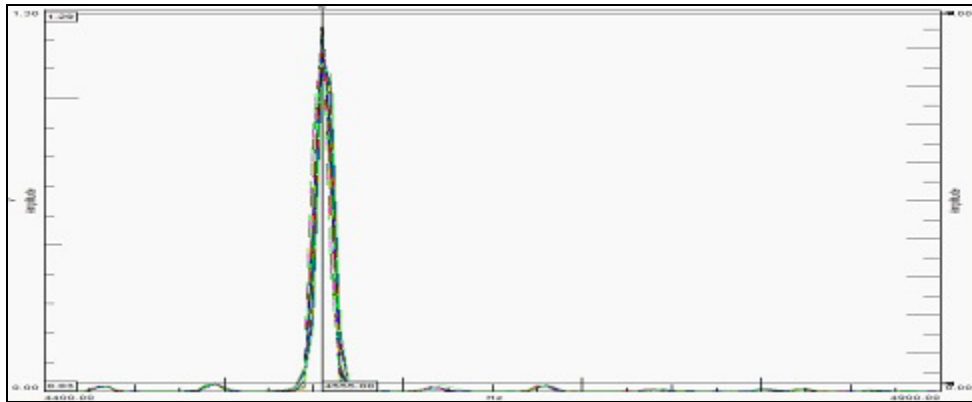
Figure E14: Damping system locked (over tightened)
(Frequency of Order 37 + sidebands,
and measured at Breather Gear sensor at an N1 speed of 67.7%)

Figure E15: Damping system with correct adjustment
(Frequency of Order 37 + sidebands,
and measured at Breather Gear sensor at an N1 speed of 66.4%)

With a correctly adjusted damper, the amplitude of the side bands is significantly reduced: it represents only 2.3% of the amplitude of Order 37. However, with a blocked (over tight) dampening system, the amplitude of the sidebands is up to 25% of the amplitude of Order 37.

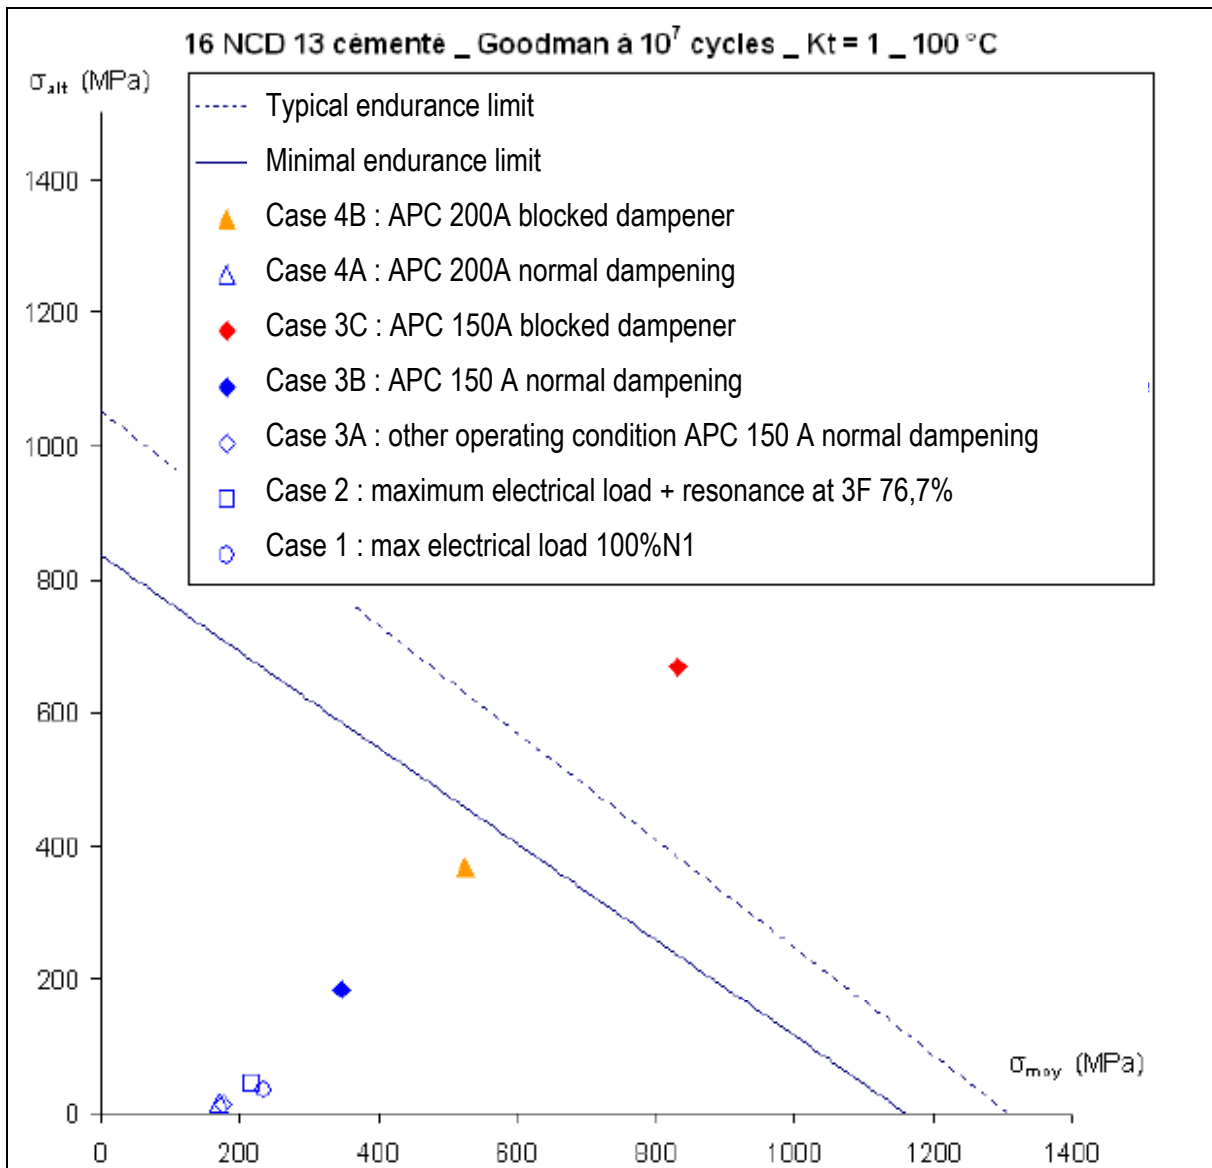
In parallel, a 3D analysis model of the 41-tooth Bevel Gear was used by the engine manufacturer to evaluate the stress in the part under resonance conditions and also in the quasi-static conditions corresponding to the rotation and the teeth meshing under torque. This model was used to translate the displacement measurements obtained on the engine Bevel Gear into stress values. The Goodman diagram in **Appendix F** illustrates these values.

Figure F16: Plot of Stress values

The above Goodman diagram represents the stress values calculated by using a 3D analysis model, which translates the displacement measurements obtained under test conditions into stress values.
