FINAL REPORT

AAIU Synoptic Report No: 2007-027

Aircraft Type and Registration:	AS 350B, G-JESI
No. and Type of Engines:	1 x Turbomeca Arriel 1B
Aircraft Serial Number:	1205
Year of Manufacture:	1980
Date and Time (UTC):	23 September 2006 @ 18.10 hrs (19.10 hrs Local)
Location:	Dunkerrin, Co. Offaly
Type of Flight:	Public Transport
Persons on Board:	Pilot - 1 Passengers - 4
Injuries:	Pilot - None Passengers - None
Nature of Damage:	None
Commander's Licence:	UK ATPL (Helicopter)
Commander's Details:	Male, aged 59 years
Commander's Flying Experience:	15,000 hours (including 43 hours on type)
Notification:	Station Manager, ATC Shannon.
Information Source:	AAIU Incident Report Form submitted by Pilot.

SYNOPSIS

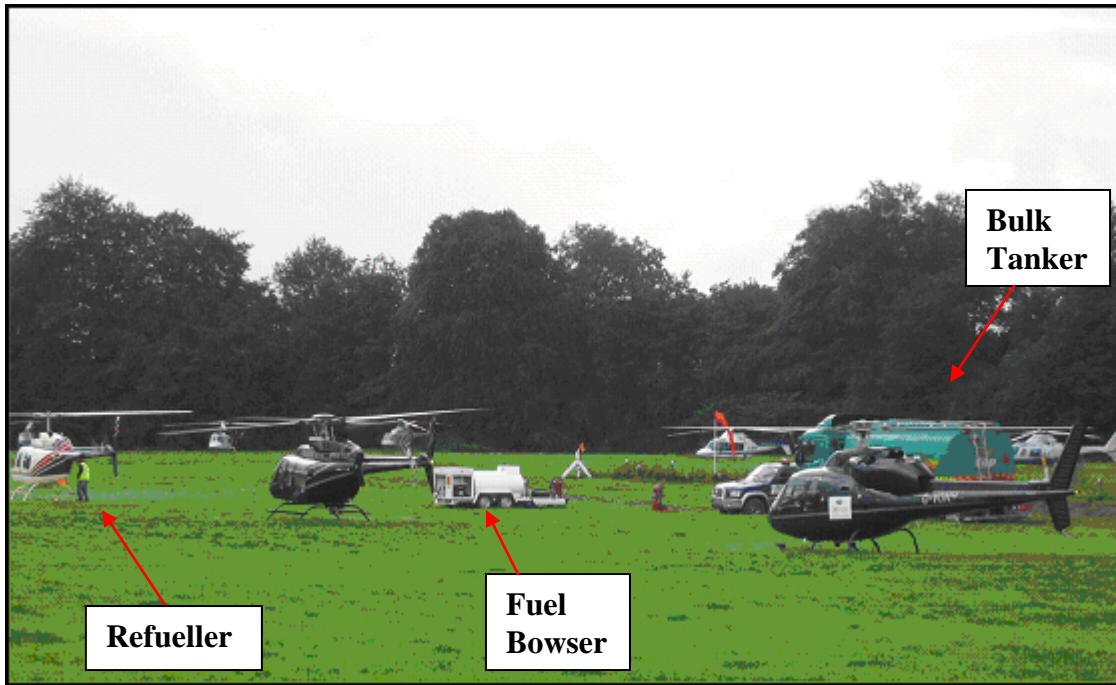
Photo 1: Overview of refuelling with rotors turning

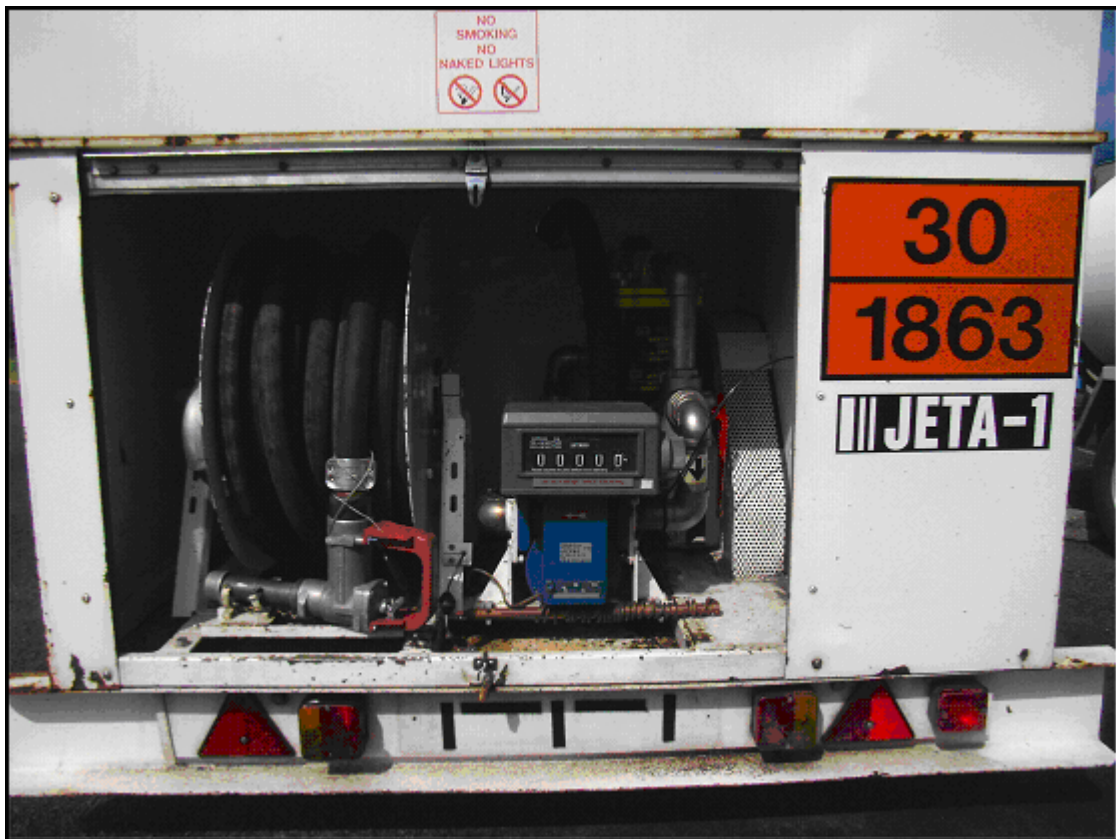
Photo 2: Rear of fuel bowser

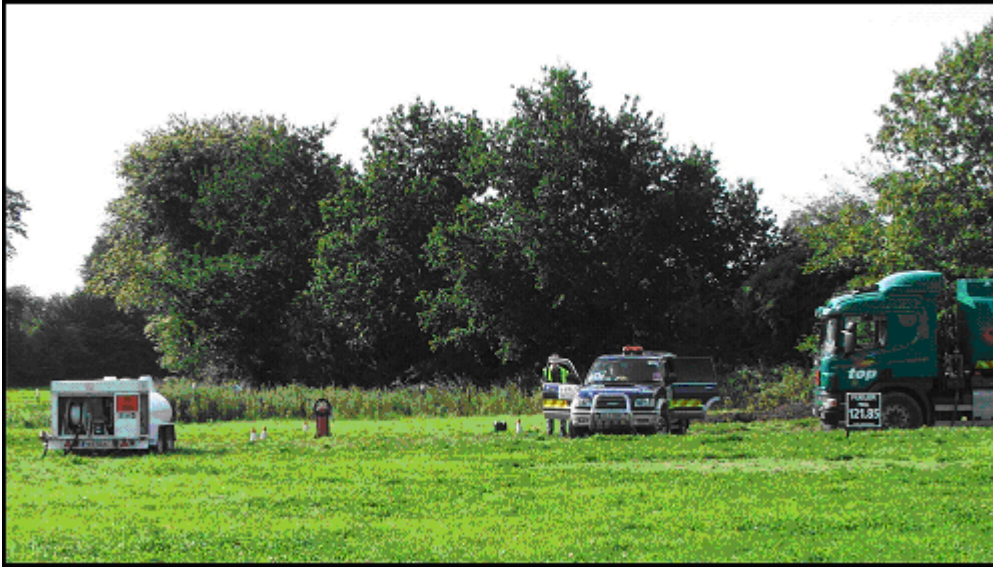
Photo 3: Fuel bowser on left, main bulk fuel tanker on right.

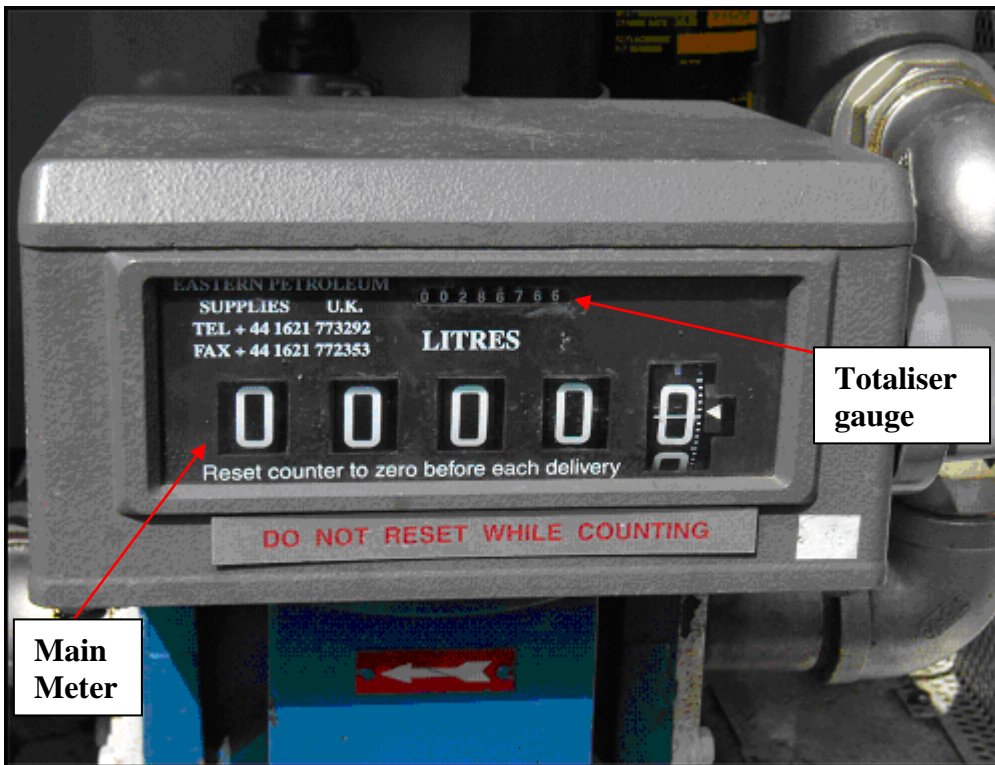
11. Final verification of this fuel uplift would normally be made by subtracting the Meter Reading Finish from the Meter Reading Start. However, these figures were not inserted in the Fuel Delivery Notices/Invoice and thus it not possible for the Investigation to be absolute in this case. In addition, the Start and Finish readings were not taken down in either the immediately previous or the subsequent helicopter refuelling to G-JESI. As a result, there was no continuity of Totaliser readings. Nor was there a carryover Totaliser reading from the last flight on the previous evening. Thus, it can be seen that this wholly manual method of recording uplifts was clearly deficient.

Photo 4: Fuel Bowser Delivery Meter
