Air Accident Investigation Unit Ireland

ACCIDENT REPORT
Irish Air Corps 265, PC-9(M)
Cornamona, Connemara, Co. Galway
12 October 2009

AAIU Formal Report No: 2011-016

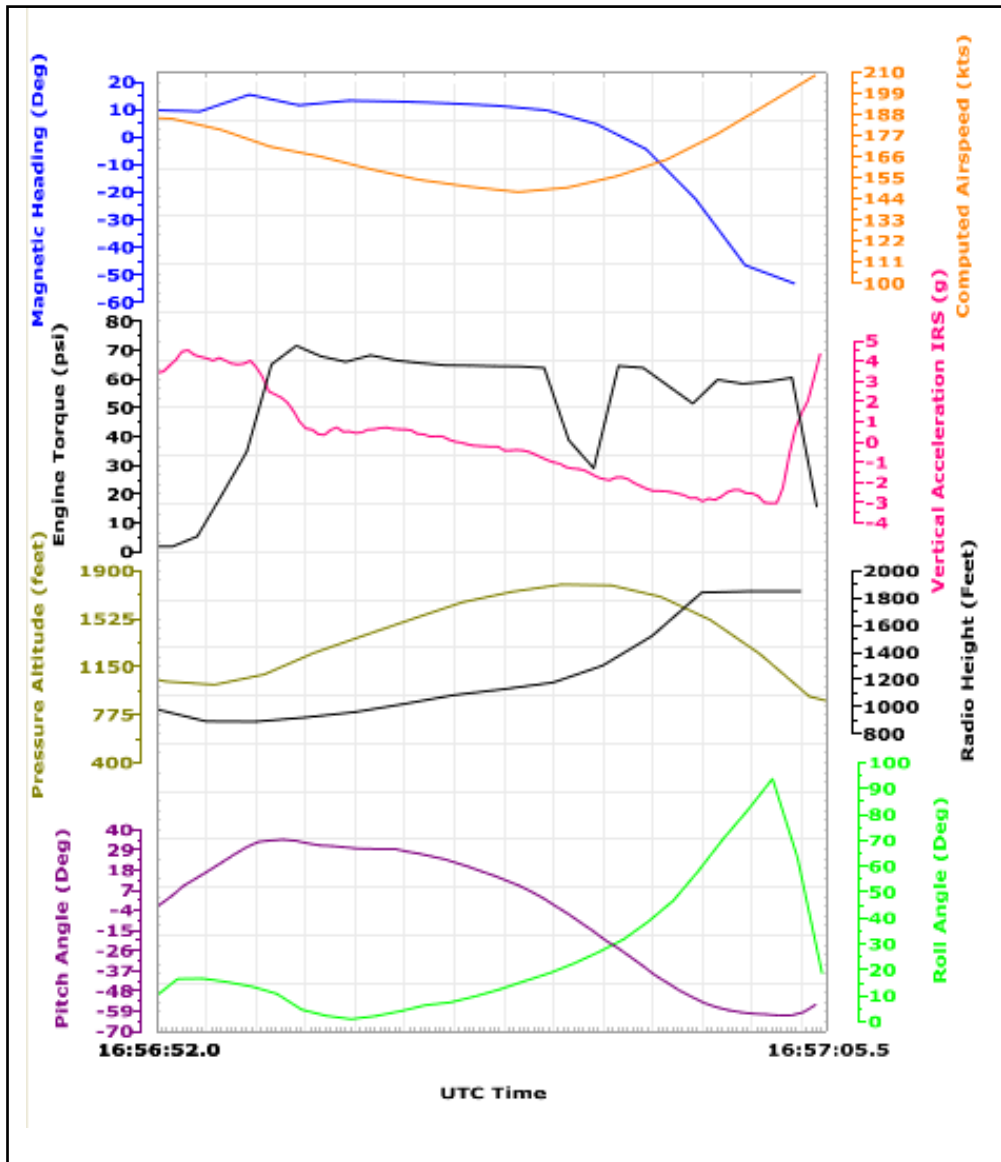
Figure No. 2: FDR Data extract showing the final 13.5 seconds

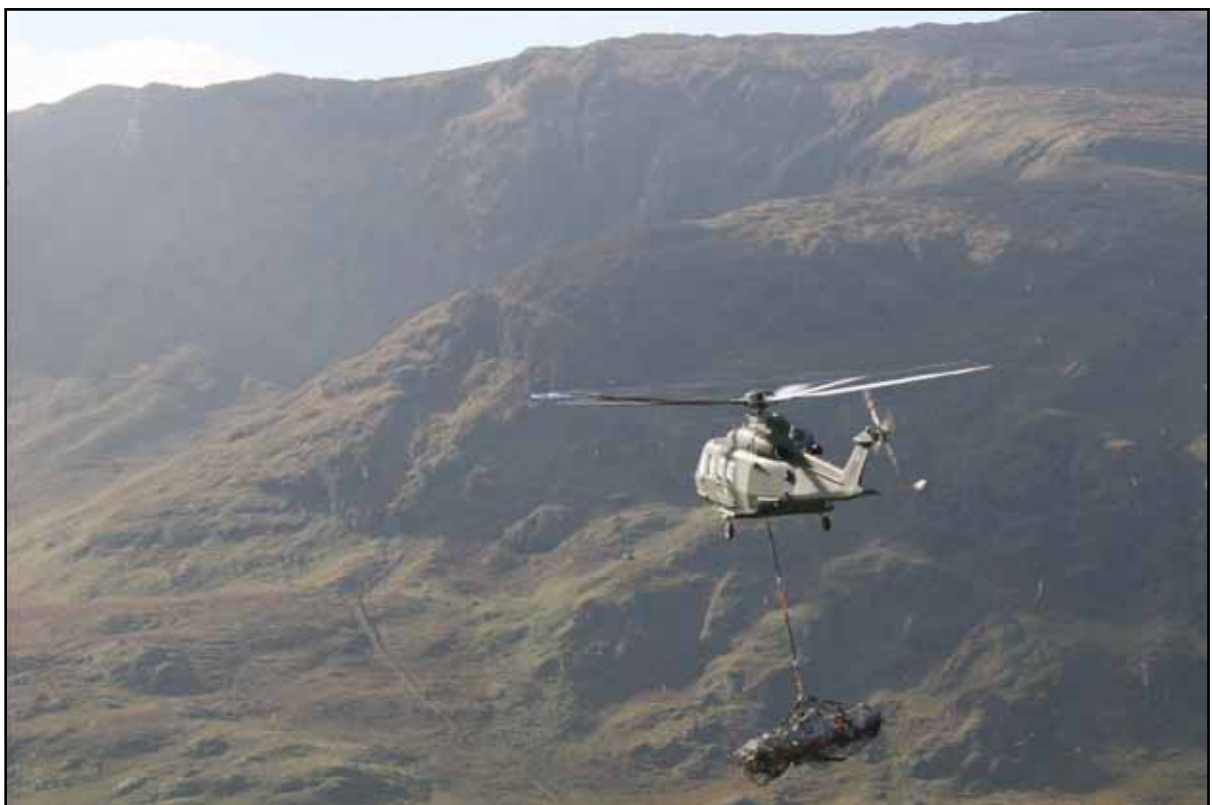
Photo No. 2: Recovery operation showing the nature of the terrain in the valley

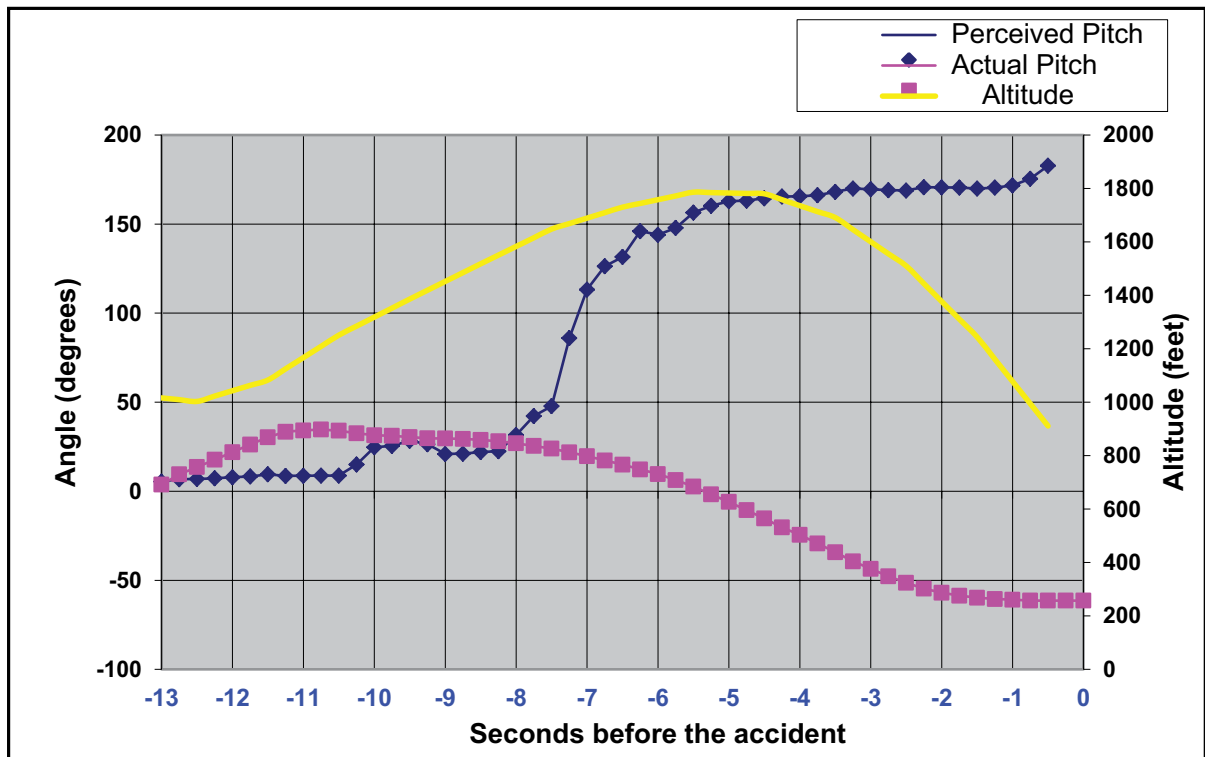
The FDR data elevator position showed that an increasing nose down displacement was commanded over -9 to -6 seconds prior to impact, which resulted in a continual reduction in pitch attitude (see **Figure No. 4** and **Appendix D** for detail). The normal (Gz) and longitudinal (Gx) F265 FDR acceleration data were then used to calculate the magnitude and direction of the Gravitoinertial vector during the final manoeuvre thus giving the perceived pitch attitude at that moment. This resulted in the blue line in **Figure No. 4**.

Figure No. 4: Perceived versus Actual Pitch, with Altitude

This plot of the Gravitoinertial force indicates that a False Climb Illusion probably commenced at 8 sec before impact. This False Climb Illusion rapidly progressed into an Inversion Illusion over a very short period.

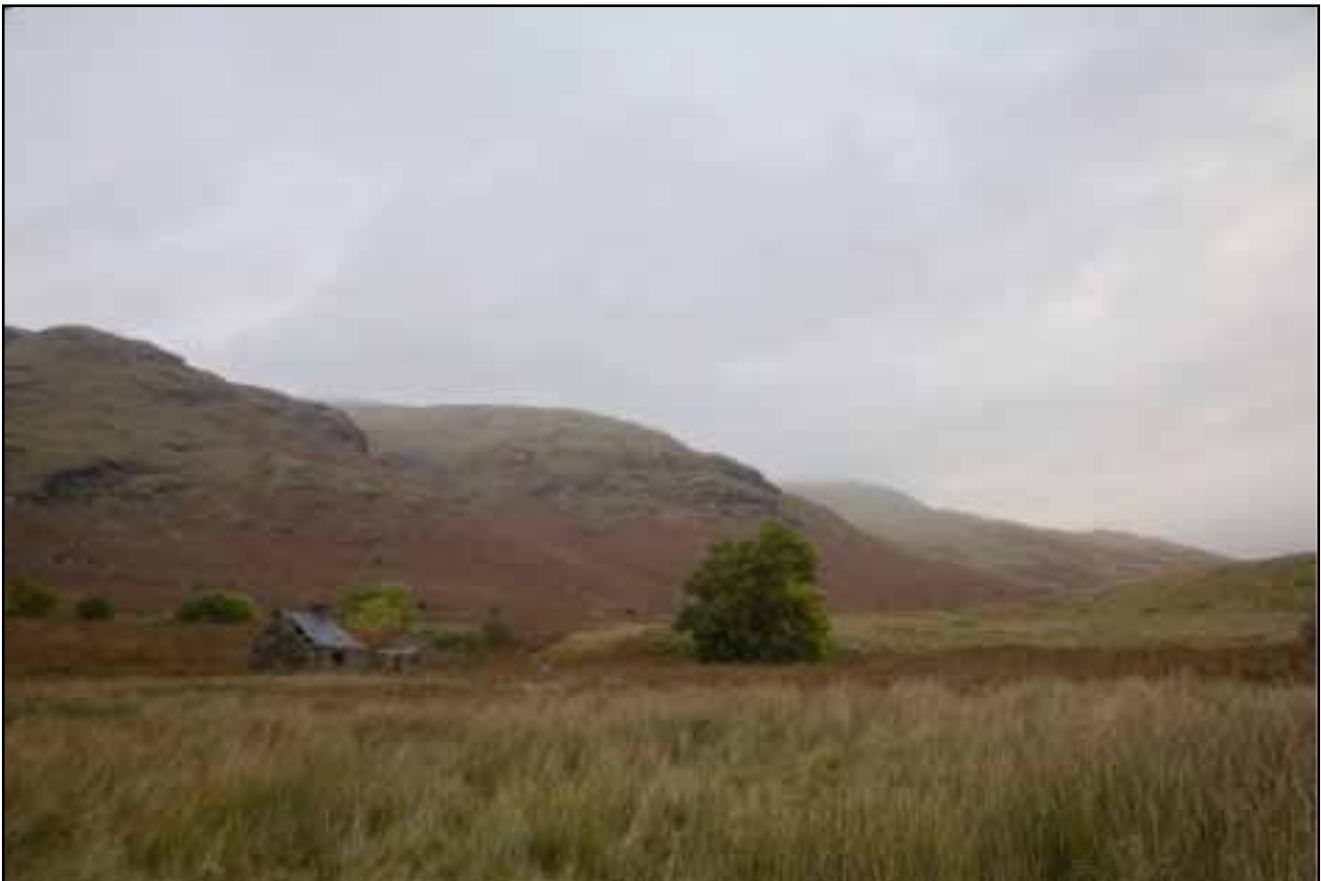
(Position N53° 33.076', W009° 33.076')

Photo No. 3 was taken 17 minutes before the accident, facing northeast (approximately in the direction from which the aircraft was approaching the area). The terrain shown rises to 1,155 ft AMSL

Photo No. 3: Time 16.39 hrs, facing northeast

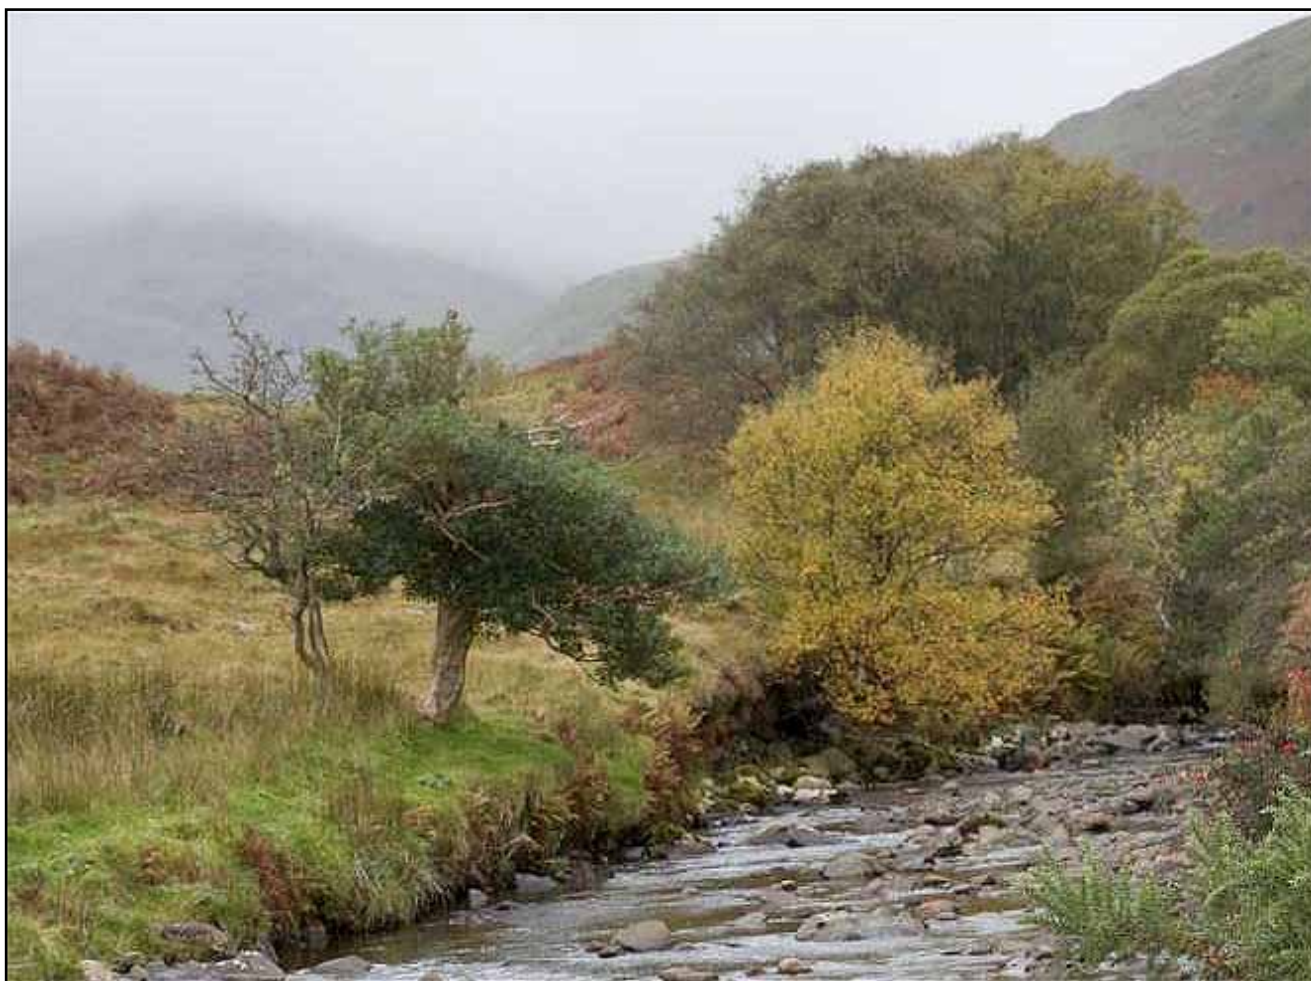
(Position N53° 33.076', W009° 32.925')

Photo No. 4 was taken 4 minutes before the accident, northwest of the accident site facing west. The obscured terrain west of this location rises to 1,900 ft AMSL.

Photo No. 4: Time 16.53 hrs, facing west

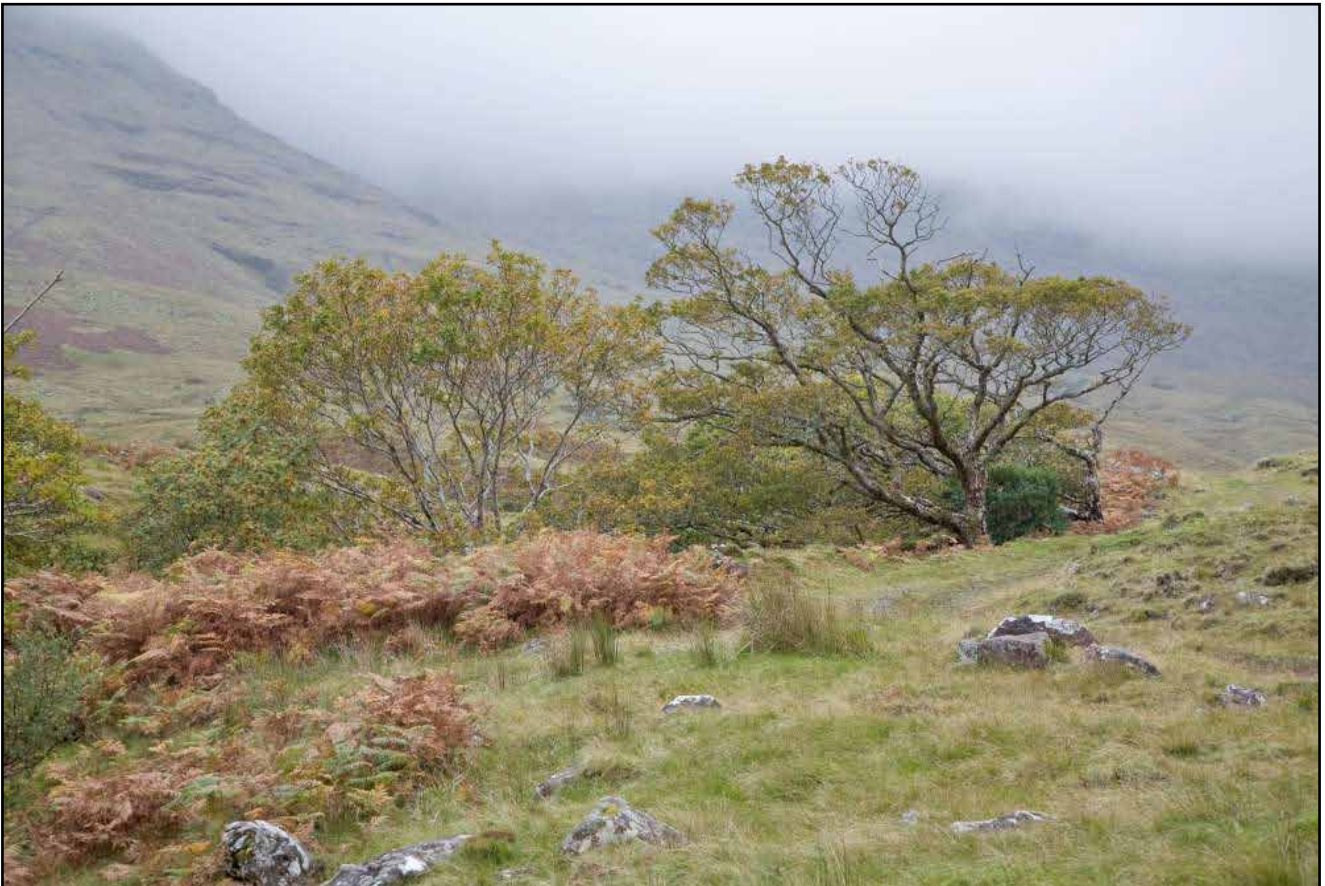
(Position N53° 33.129', W009° 33.108')

Photo No. 5 was taken 3 minutes after the accident, northwest of the accident site facing west southwest. The obscured terrain rises to 1,600 ft. This location is approximately 2 NM northwest of the accident site.

Photo No. 5: Time 17.00 hrs, facing west southwest

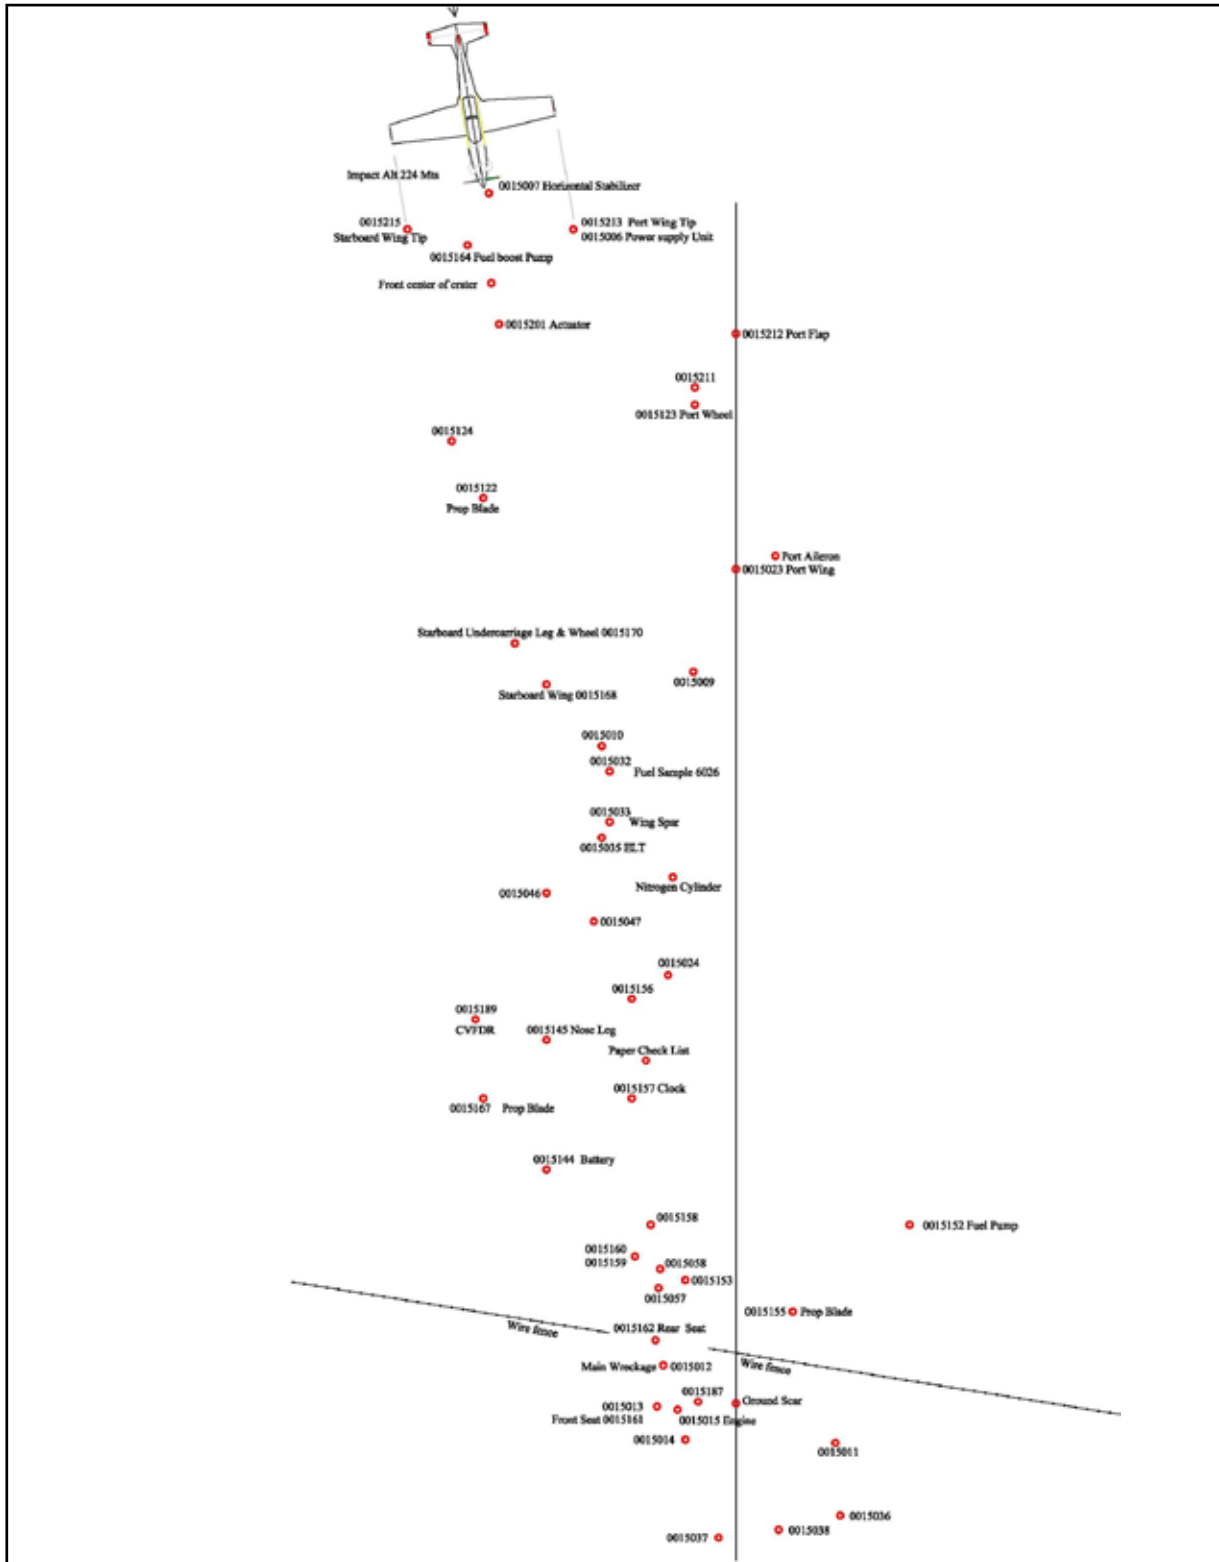
Figure No. 10: Debris Trail Plot
