**航空事故調査報告書**  
**全日本空輸株式会社所属**  
**ボーイング式747-400型 J A 8 0 9 6**  
**東京国際空港**  
**平成5年5月2日**

平成6年12月1日

航空事故調査委員会議決

All Nippon Airways Boeing 747-400, JA8096  
Tokyo International Airport, May 2, 1993

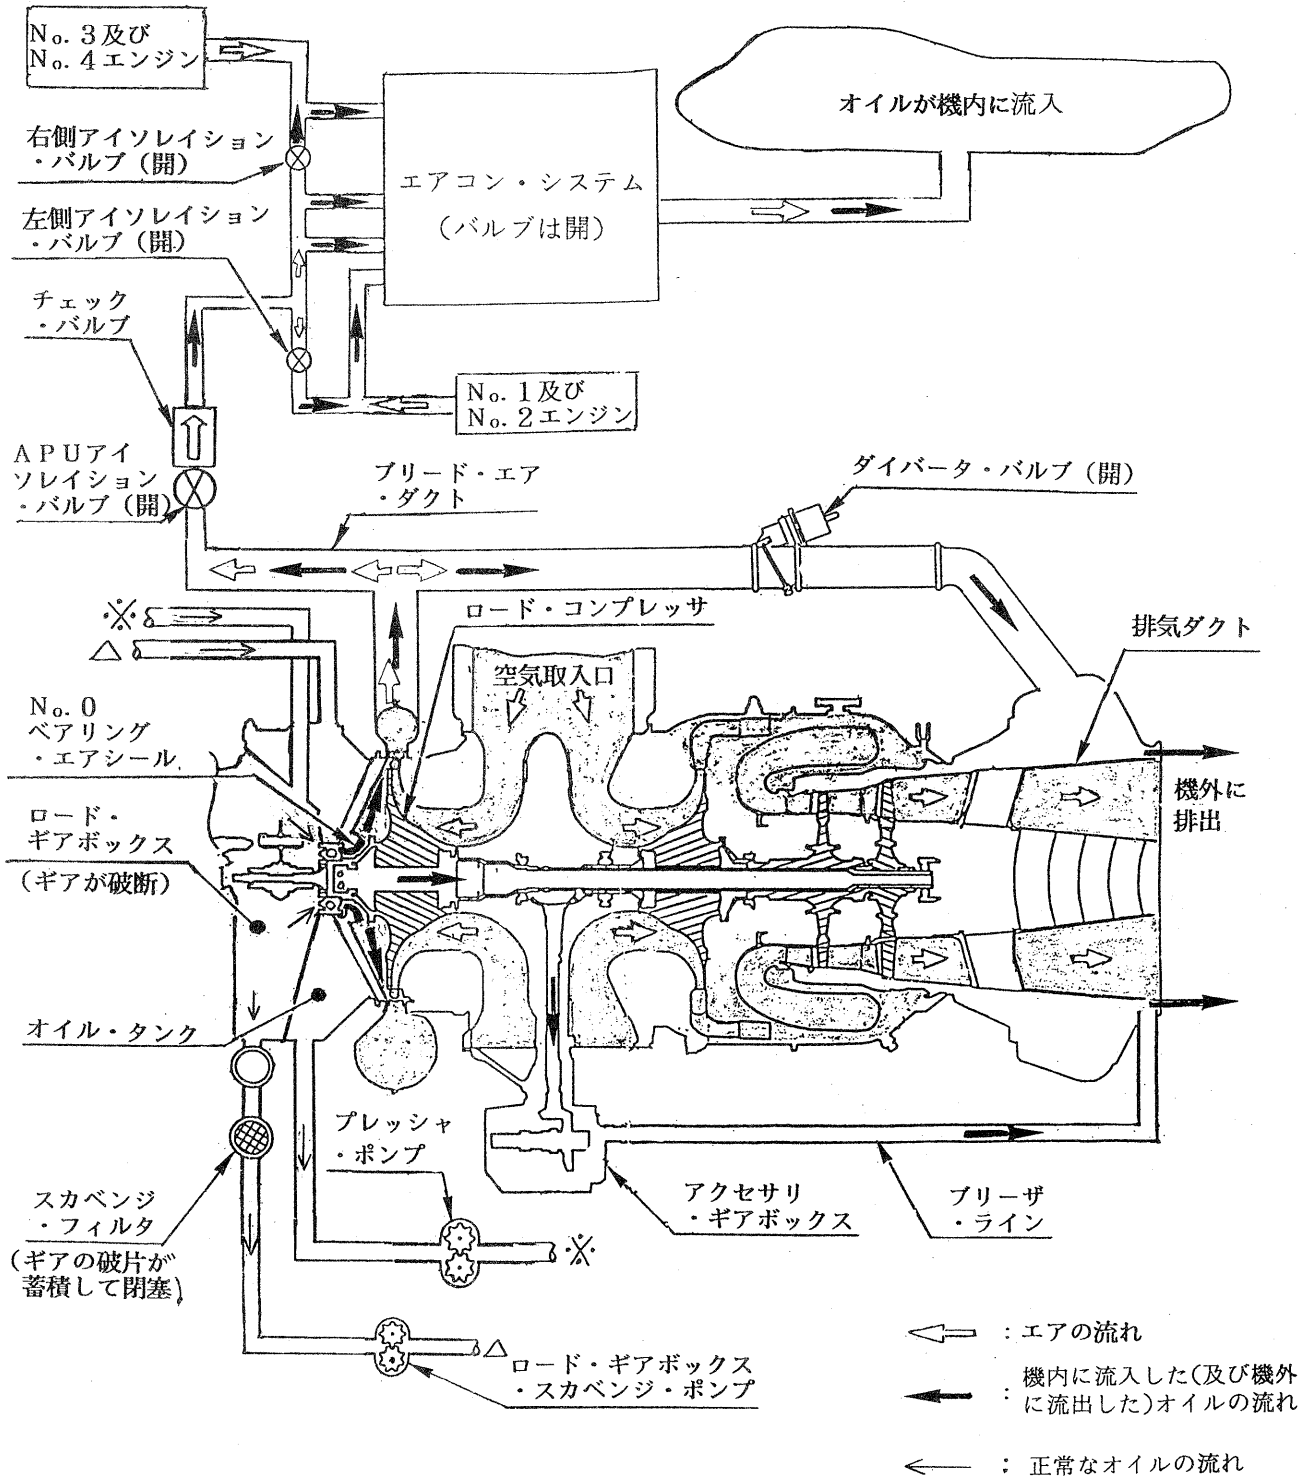
付図7 APUオイルの推定流入経路

3.2.7.5 また、エア・シールから漏洩したオイルの一部はエア・シール内部の経路を通過してエア・ブリーザ・ラインから機外に排出されるとともに、当該ラインのラバー・チューブに割れがあったことから、この箇所からオイルが漏れてAPUアクセス・ドアにオイルが付着したものと推定される。(付図7参照)

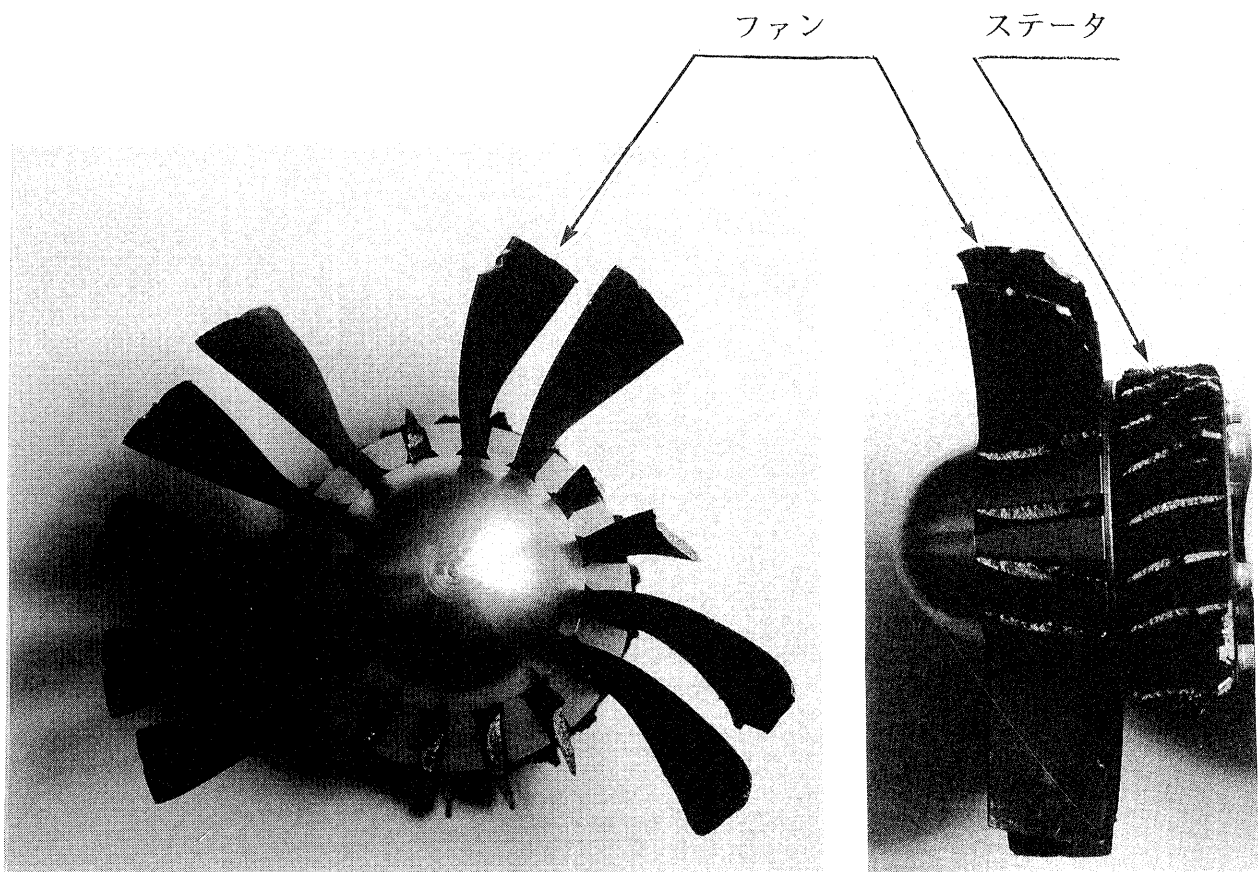
写真 1

- (1) 上側気室の右側ターボ・ファンのステータが破断しダクトから分離していた。またファンが破断し、ファンとタービンが分離していた。（写真1参照）
- (2) 破損したファンは容易に回転し、固着はなかった。
- (3) 破断したファン及びステータの破断面を調査した結果、疲労の痕跡は認められなかった。
- (4) 上側気室には、破断した右側ターボ・ファンとの結合箇所付近に、17箇所の裂け目（最大のものの長さは8cm）及び10数箇所のピン・ホールが生じていた。
- (5) 上側気室の内部にはファンの破片、ステータの破片、脱出スライドの客室側側面のフェイシャル・パネル（化粧パネル）の底面に取り付けられているPシール（P型の形状をしたシールでシリコン・ラバー製）の破片が入っていた。（写真2参照）フェイシャル・パネルを調査したところPシールがなくなっていた。
- (6) 上側気室の左側ターボ・ファンにはPシールが粉末になったものが付着していた。
- (7) 下側気室の左右のターボ・ファンには異常はなかった。

アップ・デッキ右側脱出スライドの展開が不十分であったのは、上側気室のターボ・ファンが破損したことにより空気の吸入量が少なくなり、当該気室が十分に膨張しなかったこと、並びに破損したターボ・ファンのファン及びステータの破片が当該気室に吸い込まれたことにより、気室に裂け目等が生じて気室内に送り込まれた空気等の一部が漏れたことによるものと推定される。

- 3.3.9 アップ・デッキの右側脱出スライドが十分に展開しなかったのは、上側気室の右側ターボ・ファンの破損により空気の吸入量が少なかったこと及び破損したファンの破片により上側気室が破損したことによるものと推定される。
- 3.3.10 ターボ・ファンの破損については、脱出スライドの客室側フェイシャル・パネルに取り付けられているPシールがはがれてターボ・ファンに吸い込まれ、ファン又はステータに過荷重が生じて破断したものと推定される。

破損したアッパ・デッキ右側脱出  
スライドの上側気室右側ターボ・  
ファン

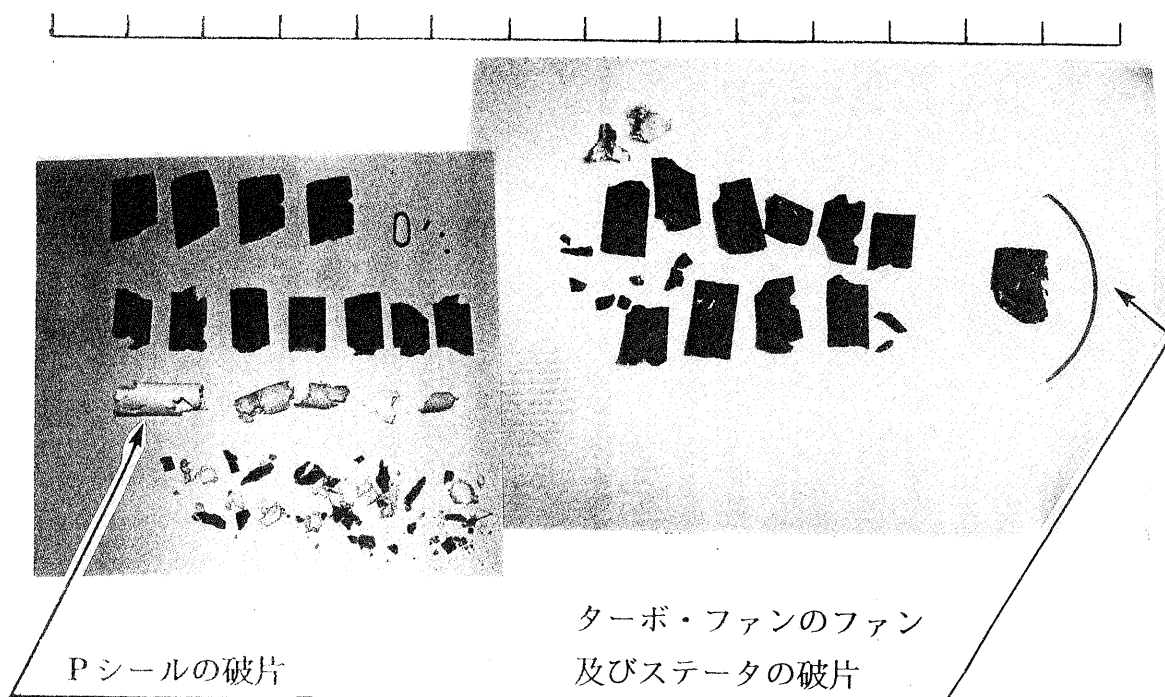
2.13.2に述べたとおり、上側気室の内部には右側ターボ・ファンのタービン、ファン及びステータの破片とともに脱出スライドの客室側側面に取り付けられているフェイスル・パネルに接着されているPシールの破片が入っていたこと並

(1) はがれたPシールがターボ・ファンに吸い込まれてファンに当たり、ファンに過荷重が生じて破断し、ファンとロータが分離し、ファンの破片がステータに噛みこんでステータが破断した。

(2) はがれたPシールがターボ・ファンに吸い込まれ、ファンが拘束されて急減速したことによってファンを保持しているステータに過荷重が生じて破断し、ステータの破片がファンに噛みこんでファンが破断してファンとロータが分離した。

写真 2 アッパ・デッキ右側脱出スライドの上側気室に入っていたターボ・ファンの破片等

Pシールの破片

ターボ・ファンのファン  
及びステータの破片

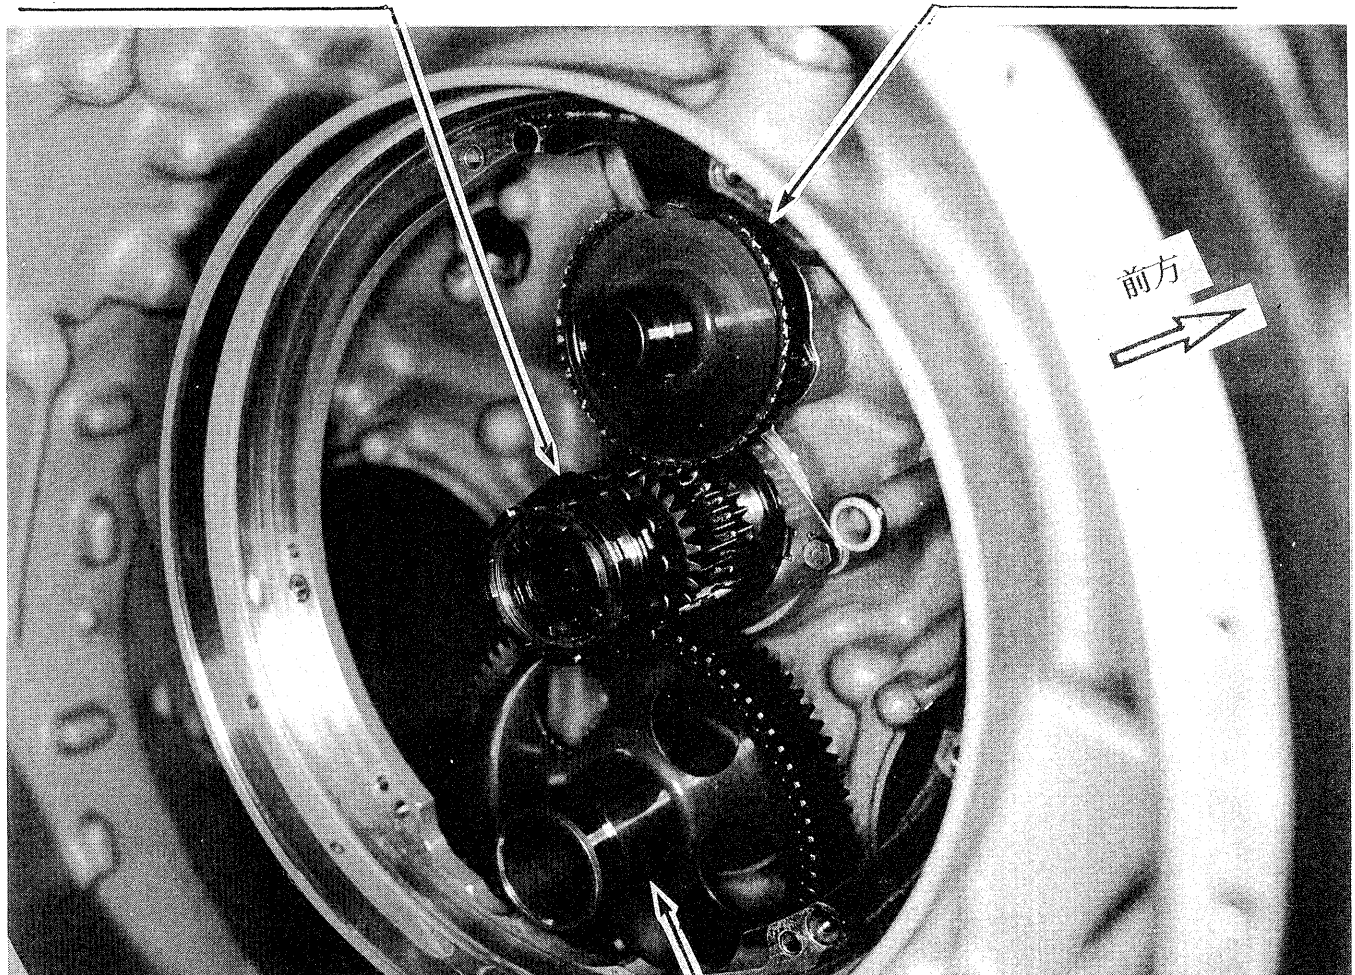
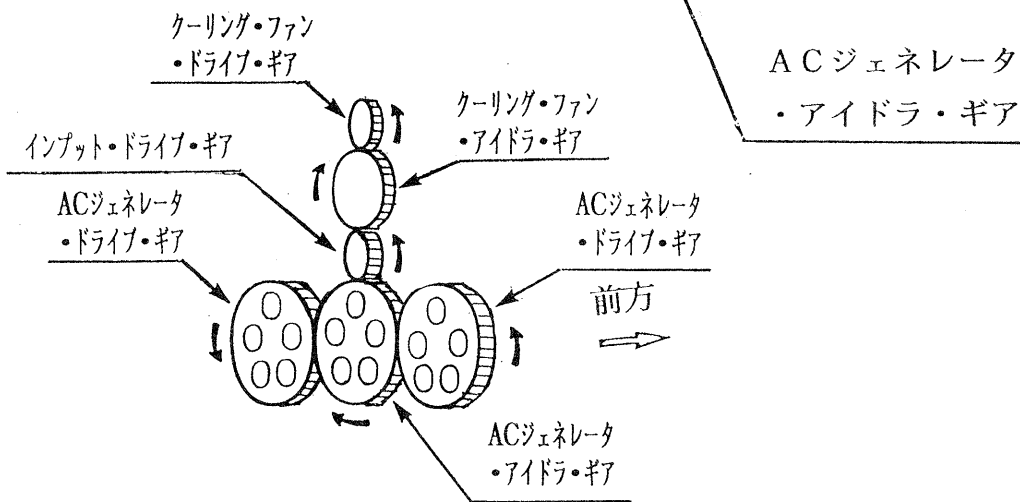
- (1) インพุット・ドライブ・ギア、クーリング・ファン・アイドラ・ギア及びクーリング・ファン・ドライブ・ギアが破損していた。ギアボックス底部にあるオイル・スカベンジ・マグネチック・チップ・ディテクタには金属片が付着していた。同底部のオイル・スカベンジ・フィルタには多量の細かい金属片が蓄積しフィルタをふさいだ状態となっていた。ギアボックス内には少量の金属片が溜まっており、また、内壁にはかき傷があった。(写真3～写真6参照)

- (2) インพุット・ドライブ・ギア(歯数26)のすべての歯の中央部が、当該ギアと噛み合うクーリング・ファン・アイドラ・ギアの歯幅分、破損していた。
- (3) クーリング・ファン・アイドラ・ギア(歯数47)は歯の根元近くのギアのウェブが、円周方向に約5cm(8個の歯分)破断していた。このうち7歯分は、破片5片となってオイル・スカベンジ・フィルタ及びギアボックス内に溜まっていた金属片の中から回収された。

インプット・ドライブ  
・ギア

クーリング・ファン  
・アイドル・ギア

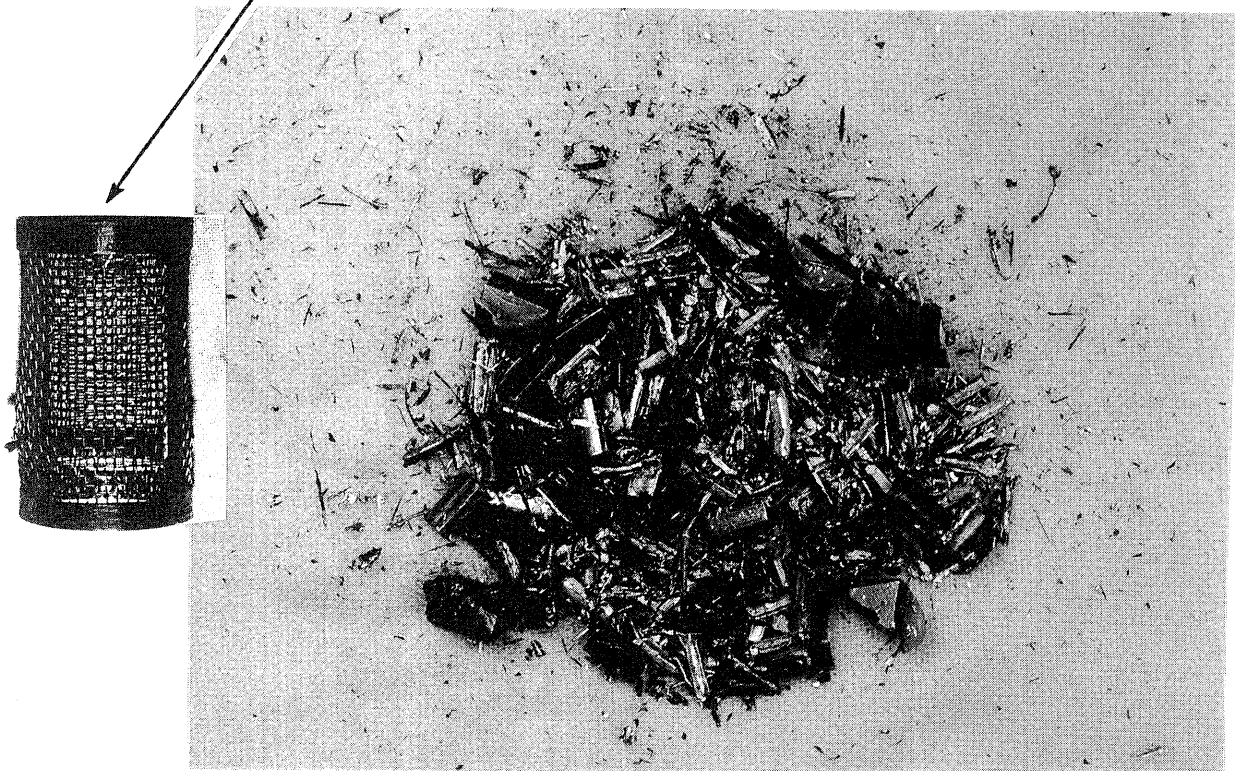
3.2.7.4 3.1.4.1(1)に述べたように、ロード・ギアボックス内のギアが破損し、多量の金属片がオイル・スカベンジ・フィルタに蓄積していたことが認められた。このことから、オイルが当該エア・シールを通過してロード・コンプレッサ内に漏洩したことは、ギアの破片がオイル・スカベンジ・フィルタを閉塞したためにオイルの排出が円滑に出来なくなり、さらに送油が続いたためにロード・ギアボックスの内圧が上昇し、No.0ベアリング・エア・シールにかかっている差圧より大きくなったことによるものと推定される。

写真 4 APUロード・ギアボックスの  
オイル・スカベンジ・フィルタ  
に蓄積していた金属片

オイル・スカベンジ  
・フィルタ

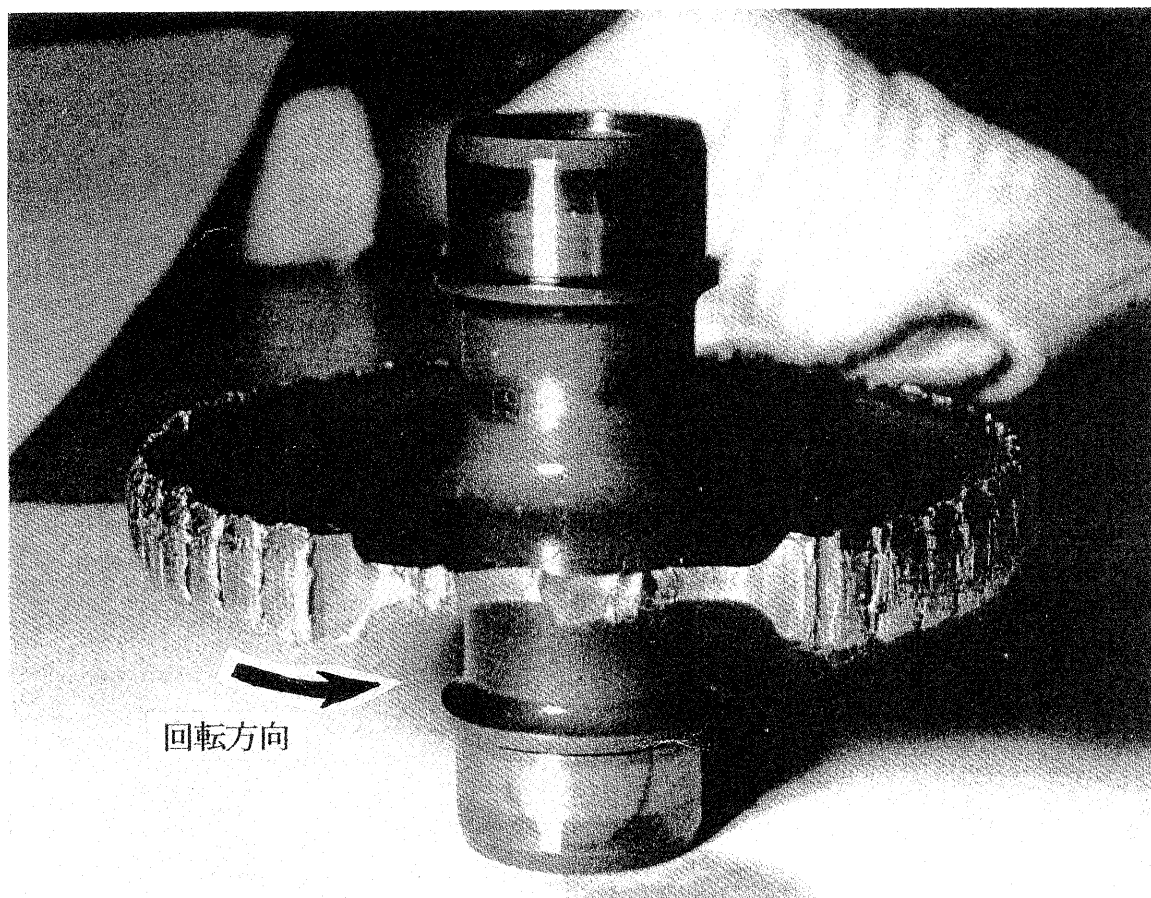
3.2.6.1 3.1.5に述べたように、クーリング・ファンのアイドル・ギア及びドライブ・ギアにビーチ・マーク等の疲労痕が認められたことから、これらのギアの一部の歯は疲労破断したものと推定される。疲労破断により一部の歯が欠落したため、両ギアの噛み合いがずれて、アイドル・ギアの歯が破断するとともに、ドライブ・ギアの歯も破断したものと推定される。

写真 5 破損したクーリング・ファン  
・アイドラ・ギア

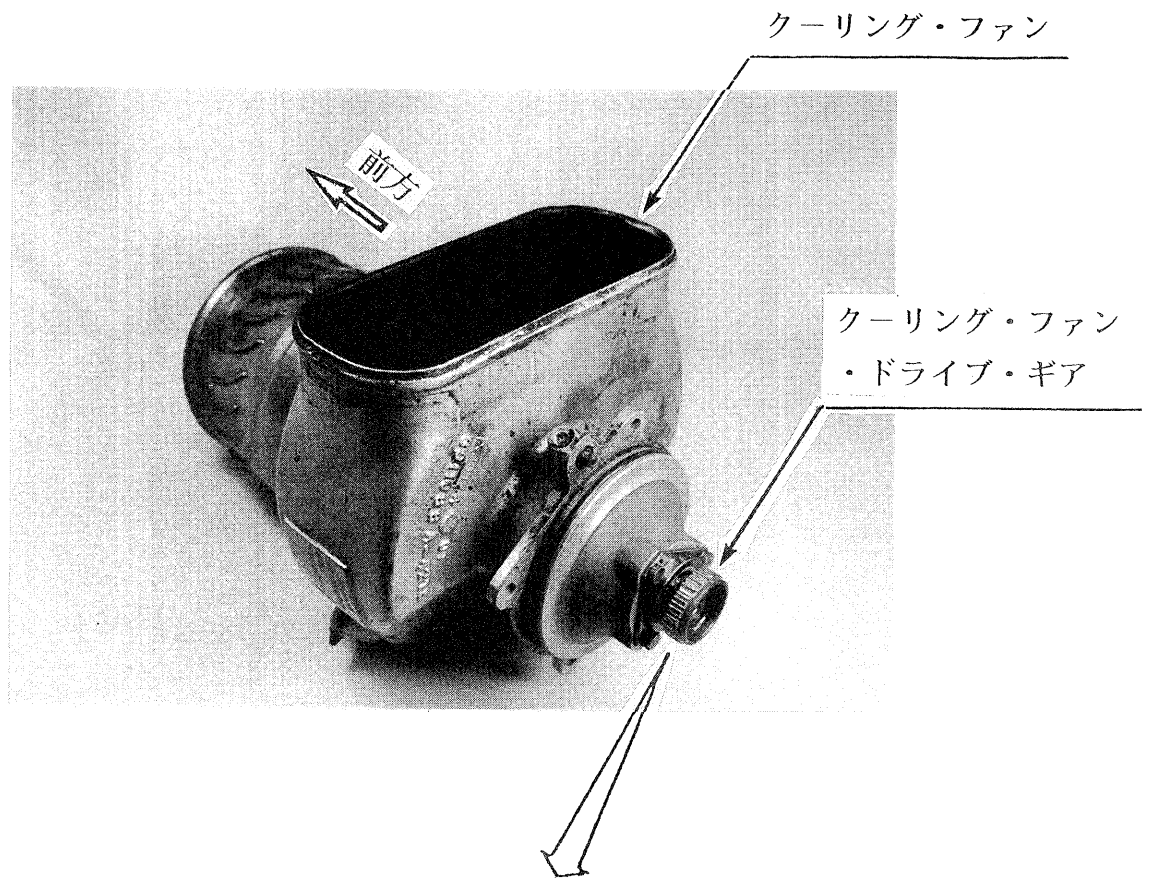
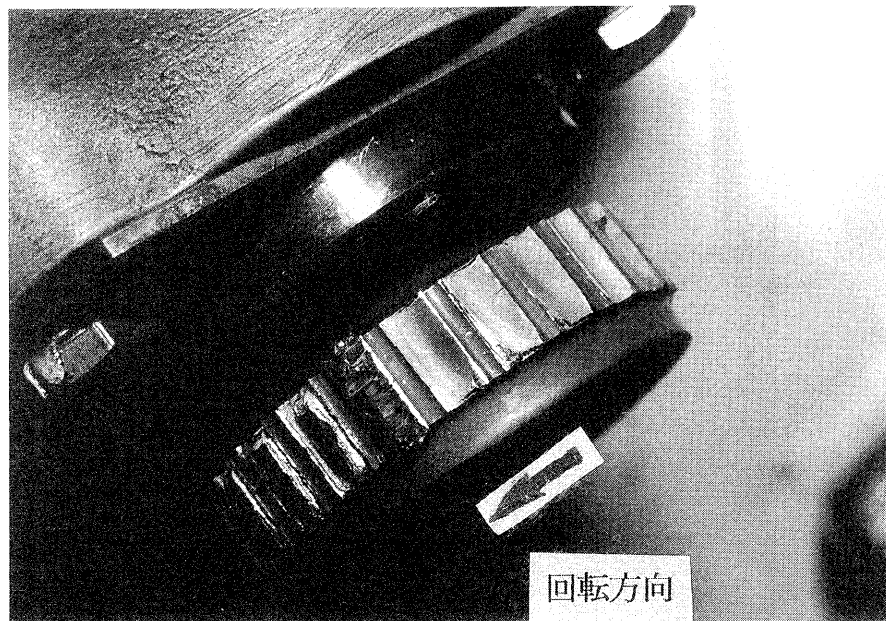
- (4) クーリング・ファン・アイドラ・ギア・シャフトの前方側ローラ・ベアリング・リテーナを取り付けている3本のボルトが緩んでいたが、ベアリング及びボルトのタブ・ワッシャには異常はなかった。
- (5) クーリング・ファン・アイドラ・ギアと噛み合うクーリング・ファン・ドライブ・ギア(歯数24)はすべての歯が根元部で破損していた。20個分の歯

の破片20片がオイル・スカベンジ・フィルタ及びギアボックス内の金属片の中から回収された。

写真 6 破損したクーリング・ファン  
・ドライブ・ギア

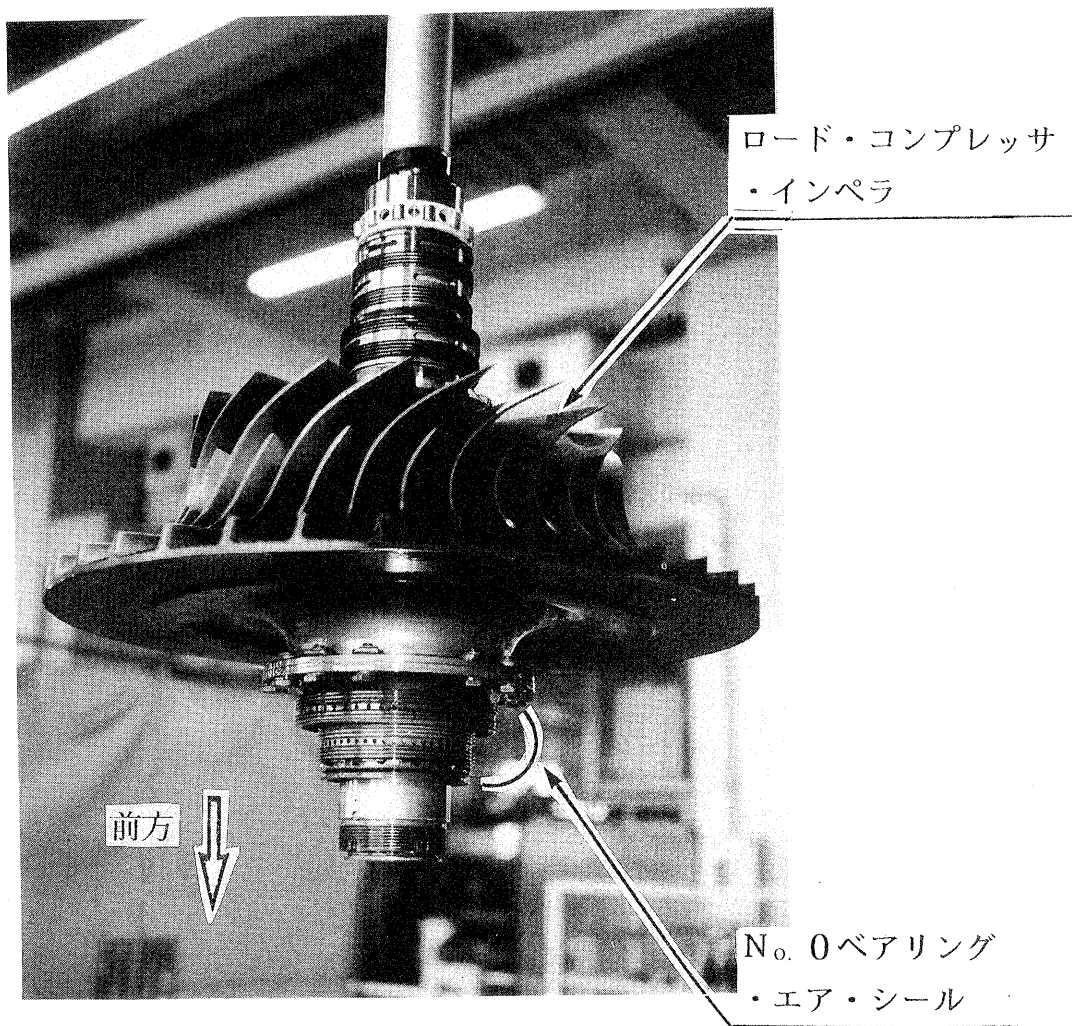
- (1) ロード・ギアボックスとロード・コンプレッサの間のNo.0ベアリング・エア・シールには損傷はなかったが、オイルが付着していた。(写真7参照)
- (2) ディフューザ・ケース内壁及びインペラにはオイルが付着していた。
- (3) ロード・コンプレッサに隣接するAPUブリード・エア・ダクト内にはオイルが付着していた。

当該エア・シールにはロード・ギアボックスの内圧より高いハイ・プレッシャ(N<sub>2</sub>)・コンプレッサの背圧がかかっており、この空気差圧によってNo.0ベアリングを潤滑したオイルがロード・コンプレッサ内に漏洩しないようにしている。この空気差圧は数psi程度である。

写真 7 No. 0 ベアリング・エアシール

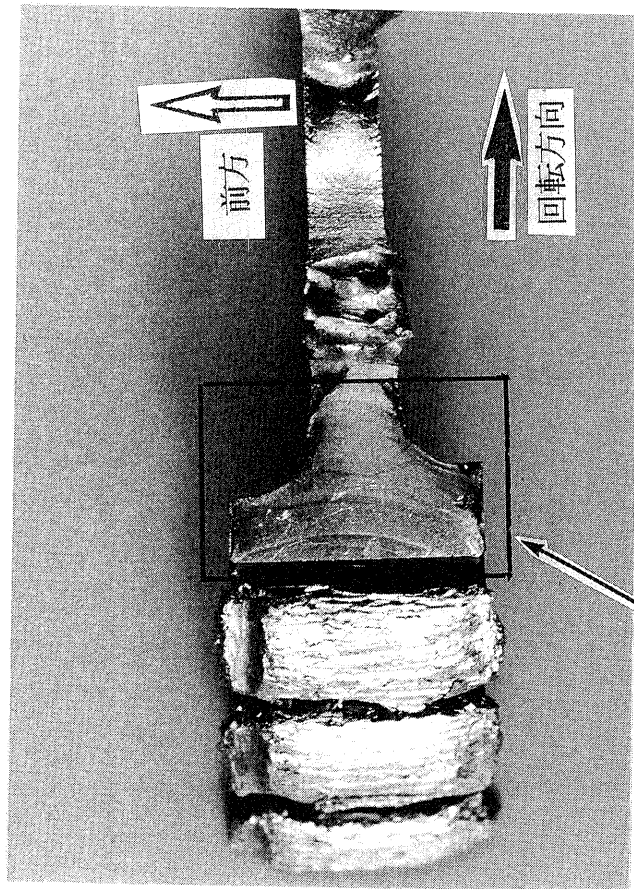
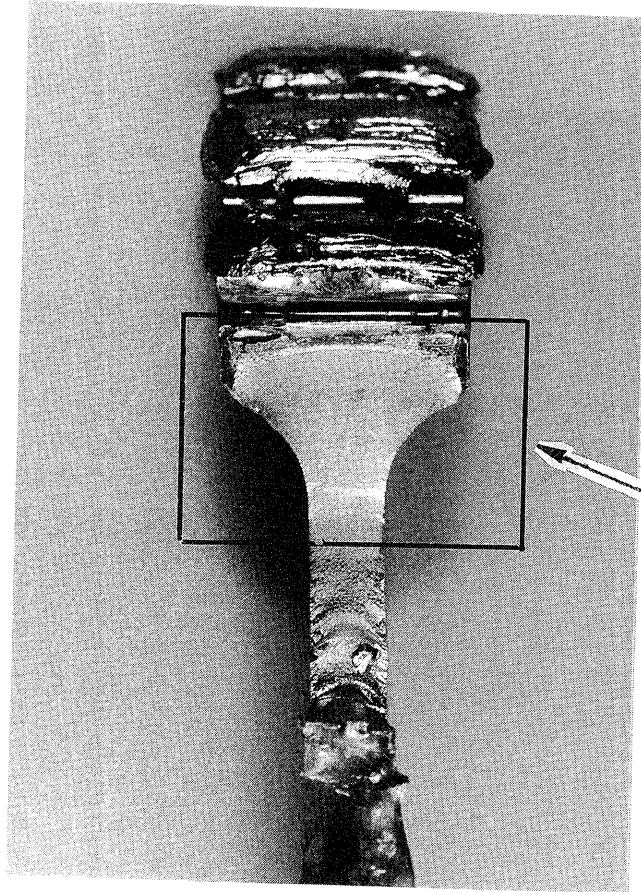
ウェブの破断面のうち2箇所及び当該破断面と対応する歯の破片に、歯の谷部を起点とし、ギアの回転方向と同方向に進行したビーチ・マークが認められた。

写真 8 APUターリング・ファン・  
アイドラ・ギアの破損状況

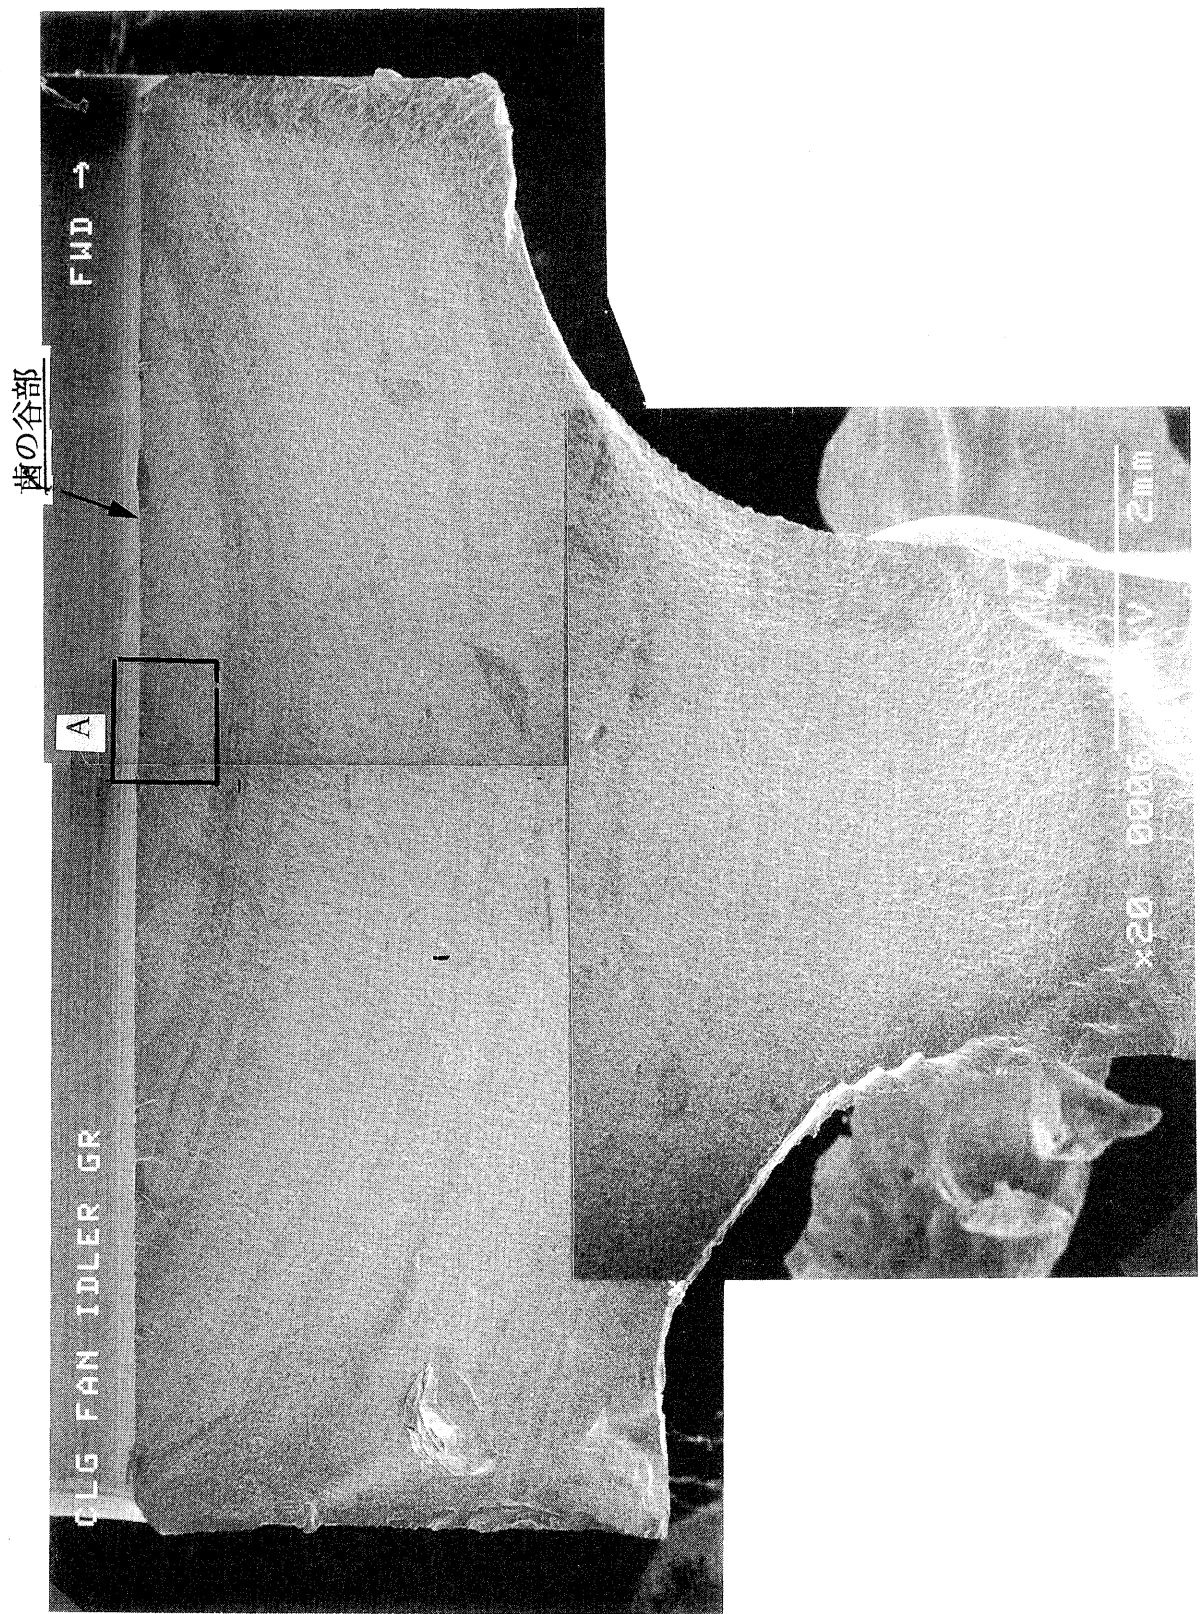
7個の歯の破断面及び当該破断面と対応する破断した7個の歯の破片に回転方向と同方向に進行した疲労痕（ビーチ・マーク及びビーチ・マークを生じない疲労痕）が認められた。その他の破断面は細かい平行な筋状の痕跡が生じていたか又はつぶれていた。

写真9 APUターリング・ファン・アイドラ・ギアの

電子顕微鏡写真

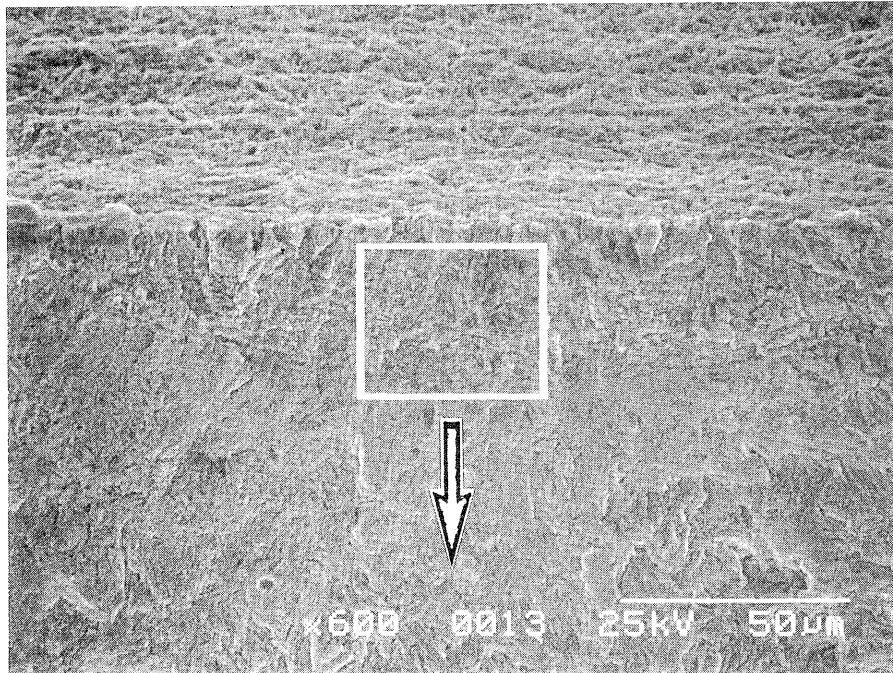
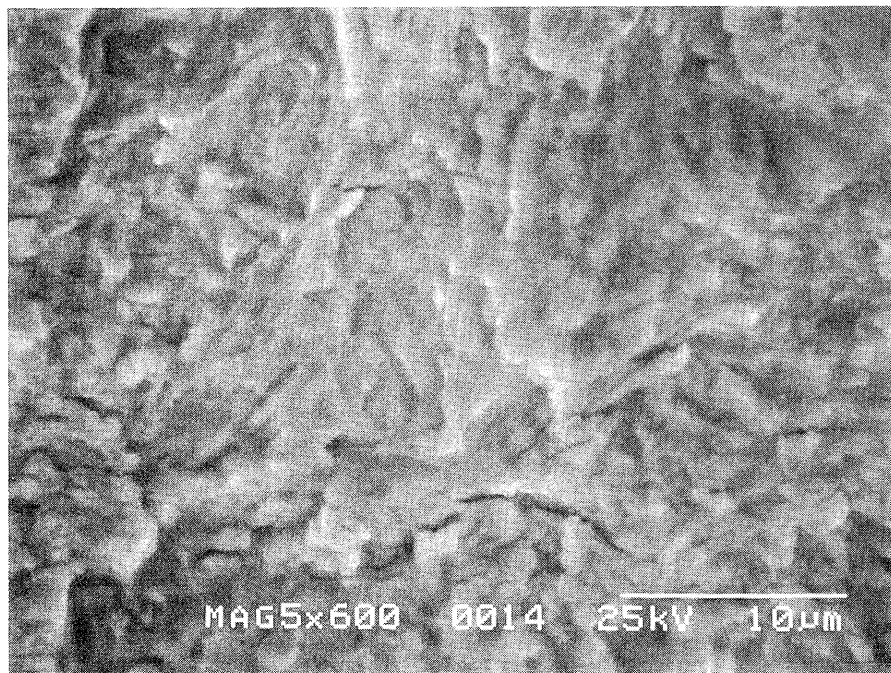
写真 10 APUケーリング・ファン・  
アイドラ・ギアの電子顕微鏡  
写真(A部の拡大)

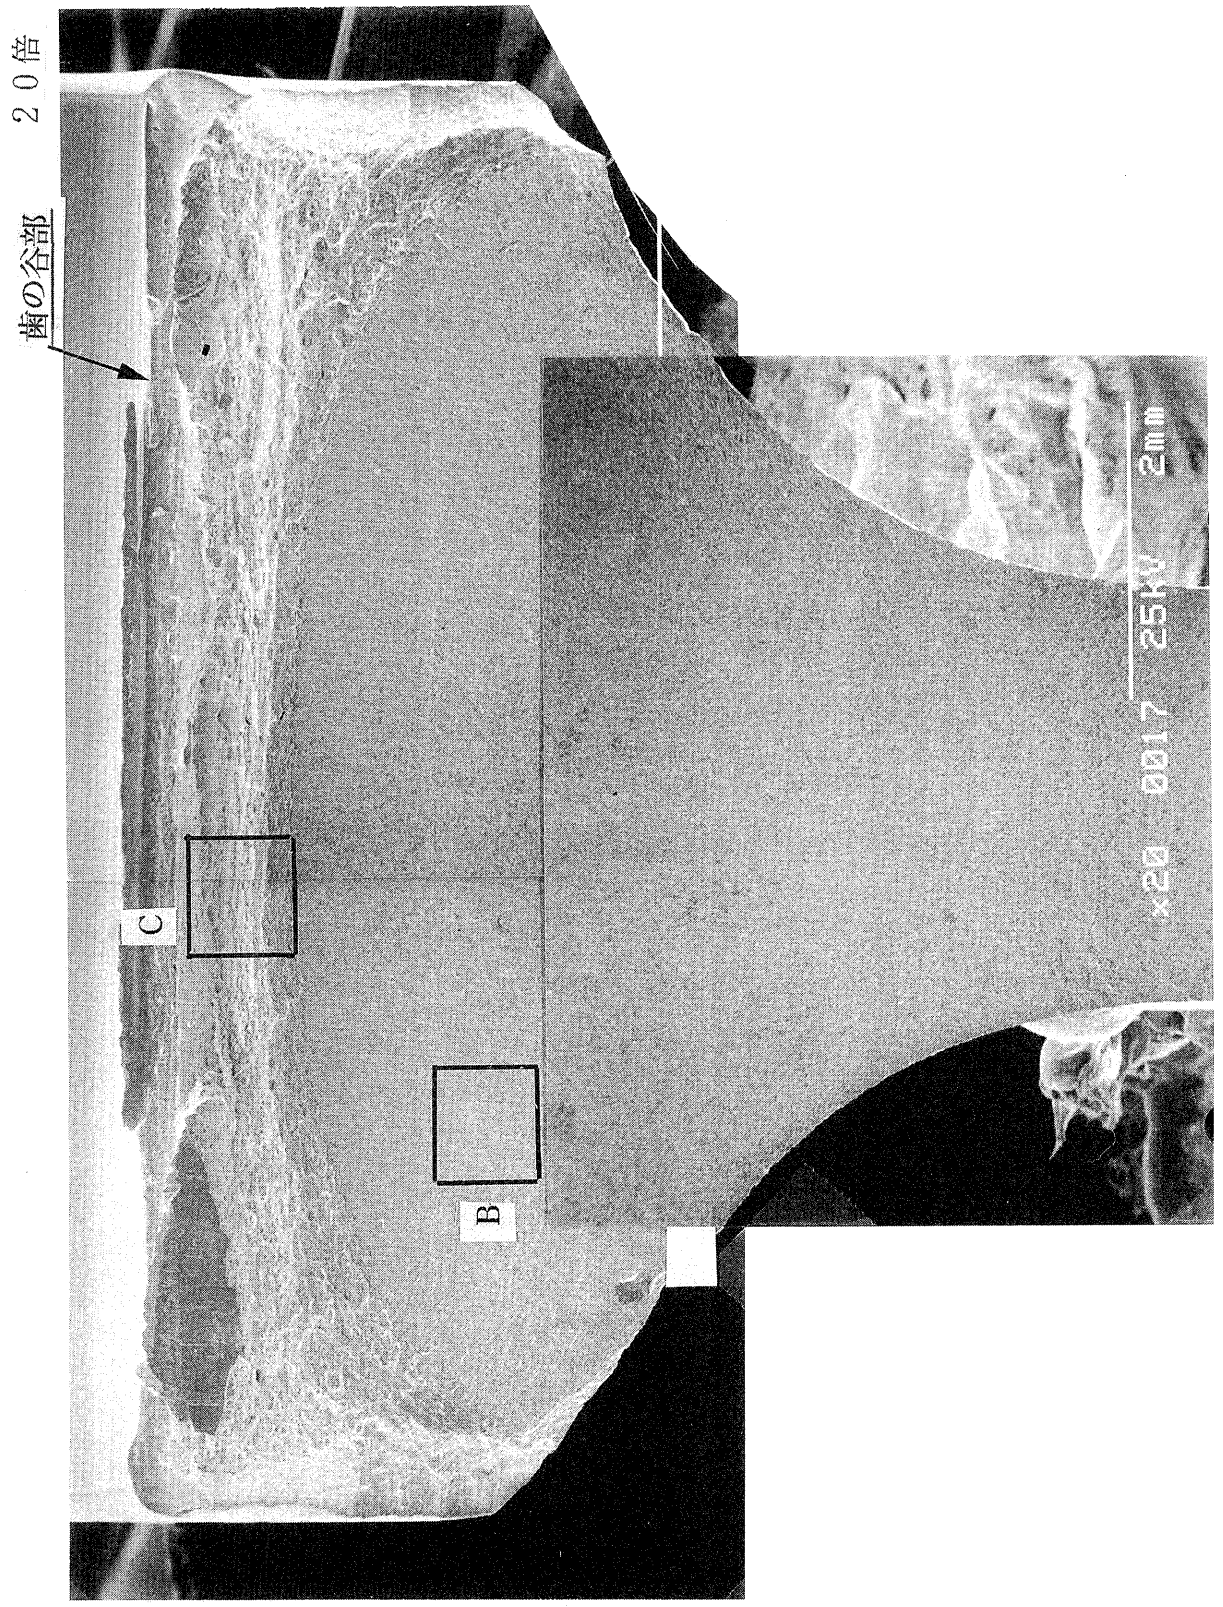
写真 II AP U クーリング・ファン・アイドラ・ギアの  
電子顕微鏡写真

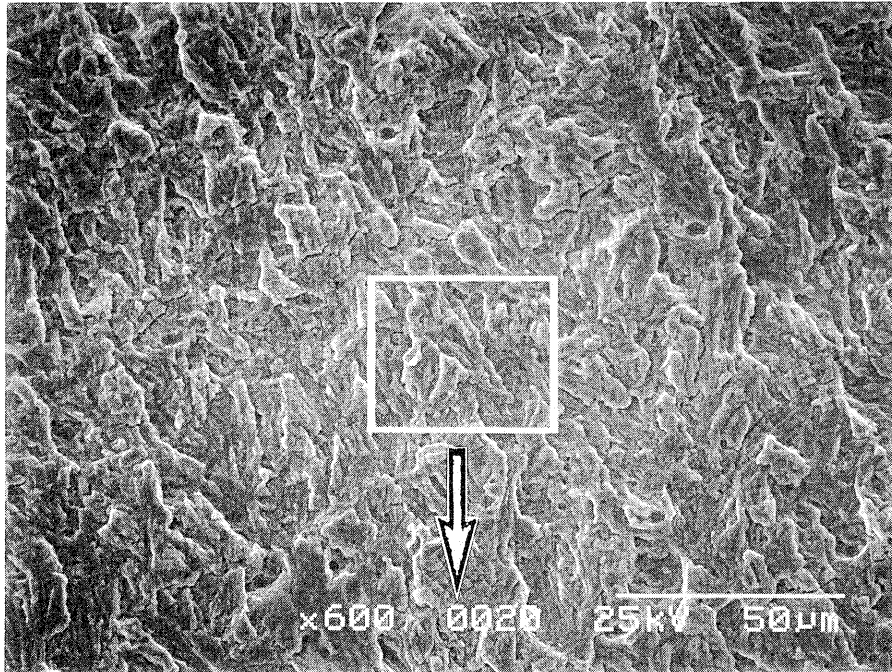
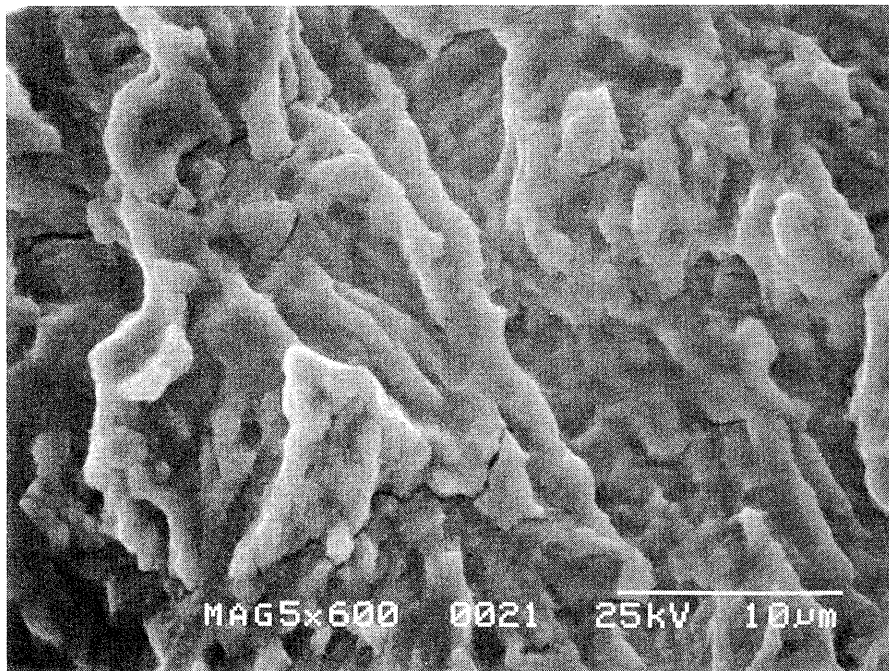
A P Uクーリング・ファン・  
アイドラ・ギアの電子顕微鏡  
写真(B部の拡大)

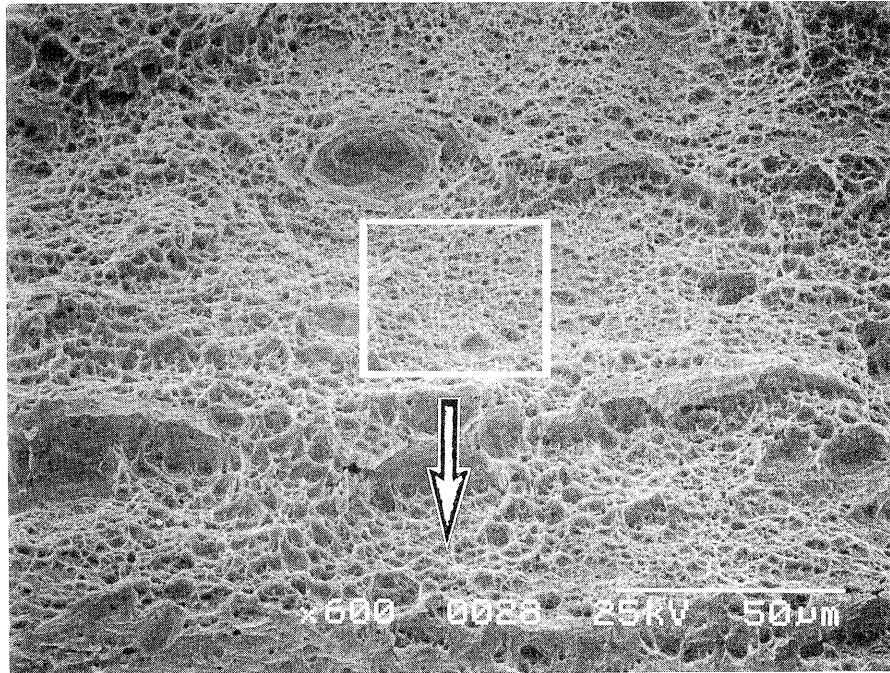
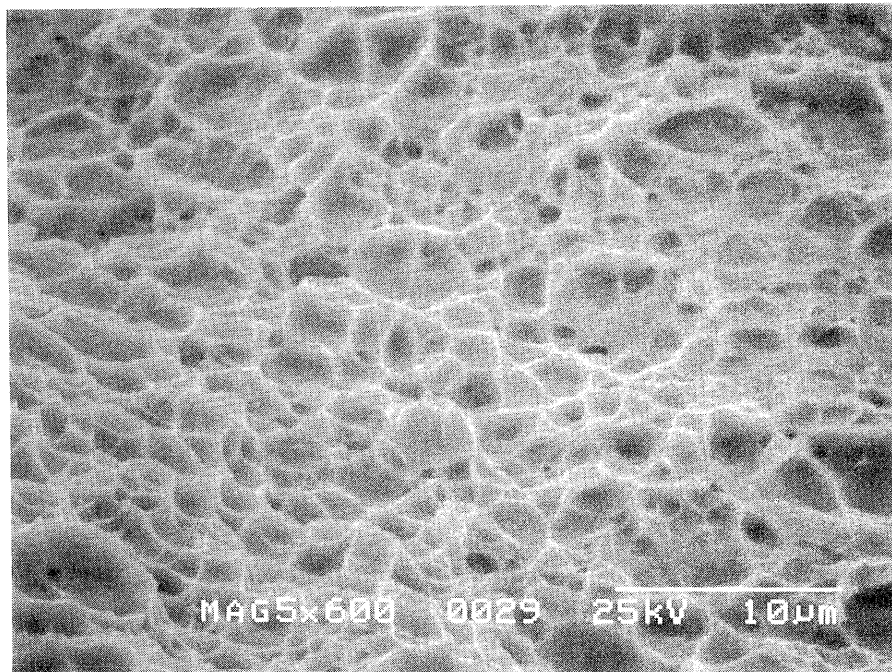
写真 13 APUクーリング・ファン・  
アイドラ・ギアの電子顕微鏡  
写真(C部の拡大)

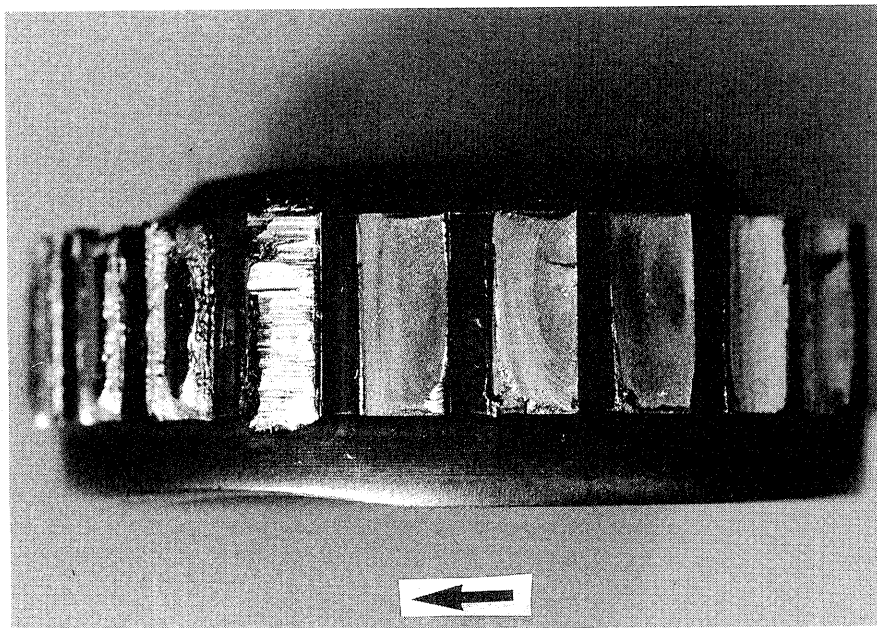
- 3.3.5 APUのロード・ギアボックスのクーリング・ファン・アイドル・ギア及びクーリング・ファン・ドライブ・ギアが破損したことについては、クーリング・ファン・シャフトの振動等により、硬度が十分でなかったギアの歯が破断したため、アイドル・ギアとドライブ・ギアの噛み合いがずれて、両ギアの歯が破損したものと推定される。

写真 14 APUクーリング・ファン・  
ドライブ・ギアの破損状況

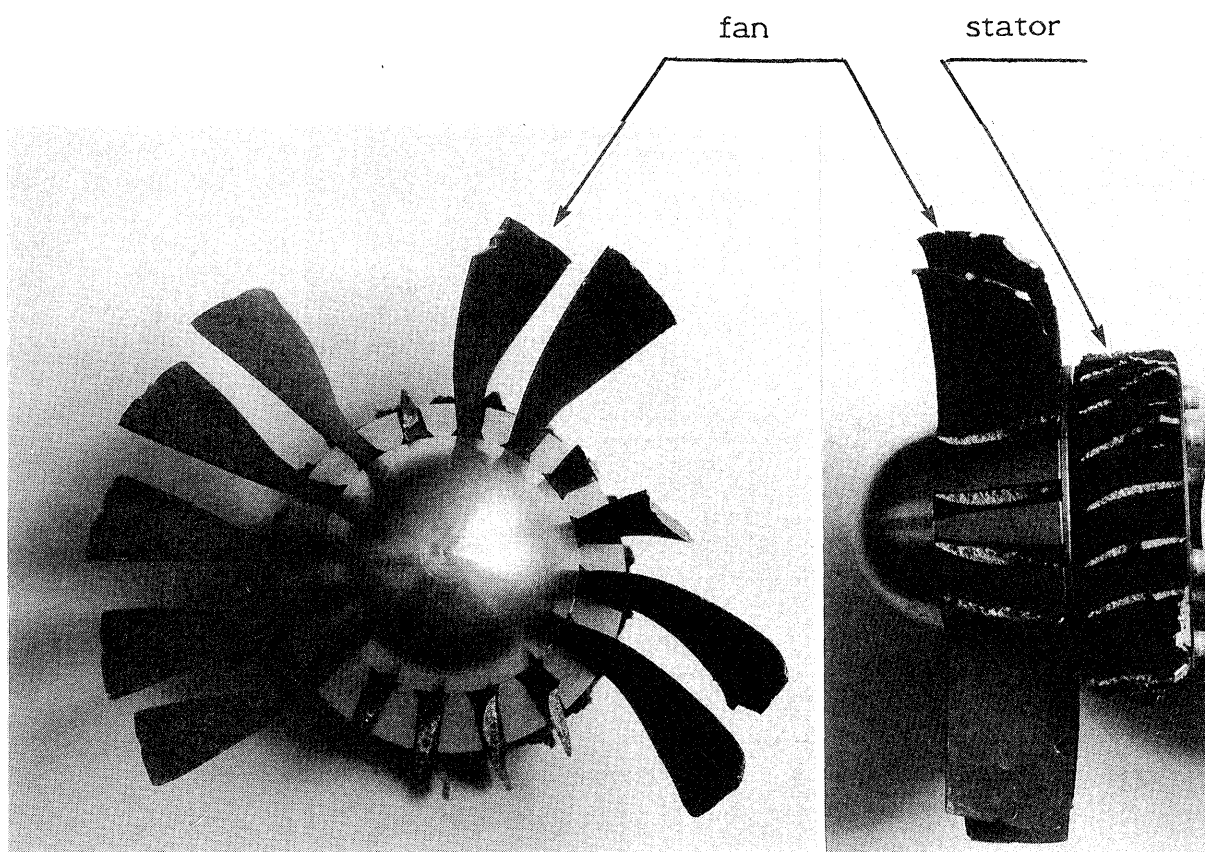
- (1) The stator of the right turbo-fan of the upper air chamber was found fractured and fan and turbine separated from each other. (see Photo.1 )
- (2) The fractured fan is rotatable not being stuck.

- (3) Investigation of fractured surface of the fractured fan and the stator showed no evidence of fatigue.
- (4) 17 brakes (maximum 8 cm in length) and more than 10 pin holes were found on the upper air chamber near the place where the right turbo-fan which was fractured is connected.

Photo. 1 Fractured Turbo-fan (right-side Turbo-fan of upper air chamber of upper-deck right-side escape slide)

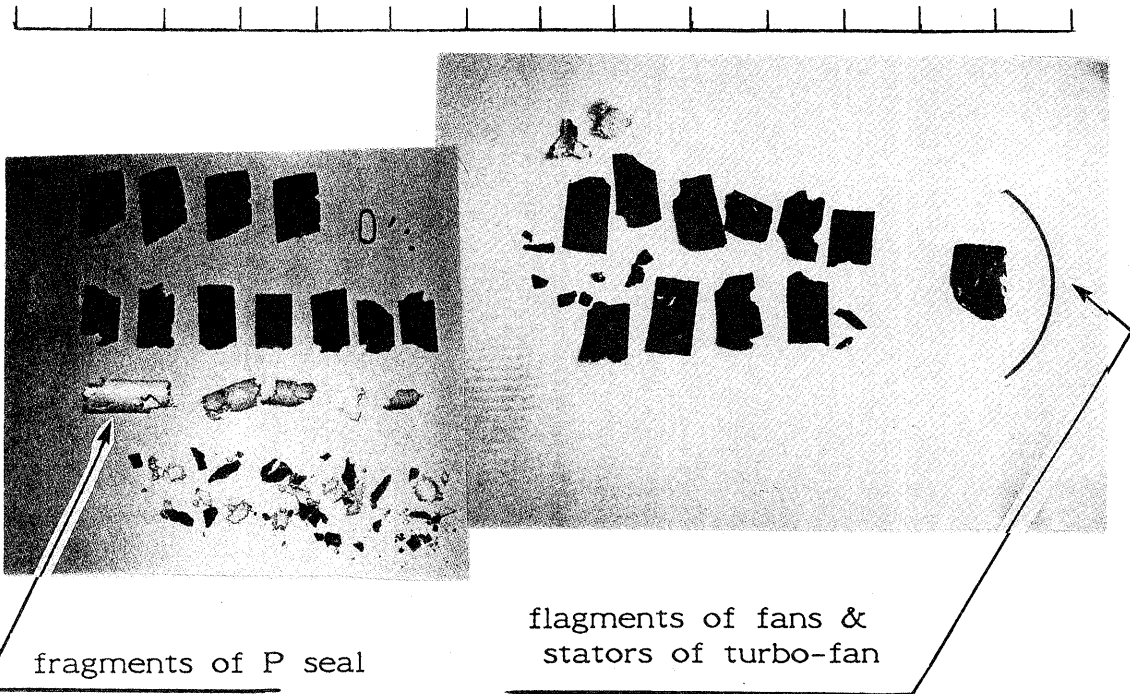
- (5) Inside of the upper air chamber were found fragments of fan, fragments of stator, and fragments of P seal (P-shaped seal of silicon rubber) attached to the bottom of the facial panel on the side of the cabin side of the escape slide. (see Photo.2 )  
Investigation of the facial panel indicated loss of the P seal.

Photo. 2 Fragments of fractured Turbo-fan  
found in the upper air chamber
