**航空事故調査報告書**  
**全日本空輸株式会社所属**  
**ボーイング式747-400型 J A 8 0 9 6**  
**東京国際空港**  
**平成5年5月2日**

平成6年12月1日

航空事故調査委員会議決

All Nippon Airways Boeing 747-400, JA8096  
Tokyo International Airport, May 2, 1993

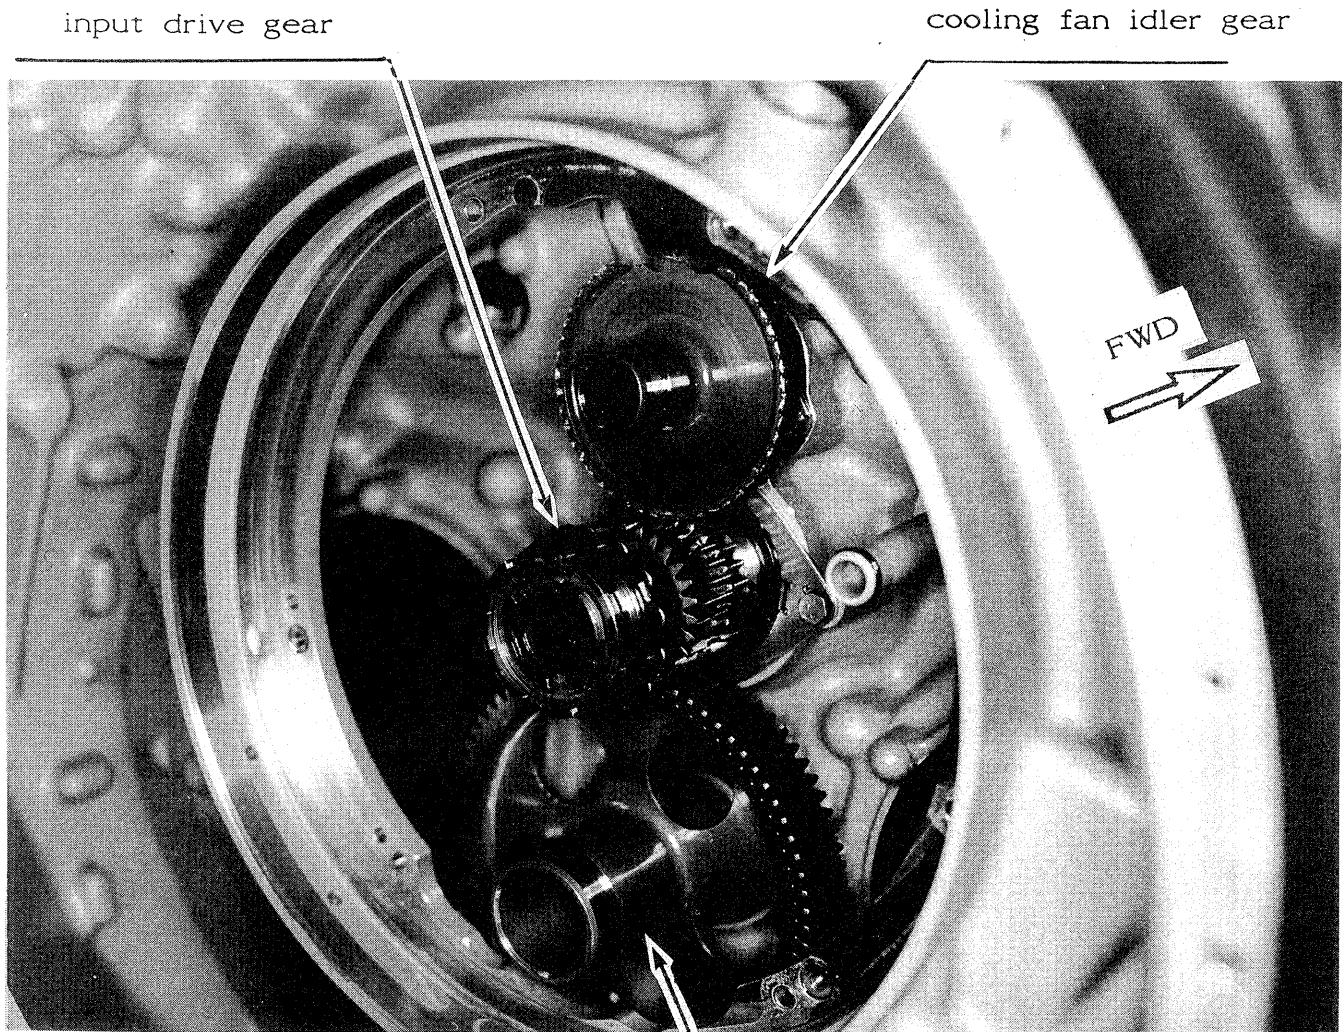
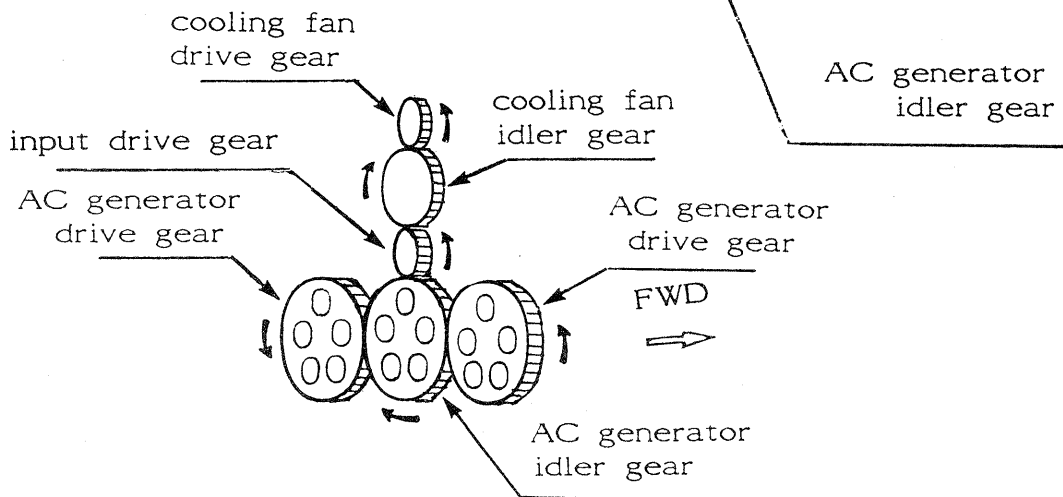
Photo. 3 APU Load Gearbox

(1) The input drive gear, the cooling fan idler gear, and the cooling fan drive gear were found fractured. Metal chips and flakes were found on the oil scavenge magnetic chip detector located at the bottom of the gearbox case. The oil scavenge filter at the bottom was found clogged by a lot of metallic fine flakes and whiskers accumulated on it. A small amount of metallic flakes gathered in the gearbox, and there were scratches found on the inner wall.

(2) All the gear teeth (26 each) of the input drive gear were fractured at the middle part by the width of the mating gear (cooling fan idler gear).

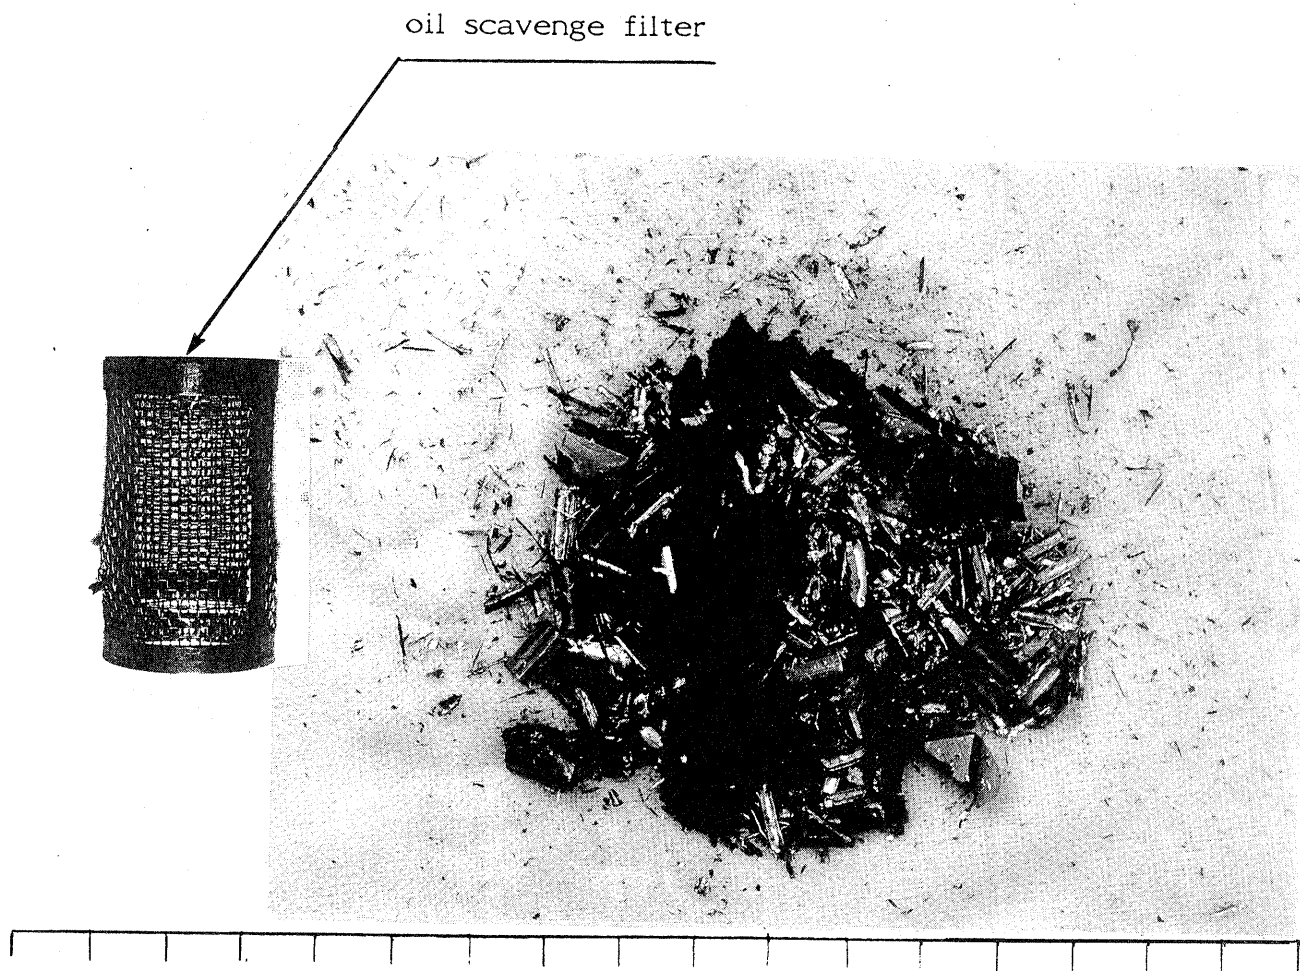
Photo. 4 Metal Fine Flakes found on Oil  
Scavenge Filter of APU Load Gearbox

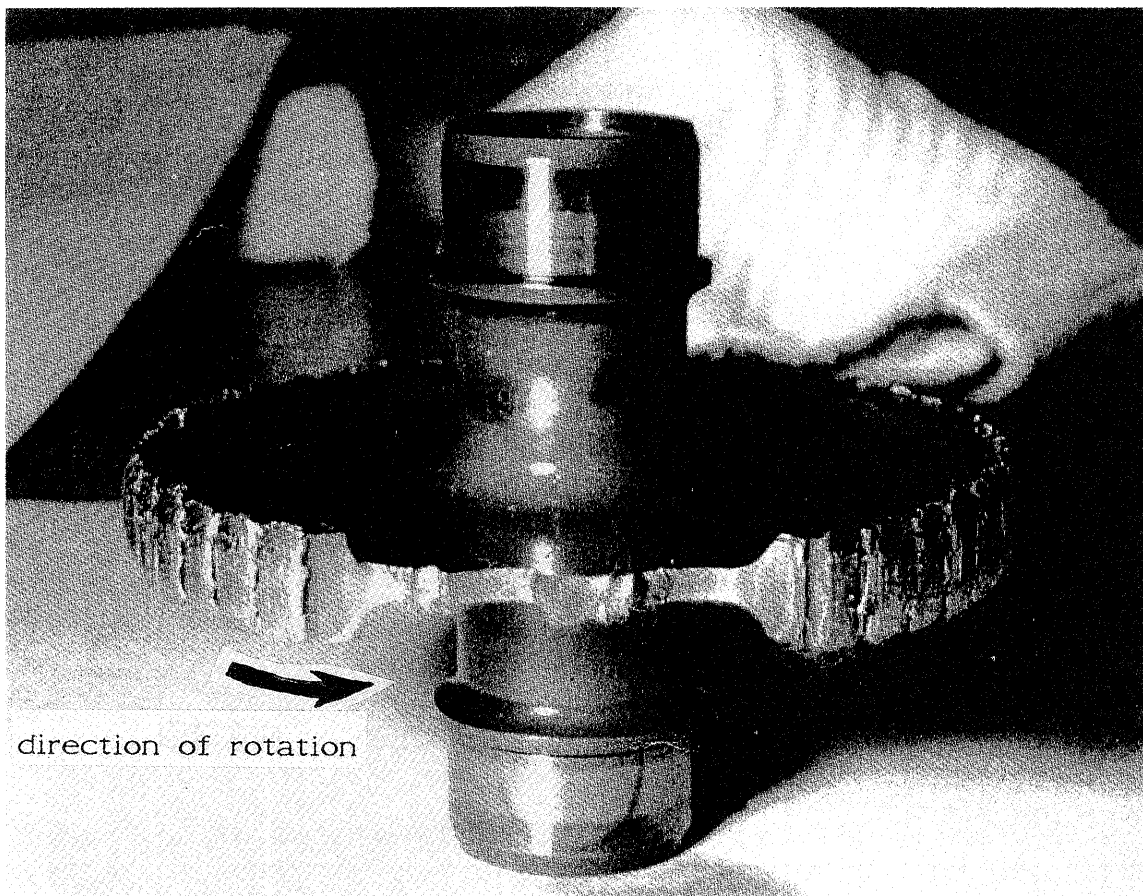
(3) An outer part of the cooling fan idler gear (47 teeth) web was fractured

circumferentially for the length of 5 cm, or equivalent of 8 teeth. Seven of the missing 8 gear teeth were found in the metal flakes on the scavenge filter or those within the gearbox.

Photo. 5 Fractured Cooling Fan Idler Gear

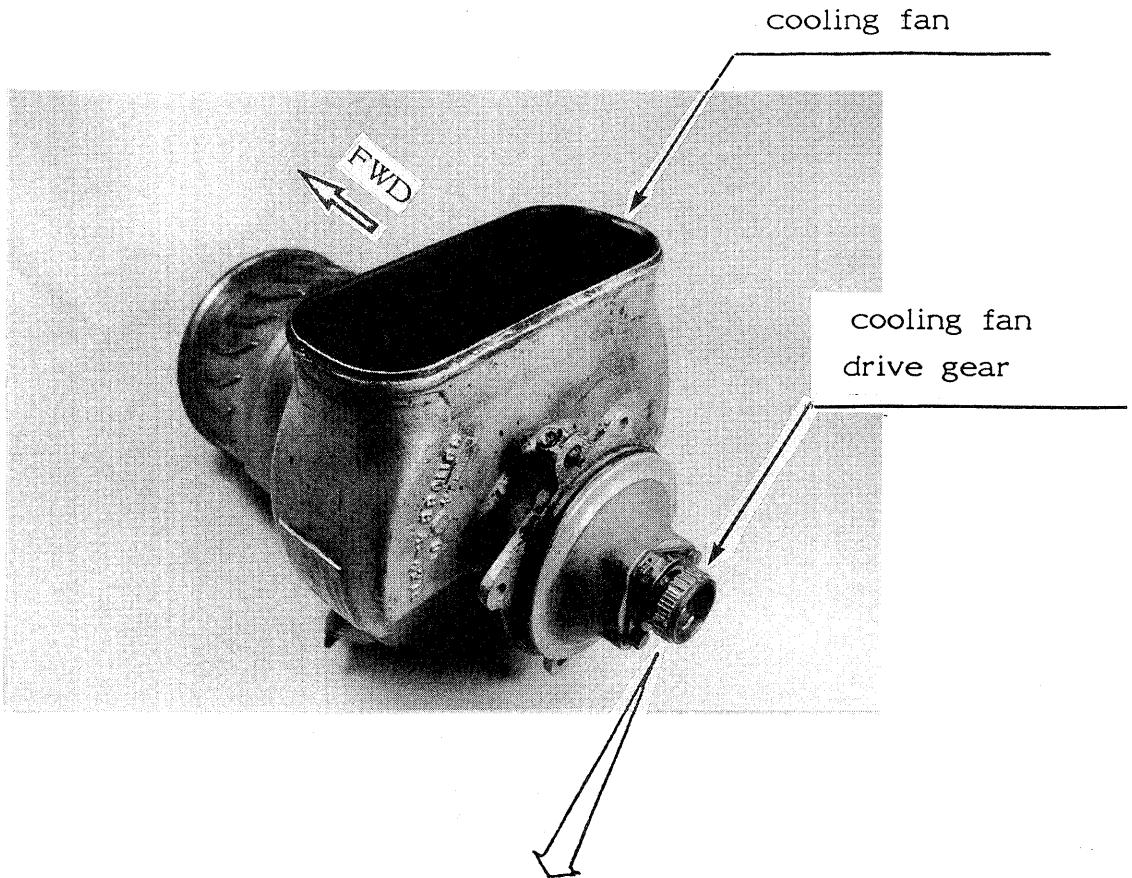
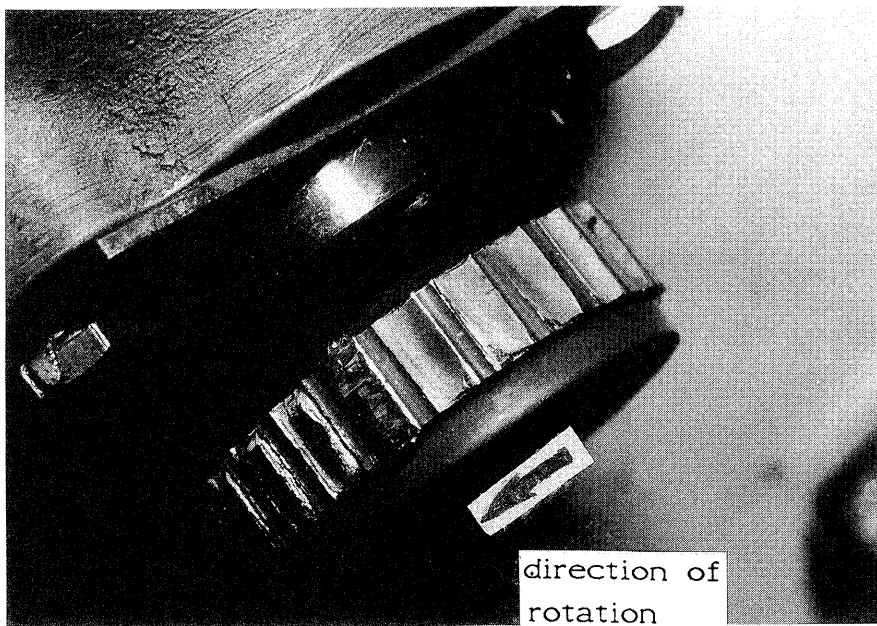
Photo. 6 Fractured Cooling Fan Drive Gear

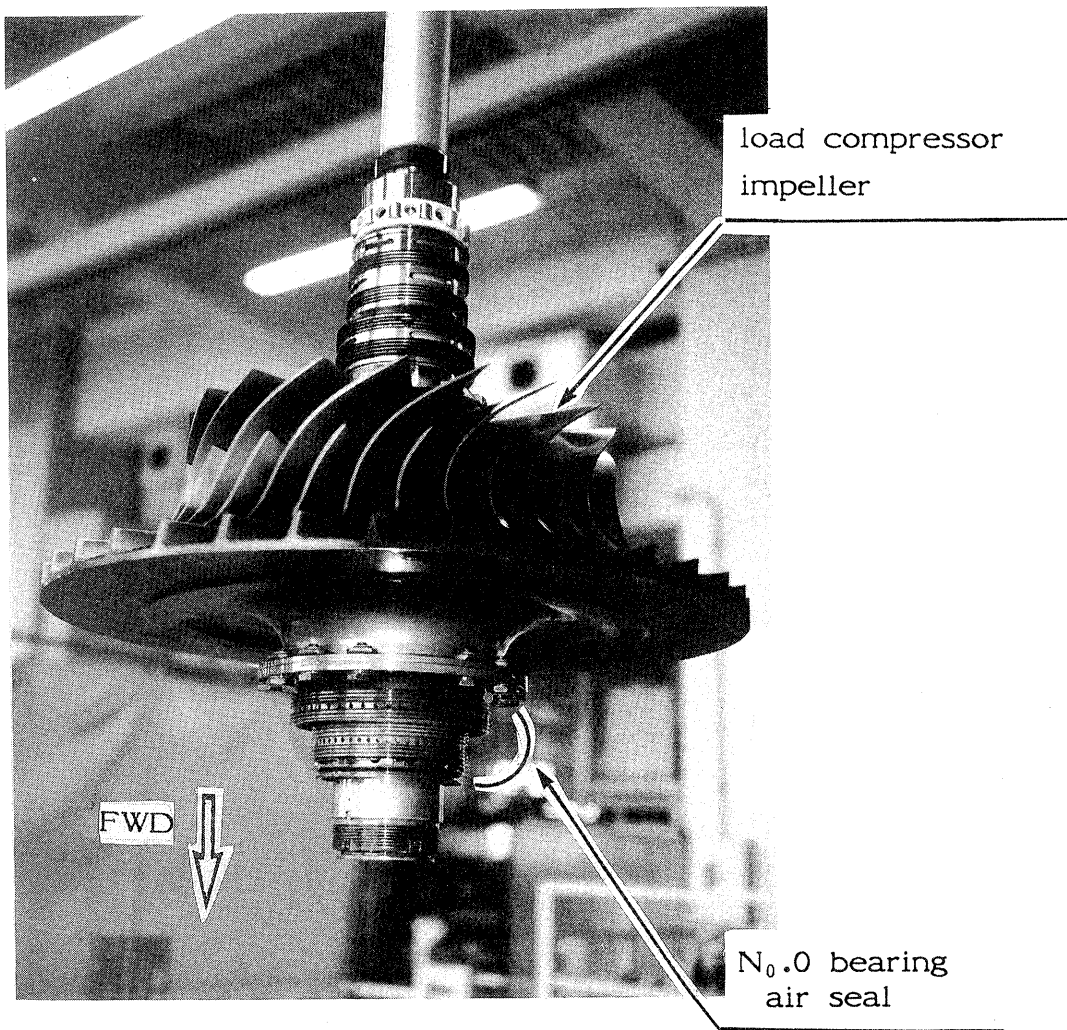
(1) The No.0 bearing air seal located between the load gear box and the load compressor was found intact but was heavily wetted with oil. (see Photo.7)

Photo. 7 N<sub>0</sub>.0 Bearing Air Seal

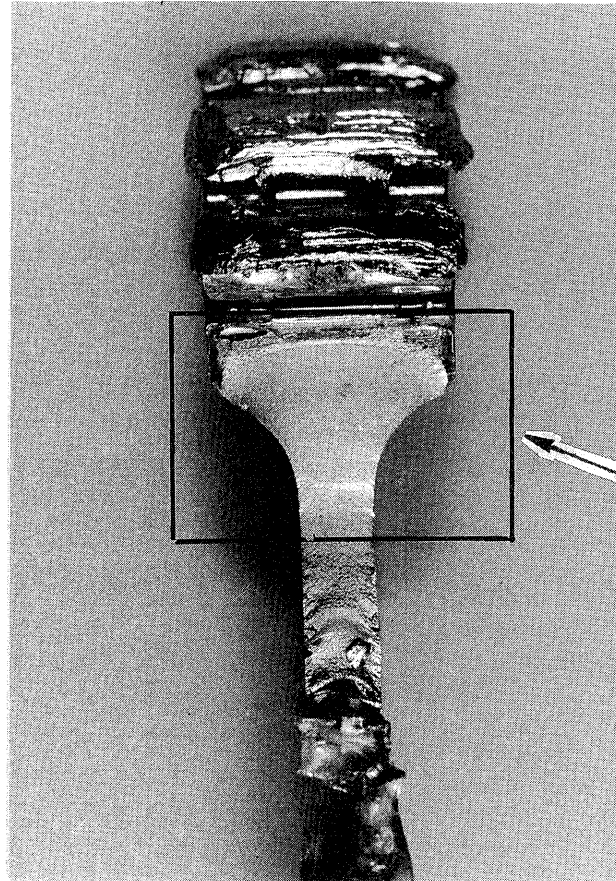
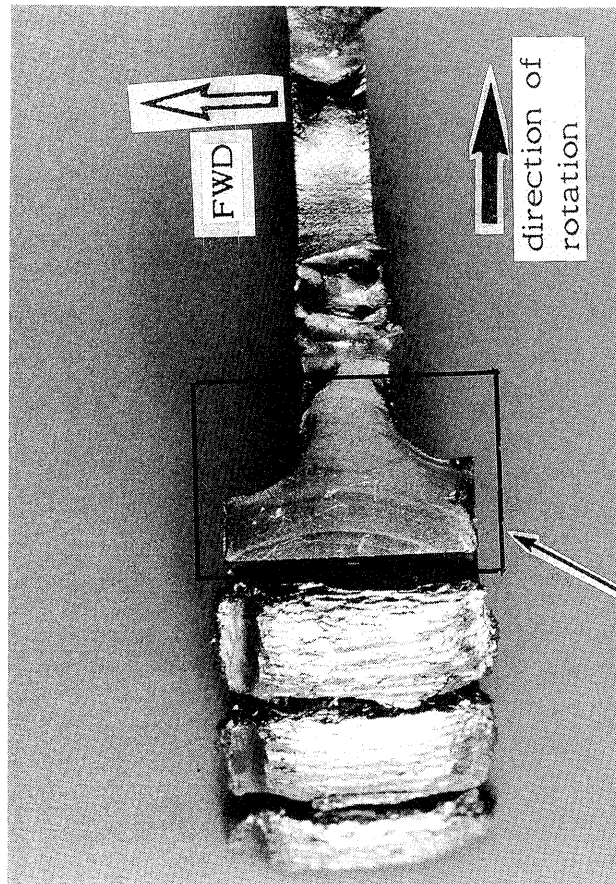
Photo. 8 Fractured Cooling  
Fan Idler Gear

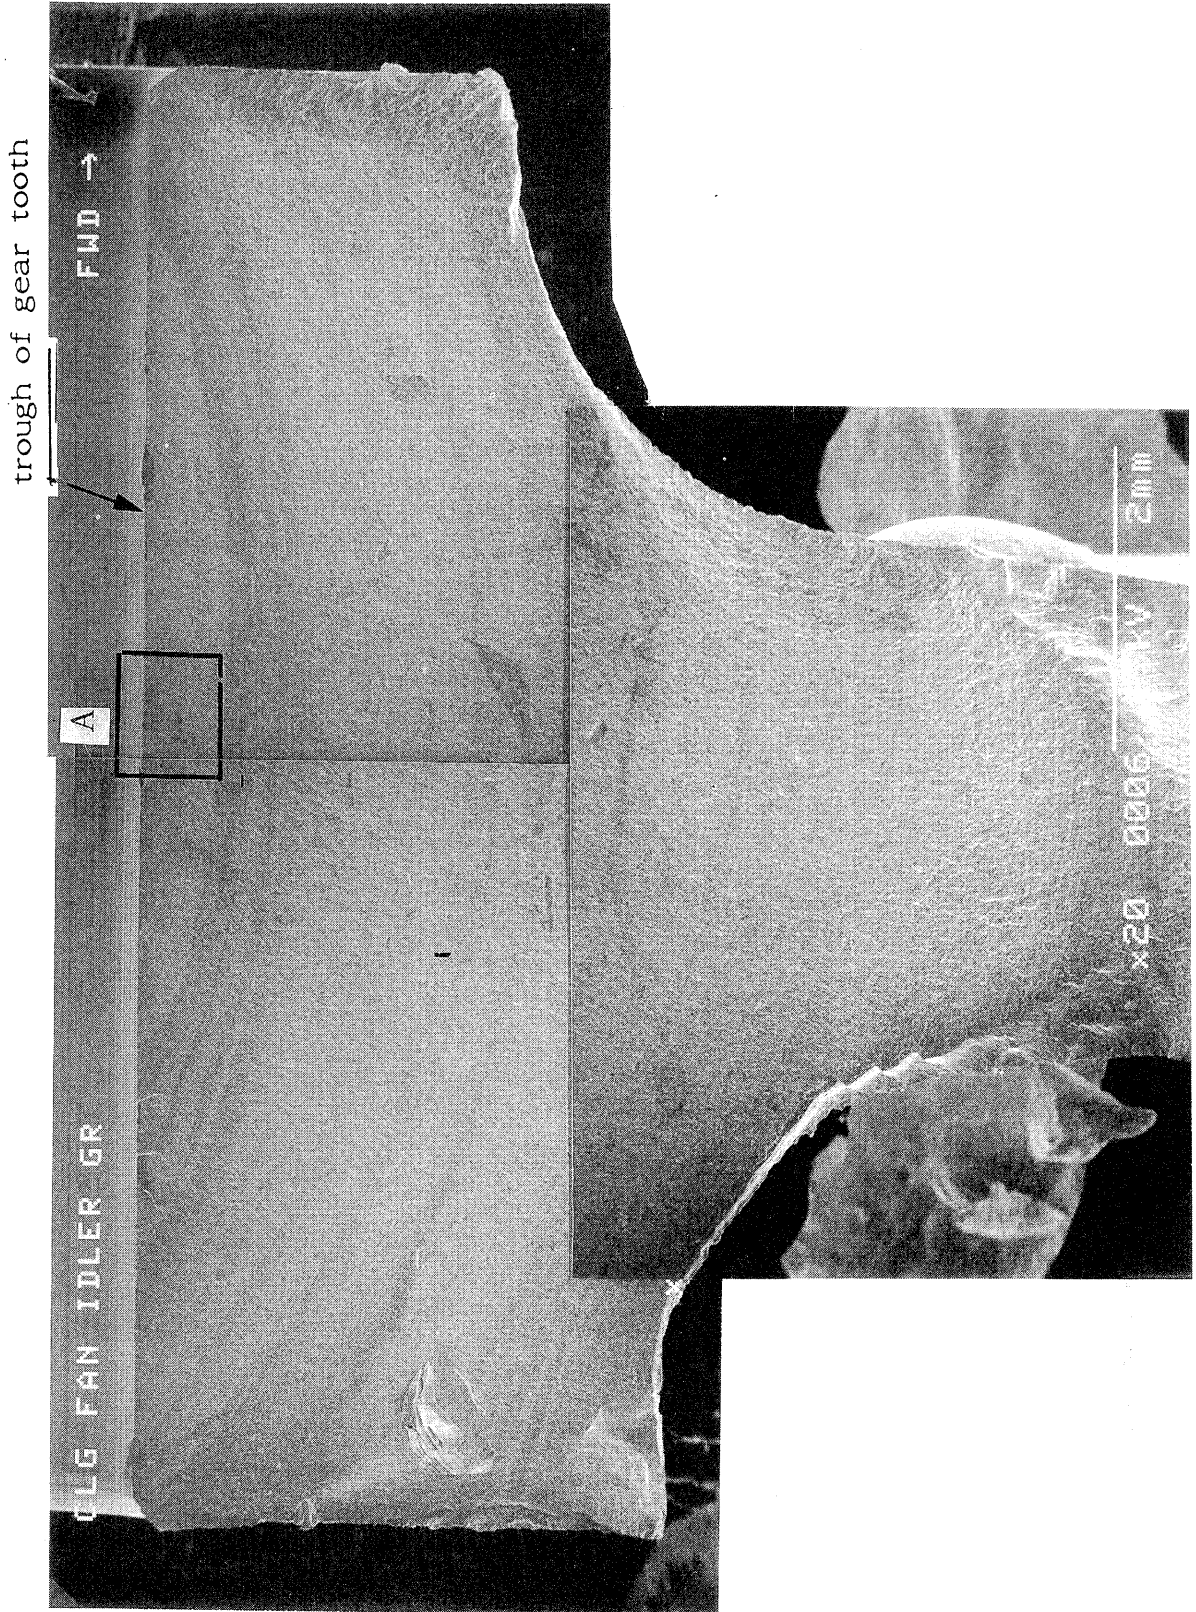
Photo. 9 SEM View of Fractured  
Cooling Fan Idler Gear

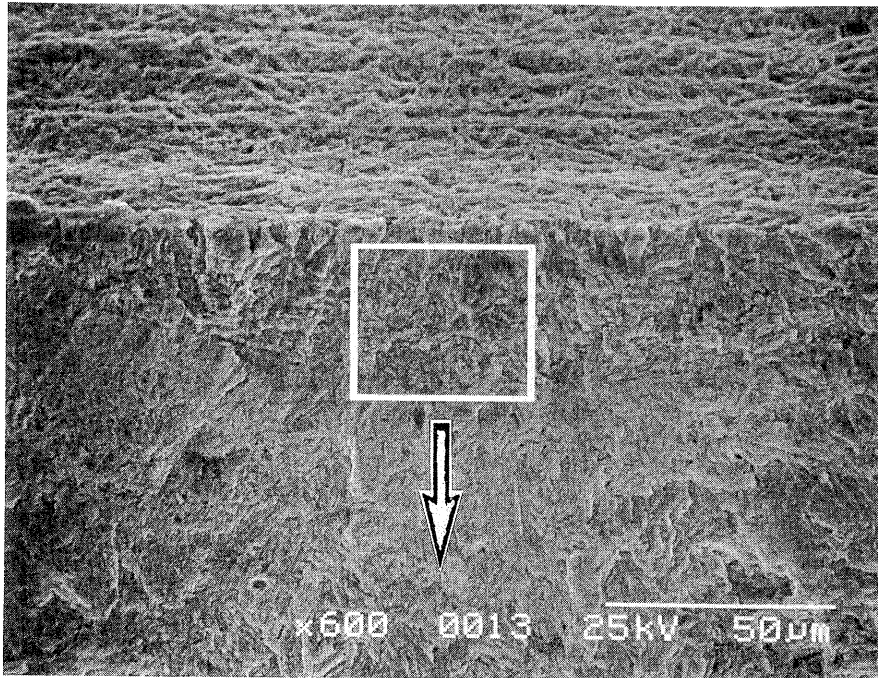
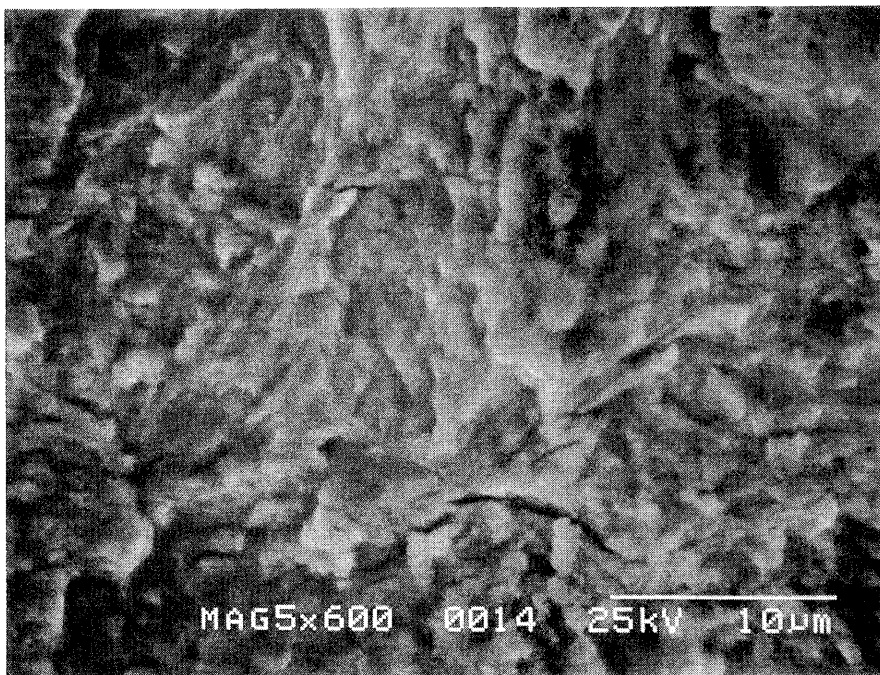
Photo.10 SEM View of Fractured Cooling Fan Idler Gear (Position A on Photo.9)

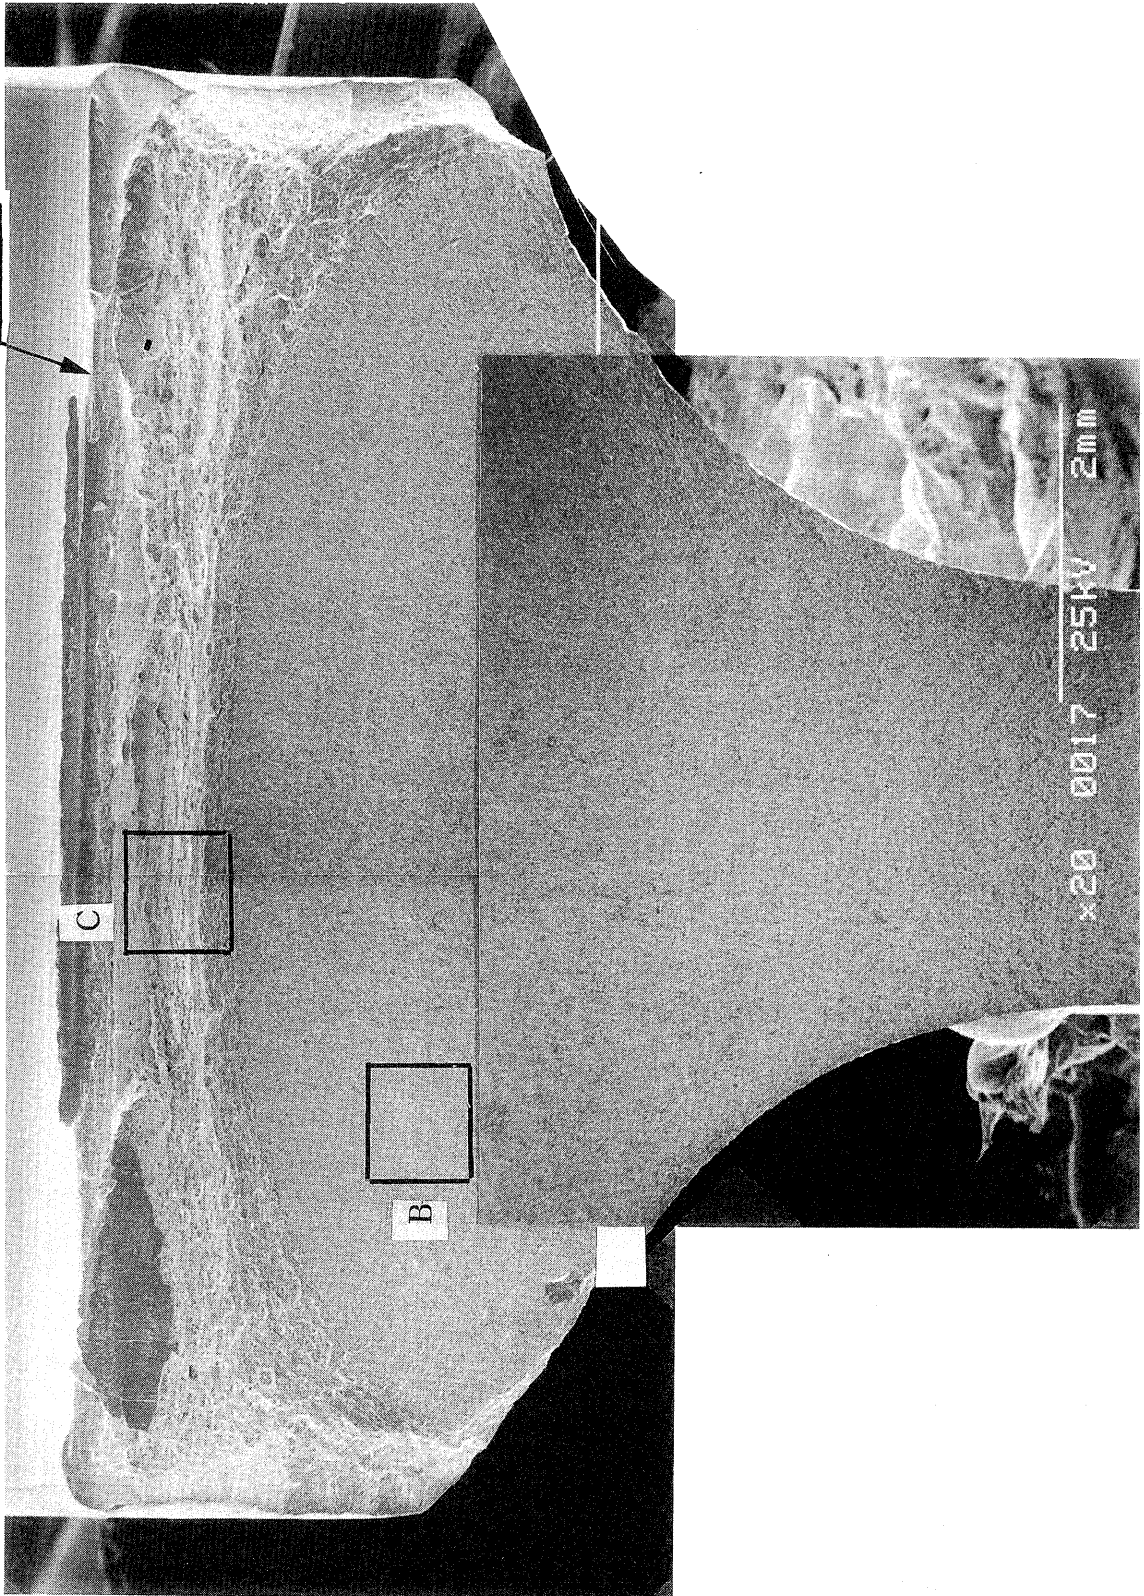
Photo.11 SEM View of Fractured  
Cooling Fan Idler Gear

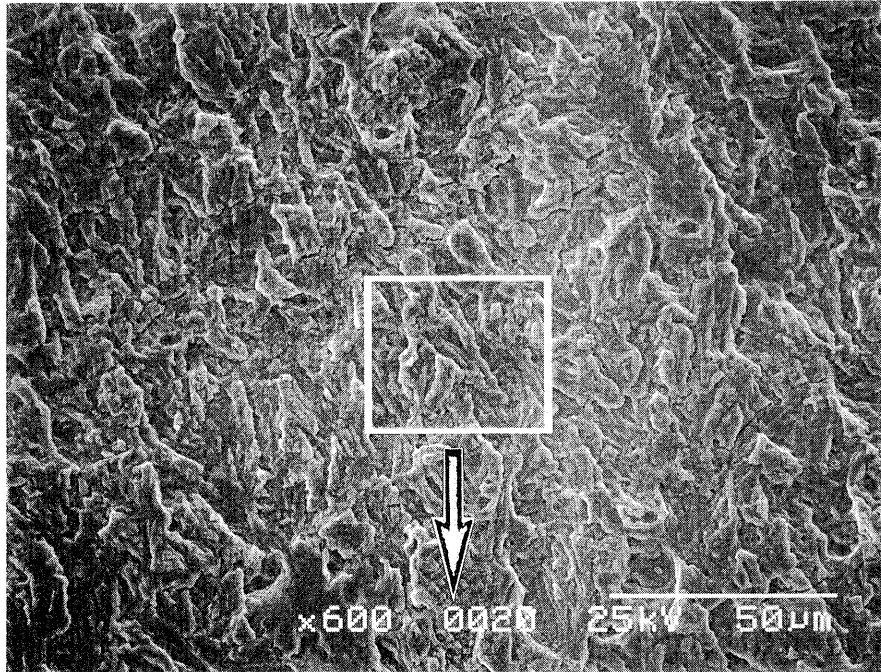
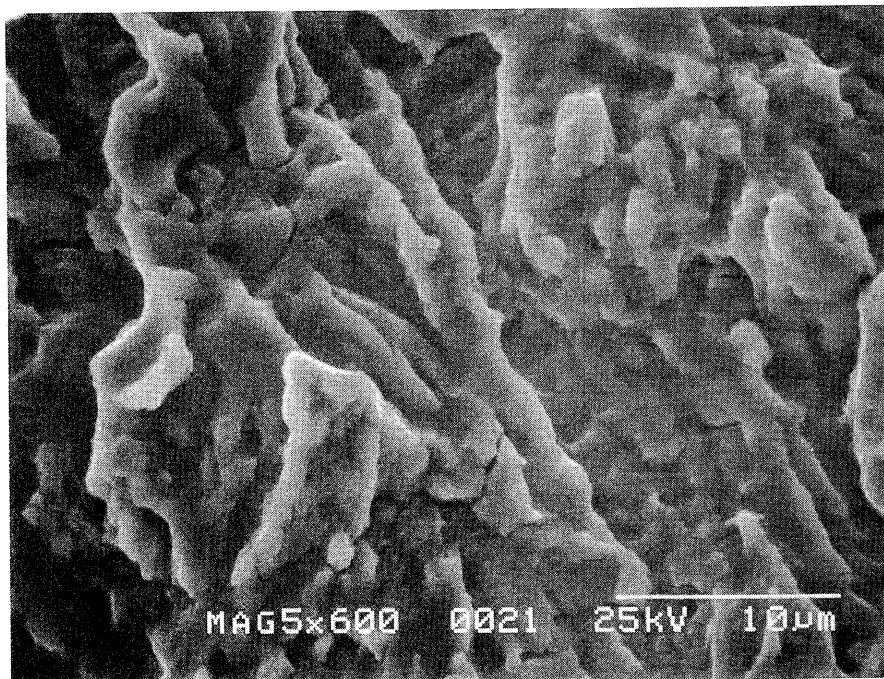
Photo.12 SEM View of Fractured Cooling Fan  
Idler Gear(Position B on Photo.11)

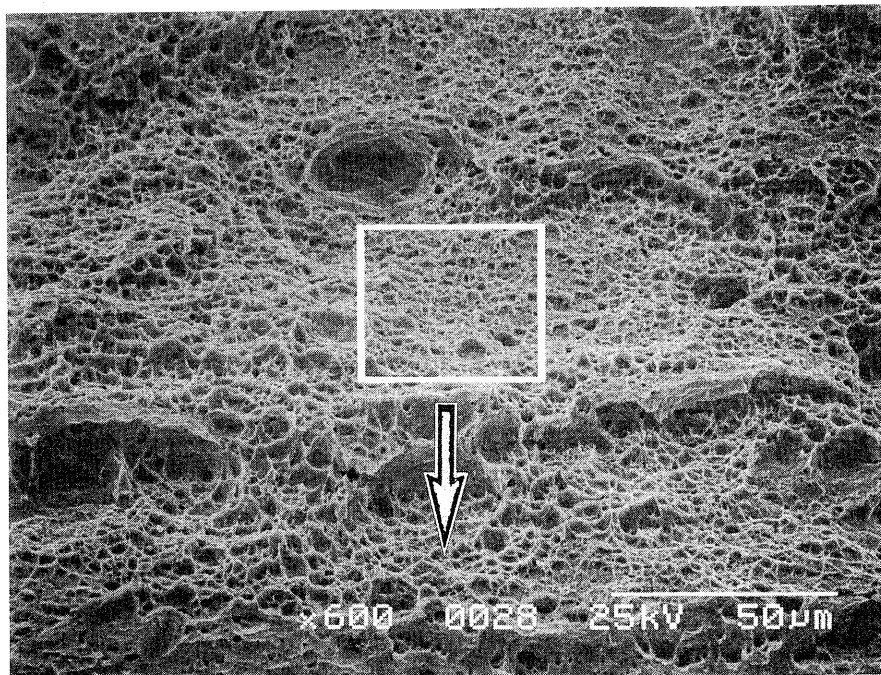
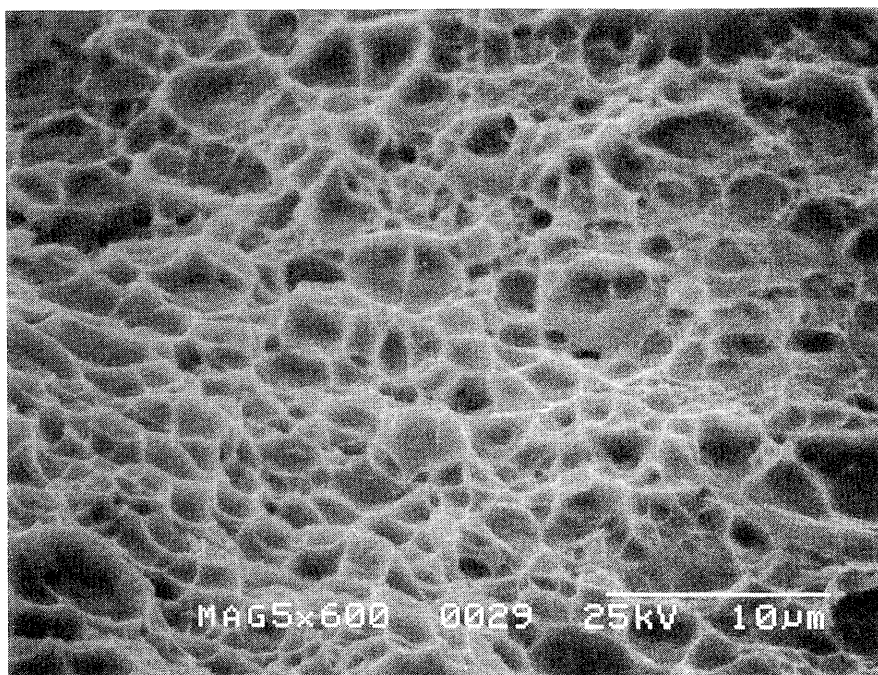
Photo.13 SEM View of Fractured Cooling Fan  
Idler Gear(Position C on Photo.11)

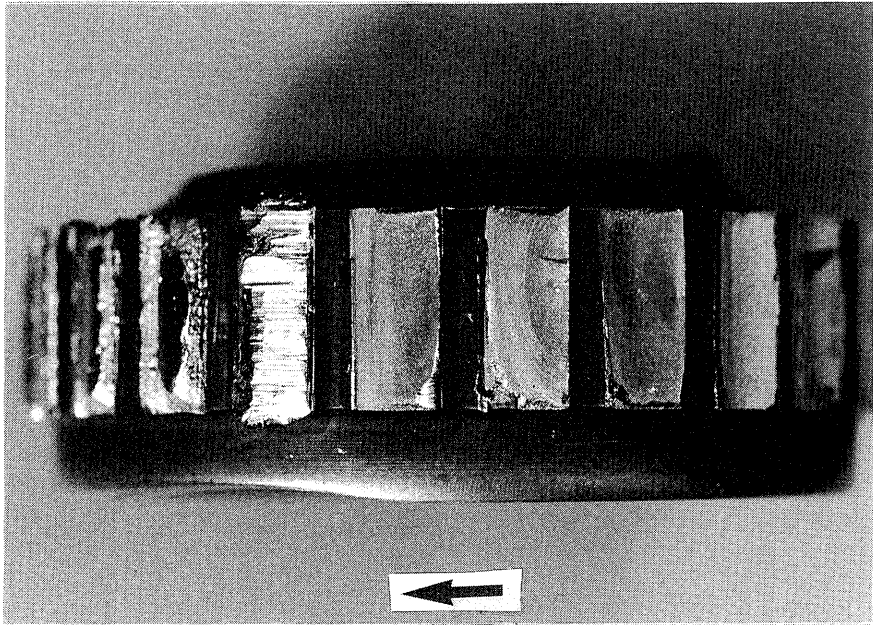
Photo.14 Fractured Cooling Fan Drive Gear
