**航空事故調査報告書**  
**ノースウェスト航空会社所属**  
**ボーイング式747-251B型N637US**  
**新東京国際空港**  
**平成6年（1994年）3月1日**

平成8年11月7日

航空事故調査委員会議決

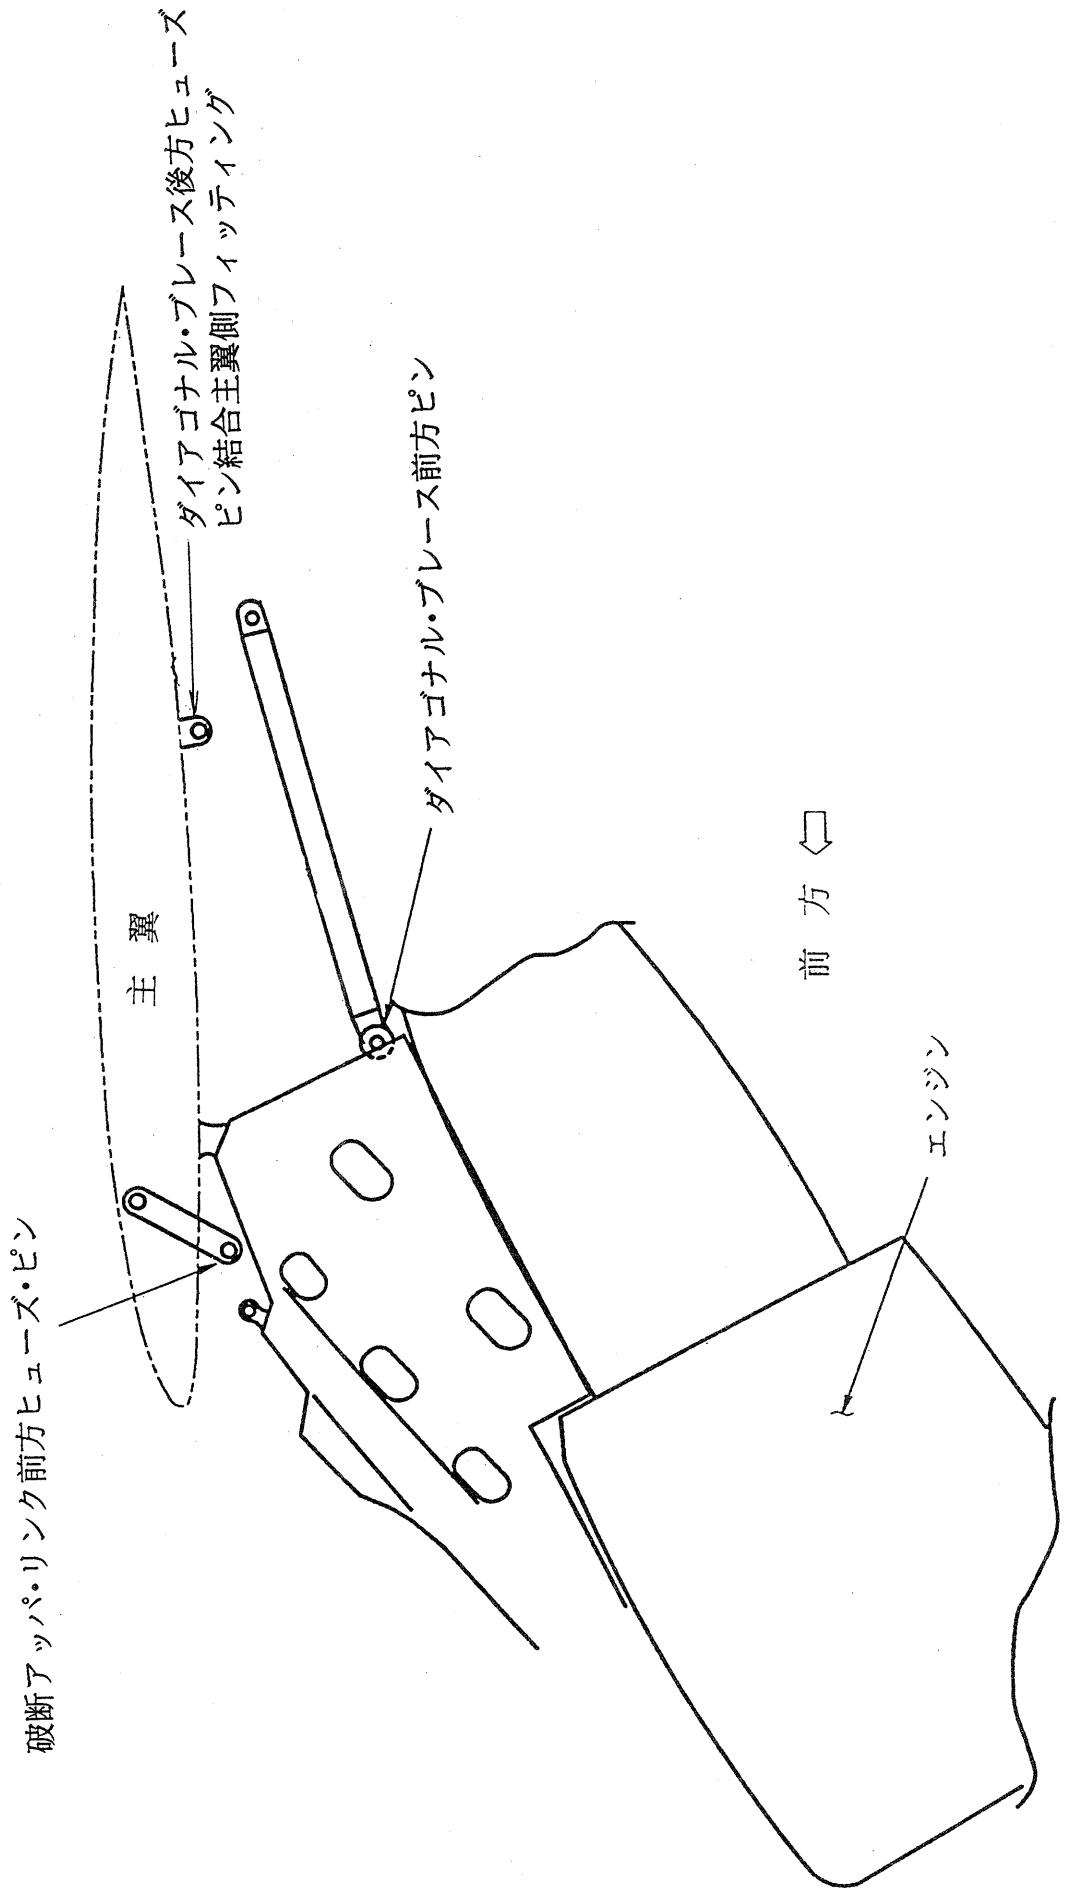
付図3 No.1エンジン・ナセル・ストラット部状況図

同機のNo. 1 エンジンは、ナセル・ストラットの主翼への取付け部であるアップ・リンクが、前方ヒューズ・ピンの破断により前方結合部で外れ、またダイアゴナル・ブレースが、後方ヒューズ・ピンのずれにより後方結合部で外れたため、ミッド・スパー・フィッティングを支点として前部が垂れ下がって接地しているのが認められた。（付図3及び写真1、2、3 参照）

機体調査の結果、ダイアゴナル・ブレースが後方結合部で外れてフェアリング・ドア内に垂れ下がり、また、アッパ・リンク前方結合部のヒューズ・ピンが破断しており、No. 1 ナセル・ストラットは2個所のミッド・スパーによってのみ支えられた状態となり、その結果、エンジン前部が垂れ下がって滑走路面に接地したものと認められる。

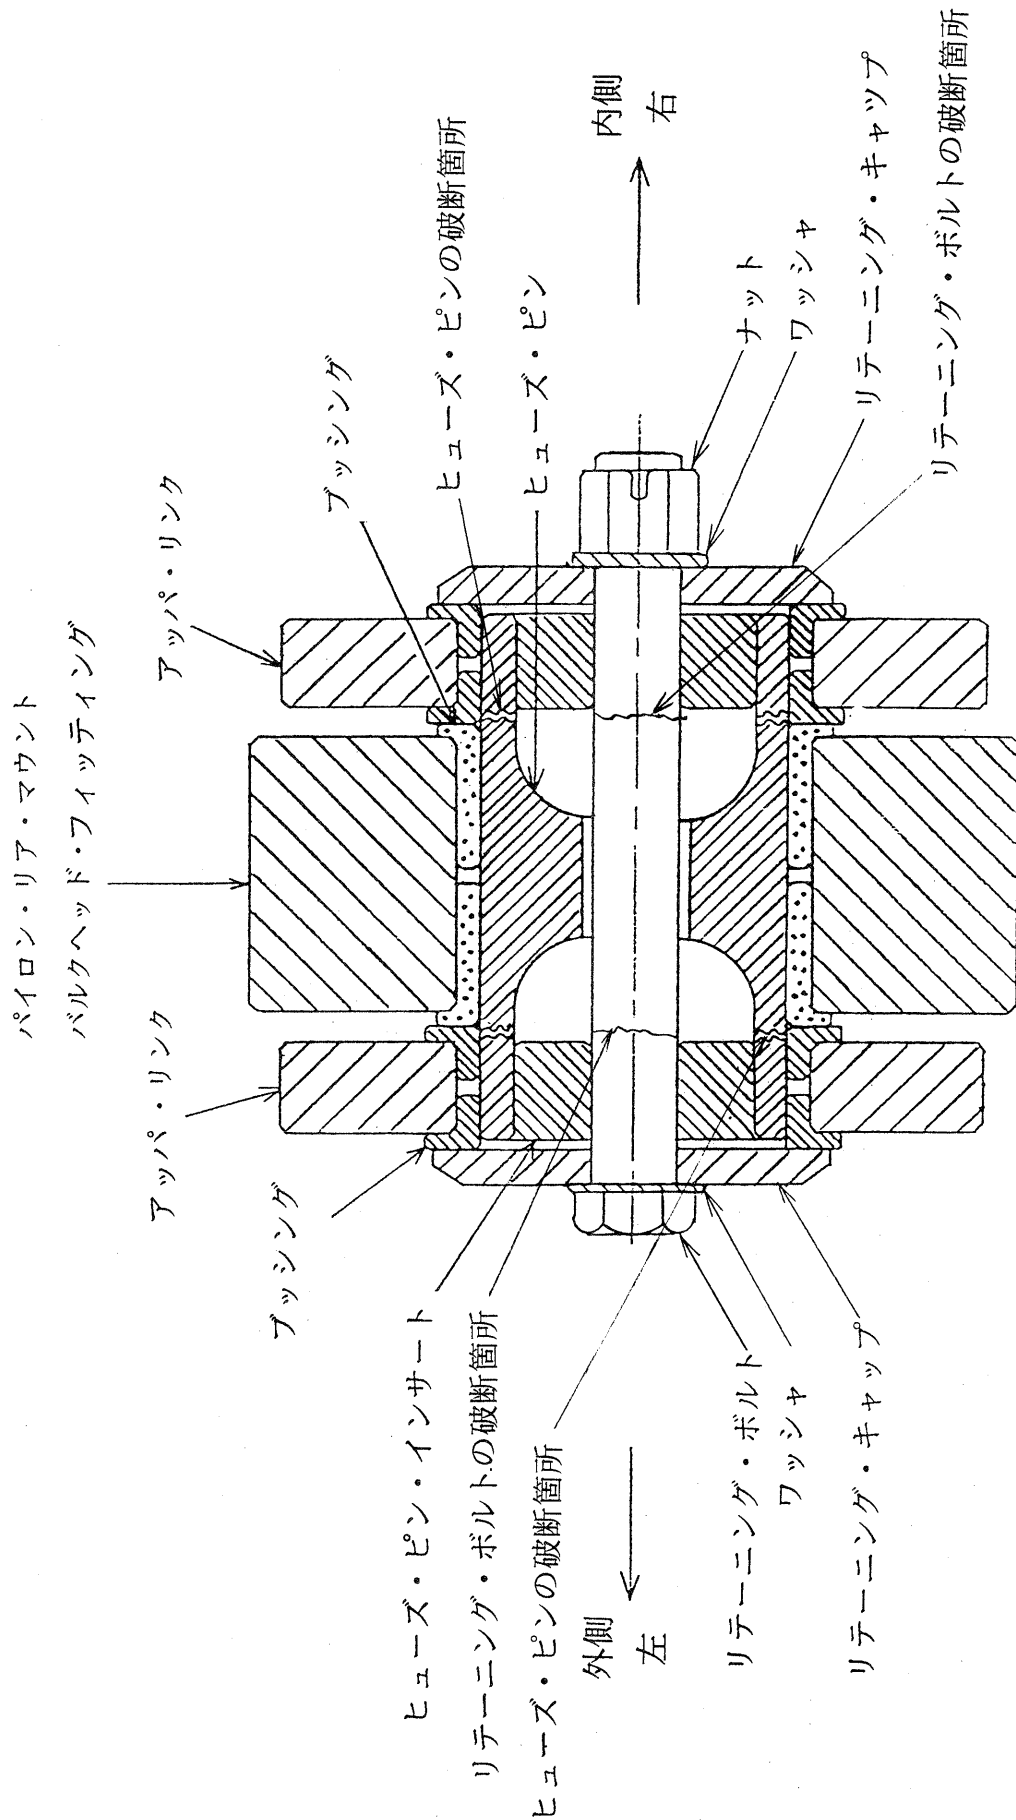
付図4 アッパ・リンク前方ヒューズ・ピン  
 結合部の断面図及び破断箇所

前方ヒューズ・ピンは3つの部分に破断し、真ん中の部分はリア・マウント・バルク・ヘッド・フィッティングに取付いたままで発見され、両端の部分は両方ともアッパ・リンクから脱落して、ストラット内に落ちているのが発見された。

当該ヒューズ・ピンのプライマリ・リテーナは、キャップ、ボルト及びナットにより構成されるアセンブリであるが、ヒューズ・ピンの破断に伴って、ボルトが3つの部分に破断し、キャップ及び破断したボルトはヒューズ・ピンに付いたままでストラット内に落ちているのが発見された。(付図4及び写真5、6 参照)

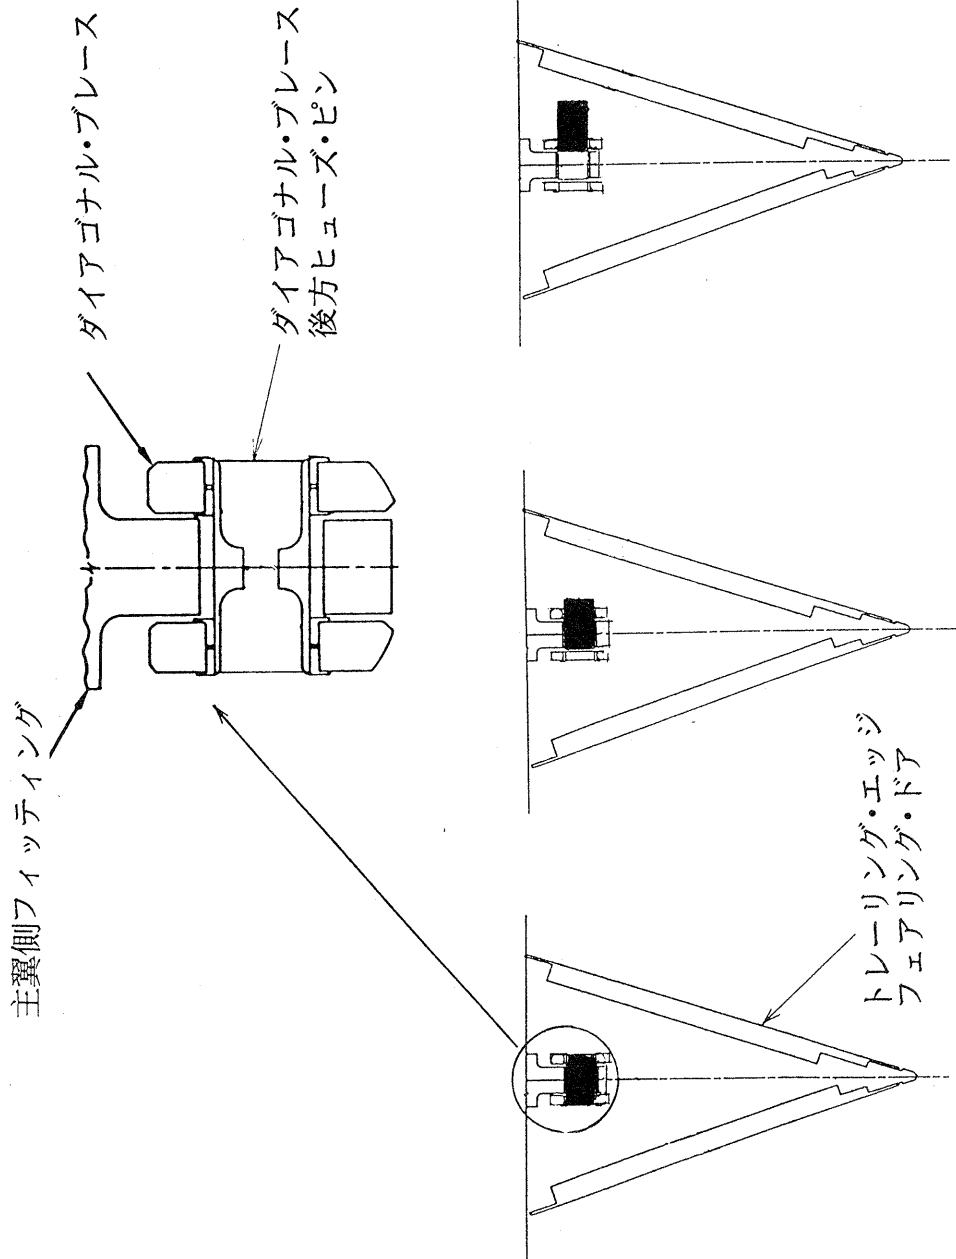
付図5 ダイアゴナル・ブレース後方ヒューズ・ピン抜け出し状況図

### 3.2.6 ダイアゴナル・ブレースの後部の結合部からの外れ及びリテーナの欠落

セカンダリ・リテーナが、運航中に破損又は外れて紛失する可能性はその大きさから考えられず、むしろ、C点検終了時、ヒューズ・ピンは装着されていたが、セカンダリ・リテーナは装着されていなかったものと推定される。

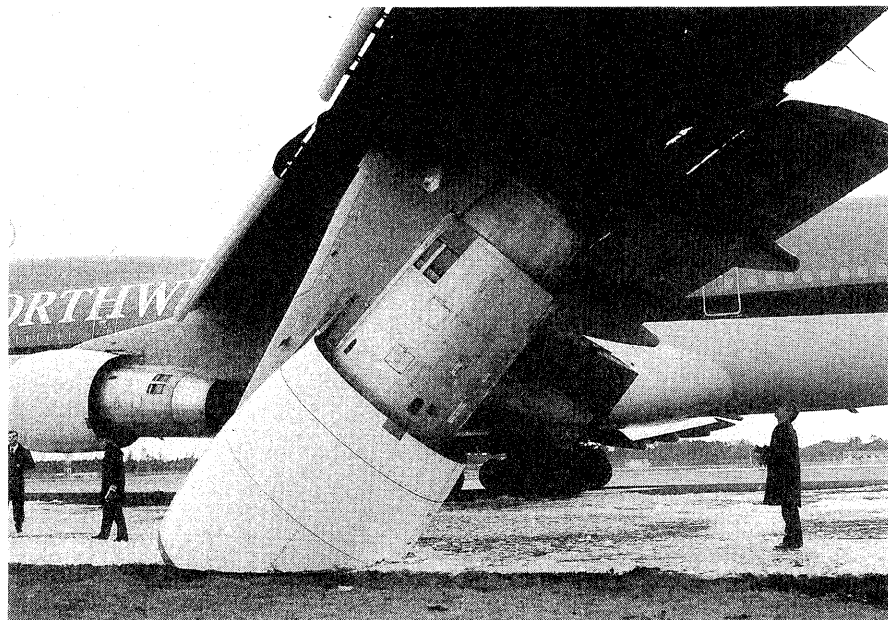
# 写真2 事故機のNo.1エンジン部

滑走及びその後の地上走行中に地上を引きずられたことによる破損が認められた。

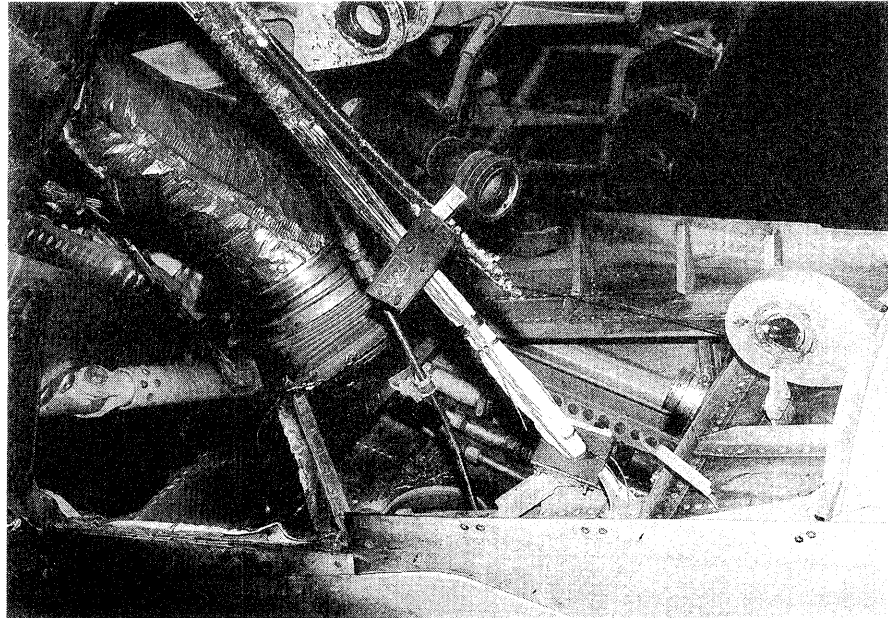
写真3 No.1 ナセル・ストラット上部  
部（分離部）

現場での外観調査の結果、同機は、No. 1 エンジンのナセル・ストラットの主翼への結合部であるアッパ・リンクの前方ヒューズ・ピンが破断してアッパ・リンクが前方結合部で外れていた。

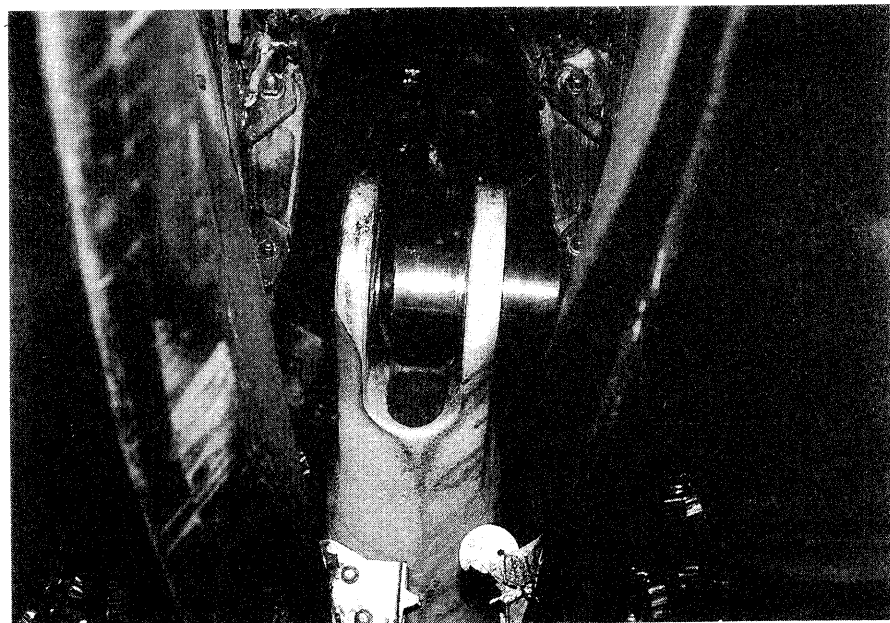
写真4 No.1 ナセル・ストラット・  
ダイアゴナル・ブレース後方  
ヒューズ・ピン及び同ブレース  
後部

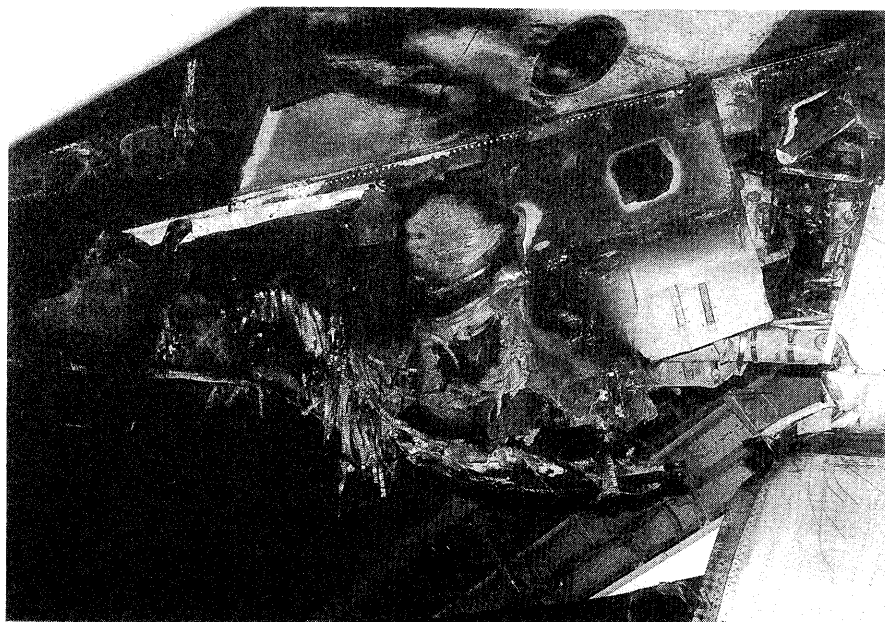
- (5) No. 1 ナセル・ストラットのミッド・スパー・フィッティング及び結合部  
ミッド・スパー・フィッティング及び同ヒューズ・ピンに異常は認められなかった。
- (6) No. 1 ナセル・ストラット及びその周辺、その他の損傷（写真5 参照）
- ・ サイド・ブレースはストラット側結合部で破断していた。
  - ・ No. 1 ハイドロリック系統のリザーバ・タンクに配管されたリターン系統のパイプが、タンク部で破損すると共に、タンクに損傷が生じ、ハイドロリック・オイルはすべて流出しているのが認められた。これらの損傷はナセル・ストラットの前方部が垂れ下がったことにより生じたものと認められ、また、火災により焼損していた。
  - ・ ナセル・ストラットと主翼の間の燃料フィード・パイプが主翼及びストラット側で結合部から分離し、また、ブリード・エア・ダクトもストラット側結合部で分離しており、損傷していた。
  - ・ 3本のジェネレータ・フィーダ・ケーブル及びスラスト・コントロール・ケーブル1本が破断し、いずれも一部焼損していた。
  - ・ ストラット・リア・エンジン・マウント・バルクヘッド・フィッティングとアッパ・リンクとの結合部の穴が、アッパ・リンクの方向に長円形に変形しているのが認められた。
  - ・ フェアリング内のリターン・フィルタ・モジュール、ケース・ドレイン・モジュール、プレッシャ・モジュール、エアー・ドリブン・ハイドロリック・ポンプは焼損していた。
- (7) フラップ  
前縁フラップは下げ位置にあった。  
後縁フラップは25ユニット下げ位置であった。
- (8) 操縦室内のレバー等の位置  
操縦室内の主要なレバー及びスイッチの位置は次のとおりであった。
- ・ フラップ・レバー 25ユニット下げ
  - ・ エンジン
    - スラスト・レバー 全エンジン : アイドル
    - スラスト・リバーサ・レバー No. 1 エンジン : フル・リバーサ位置
    - その他のエンジン : アイドル（フル・ダウン）位置

また、破損したリザーバ・タンク及びリターン配管からハイドロリック・オイルが漏洩し、漏洩したオイルが高温（約500～600℃）のタービン・スリーブ内に流入し、オイルの自然発火温度が965°F（518℃）であることから発火し、さらにそれが漏洩した燃料に引火したものと推定される。

写真5 焼損したNo. 1 ナセル・ストラット・トレーリング・エッジ・フェアリング

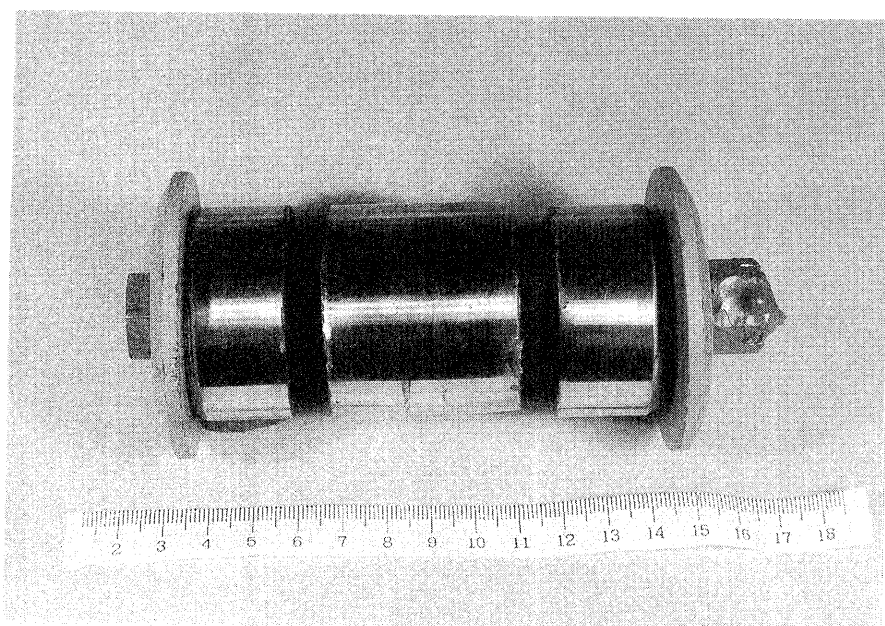
同ピンについて、走査型電子顕微鏡を使用して、破断面の調査を実施した結果、同ヒューズ・ピンはアッパ・リンク軸方向に作用した過大な引張り荷重のため、剪断破壊したものと推定される。

また、破断面に疲労の痕跡は認められず、材料傷、腐食、メッキ不良などの異常も見いだせなかった。

これらのことから、当該ピンの破断については、設計破断強度を超える荷重が作用したことによるものと推定される。

写真6 破断したアッパ・リンク前方ヒューズ・ピン

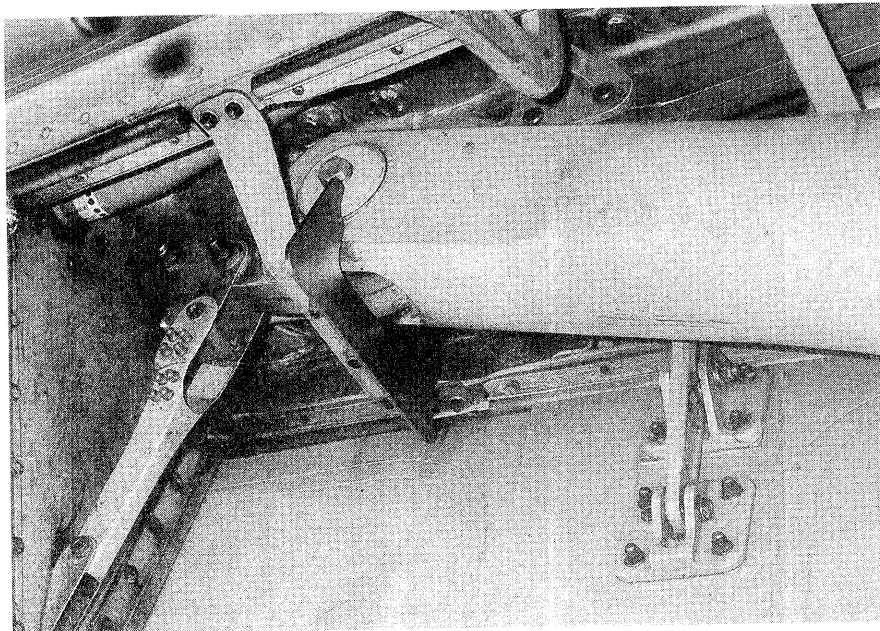
写真8 ダイアゴナル・ブレース後方  
ヒューズ・ピン・セカンダリ・  
リテーナ

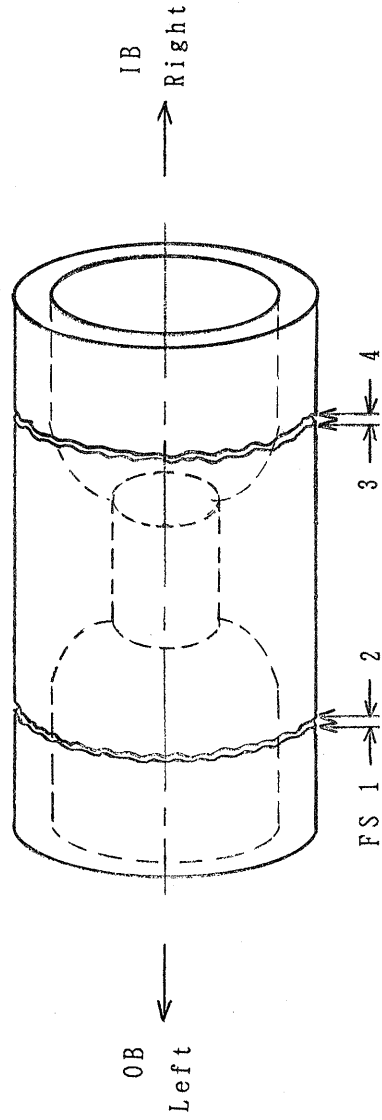
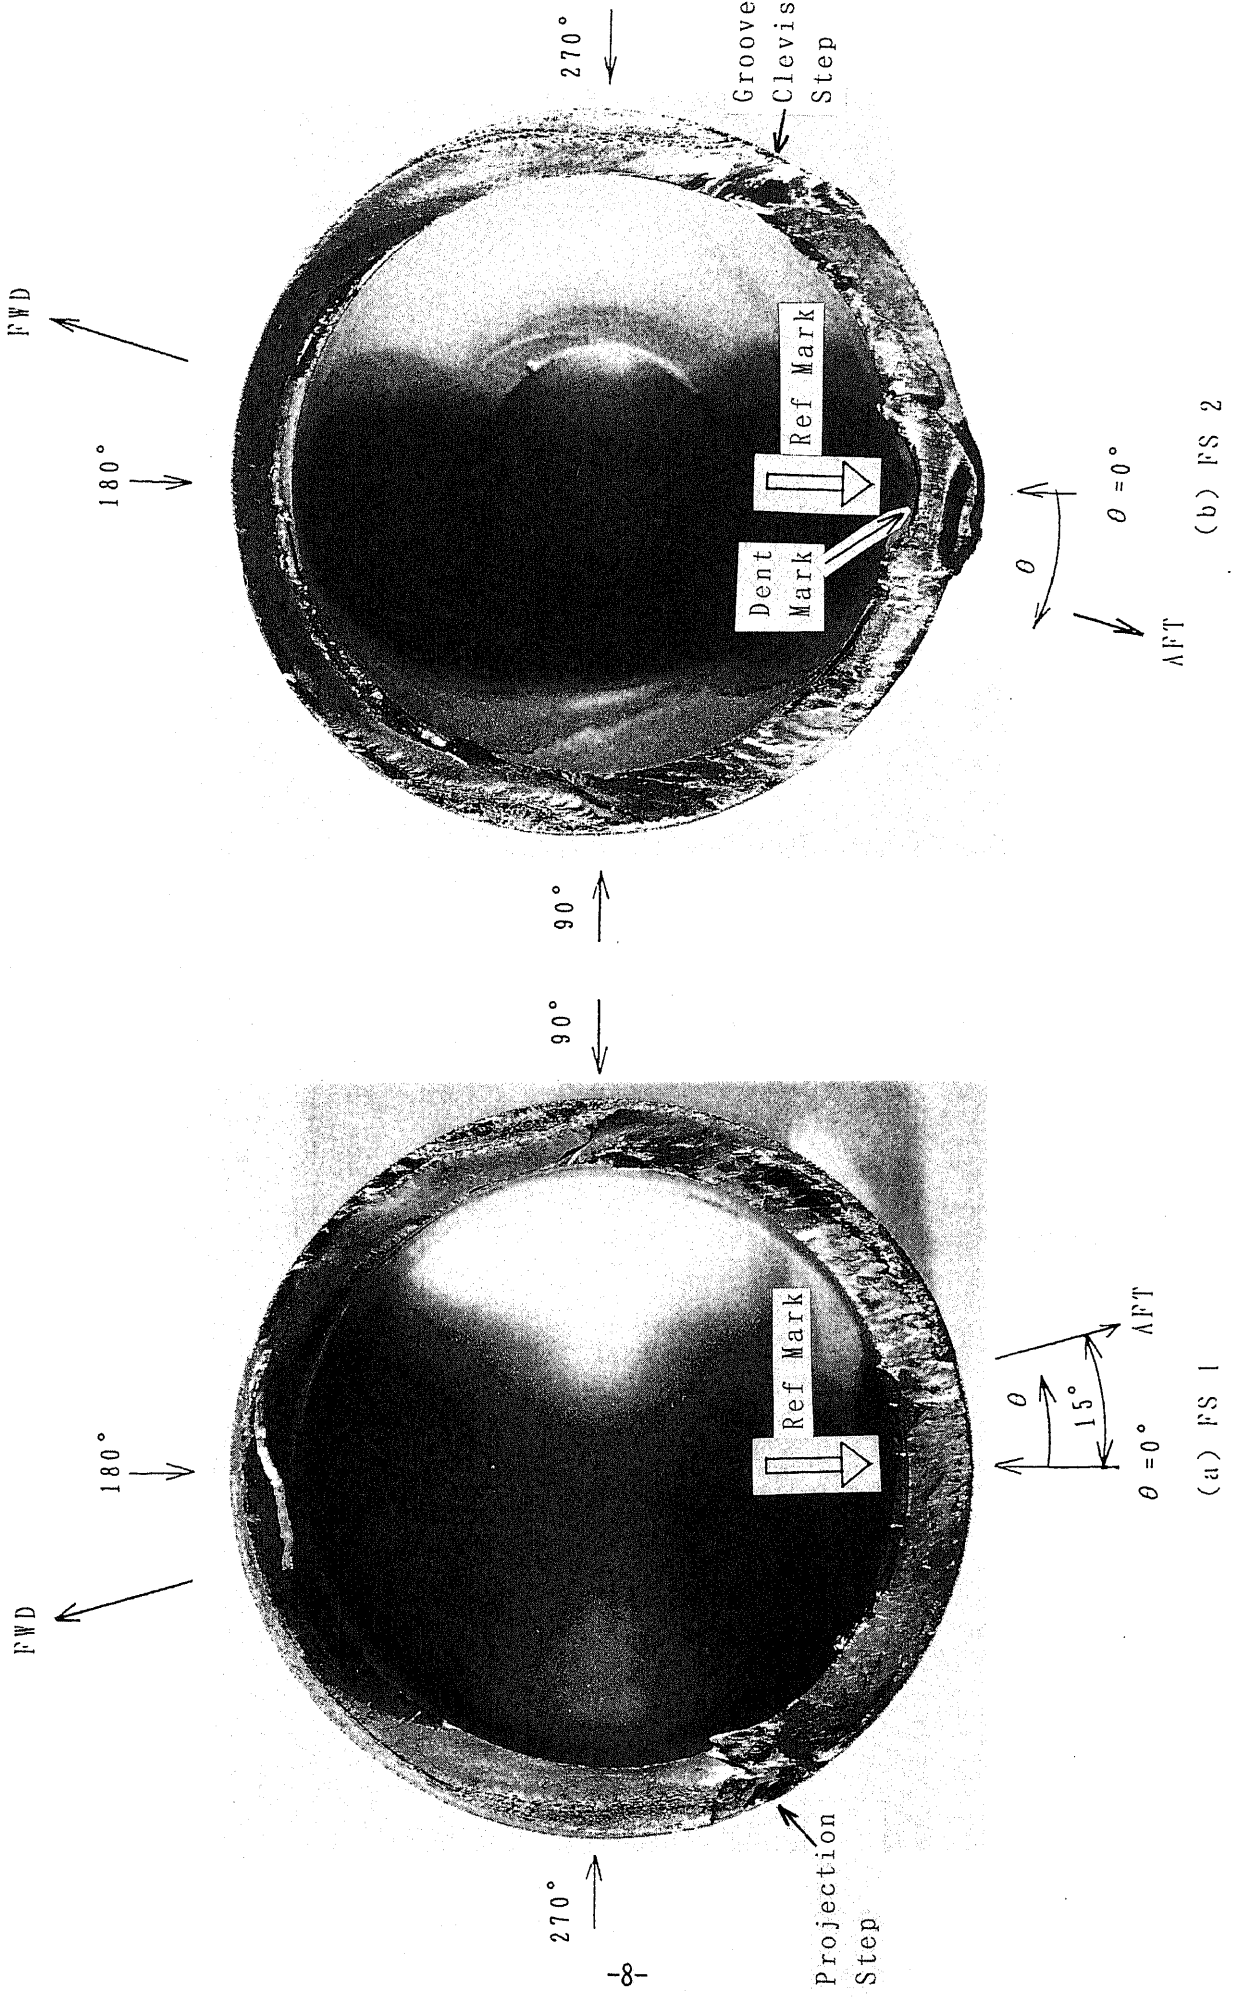
図 5. Upper Link FWD Fuse Pin  
のマクロ写真と模式図

ヒューズ・ピンは、フィッティングとアップパ・リンクの間で破断し、3つの破片に分かれていた。

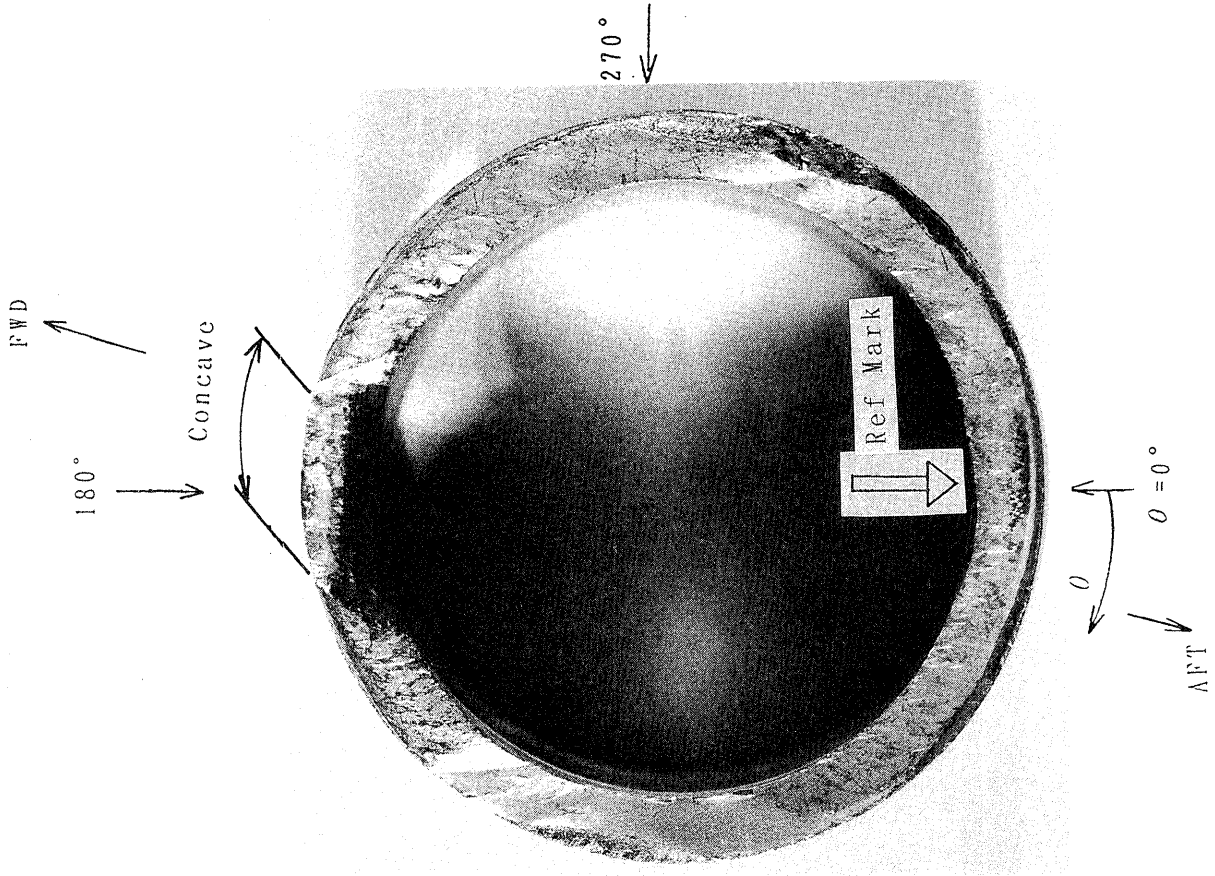
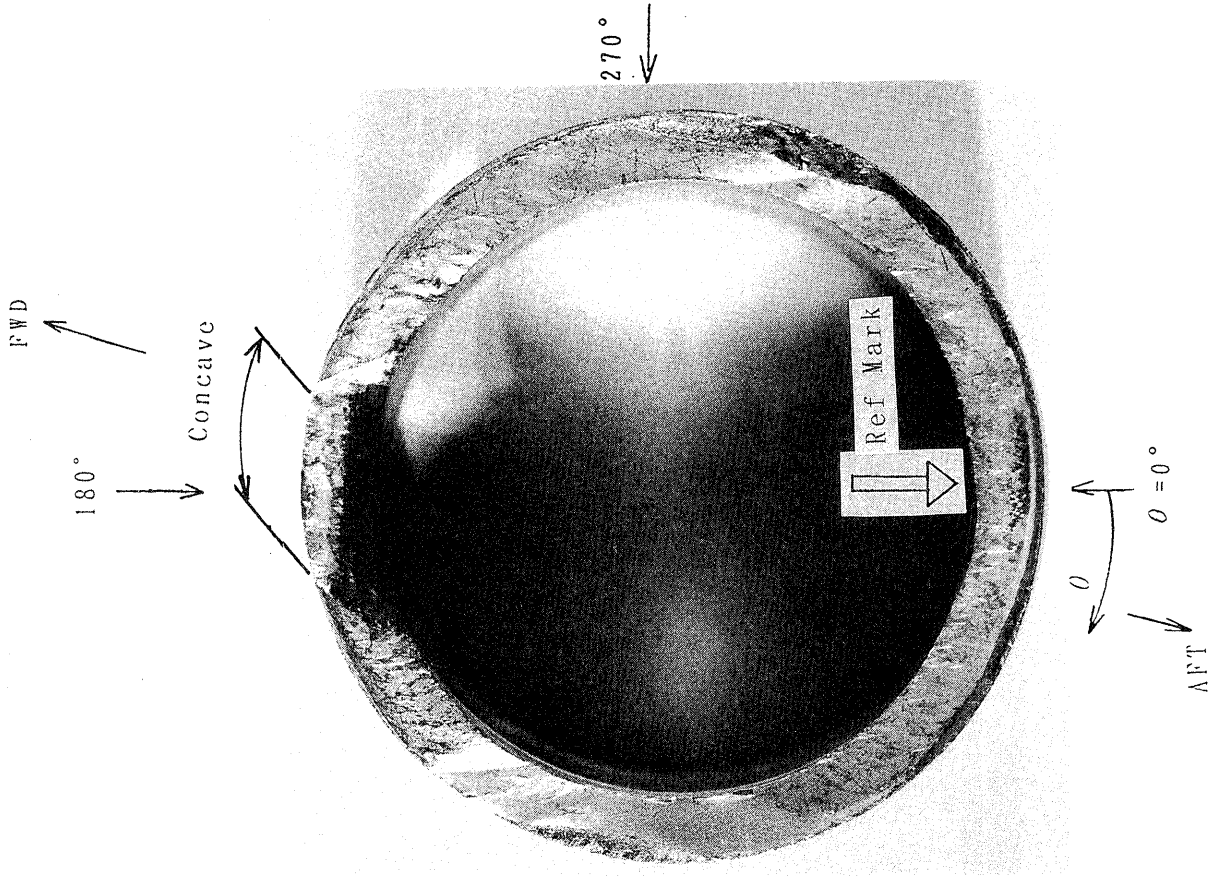
図6. Upper Link FWD Fuse Pin 破面のマクロ観察(その2、FS3と4)

まず、対をなす破面1と2、並びに3と4は、全体としてそれぞれ良く対応しており、破面1-2側と3-4側で、注目すべき差は認められなかった。

各破面は、何れも0°と180°を中心とするほぼ±60°の範囲では、剪断破壊の特徴である伸長ディンプルが多く認められた。

各破面の90°と270°を中心とする約±30°の範囲では、ディンプルの長さは短くなり、引張り破壊の特徴である等軸ディンプルも部分的に認められた。

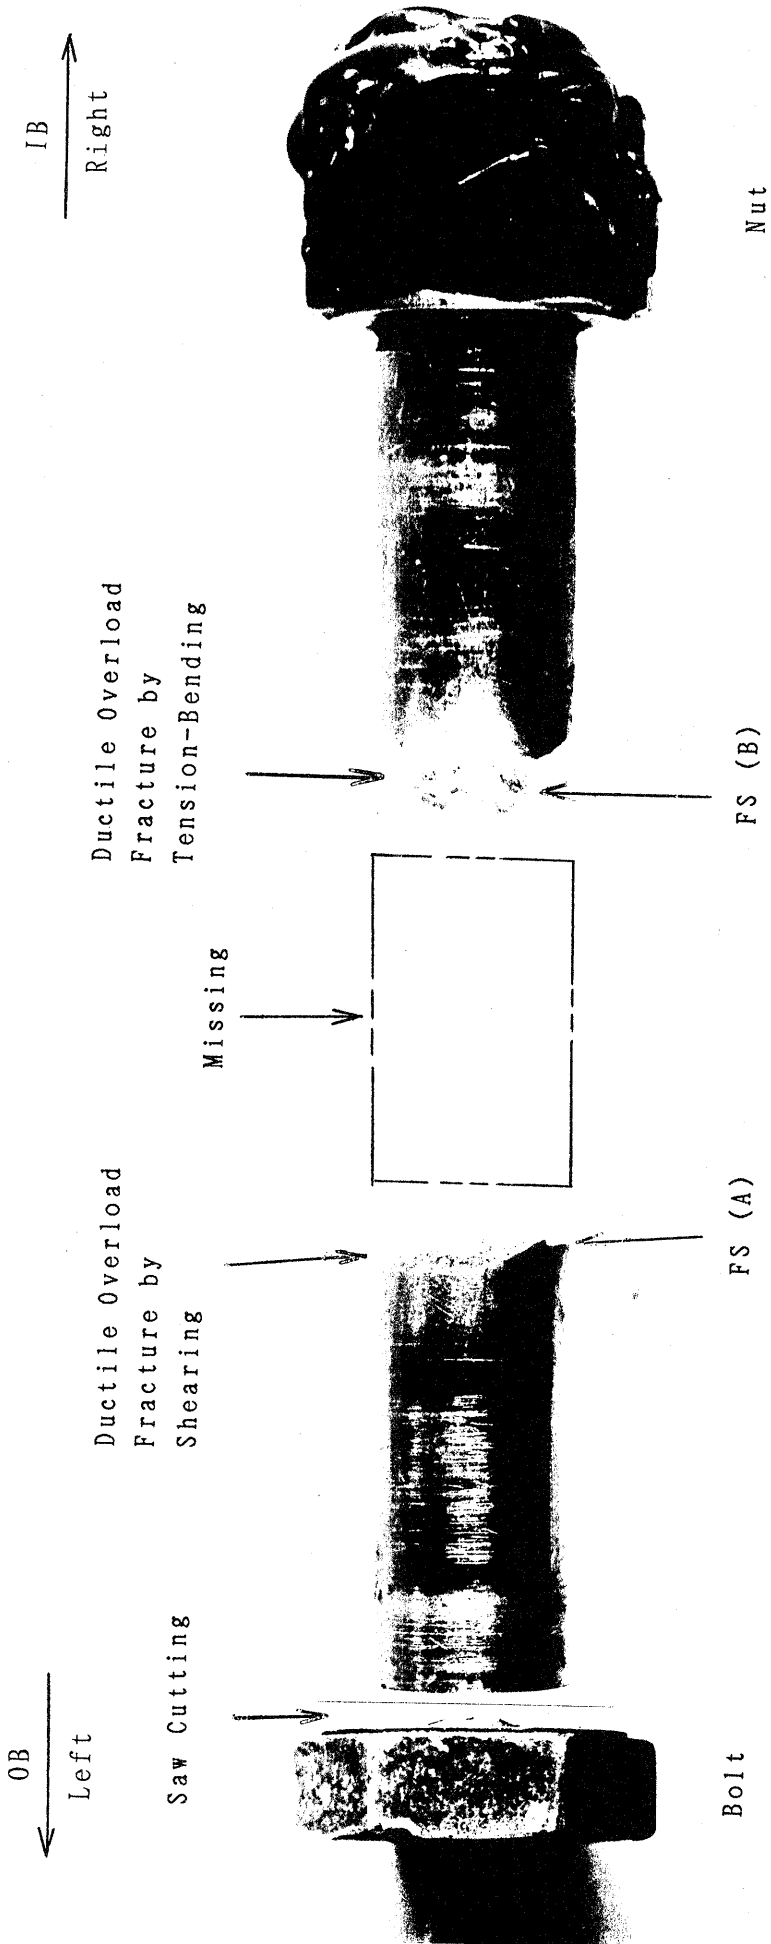
図12. Upper Link FWD Fuse Pin 締付け用ボルトのマクロ観察

また、ピンを固定していたプライマリ・リテーナ・ボルトも、ピンと同位置で過大な荷重の作用により剪断破壊したものと推定される。

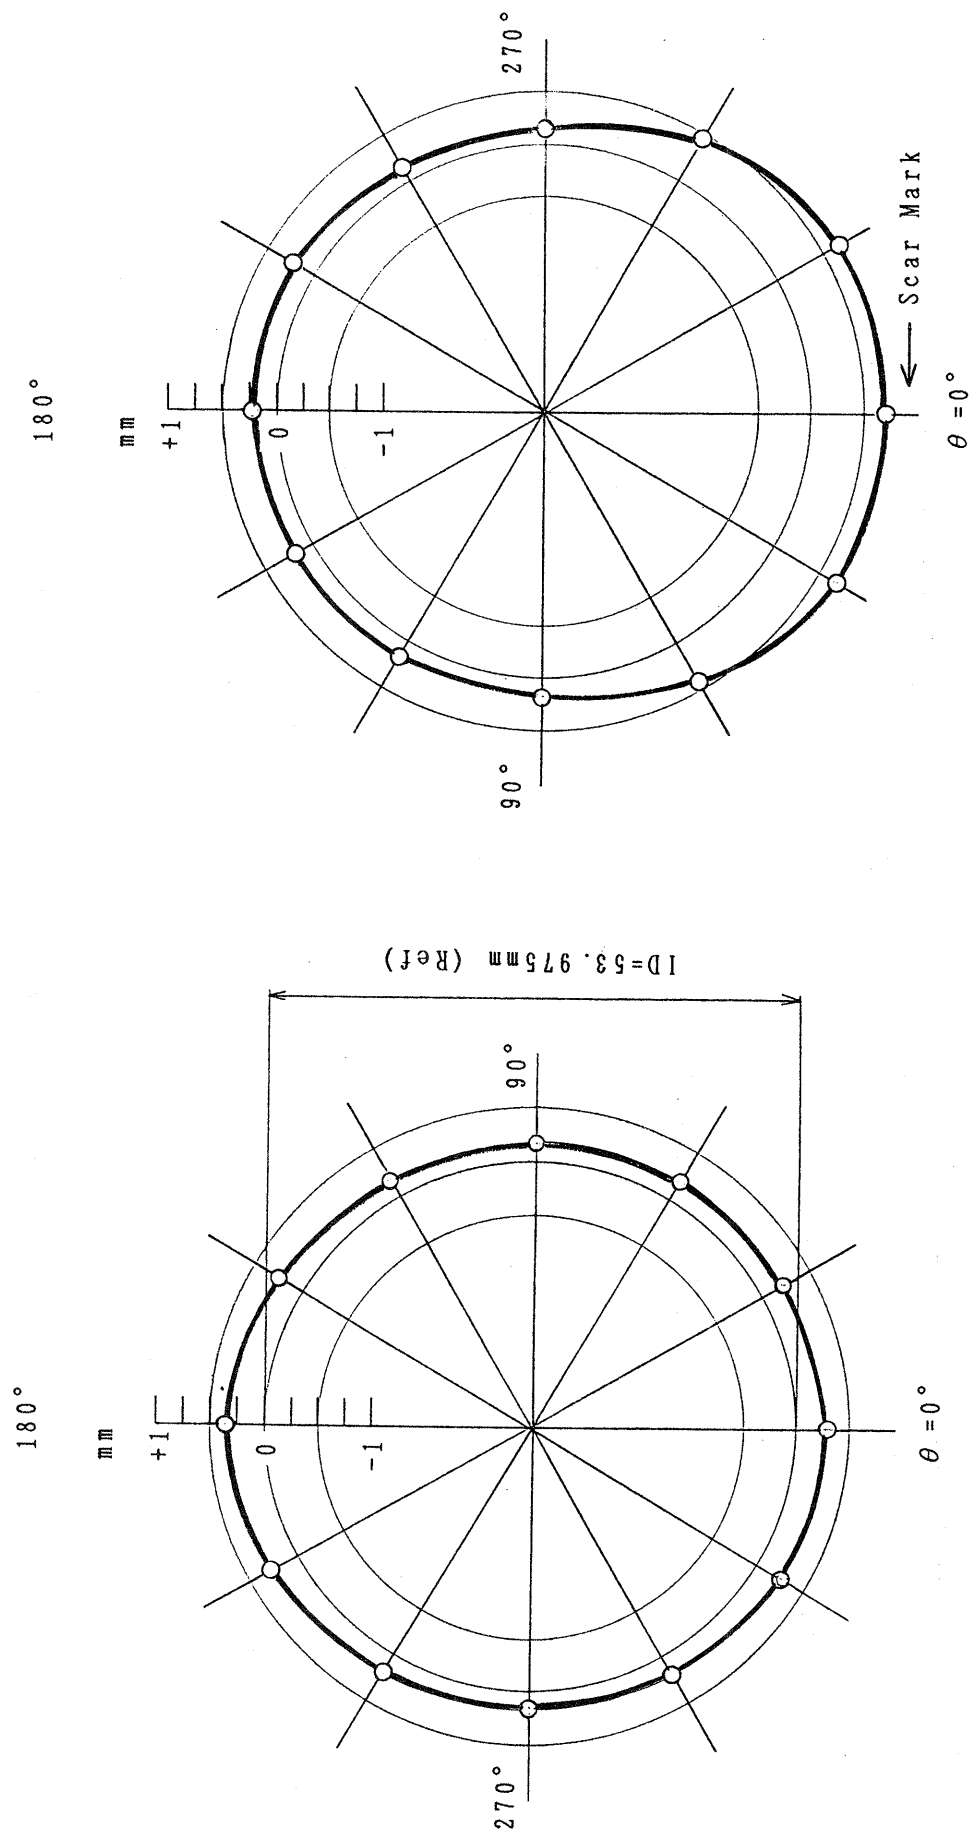
図15. Pylon Rear Mount Bulkhead Fittingの内径変化  
(現場(成田空港)において型取りしたシリコンゴムを用いて測定)

当該穴の変形測定を行ったところ、穴はやや楕円形に変形しており、内径は $90^{\circ}$  -  $270^{\circ}$ 方向に比べ、 $0^{\circ}$  -  $180^{\circ}$ 方向では約 $0.4\sim 0.8\text{mm}$ 大きくなっていた。

この変形が過大な荷重の作用によるものと仮定すると、ボーイング社の材料仕様の降伏応力とフィッティング形状寸法から、作用した荷重は約 $1,003\text{kN}$ と推算できる。この力は同ピンに作用する剪断応力に直すと $857\text{MPa}$ と推算でき、これは、破断したヒューズ・ピンについて測定したビッカース硬さより求められる引張り強さ $1,365\text{MPa}$ からミーゼスの式（剪断応力=引張応力/ $\sqrt{3}$ ）で推算される剪断強さ $788\text{MPa}$ を上回り、かつ、ボーイング社の材料仕様の引張強さの値からミーゼスの式で推算されるヒューズ・ピンの剪断強さを超えるものである。

(1) Fittingの穴の内径は $90^\circ$ — $270^\circ$ 方向に比べて $0^\circ$ — $180^\circ$ 方向で $0.4 \sim 0.8\text{mm}$ 大きくなっていた。

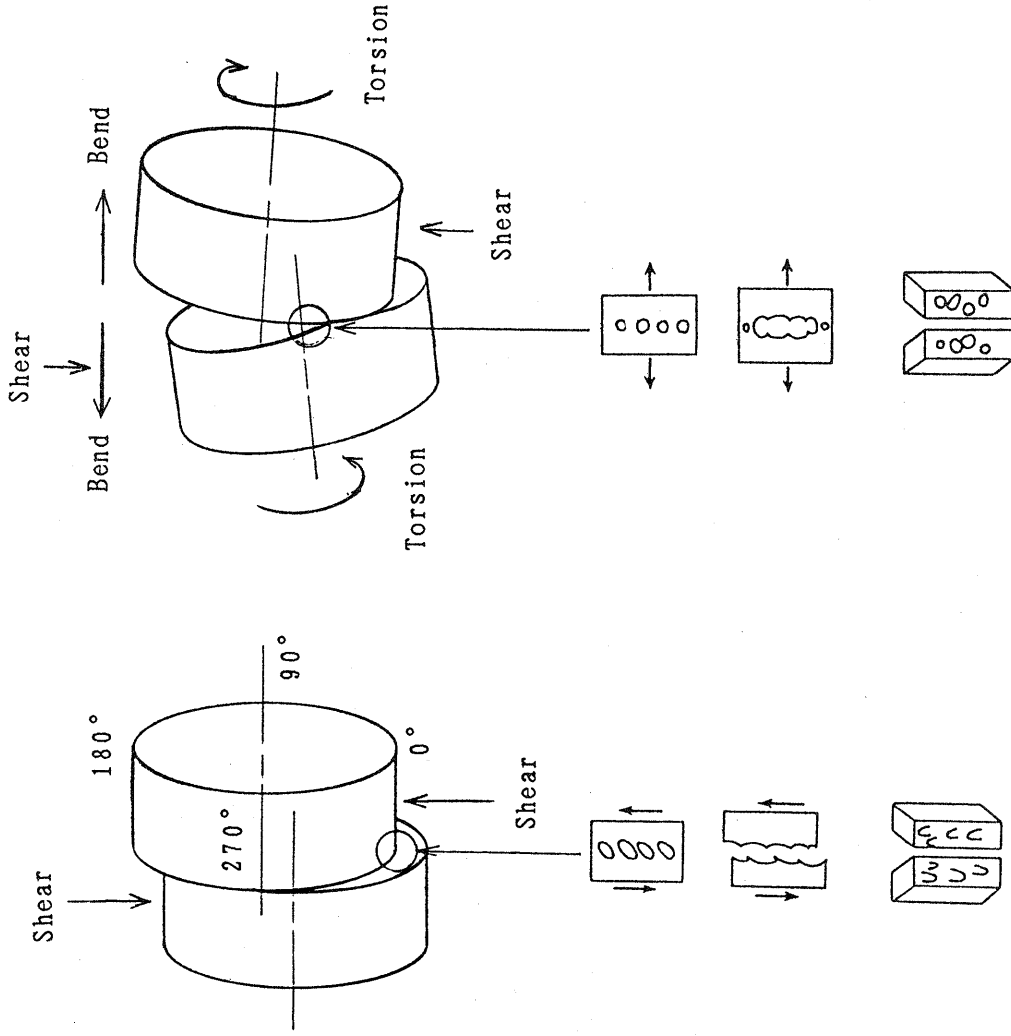
図18. 破壊と変形のまとめ

(2) Fuse Pinの破壊は次の順序で起こったと考えられる。

- (a)  $\theta = 0^\circ$ 、 $180^\circ$ の付近から伸長デインプルを伴うせん断破壊が開始する。
- (b) 残った $90^\circ$ 、 $270^\circ$ の部分では、曲げ荷重が生じるため、等軸デインプルに近づき、先に $90^\circ$ 付近で破断する。
- (c) 最後に、 $270^\circ$ 付近で破断するが、この時はねじり荷重も加わり、デインプルは外径側と内径側で逆になる。

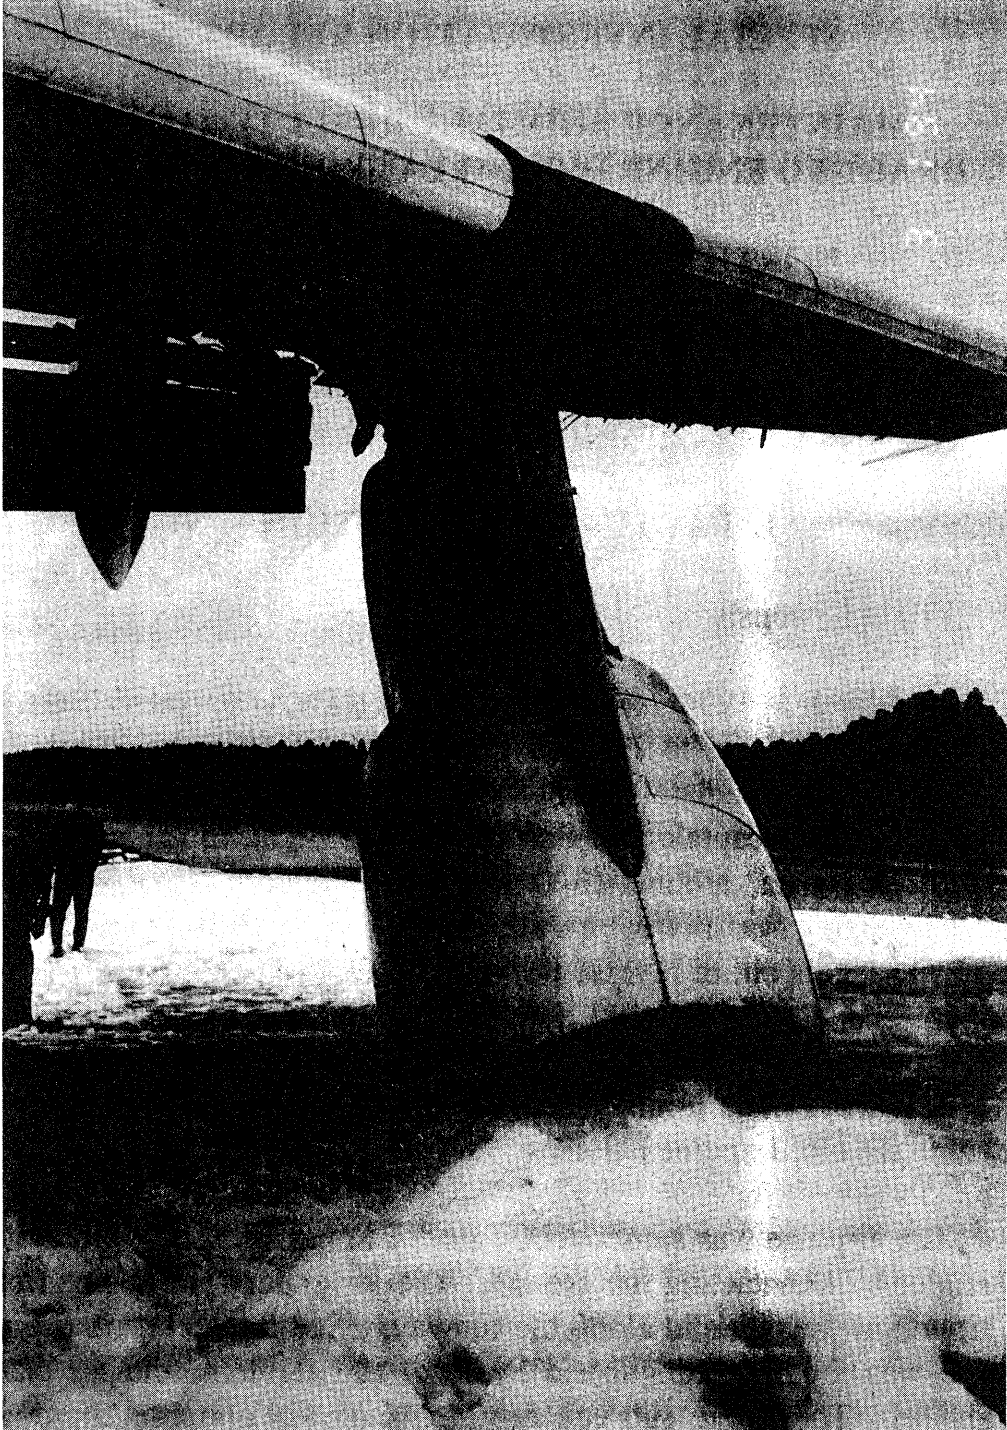
Figure 1.--No. 1 engine.

The airplane was subsequently stopped on a taxiway, with the front of the No. 1 engine still contacting the ground. The lower forward engine nose cowl had been ground away as it slid along the runway. (See figure 1). A fire near the No. 1 engine was rapidly extinguished by local fire fighters, and all passengers remained aboard. They were subsequently deplaned via portable boarding stairs about 30 minutes after the airplane was brought to a stop. There were no injuries.
