**AIRCRAFT ACCIDENT  
INVESTIGATION REPORT**

## CRASH DUE TO STALL

FUKUSHIMA MOTOR GLIDER CLUB

(MOTOR GLIDER, TWO-SEATER), JA2406

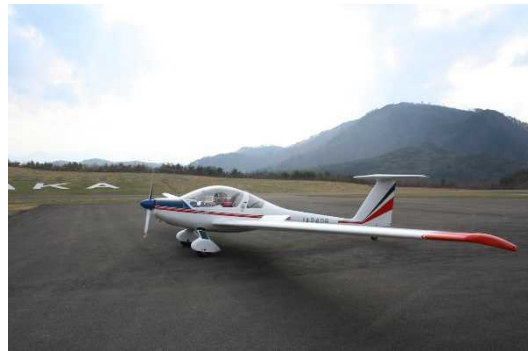
Photo 1: The Aircraft

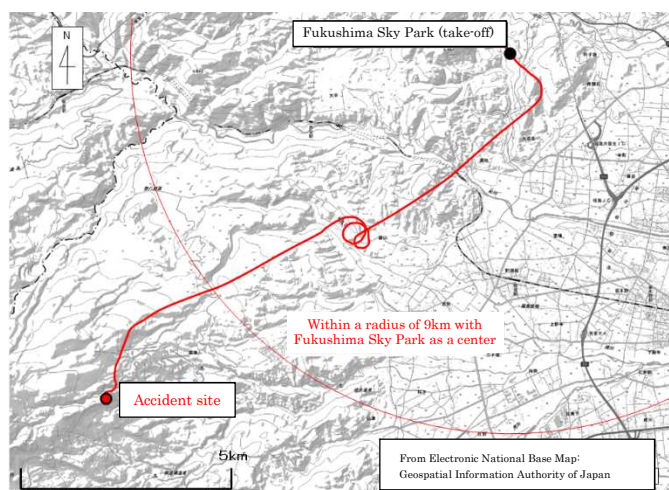
About 10 minutes after take-off, the aircraft flew near the north ridge of Fudosawa about 12 km southwest of Fukushima Sky Park (See Figure 2). Its altitude above the ground level then was about 30 m.

Figure 1: Estimated Flight Route

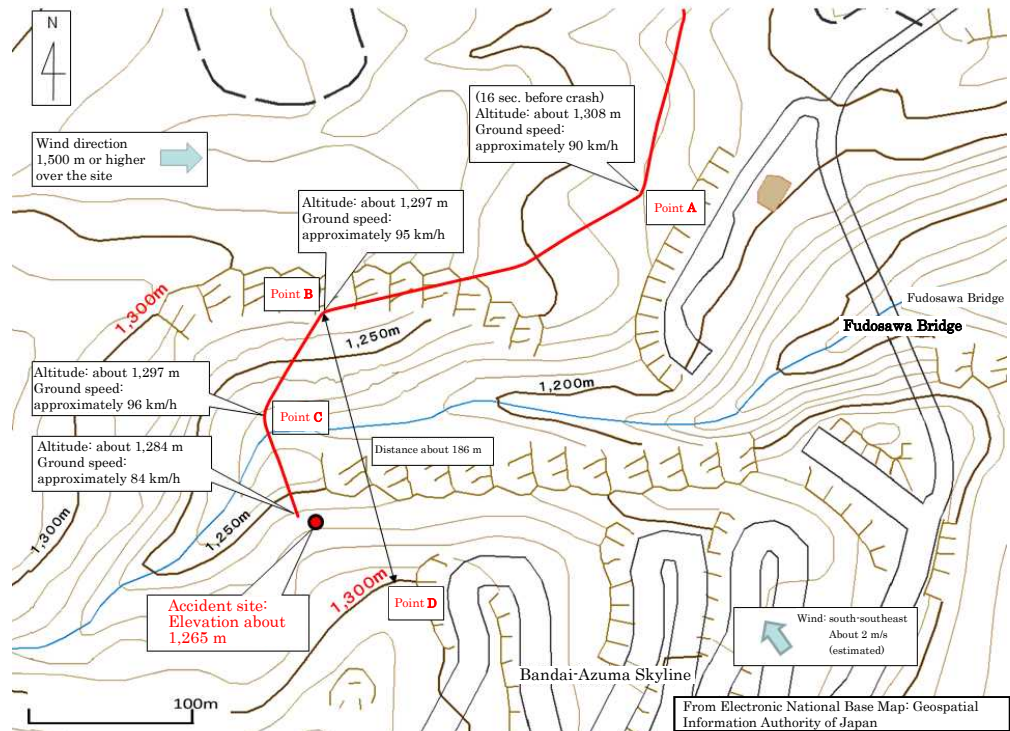
Figure2: Geographic features in the vicinity of the accident site and estimated flight route

Fudosawa in the vicinity of the accident site is a narrow and deep valley that extends from west to east with ridges of about 1,300 m high on the both sides, and that is located about three km east of Issaikyozan mountain (elevation 1,949 m) in the Azuma Mountain Range.

The altitude of the Point B in the Figure 2, where the aircraft commenced to make a left turn from the north side of the valley is about 1,297 m above sea level. Beside, there are mountains higher than 1,300 m high, ranging in the west.

There was the distance of 186 m between the Point B and the Point D

From the Point B, the aircraft made a left turn at an altitude of 1,297 m and headed to the south slope of the valley. It is probable that the captain made this left turn to fly toward the south slope of the valley by judging that it was impossible to avoid a collision with the slope of 1,300 m in the west side of the Point B. However, there was also a slope of 1,300 m in the vicinity of the Point D on the southern slope.

When the captain commenced to make a left turn from Point B to the valley, it is probable that he considered he could turn around short of the south slope, however, in order to make a successful 180° turn between Points B and D (186 m) at a ground speed of 95 km/h at the time of starting to turn, with a calculation under the condition with no wind, it requires a steep turn at a bank angle of about 40° or larger.

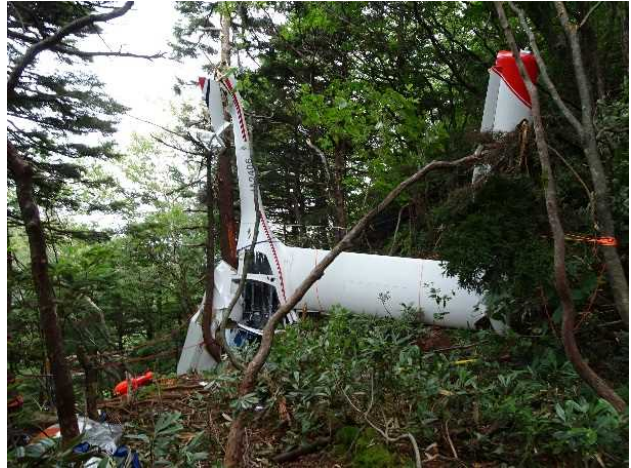
Photo 2: The Accident Site and the Aircraft which is located on the slope to the opposite side of the Point B.

Surrounded by many trees, the crashed aircraft got stuck nearly vertically into the ground with standing upside down and its upper side of the fuselage facing to the northwest; its nose part in which the propeller was severely damaged was buried in the ground; its engine cowl and the cockpit were crushed and damaged.

The left main wing was bent at about 300 cm from the wing tip. The right main wing caught between two trees next to the fuselage had scraped off twigs and barks; it was damaged, torn off at the wing root, and fallen off the cliff.

The rear part of the fuselage was bent toward the nose from the root of the vertical stabilizer in suspending from the fuselage; its rudder and elevator were fractured.
