# AIRBRACKET ACCIDENT REPORT

**No. 91-016**

**SANTANA  
HANG GLIDER**

**30 JUNE 1991**

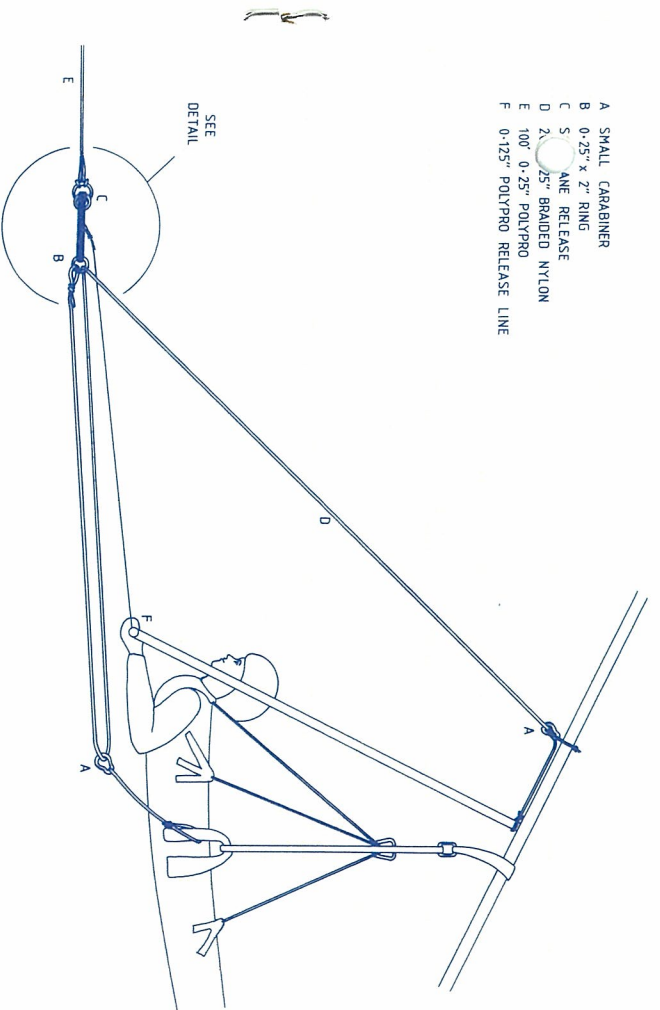
Figure 1.

- A tension monitor,
- 1000 feet of 4mm or 6mm polyethylene ski rope,
- 1000 feet of 3mm (1/8 inch) polypropylene hollow braid,
- A weak link located near the glider, designed to fail at or below a load of 200 pounds (90 kg),
- 100 feet of 6mm polyethylene ski rope,
- A glider release and,
- A Hewitt Bridle (see Figure 1).
