**MINISTÉRIO DA ECONOMIA E DO EMPREGO**  
**GABINETE DE PREVENÇÃO E INVESTIGAÇÃO DE ACIDENTES COM AERONAVES**

## **ACCIDENT FINAL REPORT**

**Aircraft: PIPER PA-38-211**

**D-EJLK**

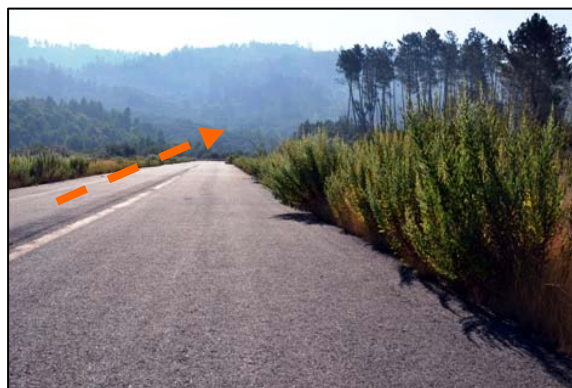
Figure No. 1. – Runway 11

It is an aerodrome not certified that shows neglected evidences highlighted by the presence of grass on the gravel runway and bunches of tall grass on the edges of the asphalt runway.

The tall grass, along the runway edges, was an obstacle to a low-wing aircraft and enhanced the pilot tendency to compensate into the opposite side.

The east mountain area slope and closeness of the airfield dissuade take-offs as well as other maneuvers, like “touch-and-go”, performed from runway 11.

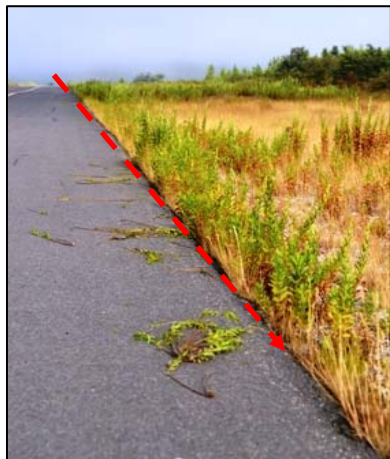
The aircraft touched down at  $\frac{1}{3}$  after the runway threshold. The landing was performed on the left side of the runway, with the left wheel to roll over the edge of the asphalt crushing the grass. Then the PF increased engine power and continued with the "touch-and-go" as he had done before on the Lousã airfield. This maneuver caught PNF unexpectedly, who merely yelled "it was to stay" but not interfering with the takeoff. Following this, the aircraft would eventually take off approximately 100 meters before the runway ending. In the meantime, PNF took over the aircraft piloting; he retracted flaps up to one notch, and started turning to the right and looking for the lowest elevation site and trying to overfly it. Meanwhile, the pilot under refreshment monitored the speed and informed the pilot in command.

Figure No. 2. – Runway edge traced by aircraft main gear left wheel.

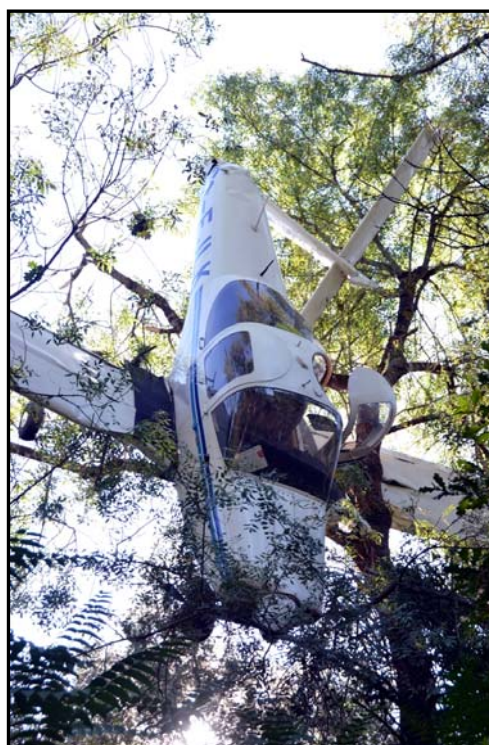
Figure Nº 3. – Accident site

The first collision took place on an oak treetop and ash tree with about 12 meters high. The trees softened the impact and prevented the fall of the aircraft, which was eventually suspended from a pin oak, supported by its wings in a vertical position of the nose down.

The propeller hub crashed into the trunk of an ash tree which was scratched by propeller rotation. The prop blade tips were curling backwards indicating that they were rotating at high speed.

The wings were dented in several places and especially at their roots.

The tail cone was broken during the first impact. This will have helped the aircraft to rotate about the longitudinal axis and taking a nose-down attitude.
