MINISTÉRIO DA ECONOMIA E DO EMPREGO
GABINETE DE PREVENÇÃO E INVESTIGAÇÃO DE ACIDENTES COM AERONAVES

INTERIM INCIDENT REPORT

HAWKER 800XP

CS-DRK

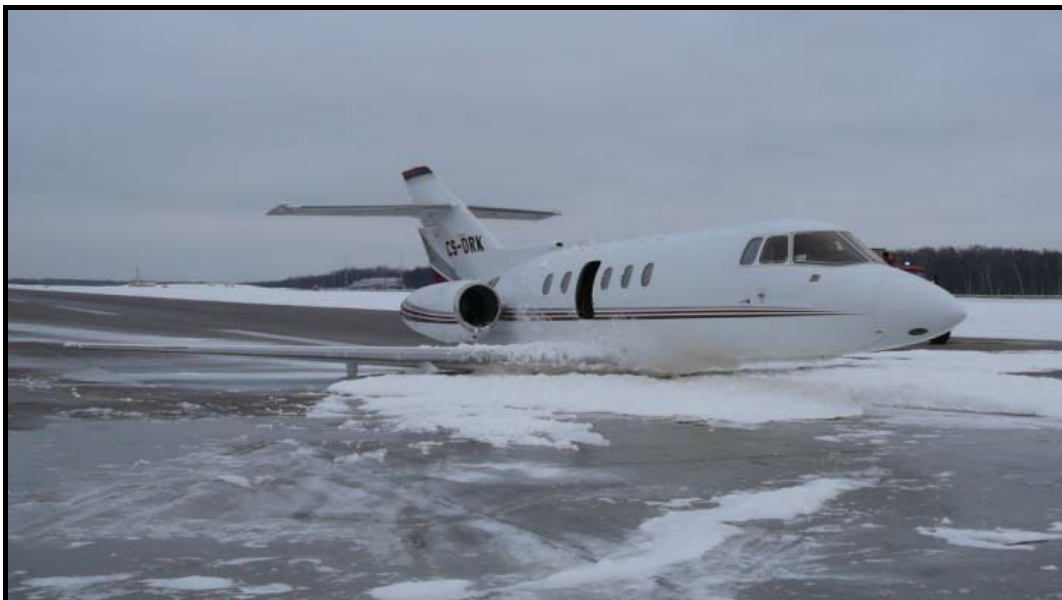
Picture Nr 1

Airport fire services came immediately and sprayed foam on runway, under and around the aircraft, to avoid risk of fire (*picture nr 1*).

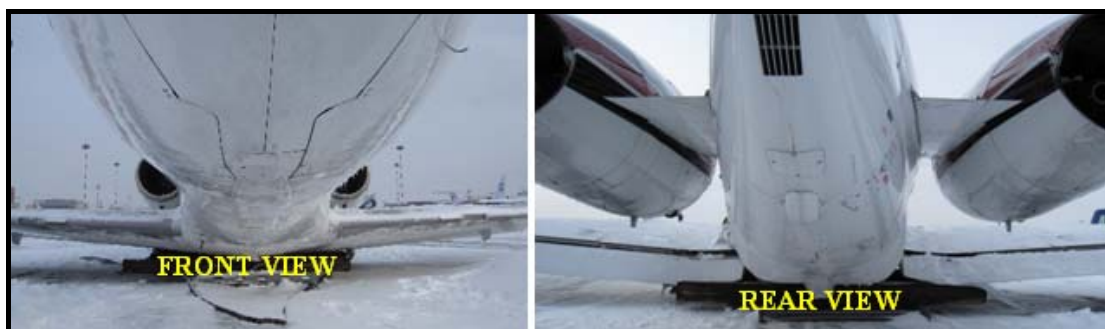
Picture Nr 2

First photos, taken on the runway show the aircraft almost intact, with cabin, wings, tail and engines undamaged (*pictures nr 1 & 2*). The aircraft slid for about 480m, on its belly, with wings levelled, on runway centreline and being subjected to abrasion effects, only.

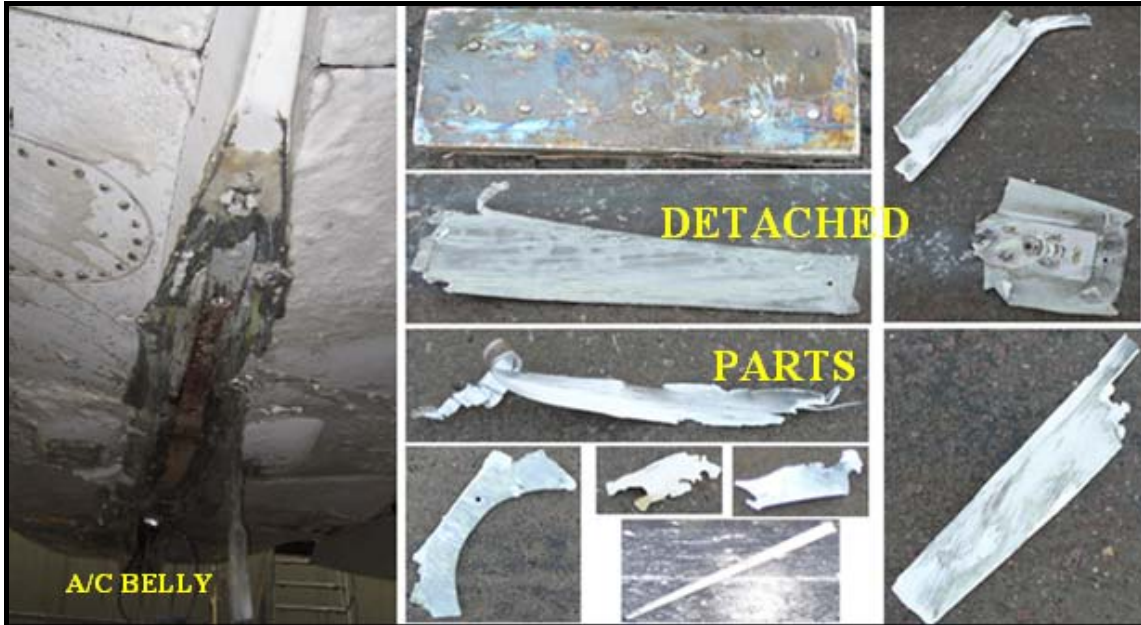
Picture Nr 3

After the aircraft had been lifted and standing on its gear it was possible to access belly damage. Wings, fuselage (nose & rear sections), tail and engines didn't contact the ground and suffered no damage, only mid fuselage under skin was in contact with tarmac and impacted with runway centre lights, becoming eroded and losing some small metal parts, detached and spread along the runway, together with some antennas and drains located underneath the fuselage (*picture nr 3*).

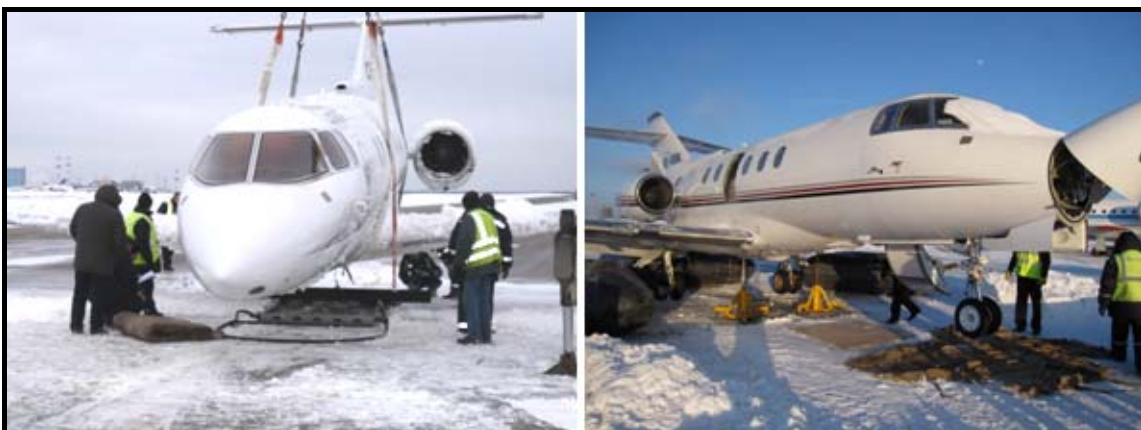
Picture Nr 4

The aircraft was recovered from the runway by means of a crane and skid which allowed the aircraft to be towed to a parking stand. However, in order to place the aircraft in a hangar, the gears had to be extended and this was done with the application of air cushions and jacks to raise the aircraft off the ground (*picture nr 4*).

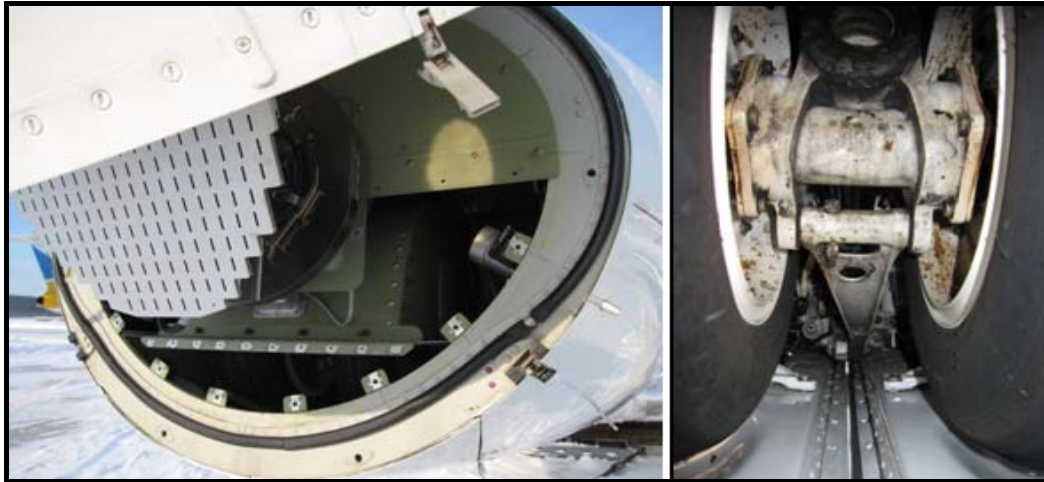
Picture Nr 5

Before the aircraft was disturbed, the team on-site wanted to ascertain whether there were any visible defects or discrepancies with the nose landing gear in the wheel well. For this purpose, it was decided that access could be gained to that area by removing a panel forward and just below the weather radar antenna, which would allow investigators to look through and see the state of the retracted NLG (*picture nr 5*).

Inspection of the NLG inside the wheel well did not reveal any damage or obstruction and the wheels were centred. Once the aircraft was ready for the gear to be extended, and upon the selection of the 'gear-down' command, the main landing gears initiated their normal extension sequence whilst the nose landing gear remained retracted. A firm tap on the external structure caused the NLG to suddenly extend and achieve full extension.

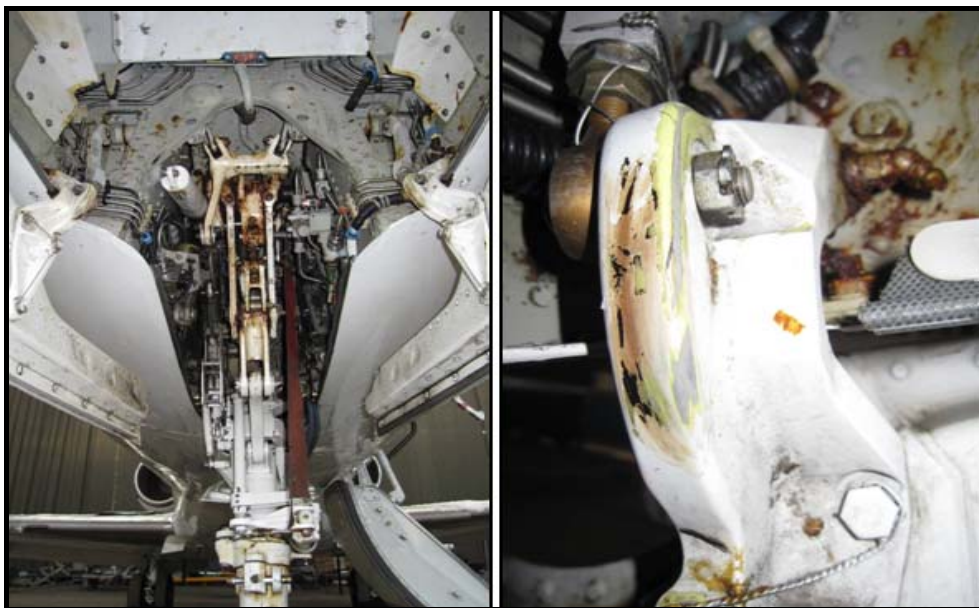
Picture Nr 6

Once the aircraft was positioned inside a hangar, a preliminary examination of the NLG was carried-out. To note, only the wear marks observed on the rear hinges of the NLG doors (*pic-*

ture nr 6). No other discrepancies were noted from both the visual inspection and the gear-swings performed in Moscow.

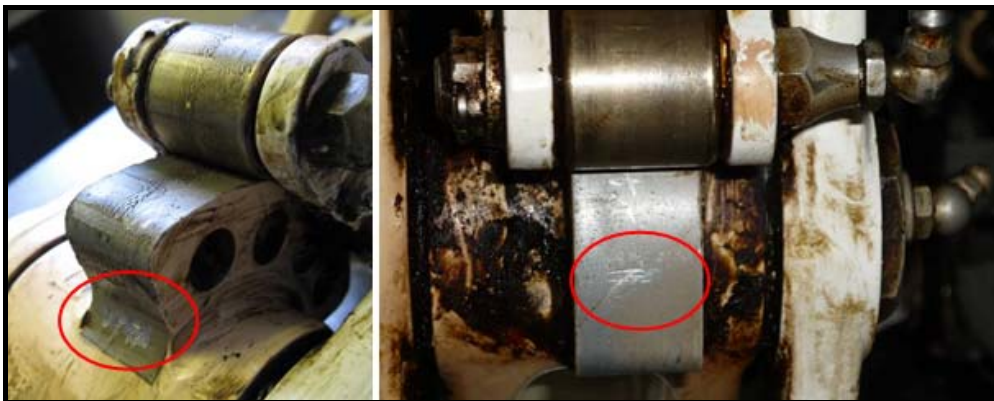
Picture Nr 7

Upon arrival in Chester, the aircraft was inspected by technicians from the manufacturer's local maintenance service centre. In addition to the wear marks observed on the rear hinges of the NLG doors, they also noted some scratch marks on the upper surface of the drag stay cam. Subsequent inspection also revealed similar marks on the end-face of the cam (*picture nr 7*).

These scratch marks are likely to have been caused due to the use of incorrect tooling or technique when setting clearances A and B. Furthermore, it is unlikely that they would have any significant bearing on the event.

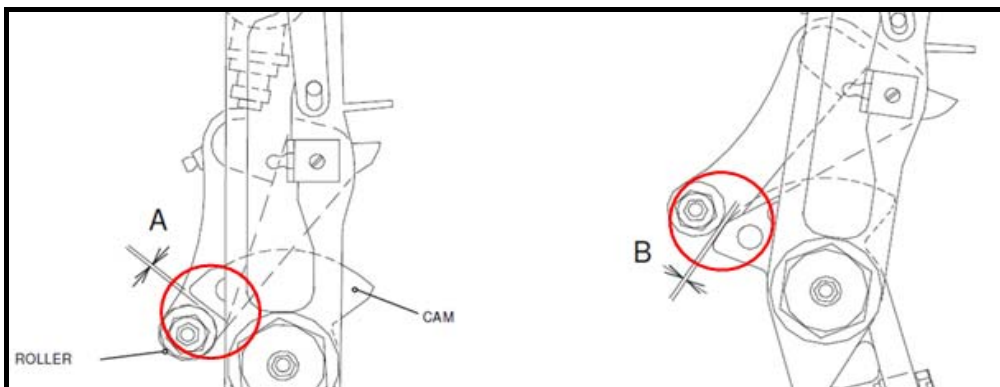
Picture Nr 8

These scratch marks appear in the same region that one would expect tooling contact when rigging the drag stay roller clearances (A and B) set in the corresponding Aircraft Maintenance Manual (*picture nr 8*).

The drag stay clearances A and B were measured in Chester as per AMM XP 32-20-21-601 and the following values were recorded (*table nr 1*):

Clearance	Measured Value (in)	Tolerance (in)
A	0.010"	0.003 – 0.008"
B	0.026"	0.005 – 0.012"

The drag stay was dismantled to allow the adjustments to be made to bring back to within AMM limits using additional shim washers, with 0.006” being added to LH arm assembly and 0.002” being added to RH arm assembly. The drag stay fully met AMM requirements after adjustment.

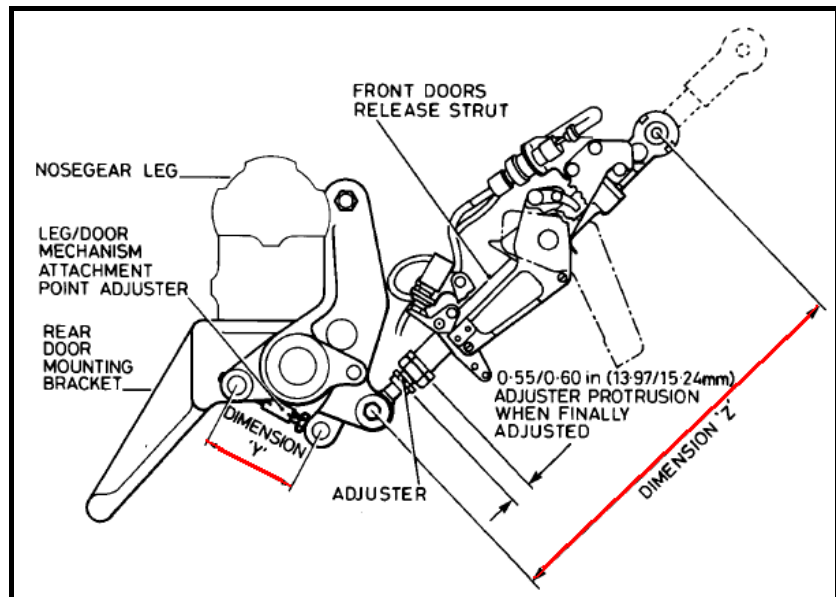
Picture Nr 9

Measurements were also taken of the nose gear door mechanism as per AMM 32-20-12-501 (*picture nr 9*). The release strut (Dimension Z) was found to be 11.197" (Tolerance 11.2 +/- 0.010"). Dimension Y was measured to be 2.197" (Tolerance 2.79 +/- 0.010"). The latter was out of tolerance.

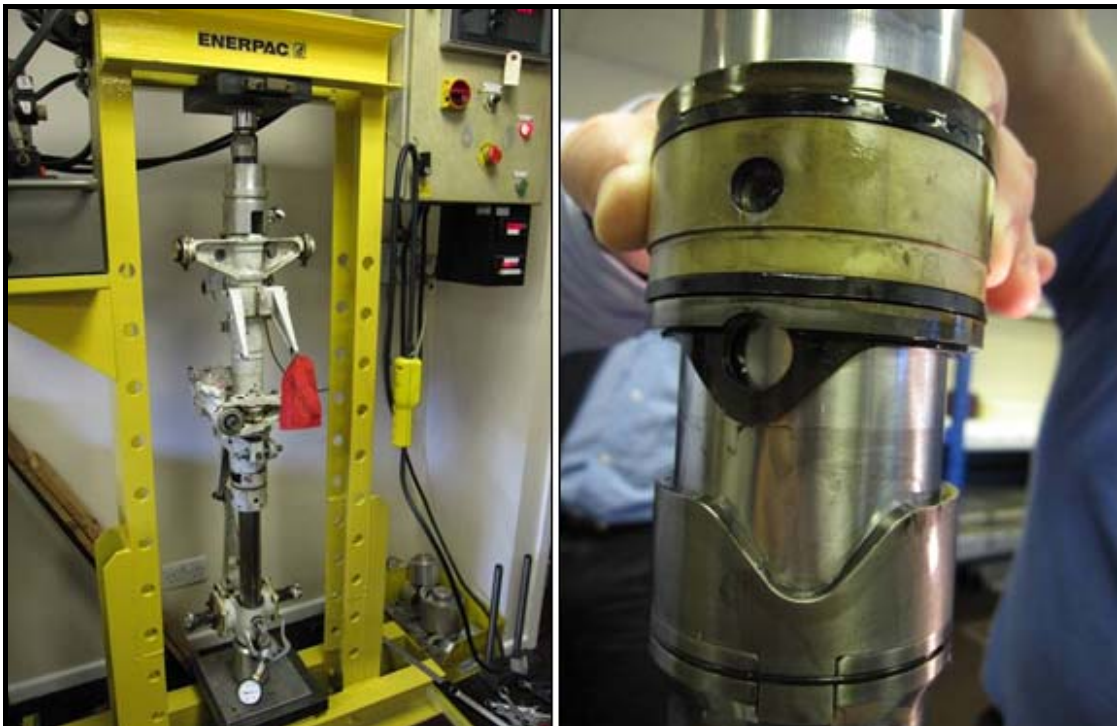
Picture Nr 9

The NLG leg was received in a fully deflated condition but it was noted that the leg would not fully compress by approximately 0.750” as air/nitrogen had entered the oil chamber.

The leg was charged with nitrogen as defined in CMM Chapter 32-20-35 page 104 para 3B (1) and (2) but to a requested pressure of 200 PSI. The 12 hour stand was not carried-out but the leg was tested to CMM Chapter 32-20-35 page 104 paragraph 3C (1 through to 9). The only observations were note (2) pressure 1890 to 2090 PSI was recorded at 1700 (probably due to the initial pressure of 200 PSI – note 7). When the oil filler plug was loosened, a small amount of air escaped, which was a likely cause stopping the leg fully compressing as received.

The self-centring check was carried-out satisfactorily during the above. The leg assembly was tested numerous times through its normal operating range with no adverse results. The leg assembly was dismantled sufficiently in accordance with CMM 32-20-35 to allow removal of the plunger tube and axle barrel assembly. There were no adverse findings and all was in compliance with the CMM. It was estimated that approximately 100ml of hydraulic fluid was required to fill the leg after the removal of trapped air (*picture nr 9*).

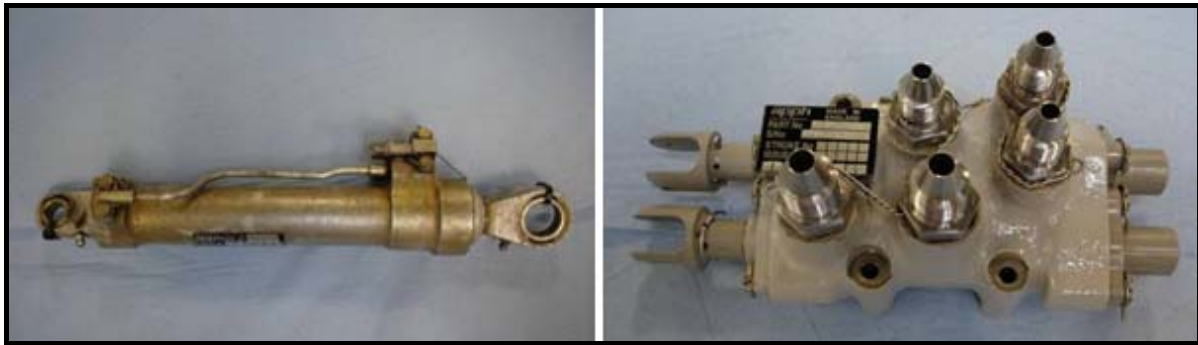
Picture Nr 10

The selector valve and NLG actuator were sent to the manufacturer of the components for acceptance testing. Both units passed the tests and no defects were reported (*picture nr 10*)

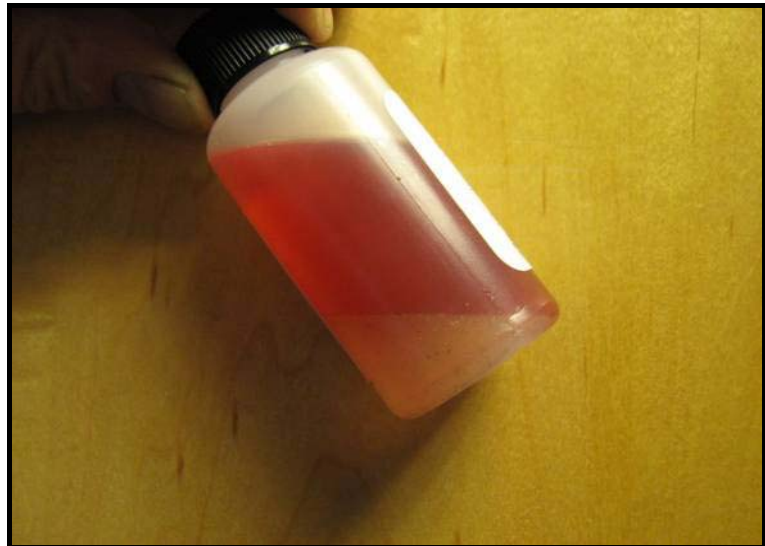
Picture Nr 11

When removing the selector valve, technicians took an uncontrolled sample of the residual hydraulic fluid.

The sample taken was insufficient for the laboratory to perform the particle count, however high water content was detected, suggesting that the clear fluid was either water or water-based (*picture nr 11*).

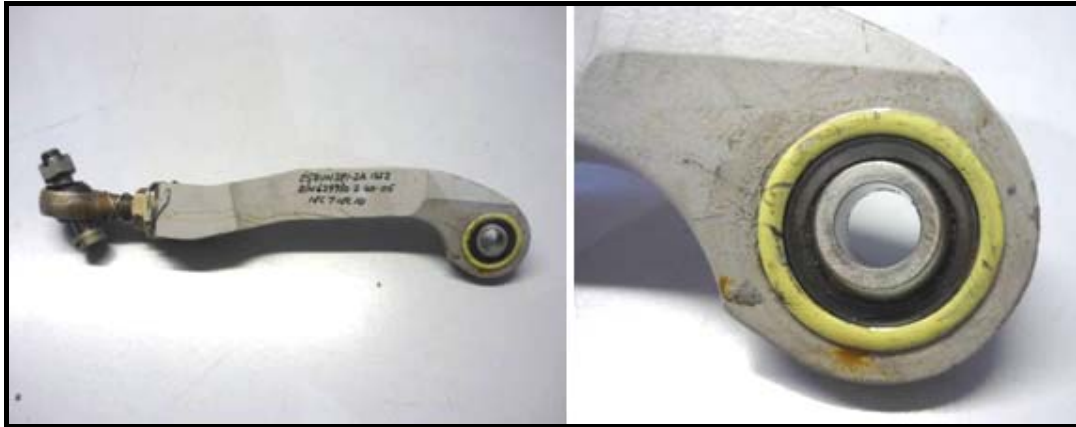
Picture Nr 12

While carrying-out a H800/750 fleet inspection of the NLG door mechanism, the operator discovered various instances of the NLG doors being stiff to operate and would only open partially in free fall. There appear to be some common factors causing additional friction in the NLG door mechanism, particularly the stiffness or even, in some cases, seizure of the upper (self-lubricating) bearing on the NLG Door struts (*picture nr 12*).

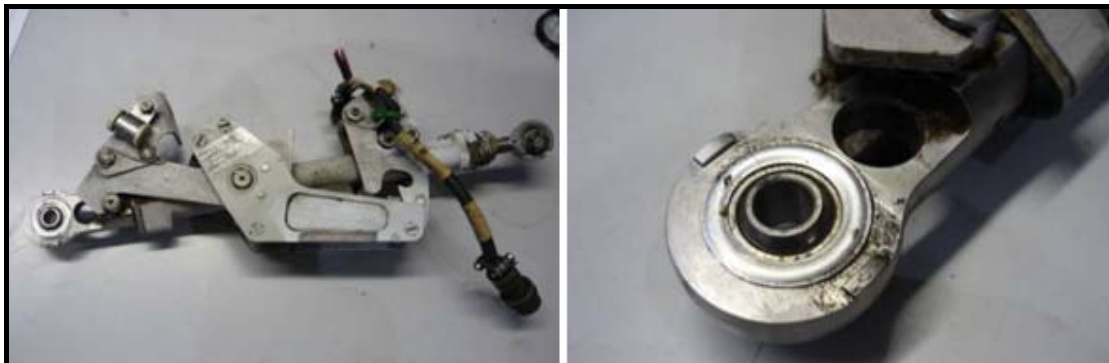
Picture Nr 13

This was also observed on CS-DRK in addition to the stiffness of the bearings of the Nose Gear Door Release Struts (*picture nr 13*).

These items will be carefully analysed to ascertain the nature of their defect.

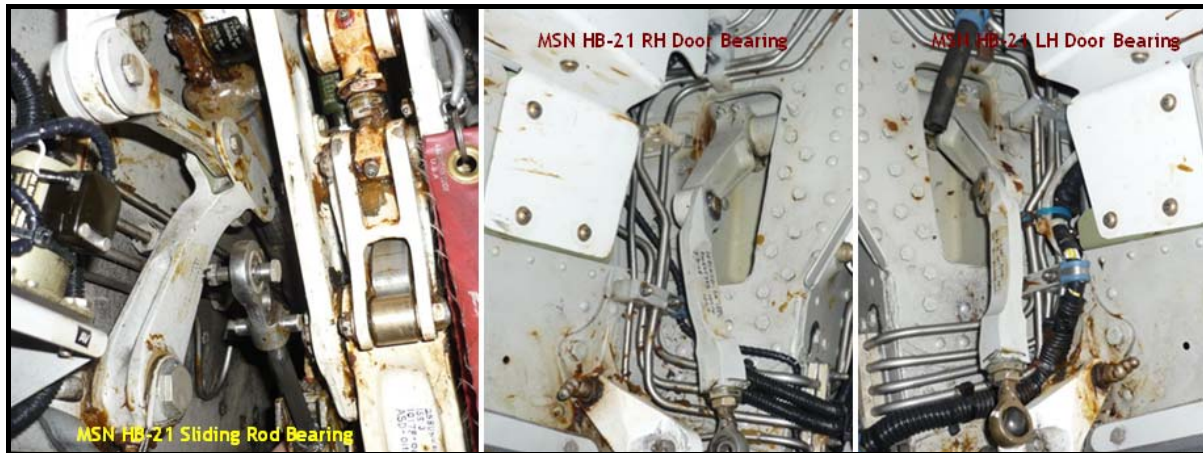
Picture Nr 14

During that inspection (three aircrafts had been inspected so far – MSN 258686, 258730, HB-21), it was discovered that the bushings on the door rear hinge assembly have migrated from the casting and cause stiffness in the operation of the hinge. Particularly on airplane HB-21, the lower slide arm bearing was almost solid, causing a great deal of friction during the door movement (*picture nr 14*). The force required to move the door, by hand, was 12lbs.

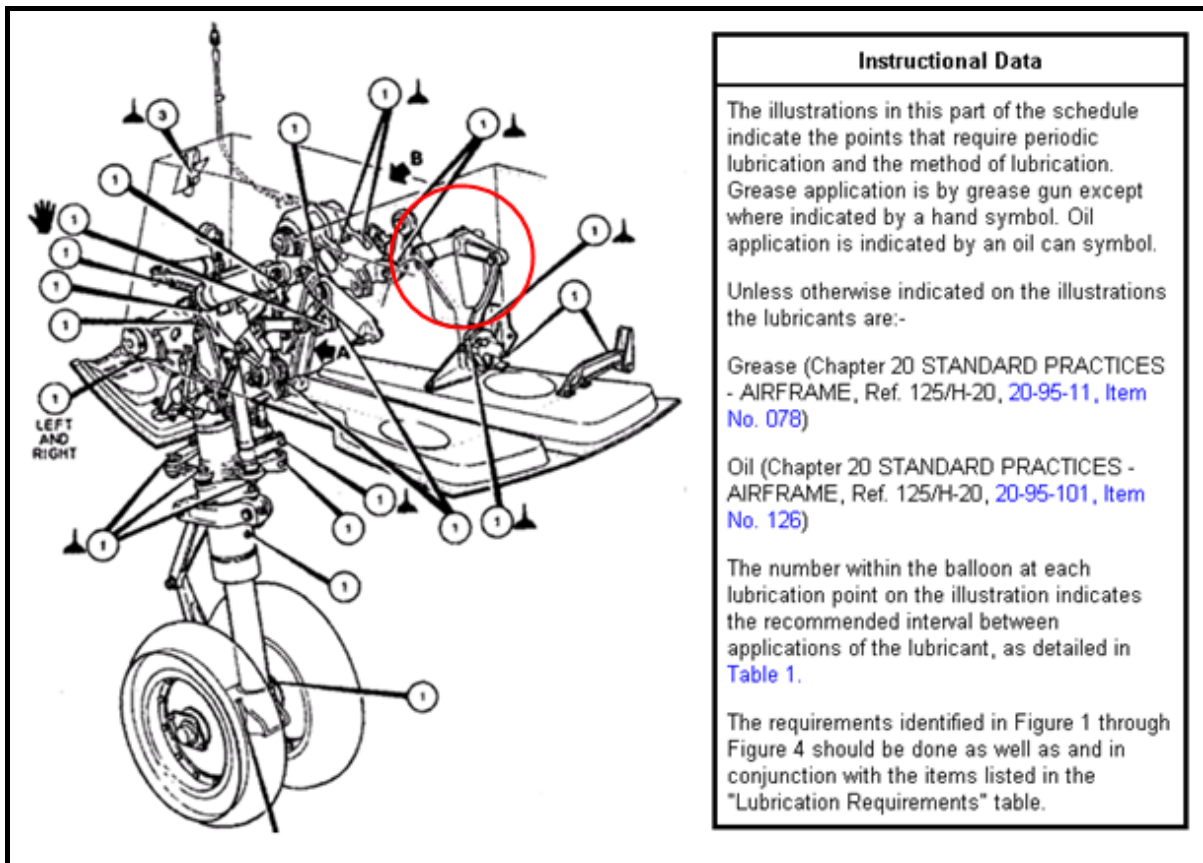
Picture Nr 15

In fact checking XP AMFS (JUN.11 version), looking for lubrication schedule and instructions we verified that, on diagram, NLG sliding rod bearing is not lubricated (*picture nr 15*).

That bearing was found stiff on two of the three aircrafts inspected so far, following the Inspection program, as per EO 2.1.39.
