**FINAL ACCIDENT INVESTIGATION REPORT**

**AIRBUS A321-211**

**G-VOLH**

**18<sup>TH</sup> APRIL 2001**

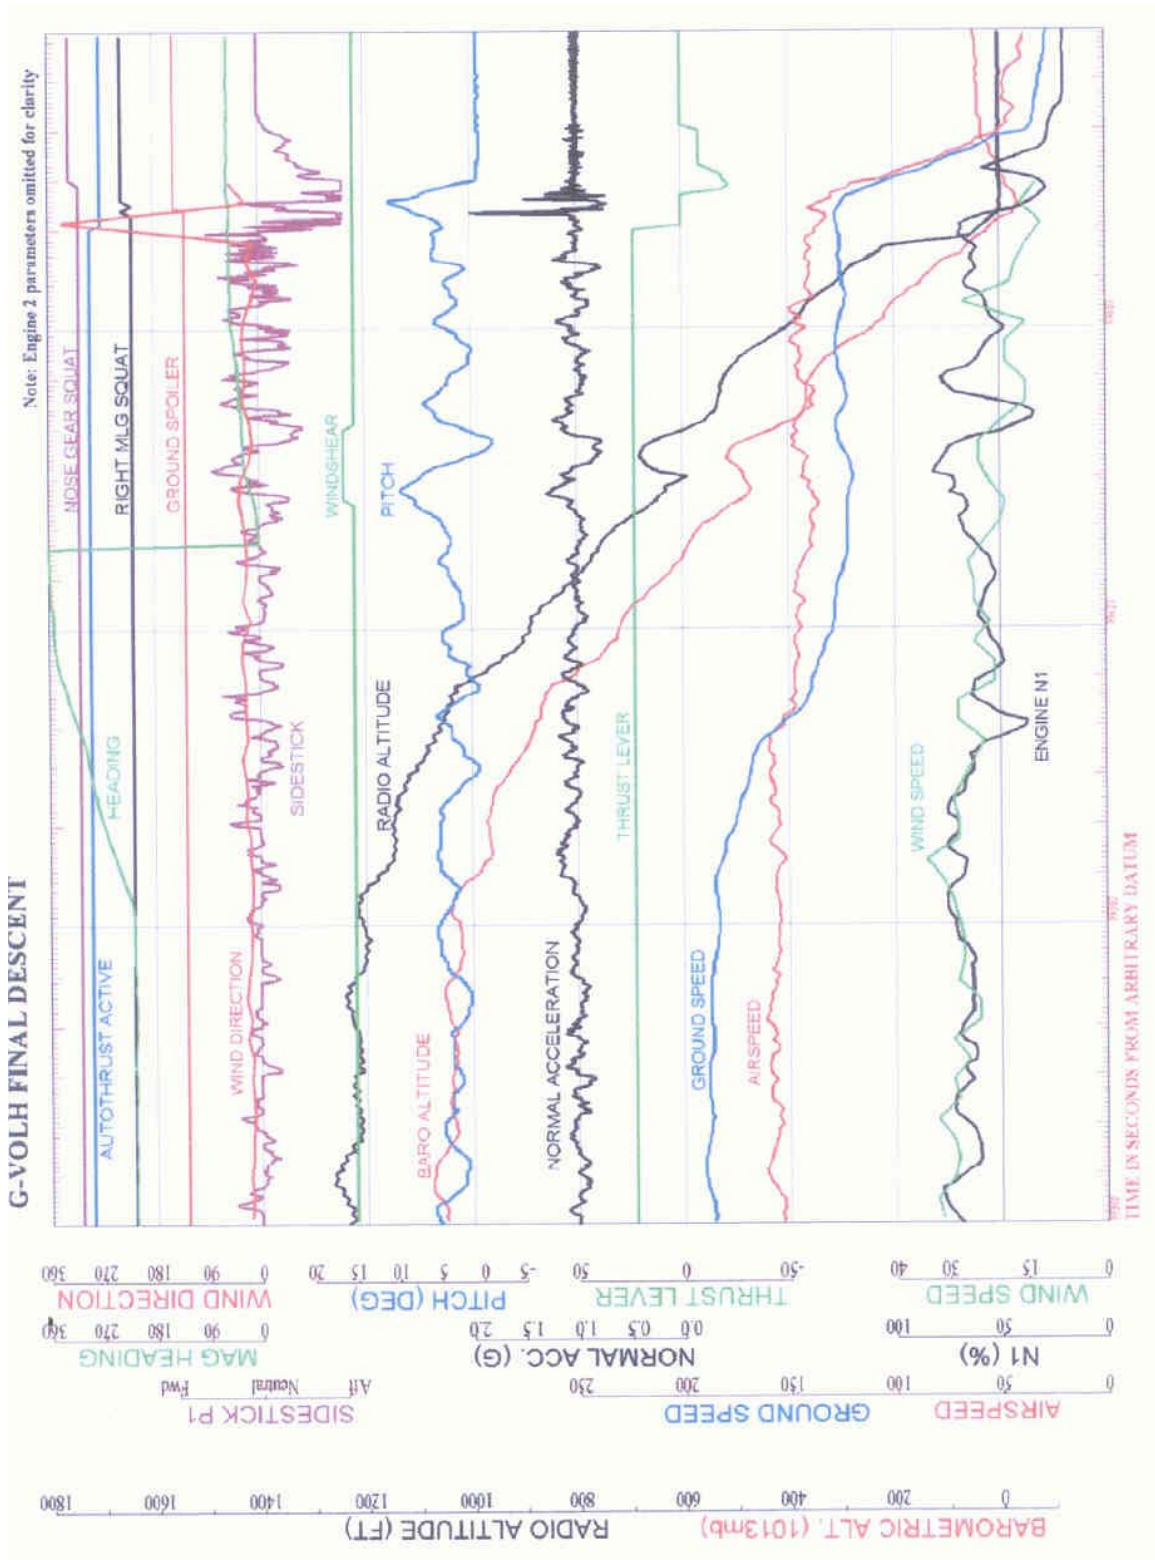
Figure 3

Graphical traces of pertinent parameters recorded during the approach and landing are shown in Figures 3 and 4.

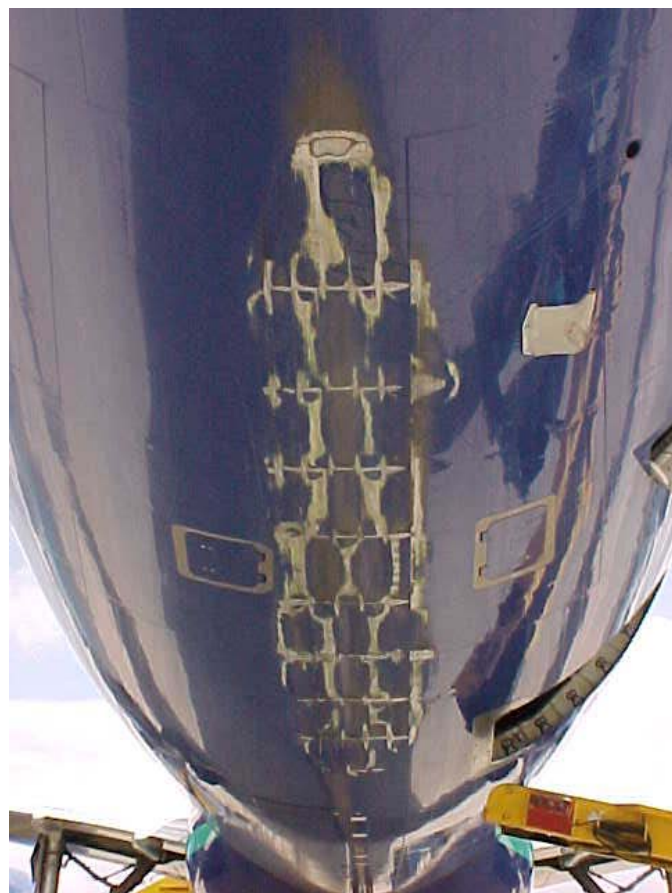
**Figure 5 – Lower fuselage**

Examination of the aircraft at Funchal showed extensive damage to the lower fuselage over a distance of some 5 metres. The lower skin was deeply abraded from Frame 61 (near the bulk cargo door) to around Frame 70 (rear pressure bulkhead). Within this area of abrasion a number of the fuselage frames (61 to 69) had suffered structural damage from the vertical loads applied in the contact with the runway. The abrasion marks were parallel with the fuselage axis, showing that there was negligible aircraft yaw at contact.

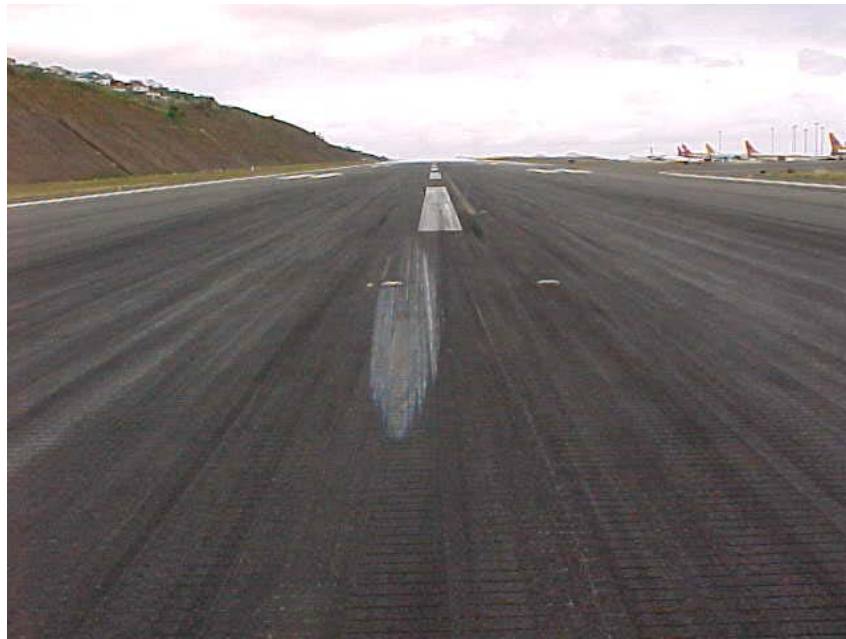
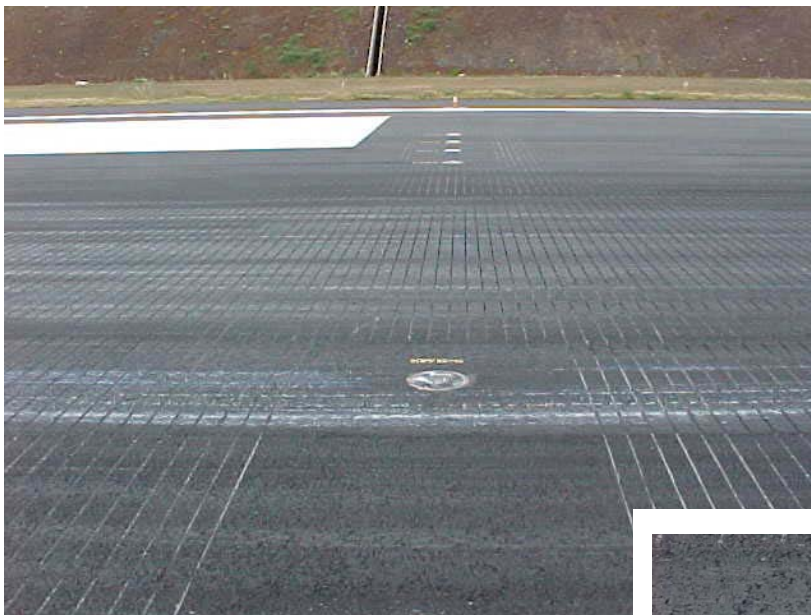
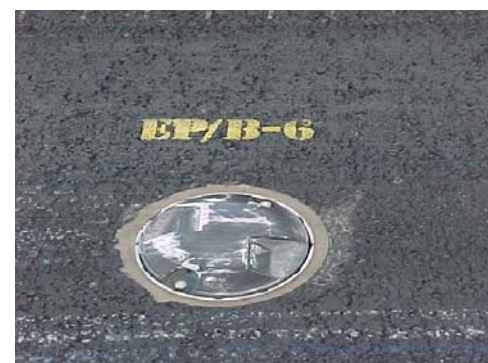
The examination of the runway showed a single mark from the contact with G-VOLH, some 13 metres long, within the normal touchdown zone and close to the runway centre line (Figures 7, 8 & 8-A).

From the geometry of the impact damage, the aircraft pitch attitude would have been between 10° and 11° relative to the runway.
