FINAL INCIDENT INVESTIGATION REPORT

LEARJET 35A

C-GRFO

LISBON AIRPORT

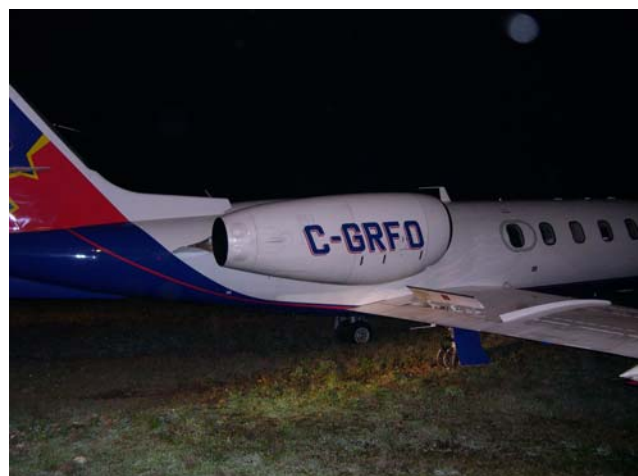
The aircraft decelerated down the runway and stayed close to the centerline. At the end of the airstrip run, at a low speed, the aircraft veered to the left and departed the runway onto the grass, stopping at about 6 meters (approximately 20 feet) from the runway edge.

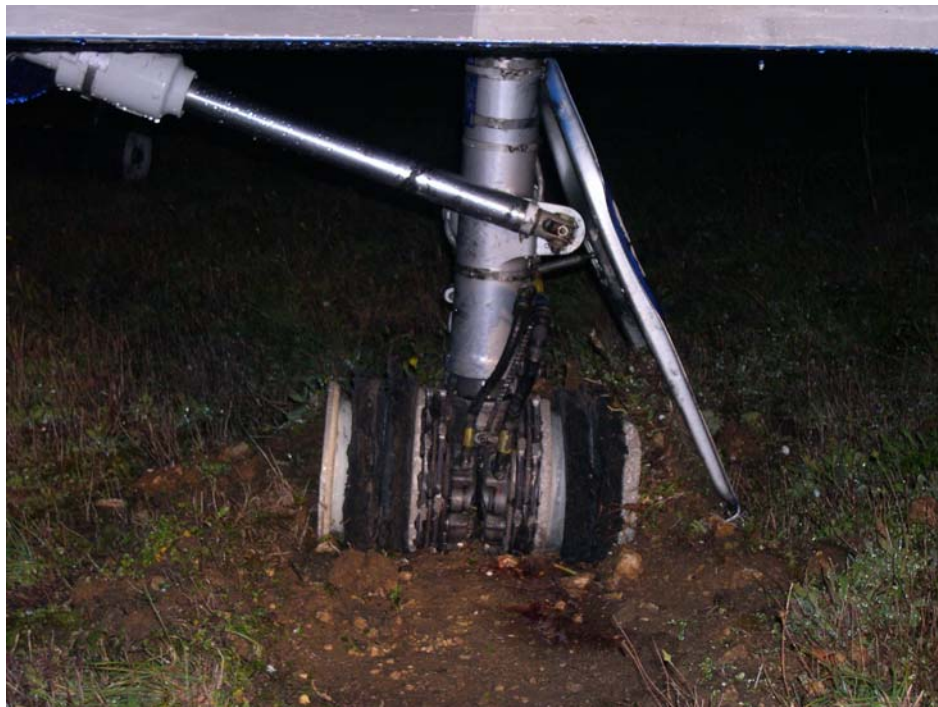
Substantial damage, limited to the right-hand main landing gear:

- Both tires were completely destroyed;
- The wheel rims and brake assemblies were severely eroded;
- Hydraulic lines were destroyed and other components were also damaged.

- a. Evidence of excessive heating such as bluing of the rubber, reverted rubber and charred nylon;
- b. Presence of liner wrinkles on sidewall and shoulder regions;
- c. X-break appearance on both tire remains.

- a. As a precautionary measure and to minimize the risk of operating their aircrafts fleet with under-inflated tires, Skyservice immediately issued a Maintenance TIB (Technical Information Bulletin), to be followed in addition to manufacturer's recommendations), where some rules have been implemented to the technicians:
 1. *Do not check/record tire pressures soon after landing.*
 2. *Always use a calibrated pressure gauge.*
 3. *Always record the pre-service pressure, and then if required, service the tire(s).*
 4. *If a slow leak is suspected, advise the applicable coordinator to insure proper monitoring.*

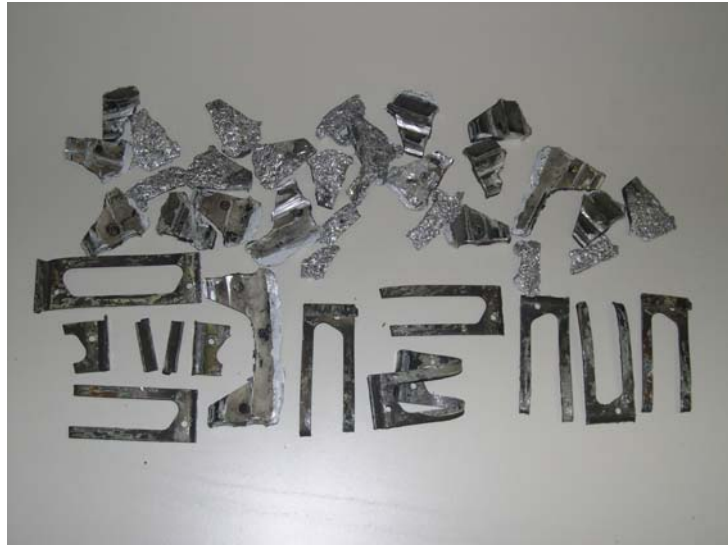
The runway was inspected following the incident. No FOD was found on the runway, other than the remains of the right-hand main landing gear tires, rim debris and brake-assembly pieces.

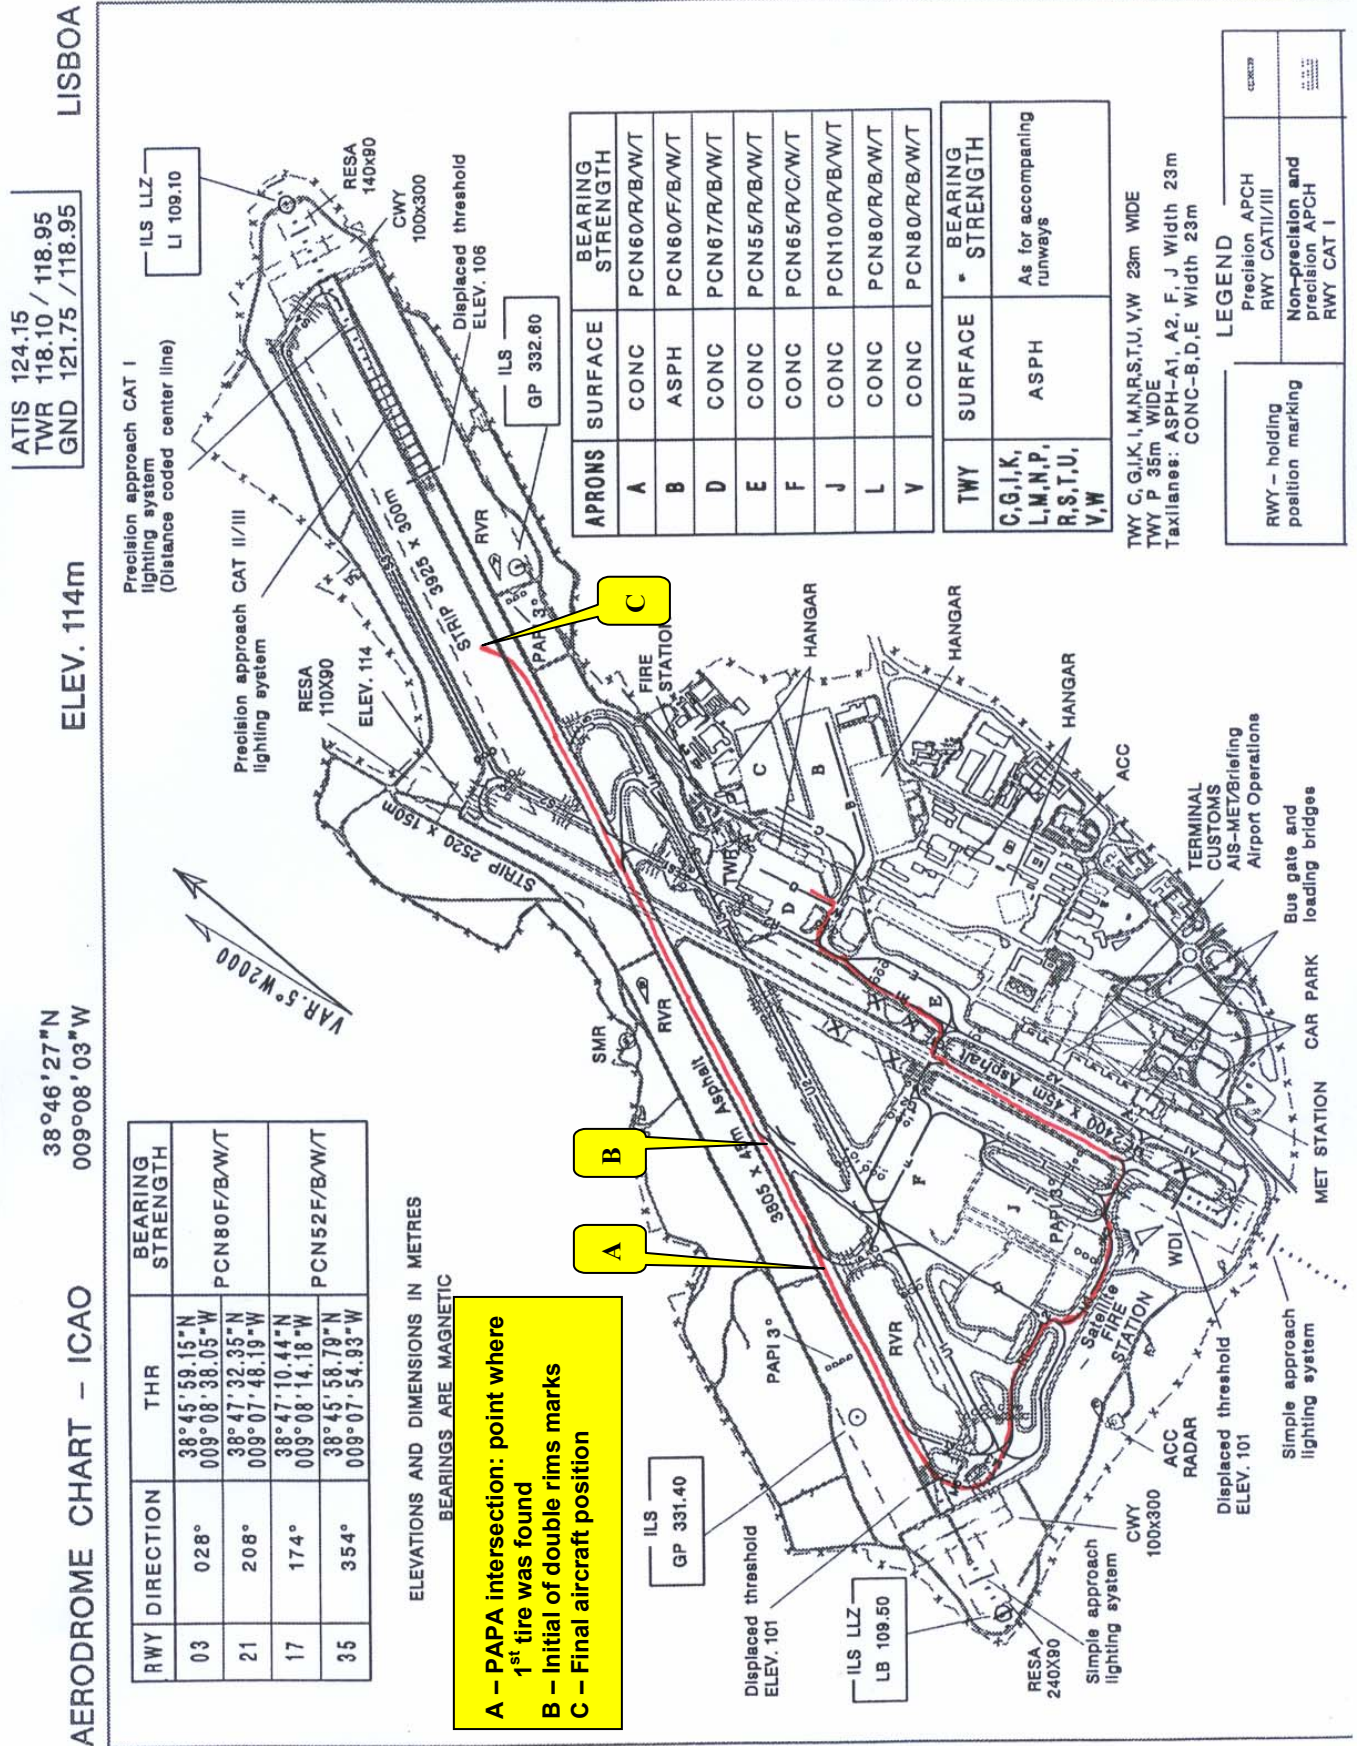
The distance between the points where the blown tire was found and where the rims marks began to be visible on runway surface was 330 feet. From this point on, a large amount of small tire rubber and metal debris was found along the runway. The distance, between the point where the rims marks began and the position where the aircraft came to a complete stop, was about 4800 feet.

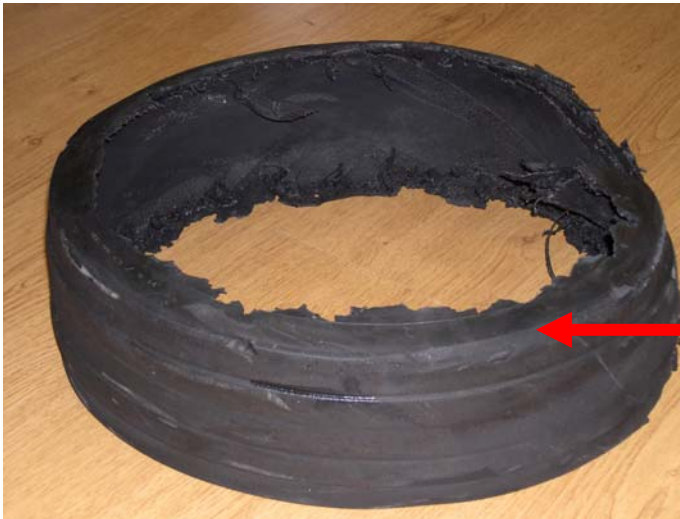
A

Evidence revealed that one of the right-hand main gear tires blew out immediately after the PAPA intersection, where two pieces of same tire were found. That was the point where the first tire thread separated.

Part **B** fits perfectly inside of Part **A**.

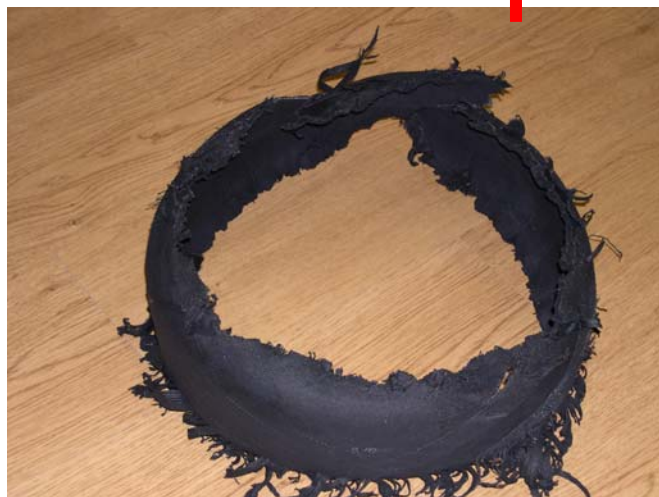
B

It is assumed that one or both of those tire pieces hit the bottom of the aircraft and that this was the sound that the captain heard.

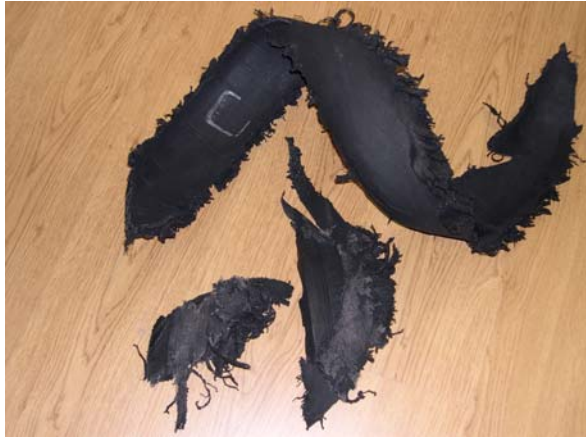
From this point on, for about 4800 feet, both right main gear rims skidded along the runway, leaving traces on the asphalt, until the aircraft had the runway excursion.
