FINAL ACCIDENT INVESTIGATION REPORT

AIRBUS A346-600

EC-IZX

REPORT Nr. 37/ACCID/2004

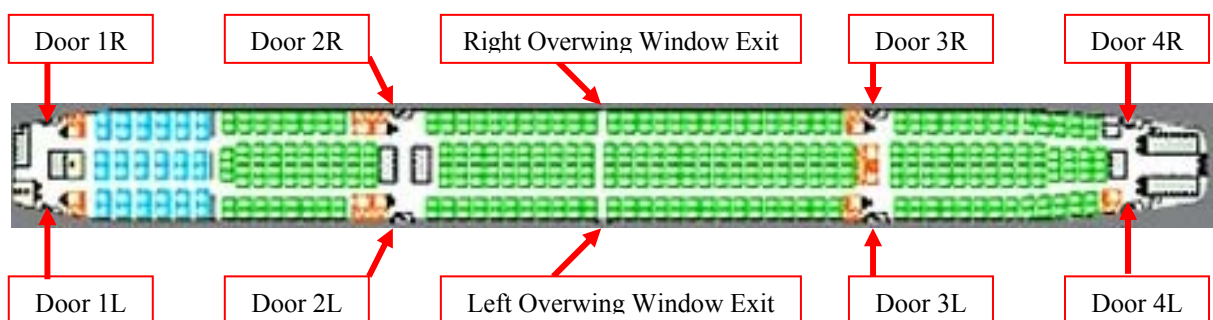
Passenger Evacuation Diagram

Door 1L: The Chief Cabin Attendant was controlling this door during the evacuation. This exit enabled the evacuation to 10 to 15 passengers, what happened in approximately 10 seconds.

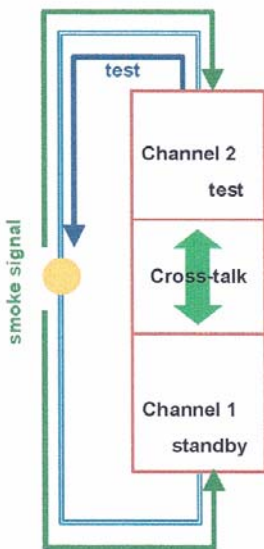
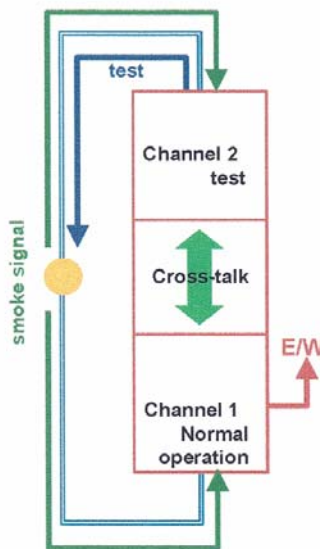
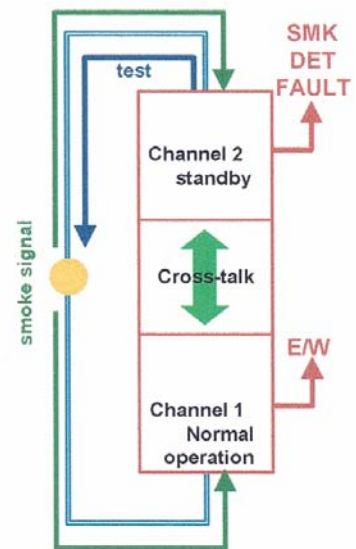
Illustrations: Test launched by channel 2 (IB6401 scenario)

There are 2 modes of desynchronization that are detailed in the following sketches. Type 1 would result in triggering of spurious E/W. Type 2 would result in triggering of spurious E/W and of smoke detector faults.

Normal operation during test sequence:
 -Channel 1(2) launches the tests
 -Channel 1(2) awaits smoke test answer from detector
 -Channel 2(1) switches to standby mode
 -No E/W and no SMK DET FAULT

Desynchronization type 1 during test sequence:
 -Channel 1(2) launches the tests
 -Channel 1(2) awaits smoke test answer from detector
 -Channel 2(1) remains in normal operation monitoring and triggers a **spurious E/W** upon reception of SMK DET signal

Desynchronization type 2 during test sequence:
 -Channel 1(2) launches the tests
 -Channel 1(2) switches to standby mode and triggers a **SMK DET FAULT** upon reception of signal
 -Channel 2(1) remains in normal operation monitoring and triggers a **spurious E/W** upon reception SMK DET of signal

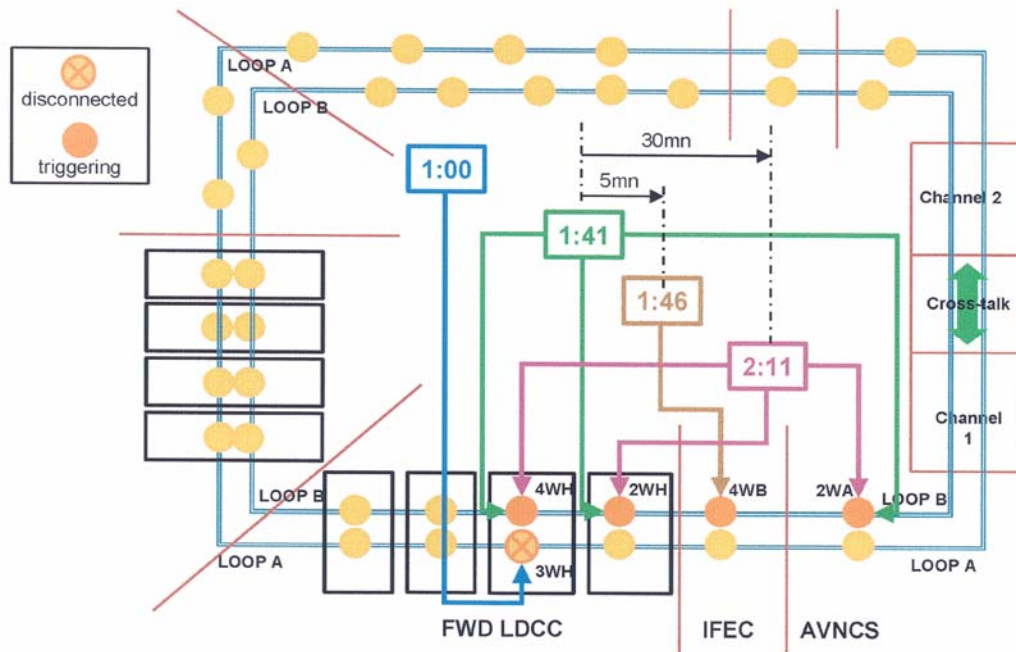
→ Together with events that occurred at 2:11, consistent with issue (1) of paragraph 3.2 with a desynchronization type 2.

This sequence of messages, reflecting the spurious E/W triggered up to 2:11, is illustrated in the following sketch:

The cause of the spurious indications, before FIREX was discharged, was determined to be SDCU PN RA12811M0103 desynchronization upon smoke detector 3WH electrical disconnection from the control loop, since engine start.

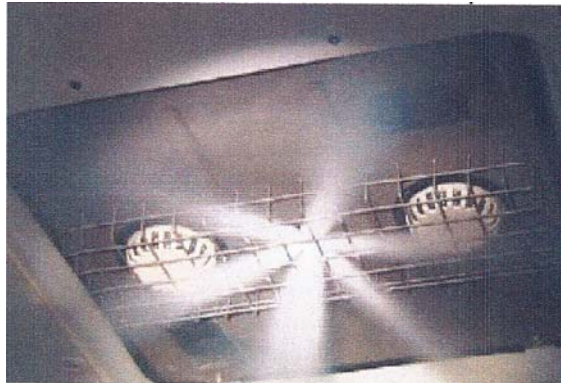
The first issue relevant to this event was the triggering of smoke warnings upon FIREX discharge. Indeed, optical smoke detectors are sensitive to the haze that builds up when FIREX is spread out as illustrated in this picture:

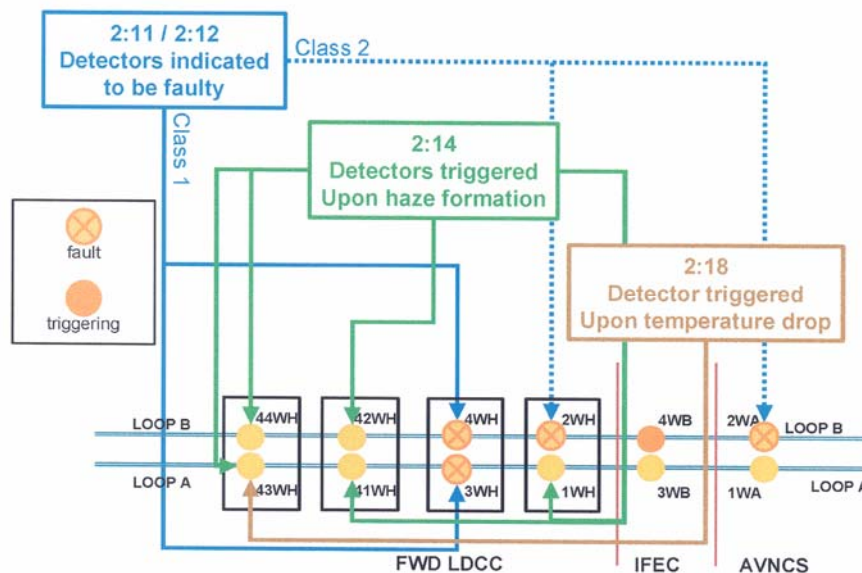
- ➔ Consistent with optical smoke detectors coming at fault upon temperature drop.

According to this analysis, the following sketch illustrates which smoke detectors were indicated to have failed and which triggered upon halon discharge:
