The Dutch Safety Board

Occurrence #: 2004106 **Classification:** Serious incident

| Aircraft model: | Lockheed L-1011-385-3 | Injuries: | None |

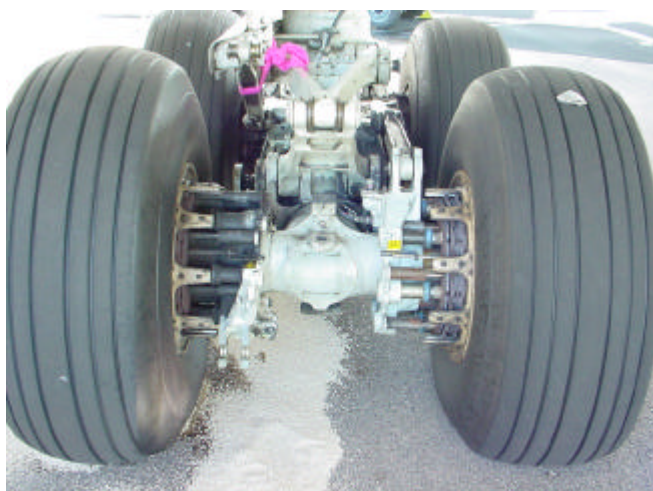
The broken lug (bottom left) of the right MLG

It was found that the right MLG had sustained serious damage during the rejected take-off. The brake link connection lug on its right front brake unit (see left picture) and a number of electronic and hydraulic lines of the brake- and anti-skid system of the right MLG were found broken. No other evidence of cracking was observed at that time. The four tires of the left MLG had deflated of which two tires showed large scouring spots. Three tires (two aft and one left front) of the right MLG had deflated partially. Several small parts of the right MLG were found on the runway. Subsequent to being towed from the runway, a very large crack was observed in the front part of the right MLG bogie beam (see right picture).

- Investigation of fractures surfaces of the broken brake unit lug showed signs of overloading.
- At the edges some mechanical damage was present. Its cause could not be determined.

2. The lugs on the brake unit broke first. This could be a result of some pre existing deficiency in it. Too much play in the bearing, existing damage, material or processing discrepancies.

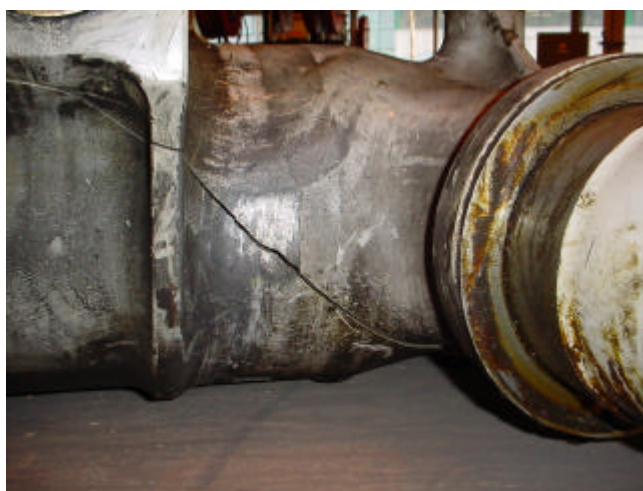
The crack in the right MLG bogie beam

- Fracture of the right main landing gear bogie beam occurred due to stress corrosion cracking, which emanated from an area of mechanical damage on the right (outboard) side of the part, approximately seven inches aft of the centreline of the forward axle lug hole.
- Evidence of bubbling in the paint along the inner surface and softening of the base material along the outer surface in the area of mechanical damage, indicated that this region reached an elevated temperature.
- No material or processing defects were observed.

1. The area with mechanical damage on the bogie beam already existed before the occurrence. This damage had caused internal residual stresses in this area. The material of the bogie beam is susceptible for stress corrosion cracking. The loads on the bogie beam applied during the rejected take-off were above the stress corrosion cracking limit, causing the beam to crack.

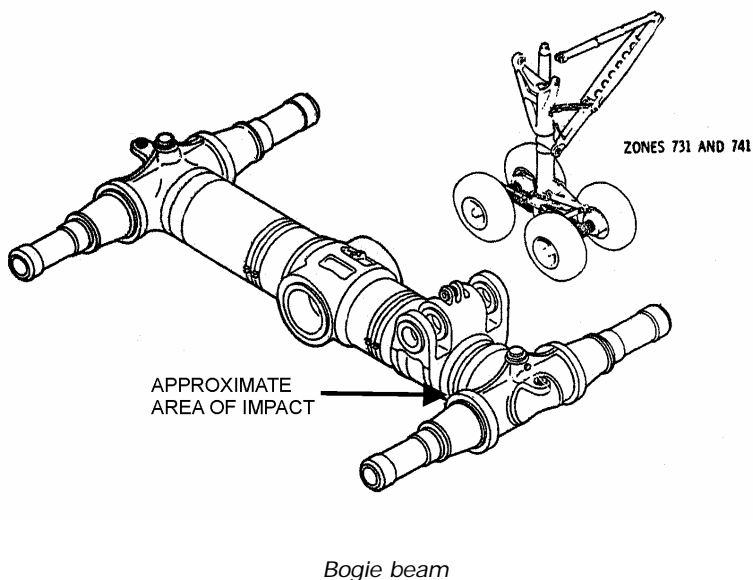
The fractured bogie beam was submitted to the Boeing Metallurgy Laboratory in California, USA, for fractographic evaluation. The objective of this investigation was to determine the cause of fracture of the bogie beam and to determine if any material or processing discrepancies contributed to the fracture. The following conclusions were drawn:

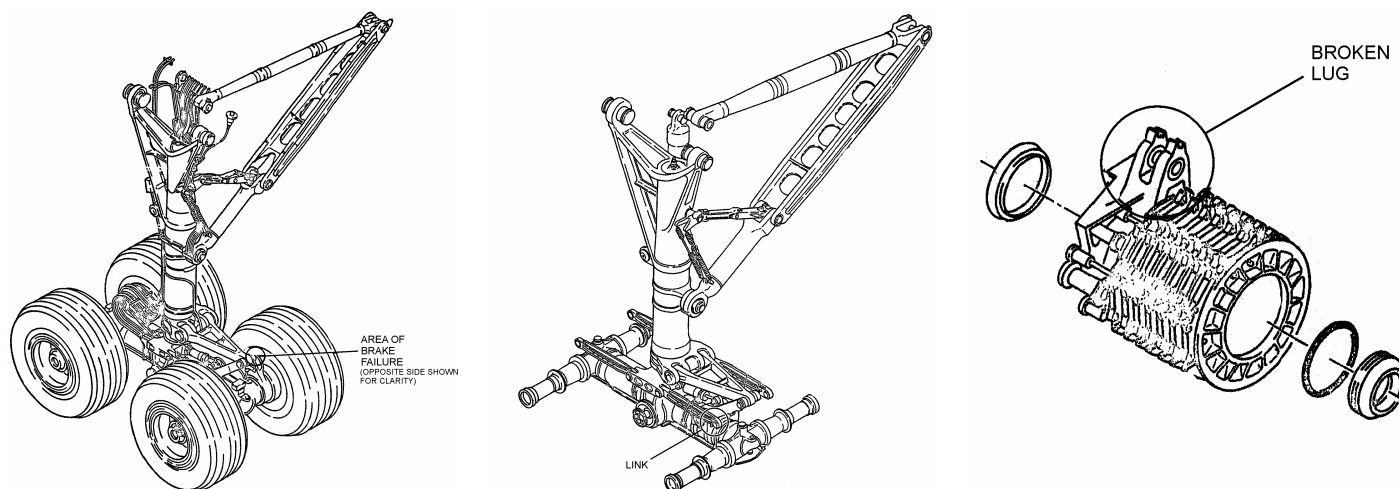
Brake link connection lug

The two detached parts of the brake link connection lug were submitted to KLM Engineering Support & Development for examination of the fractured areas. The department performed a microscopic investigation. The following conclusions were drawn by the Board:
