FINAL INCIDENT INVESTIGATION REPORT

MONARCH AIRWAYS

AIRBUS A321-231

G-OZBE

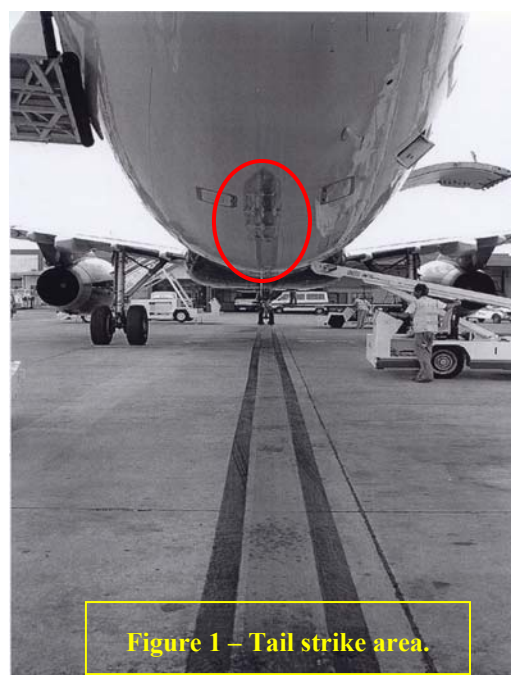
Figure 1 – Tail strike area.

Examination of the aircraft at Faro Airport showed damage to the lower fuselage. The visual inspection carried out by maintenance revealed an extension of 2 meters, approximately, of exterior skin paint abrasion under the tail section.

From the geometry of the impact damage, the aircraft pitch attitude would have been between 10° and 11° relative to the runway.

Temporary repair has been carried out accordingly with IAW Airbus Technical Disposition 942-031144/012/2004 issue with minor deviations regarding alternative fasteners IAW SRM guidelines, so the aircraft could be approved for a single unpressurised ferry flight from Faro to Luton.

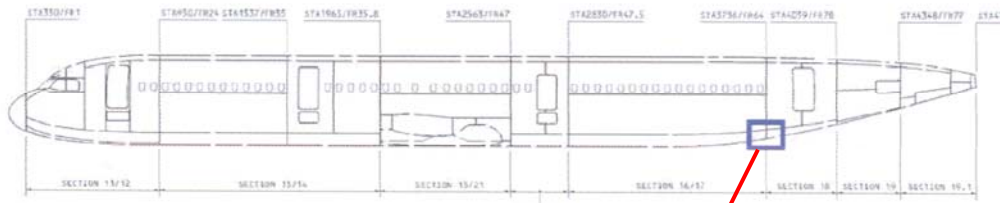
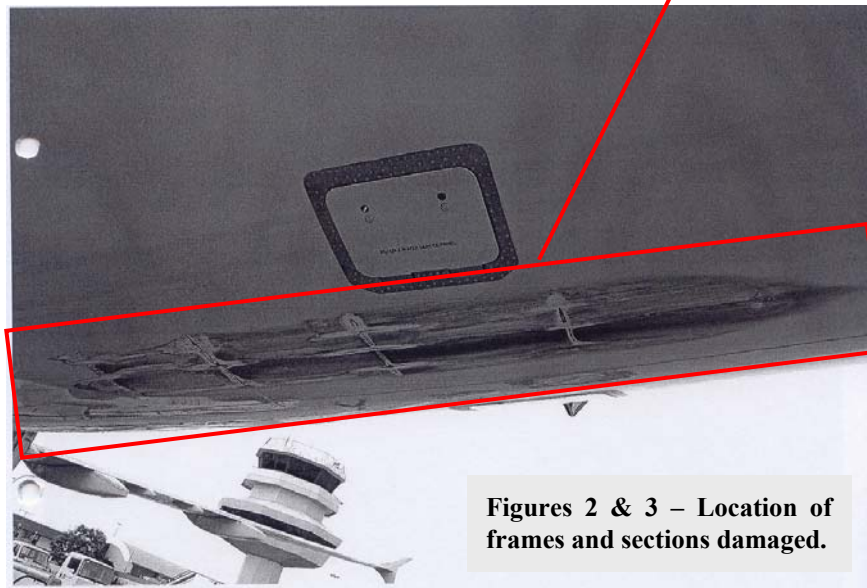
Figures 2 & 3 – Location of frames and sections damaged.

The lower skin was abraded from Frame 63 to around Frame 67 between Stringer 42 L/H and Stringer 42 R/H.

Within this area of abrasion, it seems there were no structural damages from the vertical loads applied in the contact with the runway. Nevertheless, this area was to be, latter on, the object of an accurate inspection to determine any sustaining structural damage as the result of the tail scrap during landing.

The Engineering Report still informs that also the Galley/Lavatory drain mast sustained minor damage burns during fuse contact.

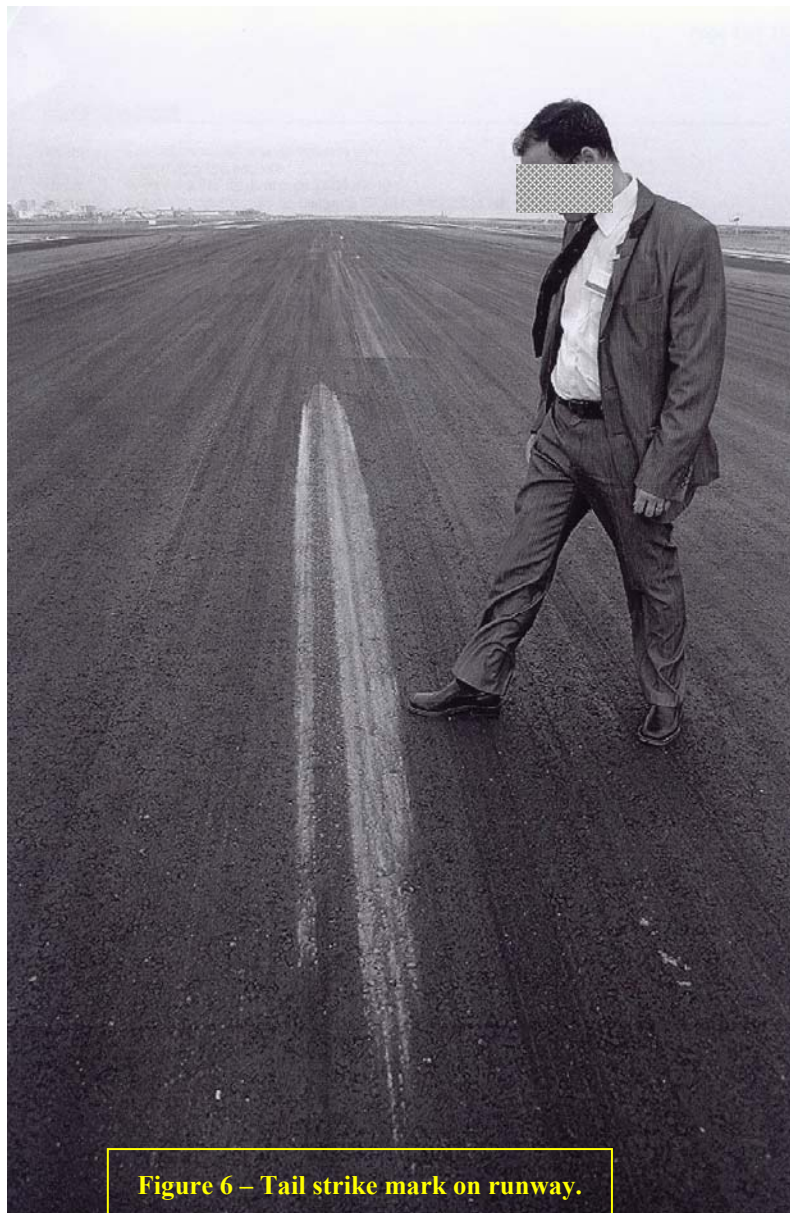
The examination of the runway showed a single mark from the contact with G-OZBE, some 5 metres long, within the normal touchdown zone and close to the runway centre line.

The abrasion marks were parallel with the fuselage axis, showing that there was negligible aircraft yaw at contact.
