FINAL INCIDENT INVESTIGATION REPORT

CESSNA 340A RAM III

D-ICFG

REPORT NR 24/INCID/2007

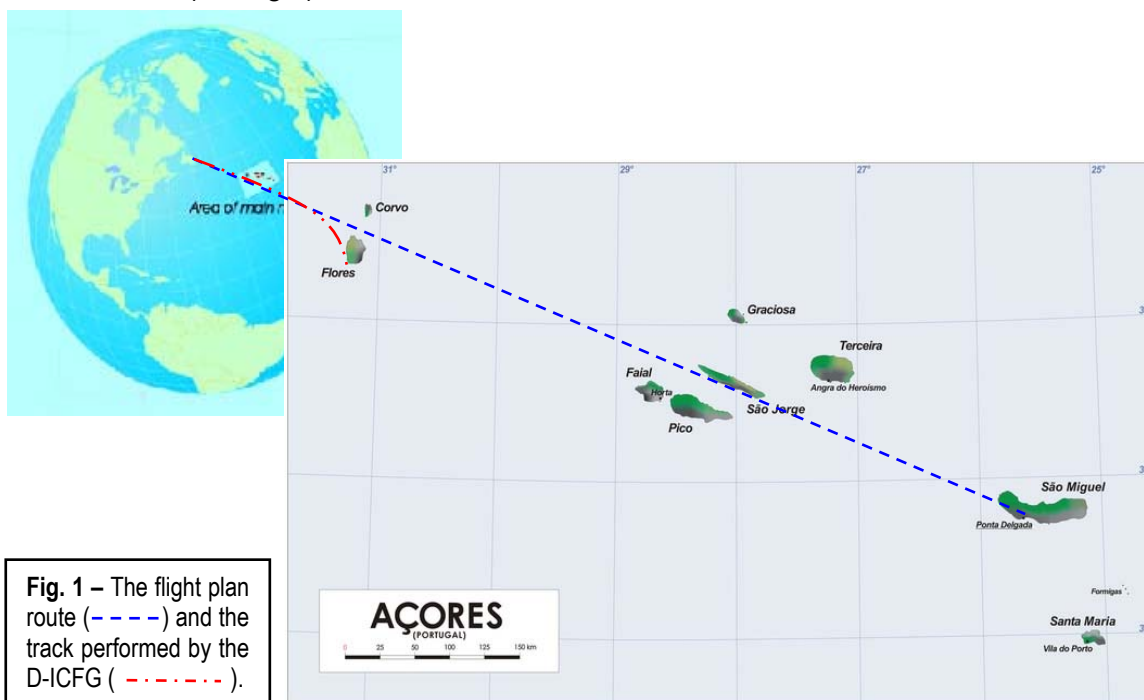
Fig. 1 – The flight plan route (---) and the track performed by the D-ICFG (- - - -).

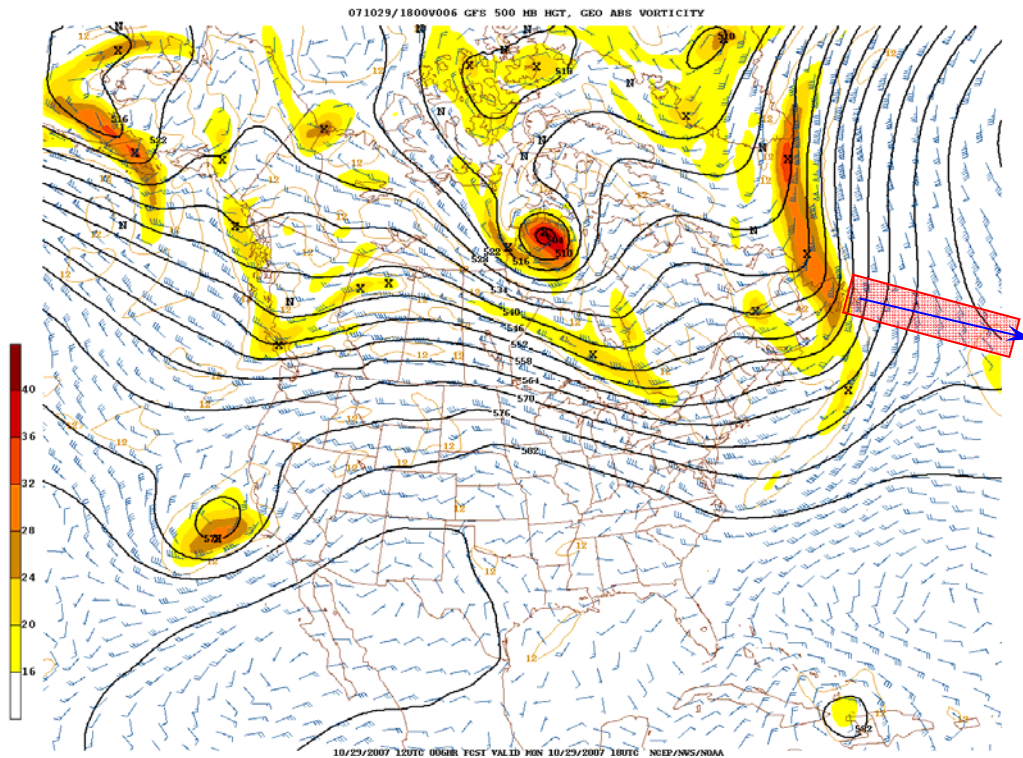
On this meteorological chart (fig. 3) it was possible to calculate, broadly, forecast winds for only the first 50%³ distance of the flight, which were the following:

Fig. 3 – Weather forecast with a the red box including the True Course (blue arrow of ± 580NM)
