FINAL INCIDENT REPORT

Cessna 208B

N21070

24th of December 2008

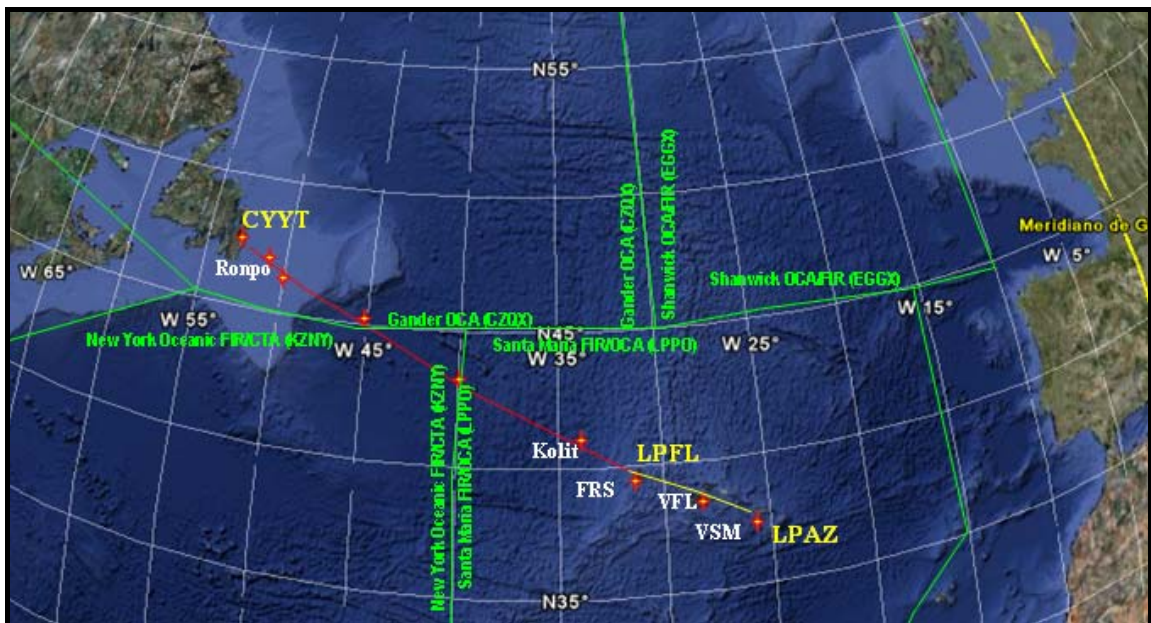
Picture Nr: 1

With full tanks (692USG \approx 13H00) and only one pilot aboard, N21070 took-off from CYYT at 10:43 and proceeded according planned routing (*picture nr. 1*) climbing to FL130.

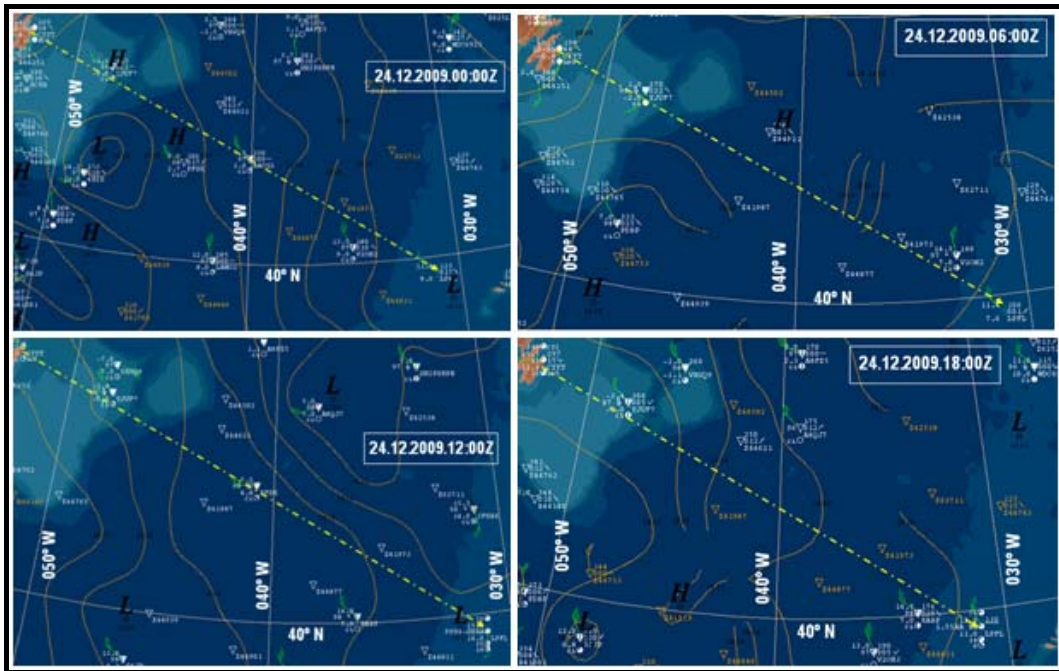
Picture Nr: 4

A general meteorological situation information was obtained from Environnement Canada, regarding the route to be flown by N21070, on the 24th of December 2008, together with respective weather charts. Situation report is reproduced bellow, with associated charts on picture nr. 4.

A 1008mb low pressure system was located near 47N 036W. The cold front extended southward from the low center through 30N given rain/showers and thunderstorms approximately 100 nautical miles to the west of Flores in the morning (1200Z). A few hours later the cold front passes over Flores (near 1600Z) given rain, mist and showers. The surface winds observed with the passage of the cold front was from the north-west and gusting up to 40 Knots and remained strong several hours after.”

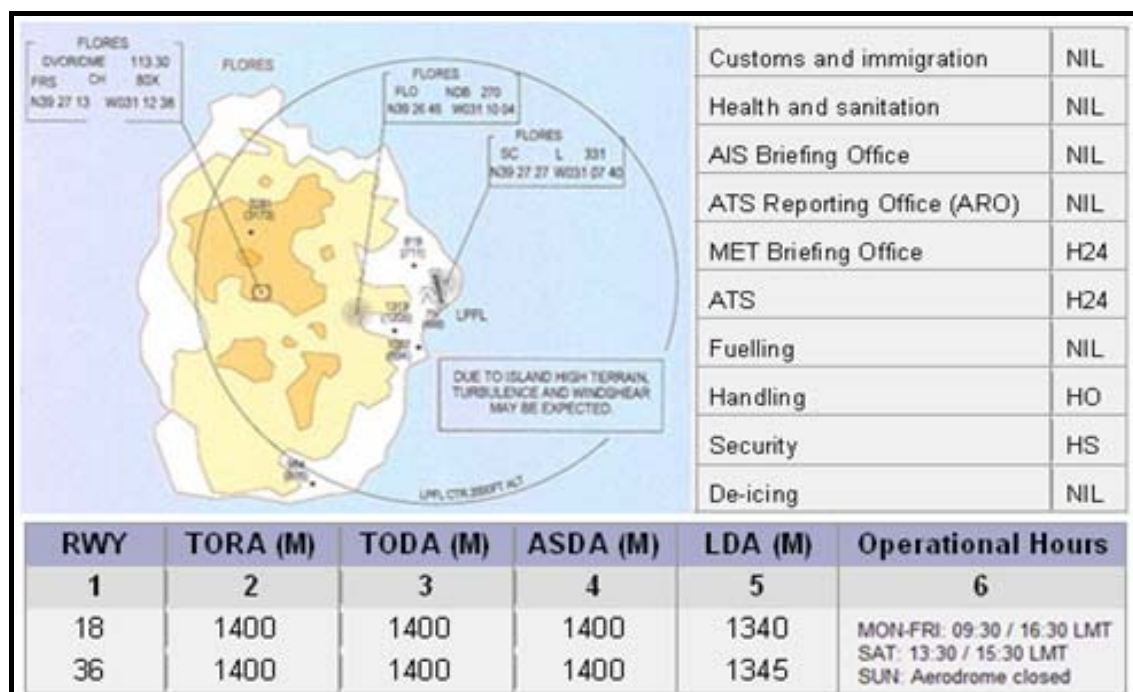
Picture Nr: 5

Location, facilities and runway dimensions are shown below (*picture nr. 5*).

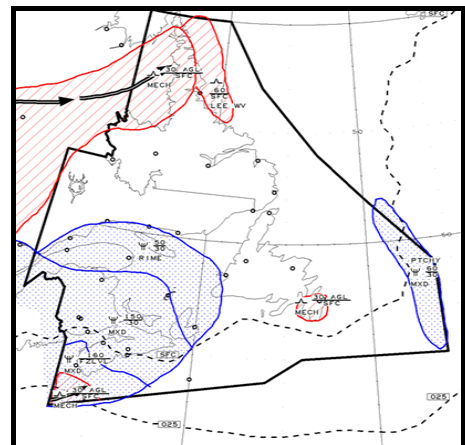
Picture Nr: 6

Environment Canada 12:00 chart (*picture nr. 6*) showed an area of moderate ice formation, which the aircraft should be passing through, when approaching 050°W. By that time the engine should be fed from main tank and extra tanks were not in use, having no air flowing through vents and facilitating ice formation. The cold front was extending from 47°N 036°W south-westerly (less than 100NM from Flores), so the aircraft was flying in cold weather and ice would stay in place, instead of melting.

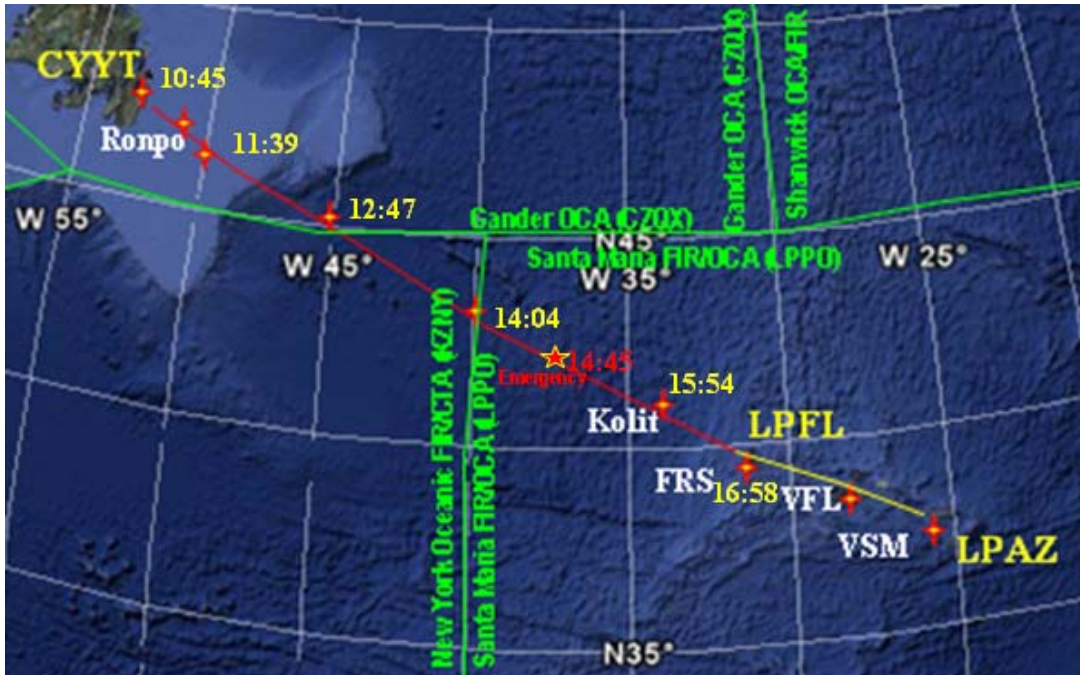
Picture Nr: 7

Following extra tanks special operation procedures, the pilot had to deplete more than half right tank, prior to select extra tanks, which would occur not before passing 045°W.

Initially, fuel was flowing from extra tanks (visually checked by pilot) because fuel gases expansion was enough to fill the tank and allow pumps to be fed. As fuel was consumed, vacuum was created inside the tanks and it became more difficult for the pumps to suck the fuel. At that stage, more than three hours after departure (passing 040°W app), the pilot noticed that fuel was not flowing in extra tank line. He checked pump electrical connections but the problem persisted. He assessed the situation and by 14:45 (037°W app), in contact with Sta Maria, declared fuel emergency and requested permission to divert to Flores aerodrome.
