FINAL INCIDENT REPORT

PRIVATE
EXTRA 300S

N80LA

FINAL INCIDENT REPORT Nr. 18/INCID/2008

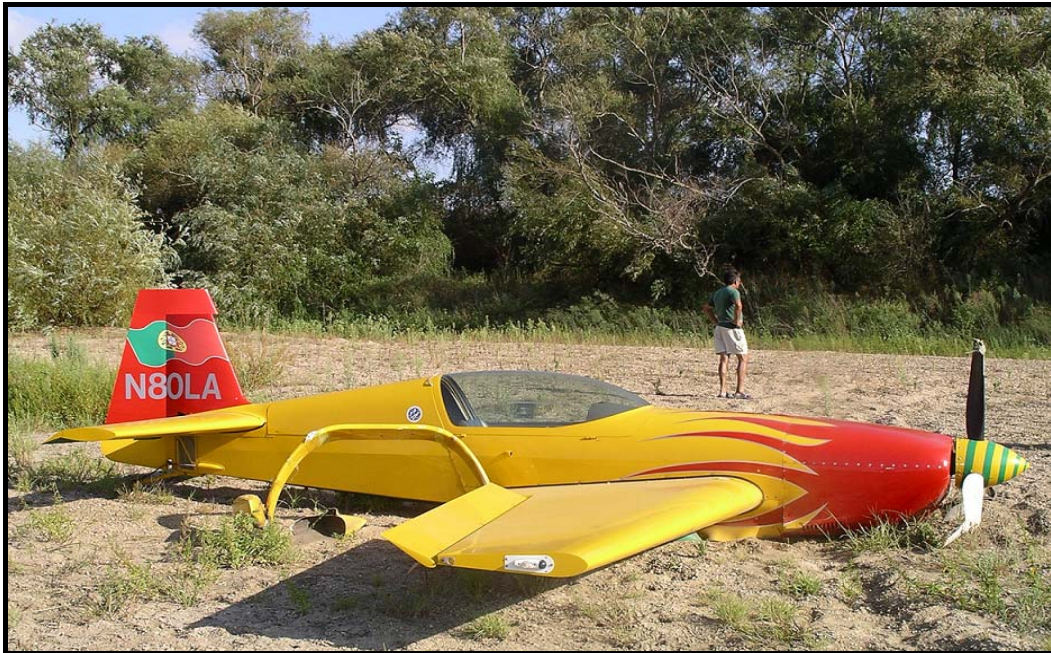
Picture Nr 2

After landing, the aircraft slid for 27m, approximately, and rested on its belly, with main gear detached (*picture nr 2*).

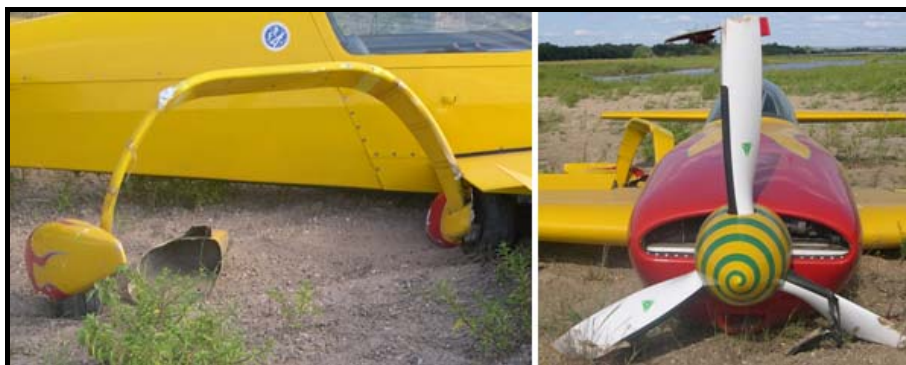
Picture Nr 3

The aircraft was slightly damaged, suffering minor damage underneath the fuselage, after the main landing gear dislodged and breaking propeller blades' tips (*picture nr 3*).

Aircraft's belly suffered some scratches and abrasion. Propeller blades impacted the ground and all had broken tips. The first (top one) showed only a small piece missing, but the other two blades lost about one third of their length (when being dragged along).

Propeller blades damage confirmed the engine was not delivering power at the moment they contacted the ground.

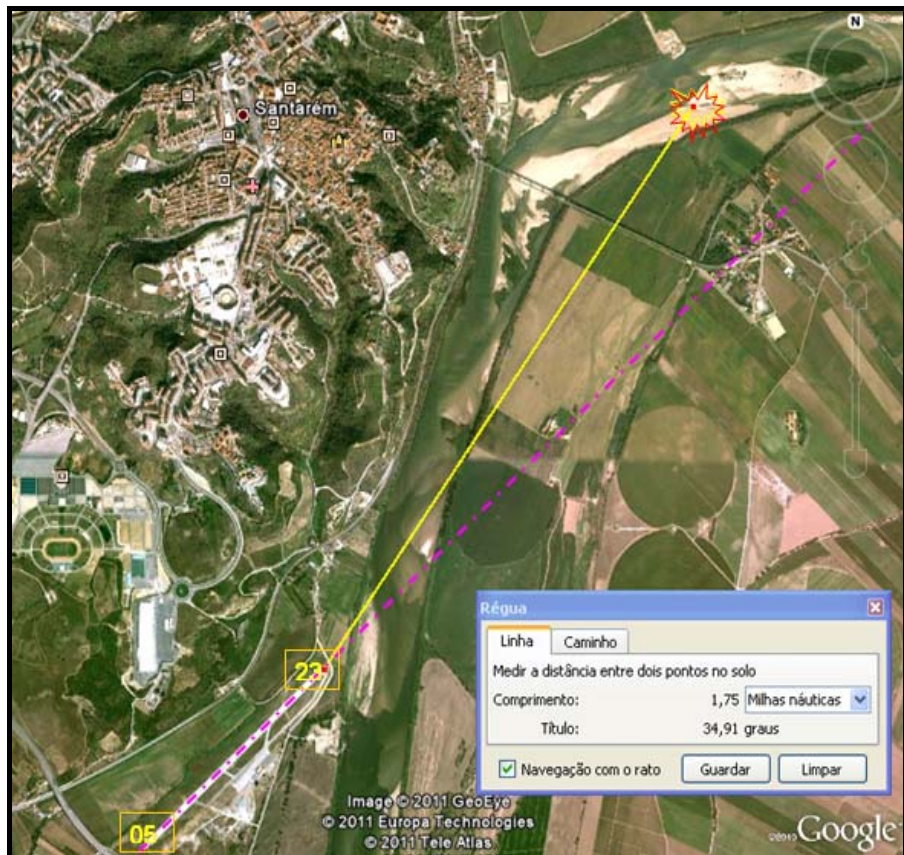
Picture Nr 8

The landing place was a small sandy island in Tagus river bed, which becomes visible only when the water flow decreases and the river reverts to a small stream of water. Nearest aerodrome was less than 2NM away (Santarém aerodrome) and landing site was close to runway axis, which means pilot was performing a direct approach to RW 23 (picture nr 8).

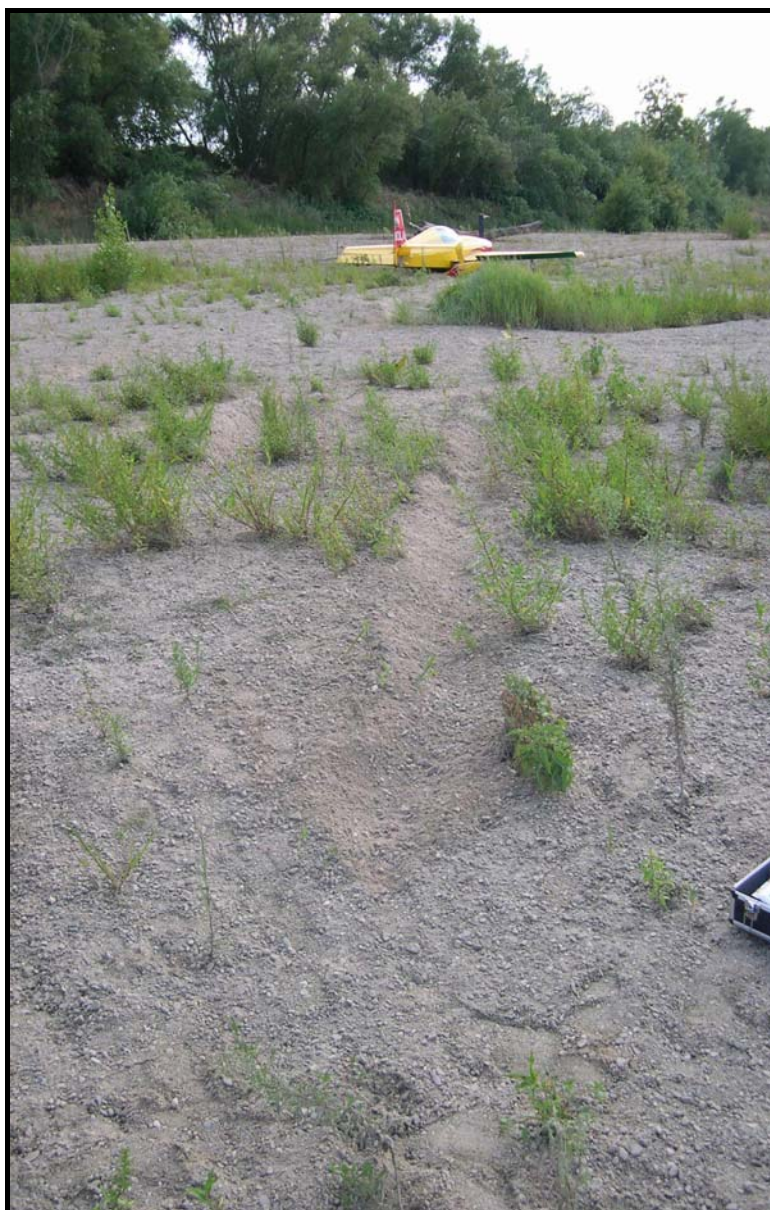
Picture Nr 9

The first impact on the ground was with tail wheel, followed by main wheels, about 5m ahead. When main wheels sank in the sandy floor, gear fuse broke and main landing gear separated. Then, aircraft belly set down and slid for approximately ten metres, veering slightly to the right, until aircraft immobilization (*picture nr 9*).

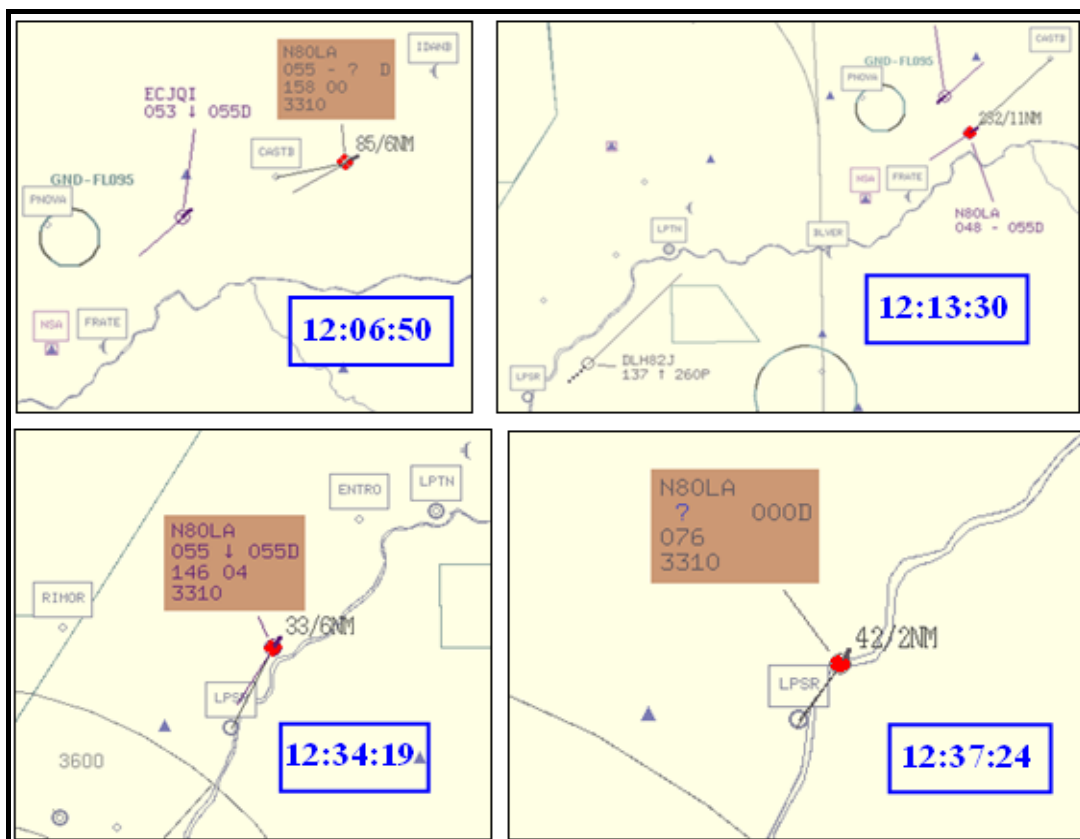
Picture Nr 10

Looking into radar snapshots (picture nr 10), the aircraft was first identified, on its way from Alcafozes to Santarém, at 5500ft (12:06:50 – first radar positive contact). Later it was spotted at 4800ft (12:13:30 – when pilot declared his intention to contact Tancos Tower in order to confirm if there was traffic in its reserved area, which was activated by NOTAM), again at 5500ft (12:34:19 – when, starting descent, it was transferred to Santarém for local traffic information) and finally, without receiving mode “C” (12:37:24 – last radar contact, 2NM North-east of Santarém aerodrome and 76kts speed).

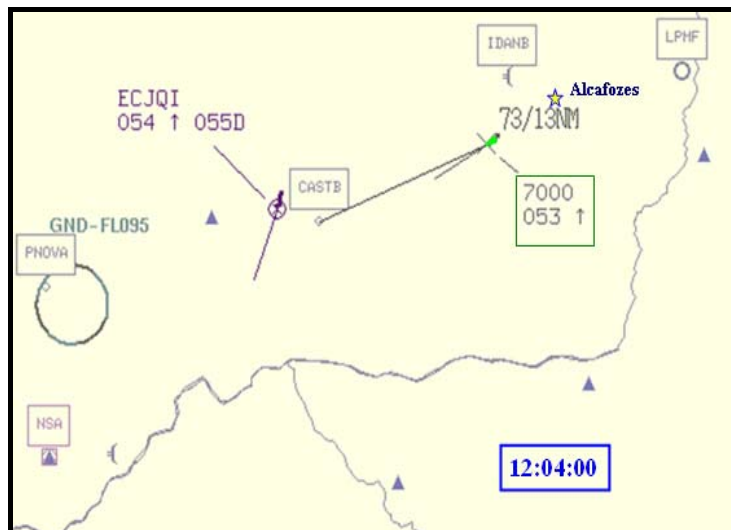
Picture Nr 11

On first contact with FIS (12:04:00), the aircraft had not received transponder code yet and could not be positively identified. Even so, radar registered an aircraft (*picture nr 11*), which corresponded to N80LA position information (*flying away from Alcafozes and heading to Santarém, maintaining an altitude of 5300ft and climbing to requested 5500ft altitude*).
