GABINETE DE PREVENÇÃO E INVESTIGAÇÃO DE ACIDENTES COM AERONAVES

## FINAL INCIDENT INVESTIGATION REPORT

# British Midland Airbus A321-231

**In-flight engine failure**

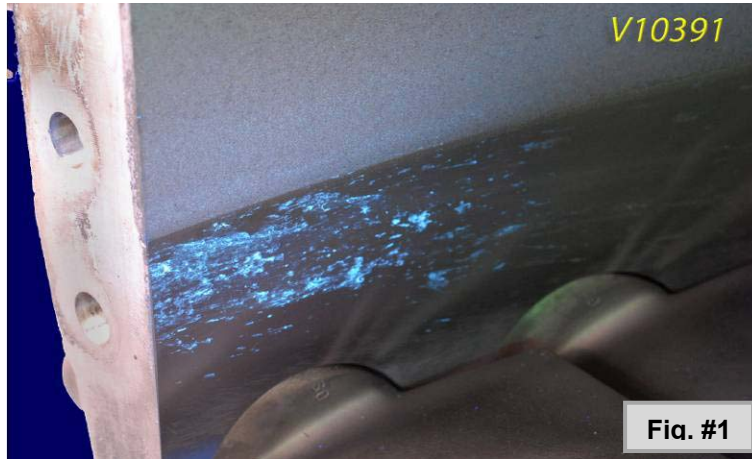
- a. During ultra-violet inspection the outer annulus behind the VSVs in front of HPC rotor 3 showed traces of organic material (Figure 1).

During ultra-violet inspection, traces of organic material have been detected in the outer annulus behind the VSVs in front of HPC rotor 3.

This fact indicates that, somewhere in a previous flight, G-MIDL engine #2 ingested FOD into the core, impacting the leading and trailing edges of the HPC stage 3 and 4 rotor blades, travelled to the HPC stage 6 impacting stator vanes and initiating cracks on one rotor blade and one stator vane.

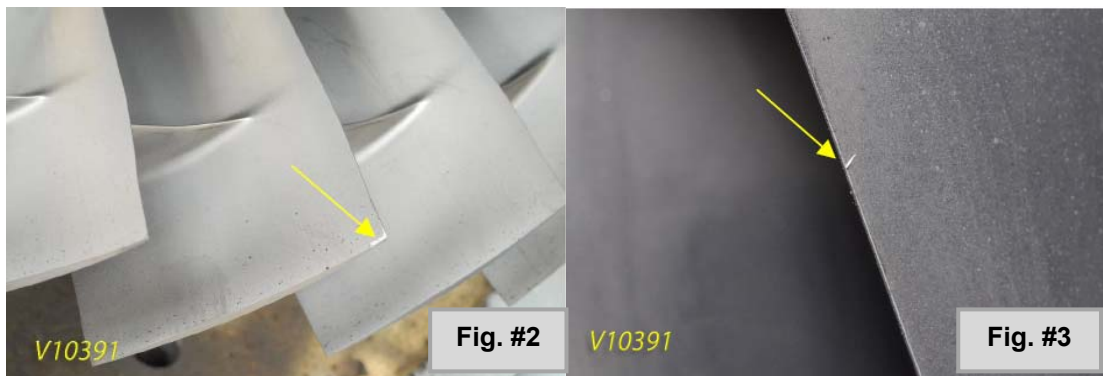
- b. Impact marks were found on HPC stage 3 and 4 rotor blade airfoils close to the leading edges and also on the tip at the trailing edges (Figure 2 & Figure 3);

- At some time during a previous aircraft flight FOD in combination with soft body FOD was ingested into the core of the engine impacting the leading and trailing edges of the HPC stage 3 and 4 rotor blades leaving impact marks on the airfoils;

FOD traveling down the gas path left impact marks and nicks on HPC stage 3 and 4 airfoils before impacting the stage 6 rotor blades and the stator vanes. Soft body FOD also impacted the leading edges of the stator vanes.

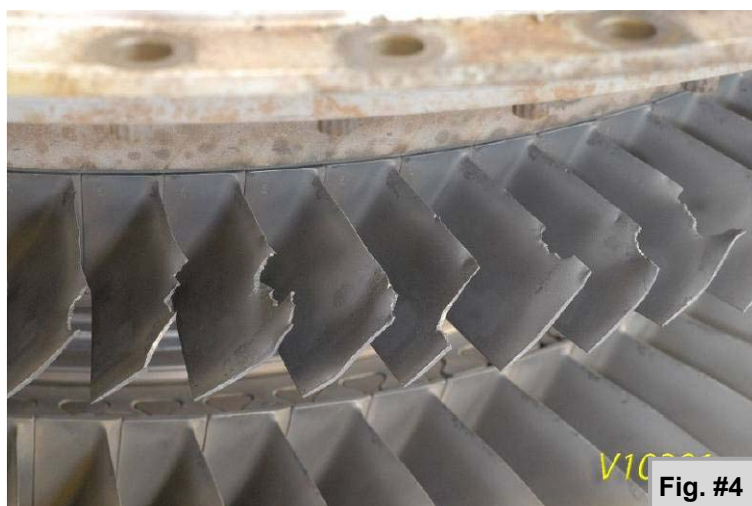
- c. HPC stage 6 rotor blades showed nicks, dents and broken airfoils at the tip areas and at the trailing edges (Figure 4).

The IAE - International Aero Engines AG lab investigation confirmed FOD impact marks to HPC stage 6 rotor blades and soft body impact to the stator vanes. One HPC stage 6 rotor blade and one stator vane were missing. Fractures were initiated, which then propagated through HCF over an unspecified period of cycles. One other HPC stage 6 rotor blade airfoil was missing and showed a fresh crack surface. This airfoil was released as a result of the initial HPC rotor 6 blade airfoil release.

The FOD impact initiated a crack in one stage 6 rotor blade trailing edge and on one stator vane. The crack on the rotor blade propagated from the trailing to the leading edge, whereas the crack in the stator vane propagated from the leading to the trailing edge.

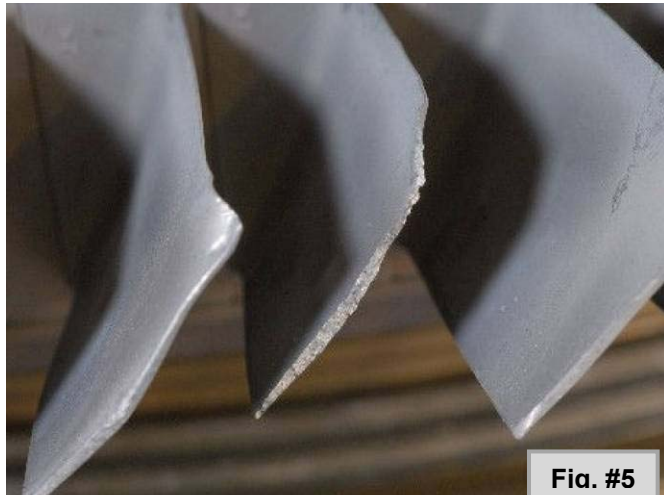
- d. One HPC stage 6 rotor blade airfoil was missing 12 mm from the tip (Figure 5);

- A crack propagated across the chord width of an HPC stage 6 rotor blade from the trailing to the leading edge;
- On 30<sup>th</sup> July 2008, the airfoil was released by final fracture;

Eventually the cracked HPC stage 6 airfoil was liberated creating a crack in another stage 6 rotor blade and further damaging the stator vanes. This was noticed at the first stall of the engine during descent in 30<sup>th</sup> July and the flight crew managed to recover the engine.

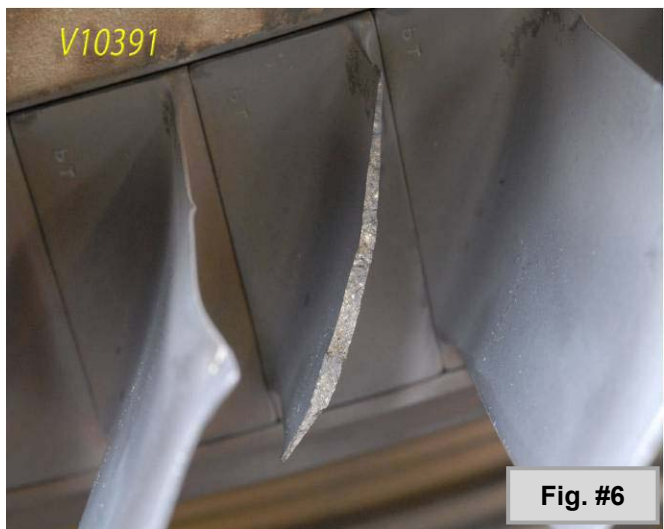
- e. One HPC stage 6 rotor blade airfoil was missing 12 mm from above the platform (Figure 6).

- The initiated crack in one HPC stage 6 stator vane and the second rotor blade propagated to eventual release causing further downstream damage;
- On 1<sup>st</sup> August 2008, the damaged and deteriorated HPC was responsible for the second stall event during cruise. The engine could not be operated above idle for the remainder of the flight.

Two days later, on 1<sup>st</sup> August (the day of the occurrence) the second HPC stage 6 rotor blade airfoil, together with the stator vane, was released causing further deterioration to the HPC. This led to another stall, which was recovered, but the engine was unable to achieve normal operation during cruise with it being impossible to operate the engine at above idle power settings for the remainder of the flight.

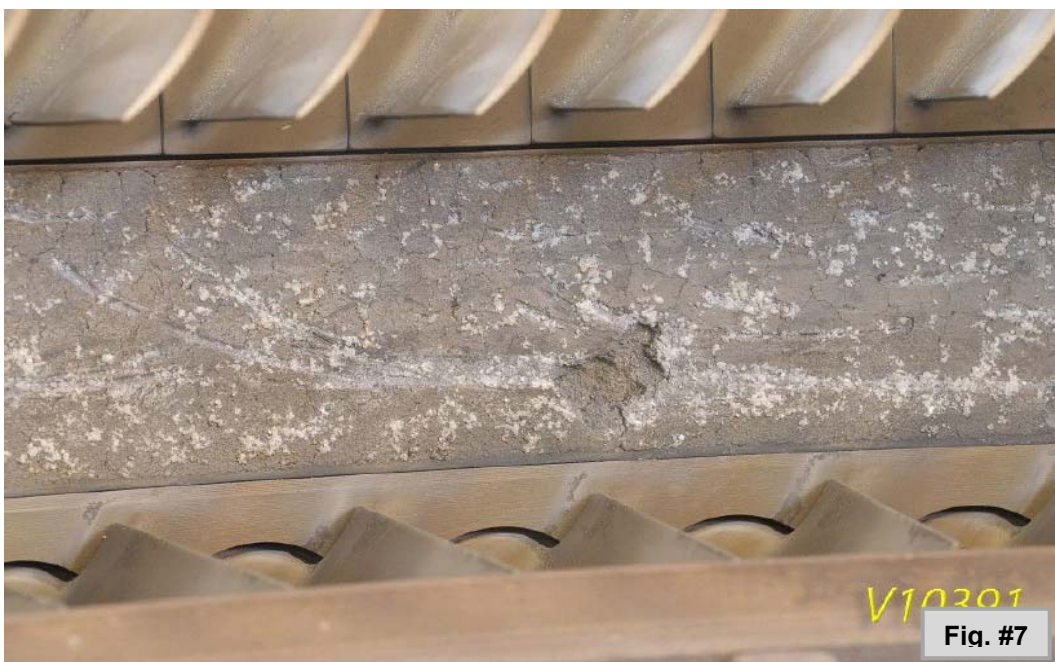
- f. The HPC stage 6 rotor path showed impact marks, gouging and material breakout at several locations (Figure 7).

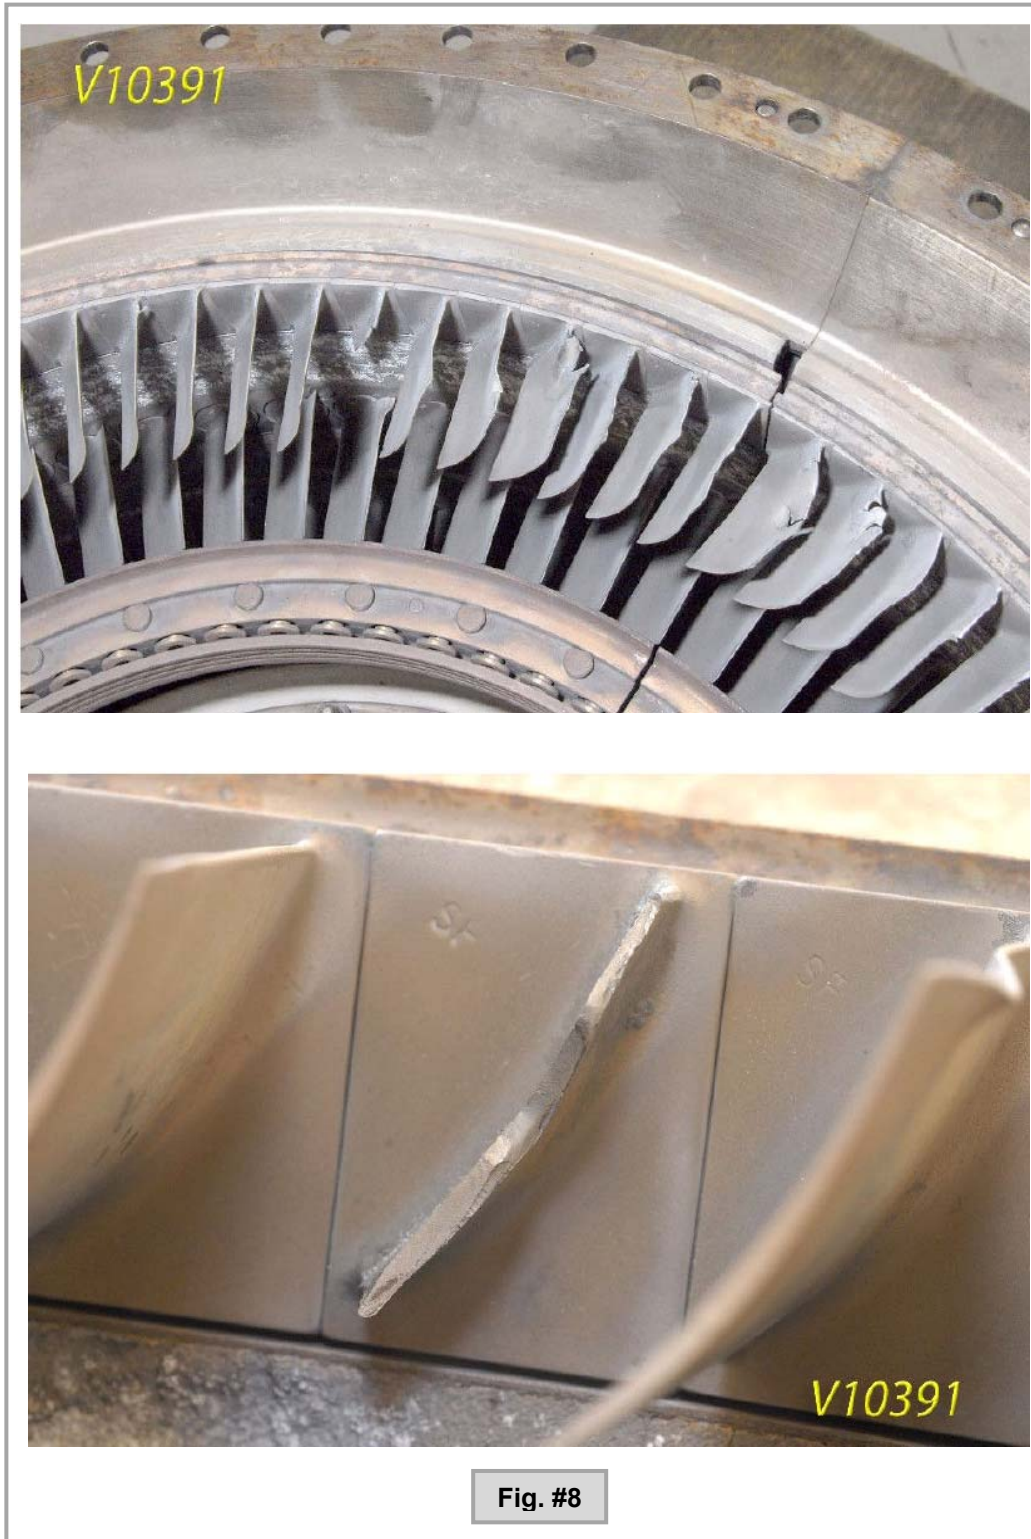
- g. All stage 6 stator vanes were damaged and showed dents, nicks and loss of material on the trailing edges. One vane was released from above the platform (Figure 8).

- Further downstream damage was caused by FOD impacting HPC stage 6 rotor blades and soft body impacting stage 6 stator vanes, initiating cracks on one rotor blade and on one stator vane;
