FINAL ACCIDENT REPORT

Piper PA-34

CS-AUE

FINAL ACCIDENT REPORT Nr: 15/ACCID/2008

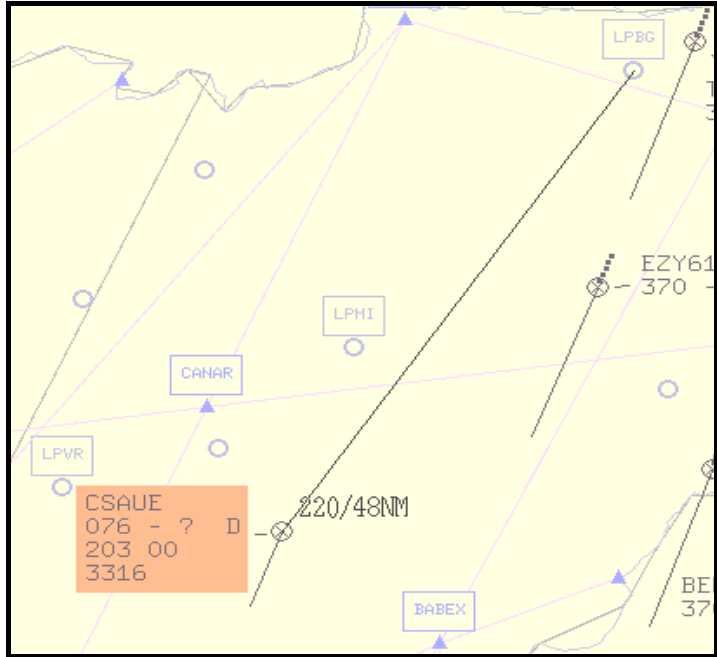
Picture Nr: 3

He contacted LIS ACC North sector Controller, in sequence, getting clearance confirmation and informed of no radar contact at that moment. First radar contact would be established at 08:09:10, when the aircraft was passing abeam Vila Real (LPVR) at an altitude of 7600’ (picture nr. 3).

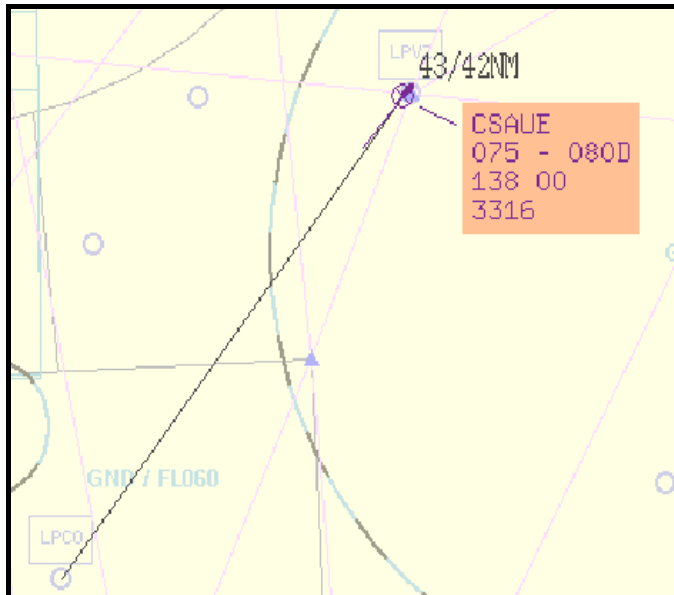
Picture Nr: 4

By that time (08:26:12), the aircraft was abeam Viseu (LPVZ) at an altitude of 7500’ and on course ($\pm 220^\circ$) to destination, with 138kts speed (picture nr. 4). The new LIS ACC north sector Controller didn’t identify that station, being his first contact with that aircraft (*he was starting his duty period*). By part’s exclusion, checking traffic under his responsibility, the Controller identified CS-AUE as probable transmission source and made a call (08:26:44), which had no answer.

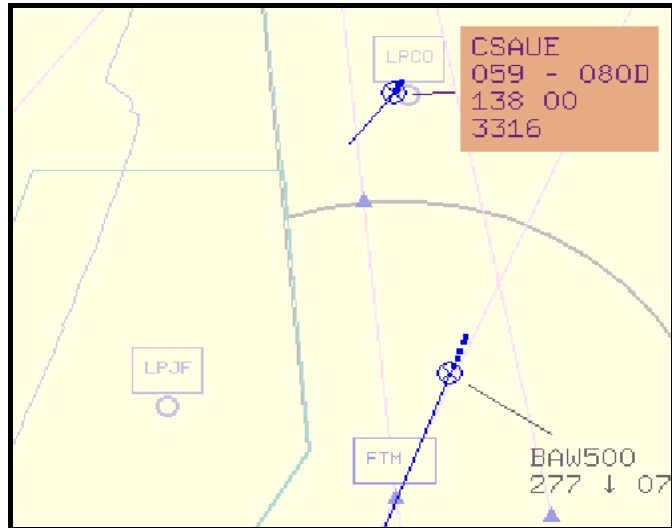
Picture Nr 5

The aircraft was kept under radar monitoring and passed abeam destination, Coimbra aerodrome (LPCO), at 5900ft, by 08:44 (picture nr 5) turning slightly to the right ($\pm 20^\circ$).

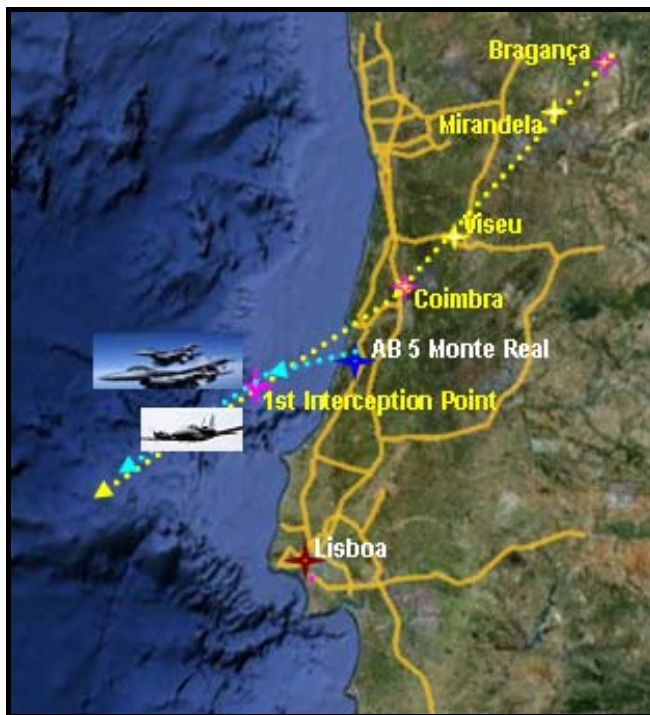
Picture Nr 6

CS-AUE flew abeam Monte Real (LPMR) at 08:55 and was intercepted the first time by 09:13, at position N 39° 41' 39" / W 009° 45' 00" (picture nr 6). The aircraft was flying at 5200ft, heading 250°, keeping a speed of 128kts.

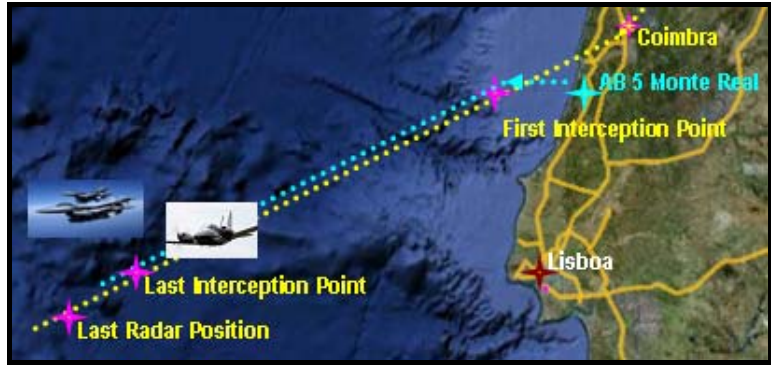
Picture Nr 7

This F-16 team followed aircraft flight progress until about 208NM from AB 5 (limit of its endurance), registering aircraft last position at N 38° 40' 18" / W 012° 48' 37" coordinates, at 10:29 (picture nr 7), landing back on base at 11:05.

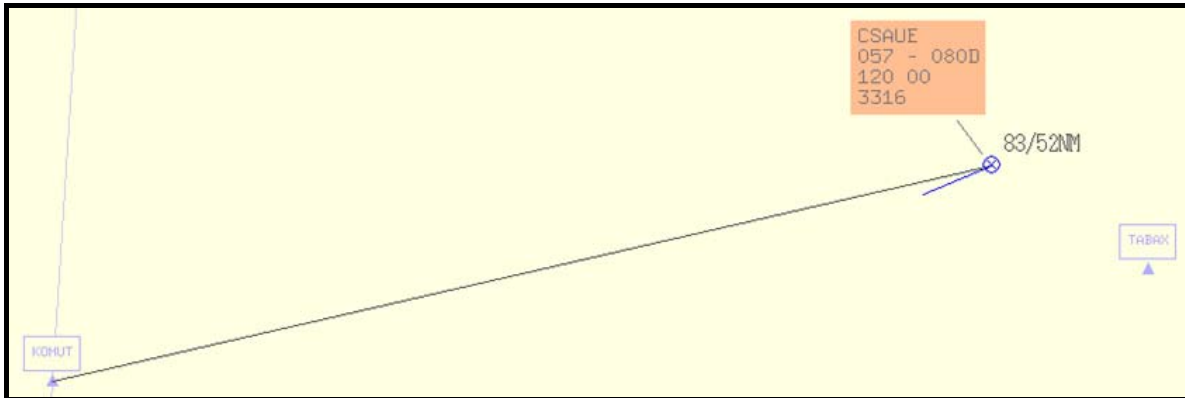
Picture Nr 8

The aircraft proceeded its flight, keeping approximate heading of 250°, until it disappeared from radar displays, by 10:58, at an altitude of 5700ft, speed 120kts, on coordinates N 38° 14' 38" / W 013° 56' 08" (picture nr 8).

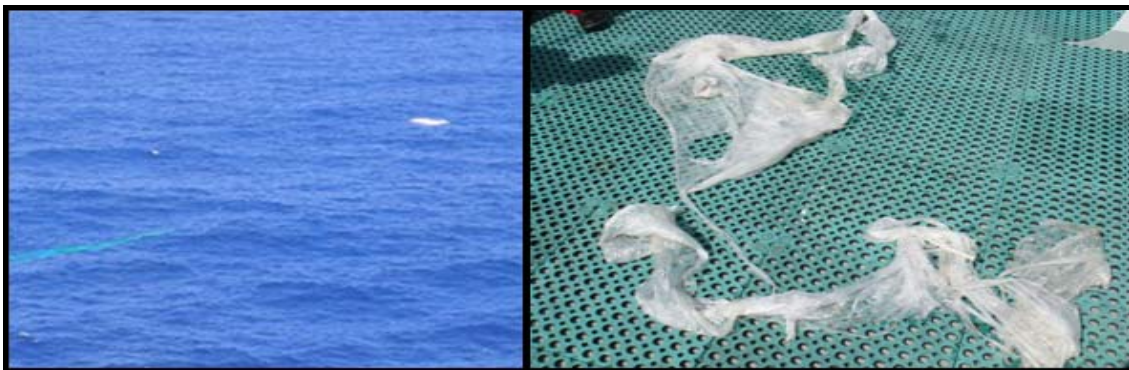
Picture Nr 9

During a second sortie, the F-16 team, airborne at 11:53 from AB 5 (Monte Real), was not successful in intercepting the distressed aircraft, but discovered some wreckage floating on the sea at position N 38° 10' 15" / W 014° 10' 29", which showed, after being recovered by cargo ship "ALIANCA MAUA", to be not part of the disappeared aircraft (picture nr 9).

During the second sortie, F-16 team detected some wreckage floating in the probable crash zone. Being recovered by the merchant ship "ALIANCA MAUA", it was confirmed as a piece of plastic, most probable detached from a container cover. No aircraft wreckage was found.

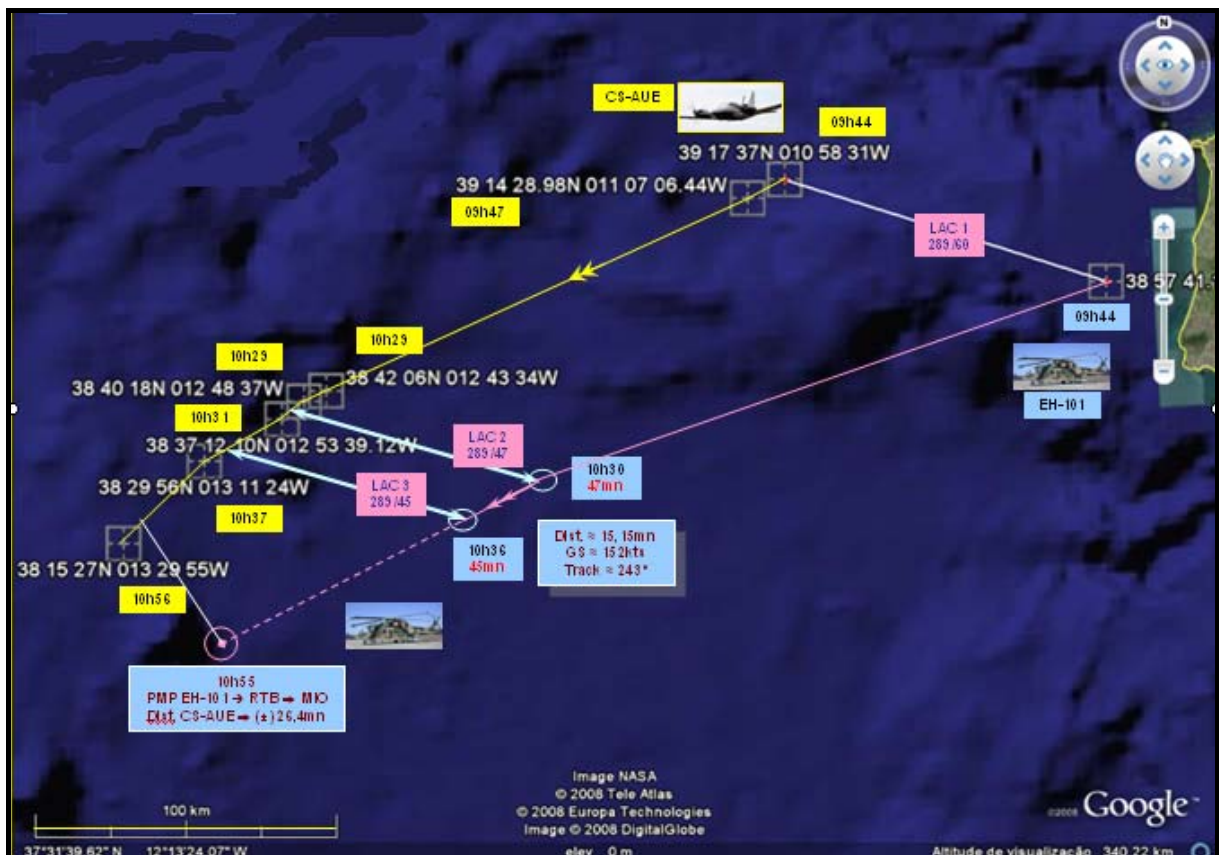
Picture Nr 13

First SAR mean to be activated was a helicopter, equipped with a MA1 Kit, to assist the victims. According with installed mechanism, alerting time for this helicopter used to be 30 minutes. Being advised at 09:05, the helicopter took-off at 09:25, from AB 6 (Montijo) and was radar guided for interception of distressed aircraft, in order to rescue the victim when it crashed in the water (picture nr 13).

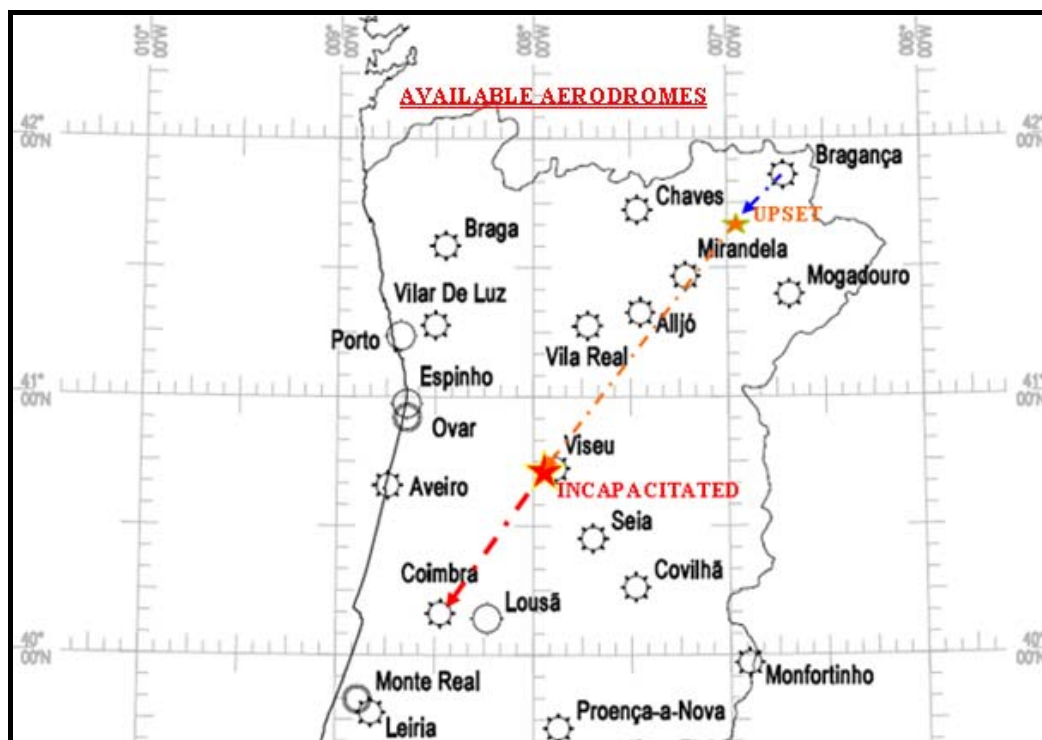
Picture Nr 17

On another way, when he felt sick in flight, having plenty of aerodromes available for an emergency landing (*picture nr 17*), he preferred to continue to destination, over evaluating his physical and emotional capacities.

Checking followed track, after the first upset signs till the moment he became incapacitated, it would be possible to the pilot to perform a safe landing in anyone of reachable aerodromes (which were familiar to him), where adequate medical care would be provided.

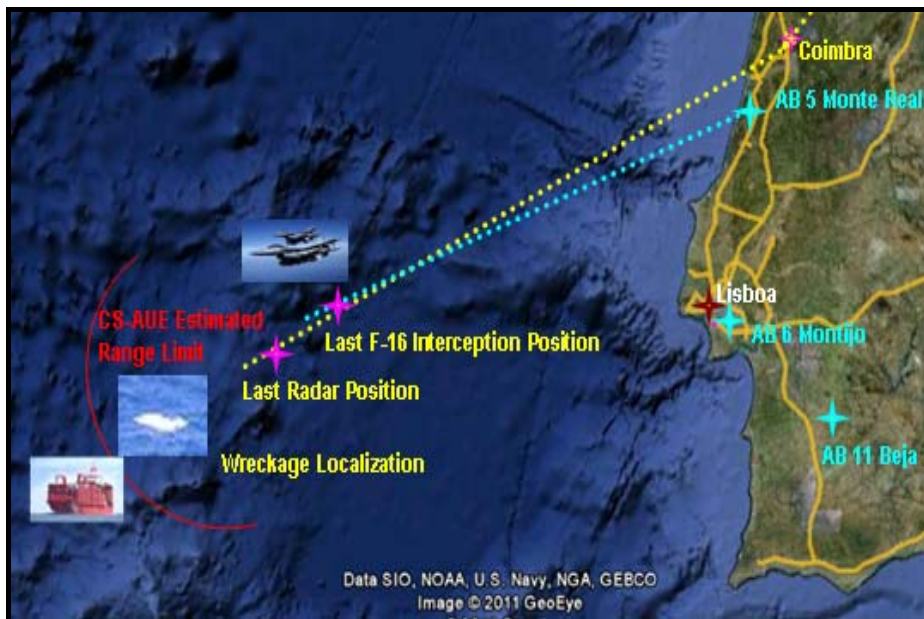
Picture Nr 18

Considering that the aircraft in emergency departed at 07:45, with four hours endurance, its fuel would presumably be exhausted by 11:45, forcing it to precipitate in the sea. Being lost contact before, it could be forecasted that the aeroplane would crash within a 120NM arc (*picture nr 18*) centred on radar last position registered at 10:58.
