## **FINAL ACCIDENT REPORT**

**EXTRA 300L**

**D-EMCK**

**FINAL ACCIDENT REPORT Nr. 12/ACCID/2008**

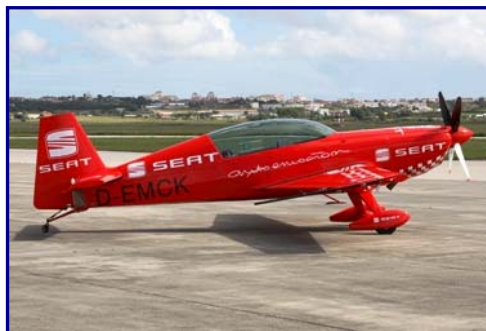
Picture nr 1. D-EMCK aircraft

The aircraft sustained substantial damage .

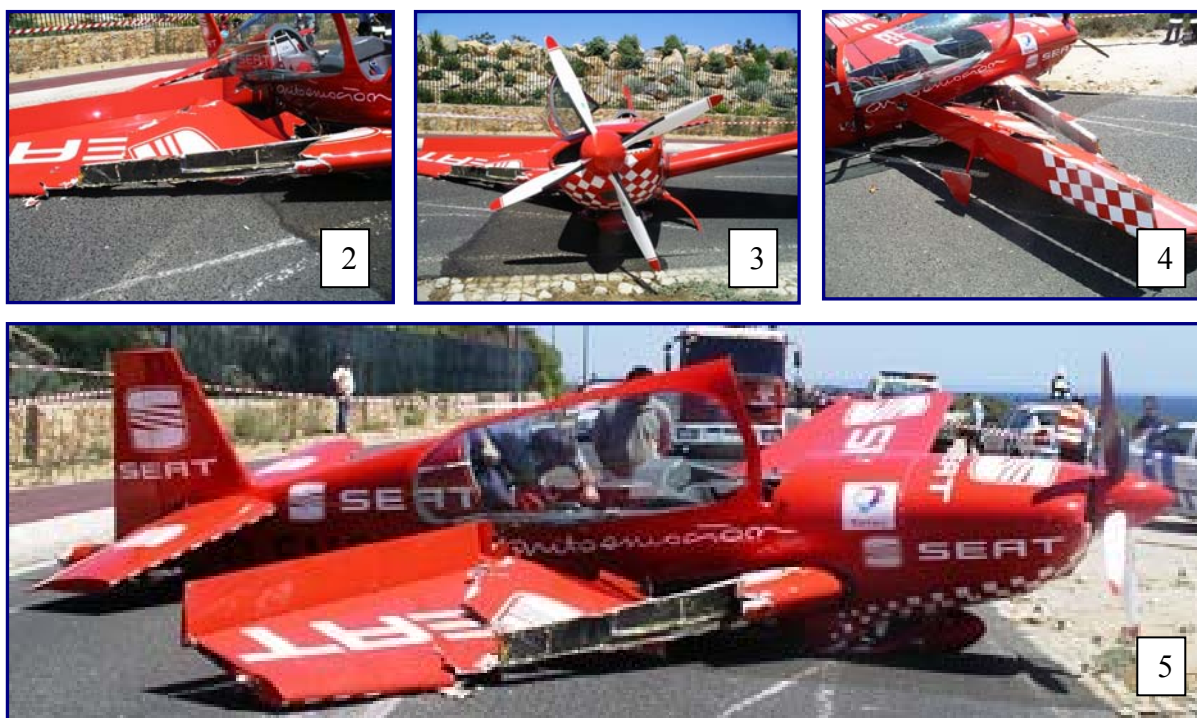
Pictures nr. 2,3,4,5.

Right wing was separated by its root and was severely damaged, particularly on its leading edge. The fuselage showed several crushing. Landing gear main legs were broken. Propeller blades were damaged. Right wing fuel tank was destroyed.

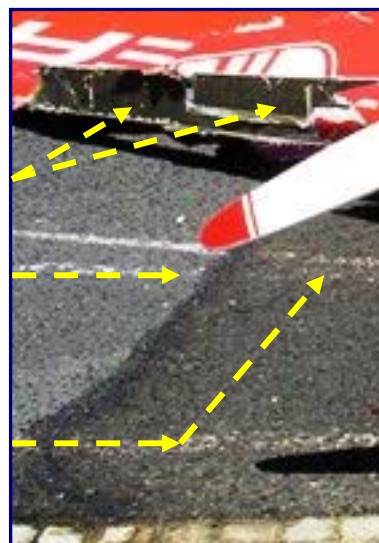
Right wing leading edge and respective fuel tank were destroyed when the aircraft collided with a car.

There was some fuel spillage from right wing tank.

Picture nr. 9 – Right wing.

Research on accident site detected fuel spillage under the right wing (picture nr. 9). Such leakage was due to right wing tank damage and confirmed there was some fuel in wing (interconnected) tanks. The fact that both tanks are interconnected and the aircraft was banking to the right (right wing on the ground) allowed wing residual fuel to flow out.
