Investigation Report No. u2092 by the Aircraft Accident Investigation Bureau

concerning the serious incident (AIRPROX)

involving the Airbus A321 aircraft, registration F-GTAE
operated by Air France flight no. 1242 / callsign AFR 1242
and the Airbus A320 aircraft, registration CS-TNG
operated by Air Portugal flight no. 945B / callsign TAP 945B

on 1 July 2008

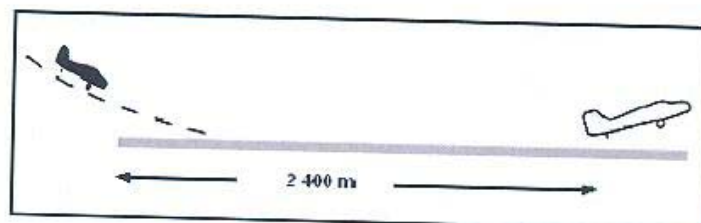
Fig. 9-11

the preceding aircraft is airborne and has passed a point at least 2 400 m from the threshold of the RWY (Figure 9-11).
