MINISTÉRIO DAS OBRAS PÚBLICAS, TRANSPORTES E COMUNICAÇÕES
GABINETE DE PREVENÇÃO E INVESTIGAÇÃO DE ACIDENTES COM AERONAVES
GPIAA

FINAL INCIDENT REPORT

EMA
(EMPRESA DE MEIOS AÉREOS)
KAMOV KA-32A 11BC

CS-HMN

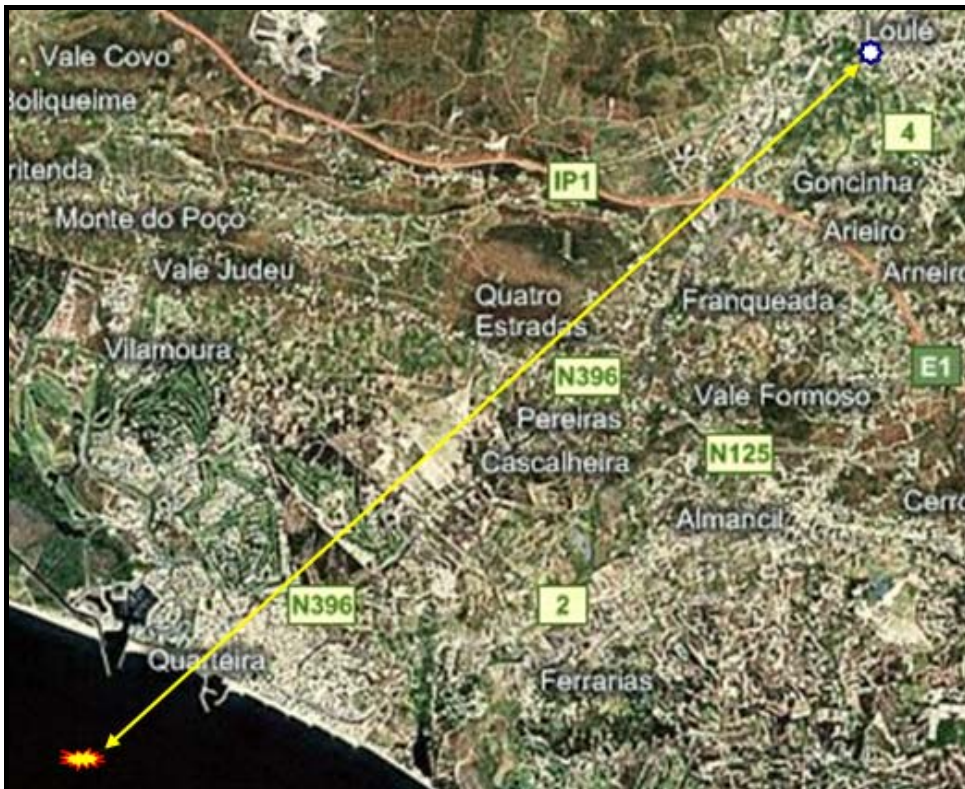
Picture Nr. 1

Mission purpose was the training of rescuers (R/S) and hoist operator (OPG), on this particularly type of air platform, recently introduced into service. As there was no qualified hoist operator with the company, a military instructor was acting as instructor for company operators. The helicopter flew from Loulé heliport to the sea (about 2NM south of Vila-moura), where a support boat was attending with three presumed victims, to be recovered, on board (*picture nr. 1*).

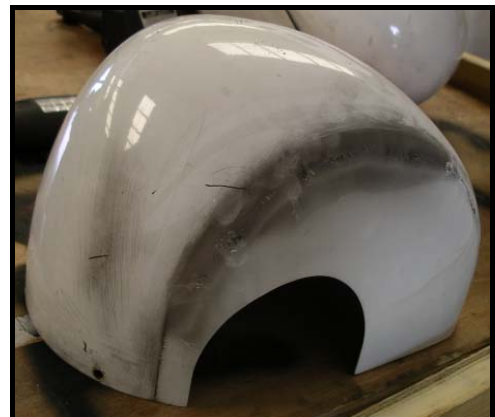
Picture Nr. 2

At first sight, one could notice sooting marks and missing paint on hoist assembly cover (*picture nr. 2*) caused by a heat source. Once the cover was removed, colour changes were noticed on some electronic components, revealing the equipment has been submitted to extreme temperatures. Hoist was reassembled and sent to the factory for deeper investigation.

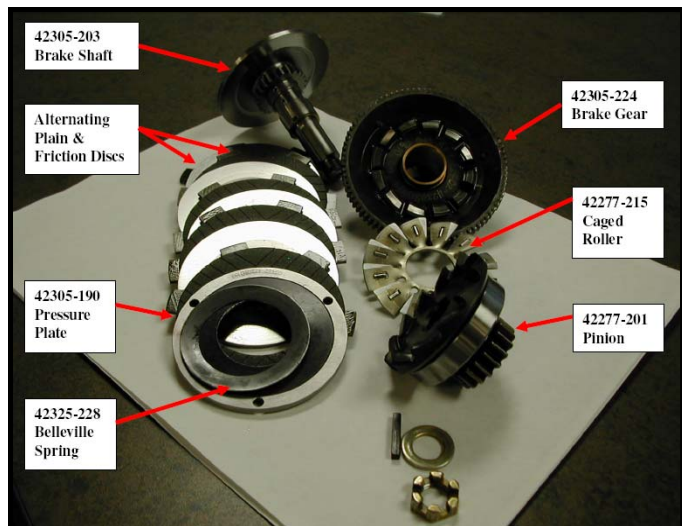
Picture Nr. 3

Picture nr. 3 shows the main parts that form Goodrich hoist model 44311-10-2 brake system, p/n 42325-200.

2nd “To provide for the replacement of old 42325-200 brake system, equipping Goodrich 44311-10-2 hoist, in service on Kamov KA-32 helicopters, by the new compatible 44301-200 brake system”.

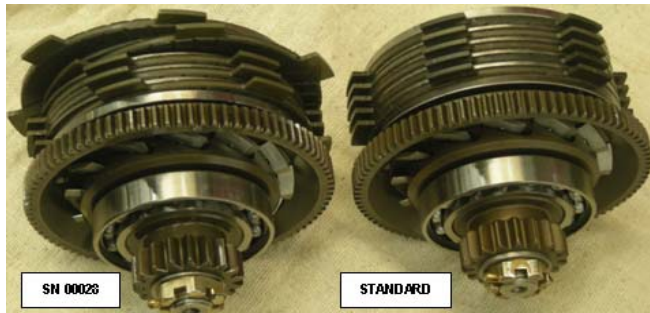
Picture Nr. 3

◀ 1st - Two discs were loose and out of place. When manipulated they returned into normal position.

2nd – Several components showed wearing and colouring indicating they were exposed to temperatures greater than 550°F.

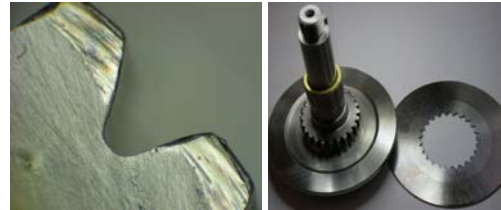
Picture Nr. 4

◀ 3rd - Brake shaft (42305-203) and pinion teeth (42277-201) showed damage and two broken teeth, separated by a four teeth interval, meaning there were two different overload impacts.

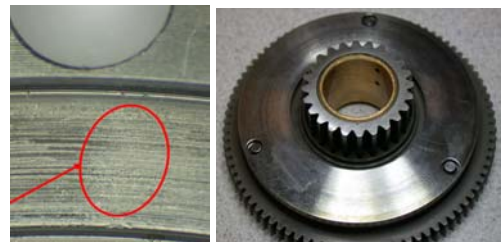
Picture Nr. 6

4th – There were some abrasive marks on pressure plate (42305-190) contact surface, associated with some fretting under all three Dowel pin holes, only possible due Belleville spring (42325-228) loss of elasticity when subjected to a force greater than 2810lb. Micro pitting was observed where pressure plate contact brake gear (42305-224), signalling that Belleville spring was flat.

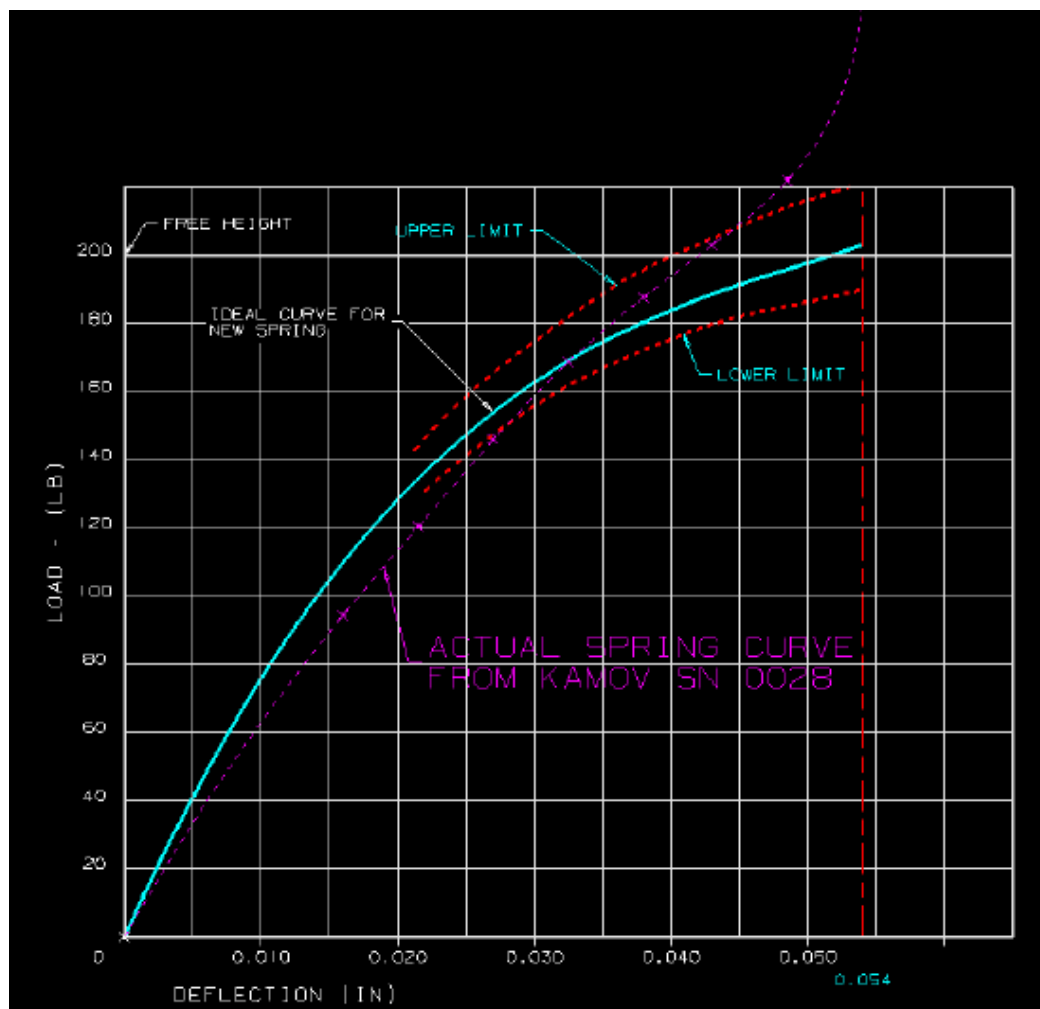
Picture Nr. 8

1st – There was an alteration of 42325-238 Belleville spring performance due continued operation under high temperatures, leading to an elasticity degradation (*picture nr. 8*);

- 2nd – That elasticity degradation allowed the discs to slide and have a relative rotation between them and pressure plate (42305-190) causing a temperature increase, which caused the Dowel pins to expand and contact the rotating brake gear (42305-224), increasing temperature even more and reducing spring (42325-228) elasticity to a minimum;
- 3rd – That lack of elasticity reduced more the system braking capacity and, when movement was reversed to allow people to enter the helicopter, cable descent couldn't be stopped;
- 4th – Trying to stop descent, reverting hoist operation, could be the cause for pinion teeth fracture;
- 5th – Men fall couldn't be avoided because spring limited elasticity was not enough to compress braking discs and stop cable movement.

According manufacturer records, since the beginning of operation (1978), never such anomaly was detected, with any in service model. Even so, considering that friction of pins on pressure plate (42305-190) against brake gear (42305-224) caused a significant temperature increase, the manufacturer recommended 42325-200 brake system model replacement by newly conceived compatible 44301-200 brake system model, which may support higher operating temperatures and be less prone to binding.
