MINISTÉRIO DA ECONOMIA E DO EMPREGO
GABINETE DE PREVENÇÃO E INVESTIGAÇÃO DE ACIDENTES COM AERONAVES
(GPIAA)

ACCIDENT FINAL REPORT

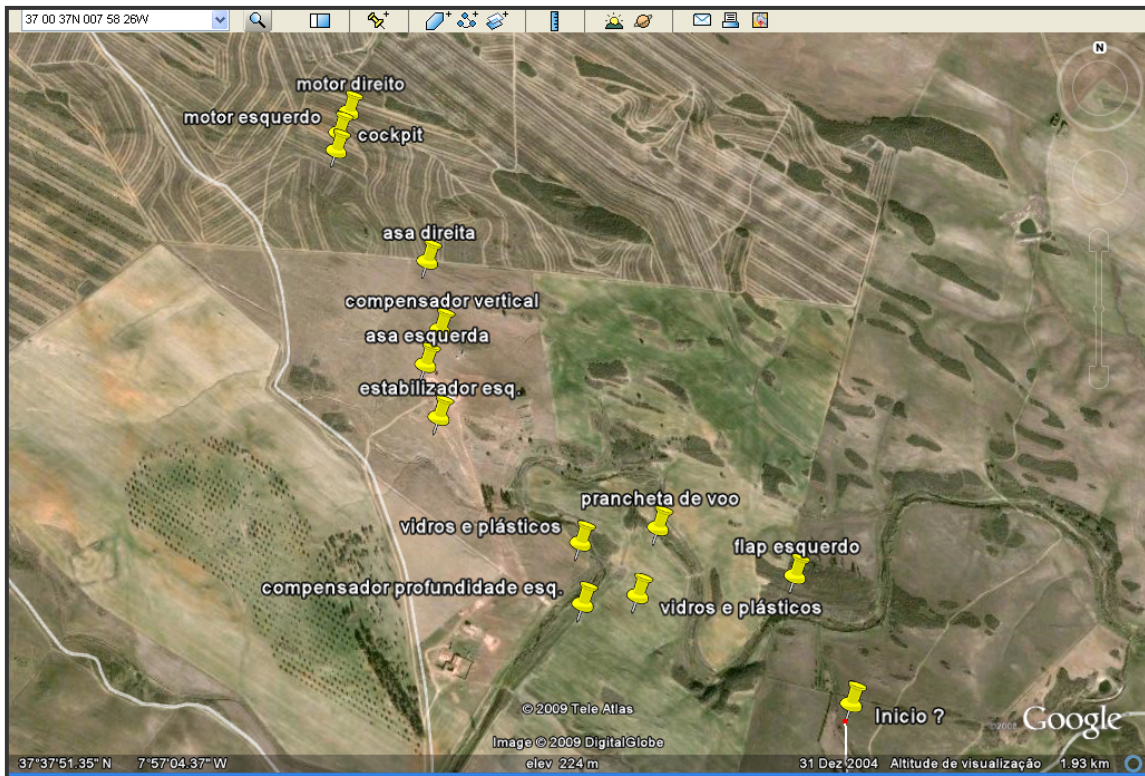
On same line of the flight as the clipboard, perpendicular to the wreckage line, several pieces of glass and plastic from canopy and from windows were found, as well.

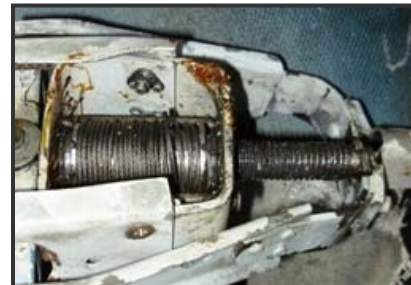
The remaining wreckage of the aircraft was sent to the Department of Aerospace Sciences at the University of Beira Interior (UBI), located in Covilhã, where it was submitted to various types of structural tests:

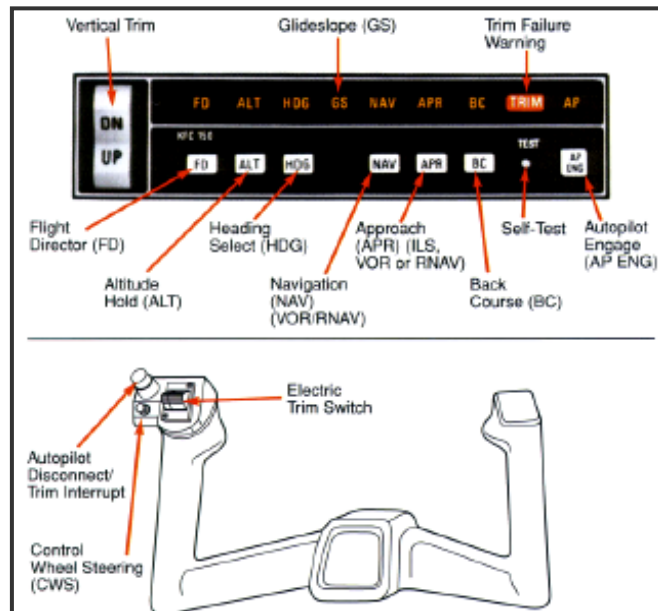
The pilot shall immediately recover the flight control, overlapping the AP action as needed, disconnect immediately the autopilot and do not reengage it before the problem has been identified and solved.

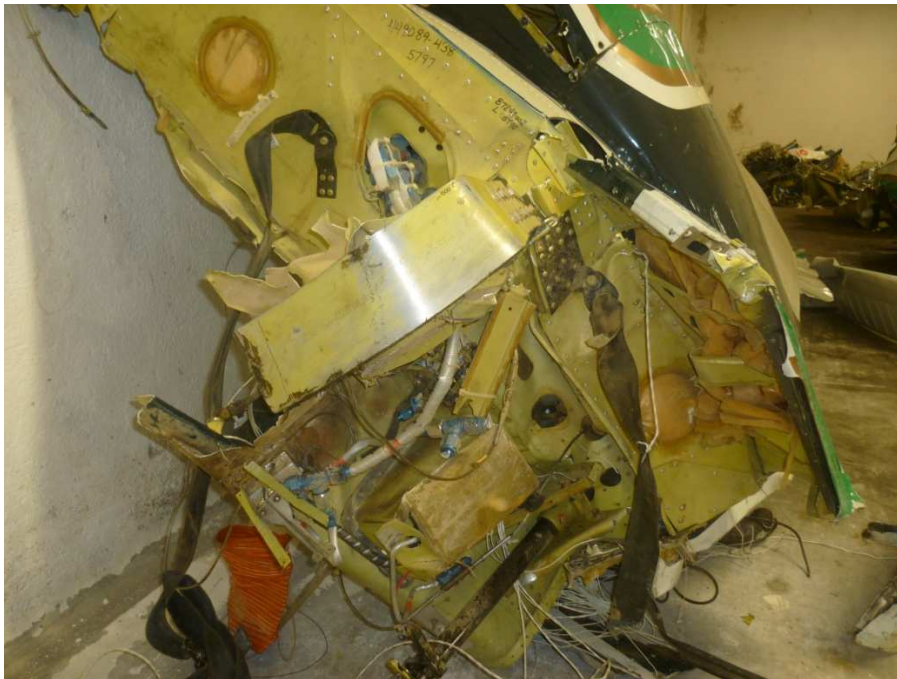
Fig. 1 – Estado de deformação da longarina principal da asa direita junto à raiz.

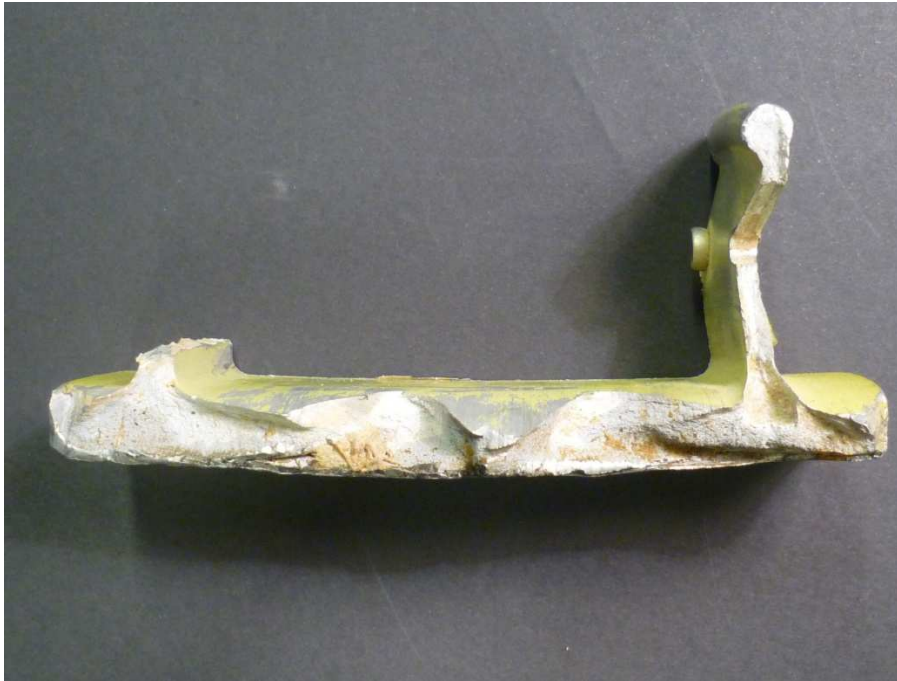
Fig. 2 – Superfície de fractura da longarina principal da asa.

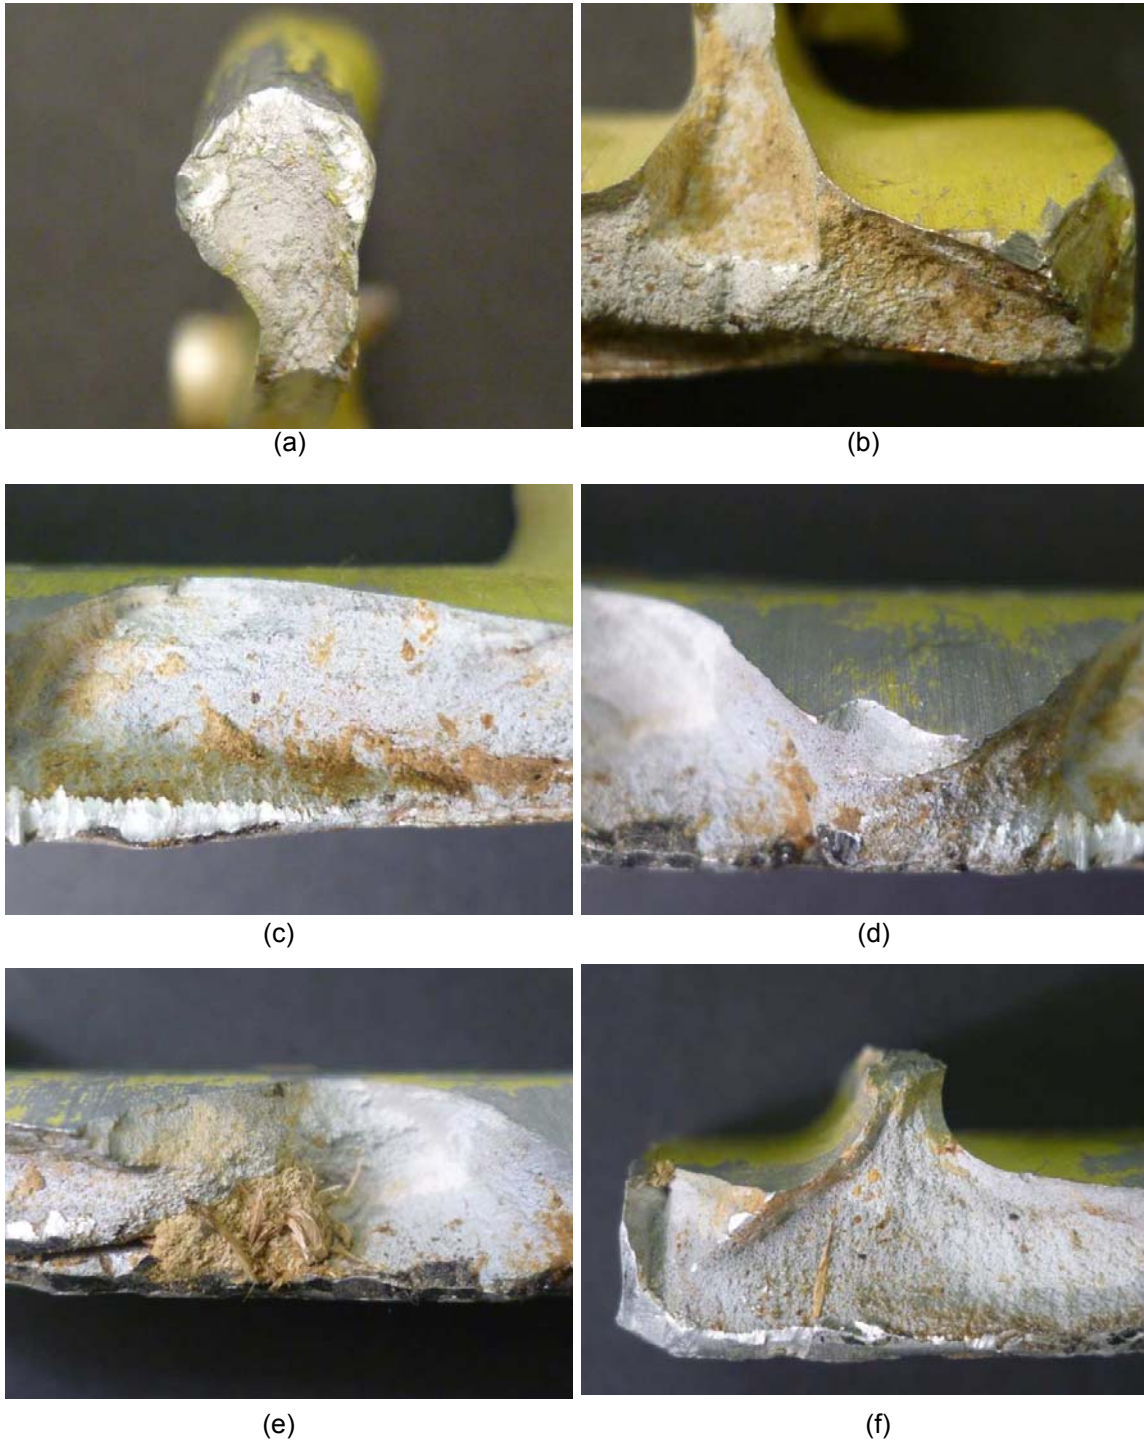
Fig. 3 – Observação detalhada da superfície de fractura da longarina da asa considerando uma divisão da mesma em 8 regiões distintas.

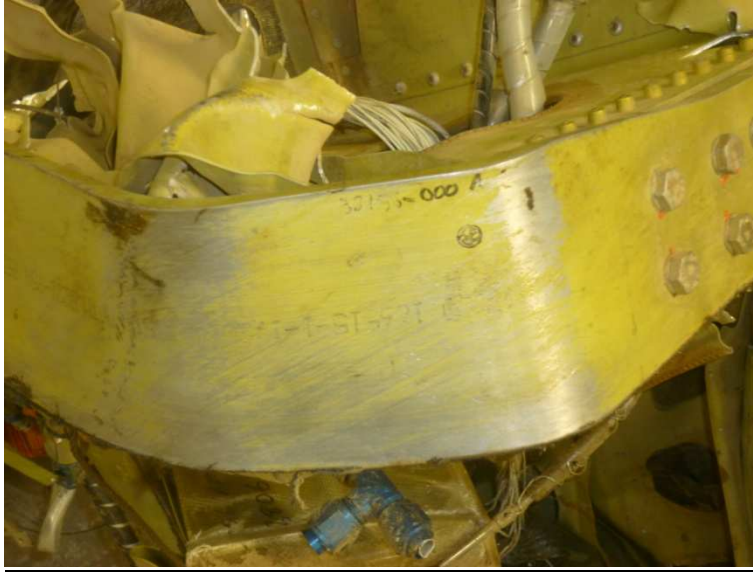
Fig. 4 – Imagem de marcas de raspagem localizadas numa das mesas da longarina principal da asa.

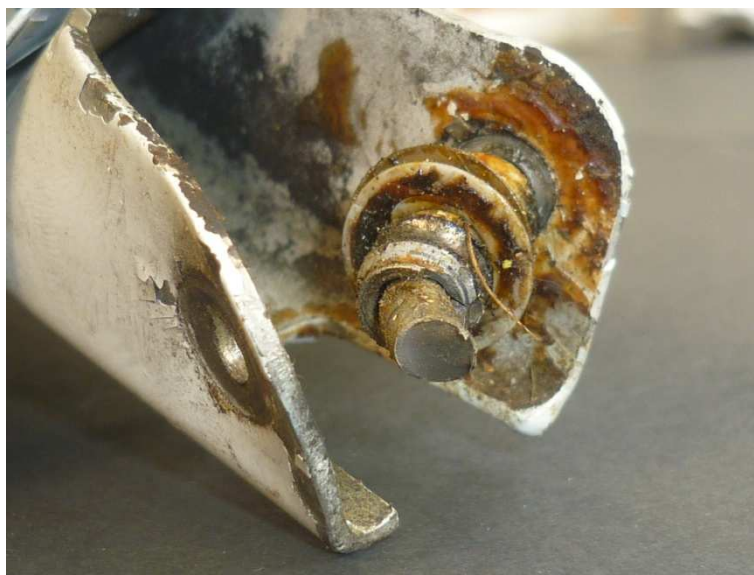
Fig. 10 – Superfície de fractura de um dos pinos de articulação do flap da asa esquerda.

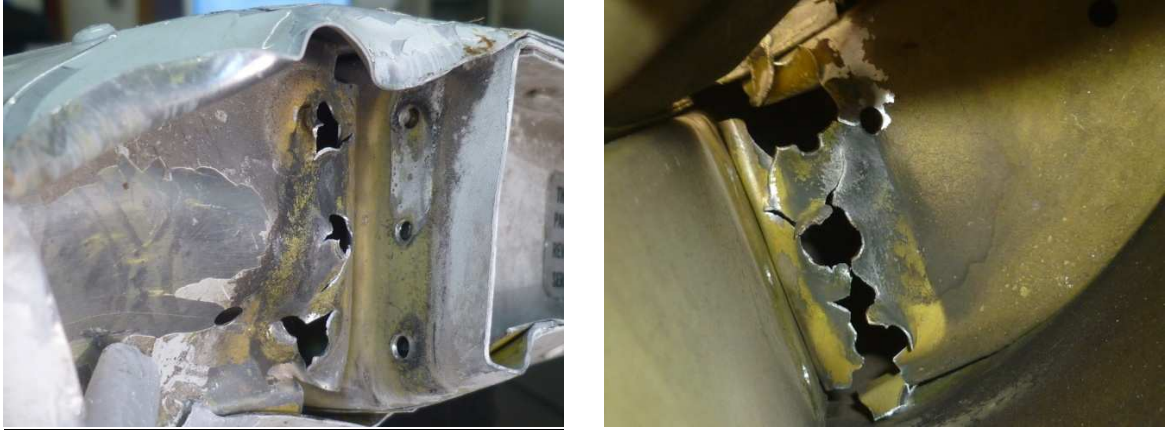
Fig. 11 – Dois exemplos de esforços de corte devido a arrancamento na vizinhança dos rebites das zonas de fixação do flap

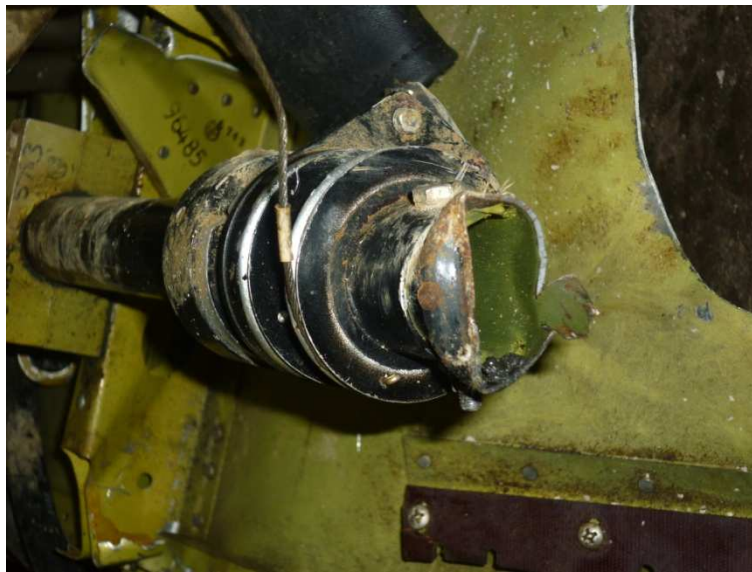
Fig. 15 – Deformação do tudo de accionamento dos flaps na zona de fractura.

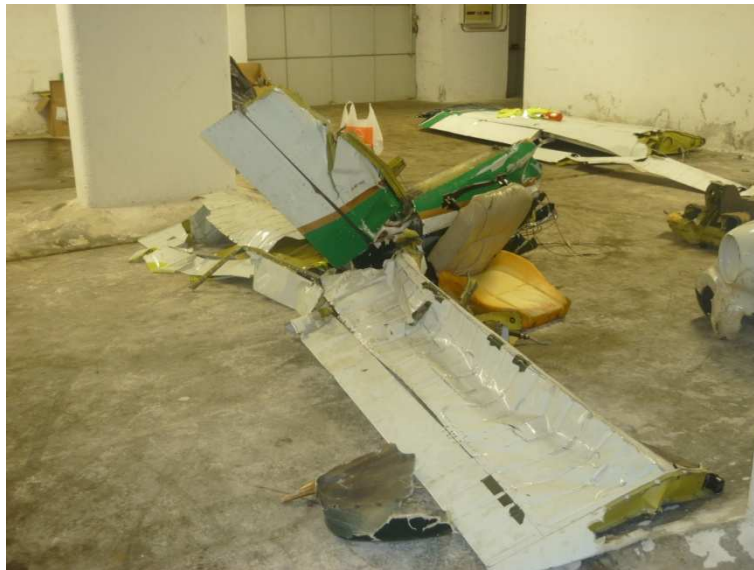
Fig. 16 - Estado geral de deformação da cauda da aeronave (leme de profundidade, leme de direcção e estabilizador vertical).

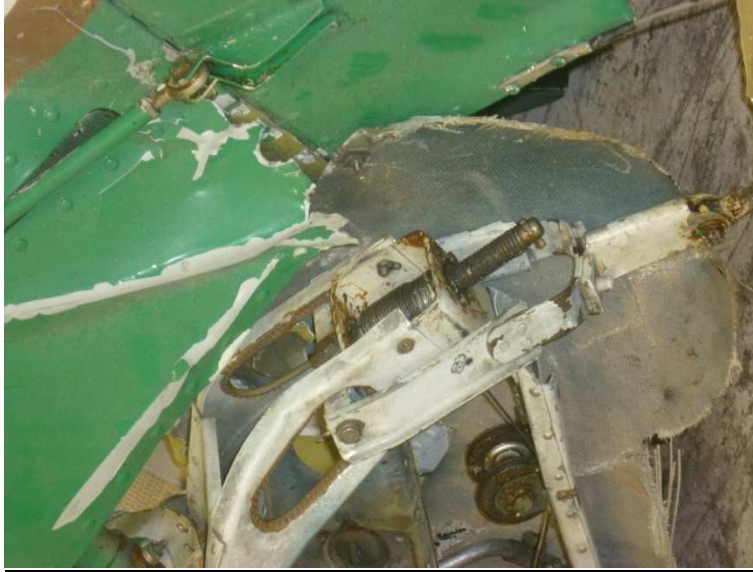
Fig. 19 – Pormenor relativo à posição do actuador do compensador do leme de profundidade.

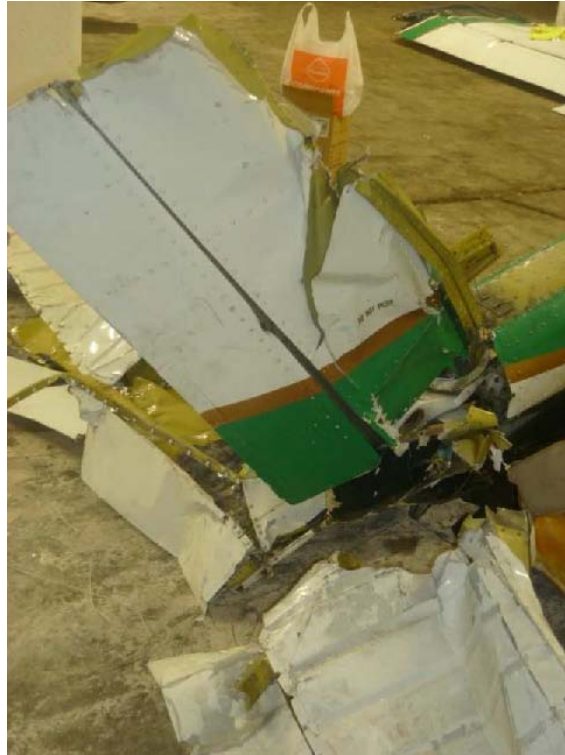
Fig. 20 – Imagem da empenagem vertical (leme de direcção e compensador).

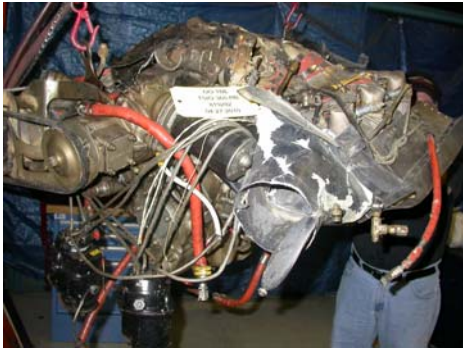
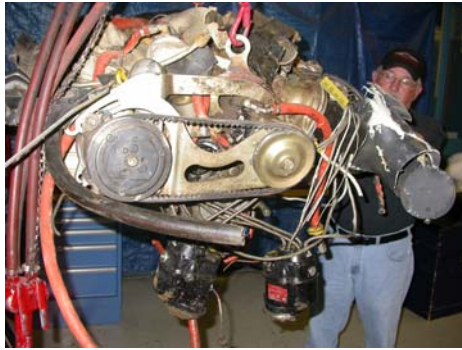
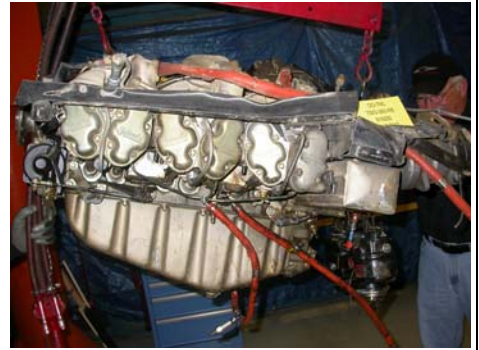
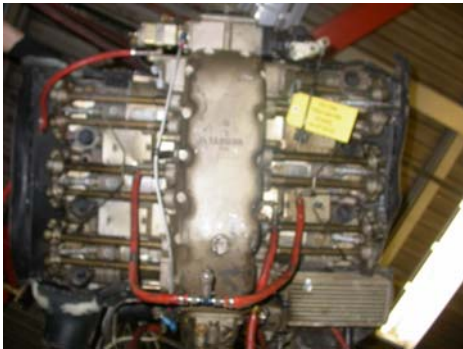
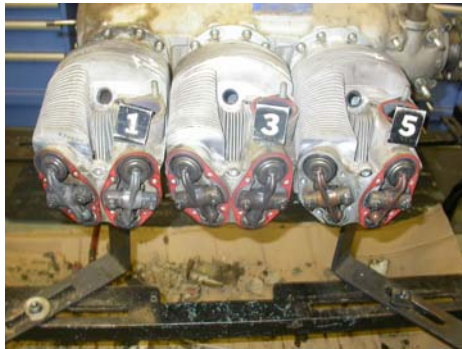
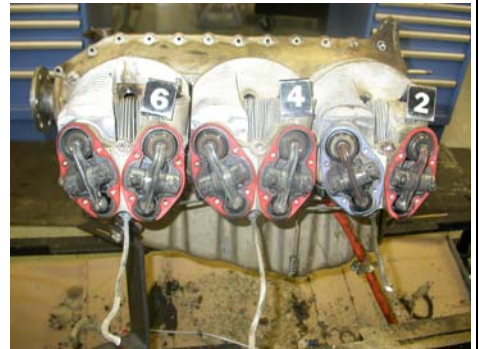
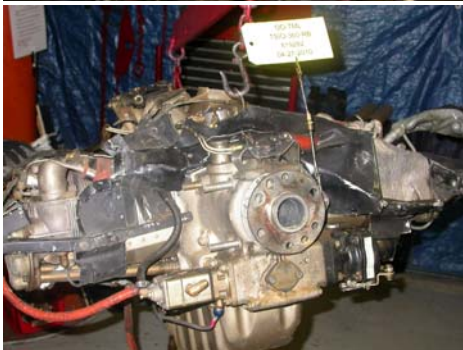
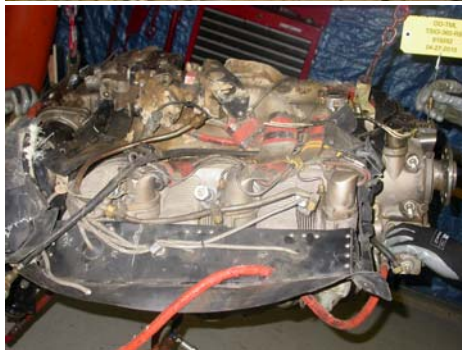
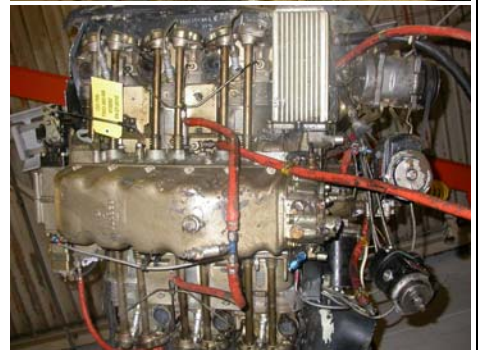
AIRFRAME PARTS RETURNED WITH ENGINE: Portions of control cables, air conditioning compressor, cooling baffles, propeller governor, de-ice block, fuel lines, and miscellaneous hoses and wiring.

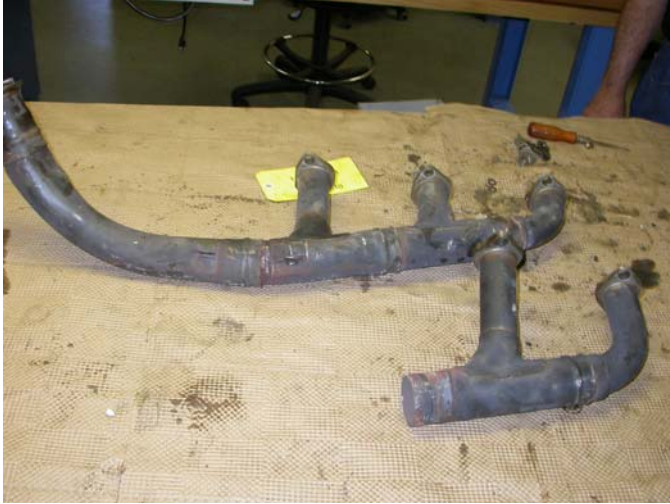
Condition: The exhaust system components were already disassembled and exhibited impact damage.

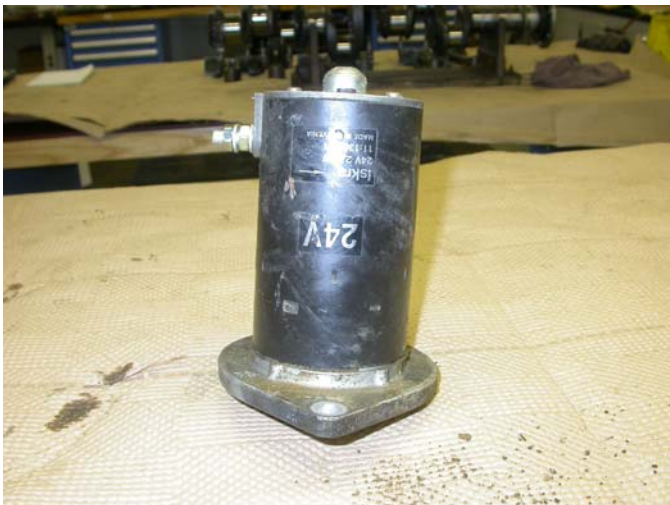
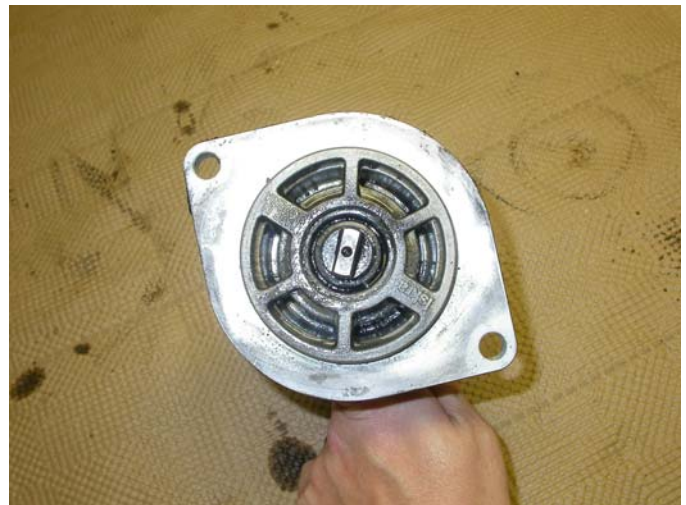
| Date | Engine Model | Engine Serial No. | Aircraft Registration | Page |

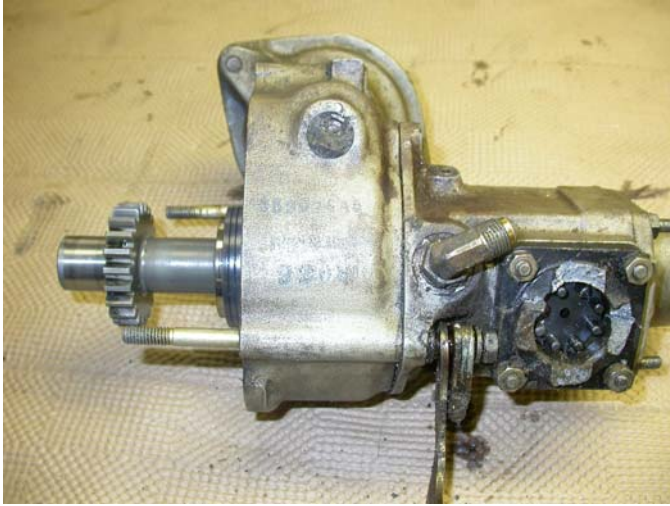
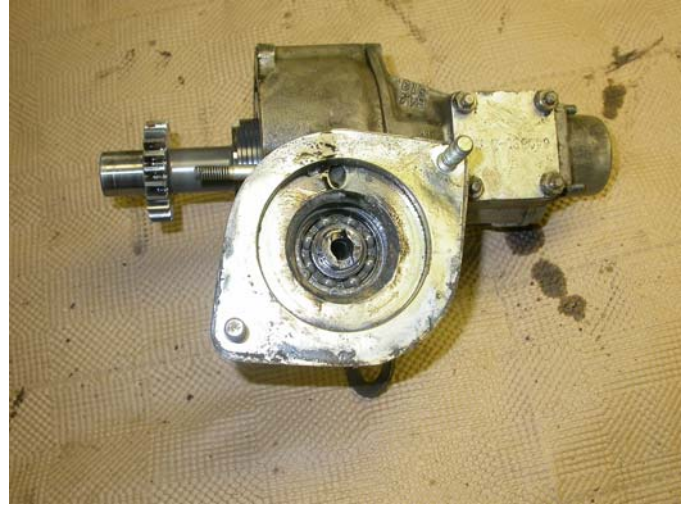
Crankshaft to Camshaft Timing

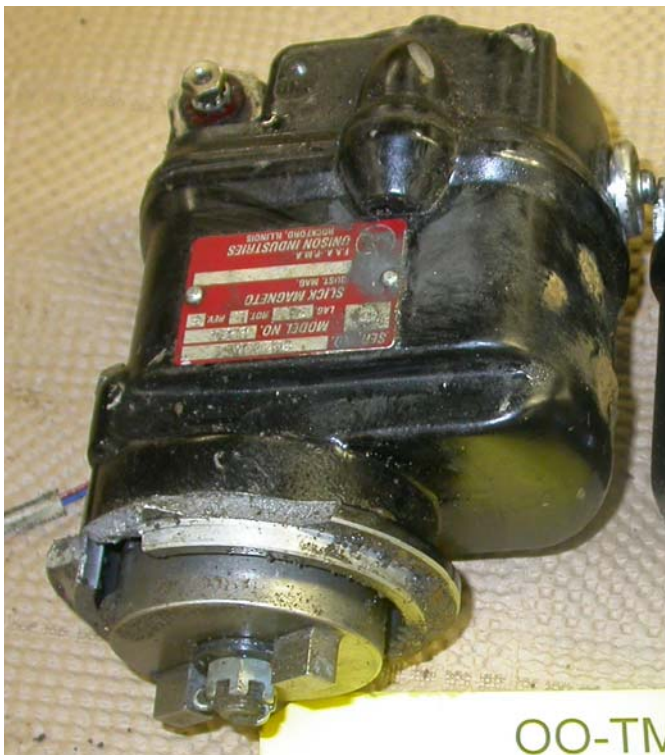
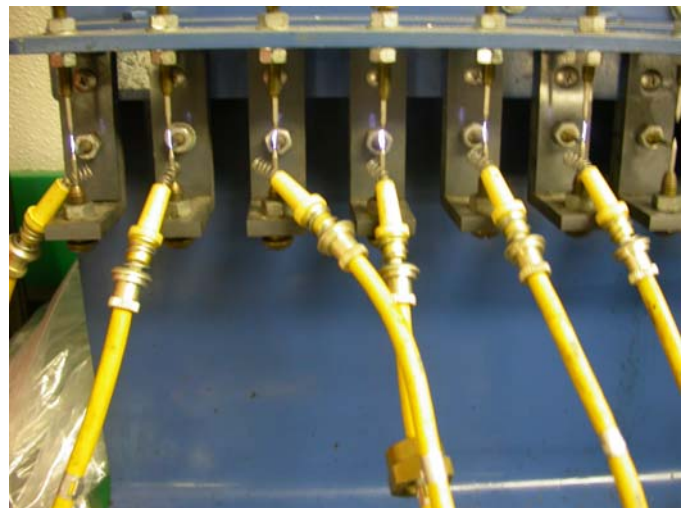
| Date | Engine Model | Engine Serial No. | Aircraft Registration | Page |

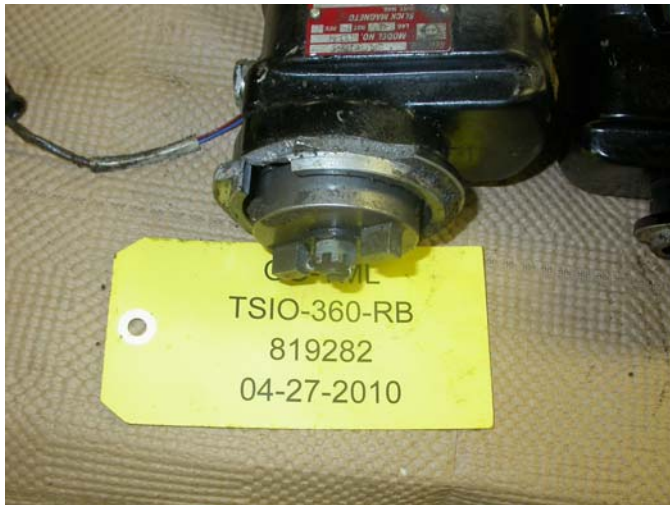
Condition: The right-hand magneto would not rotate. It was disassembled and the points were impact damaged. The magneto also had impact damage on the mounting flange.

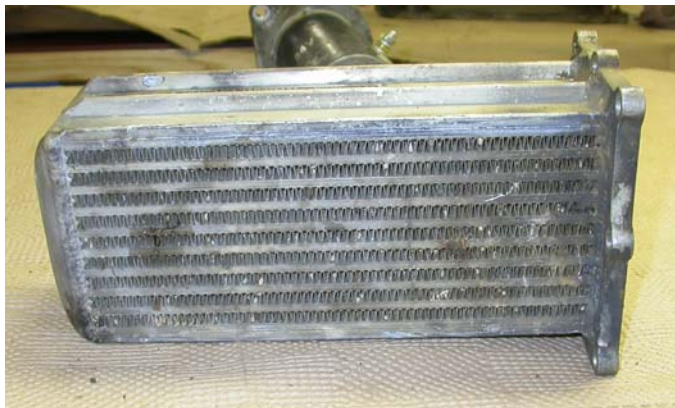
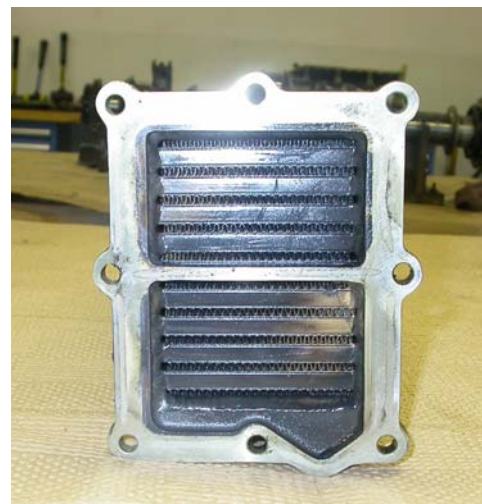
| Date | Engine Model | Engine Serial No. | Aircraft Registration | Page |

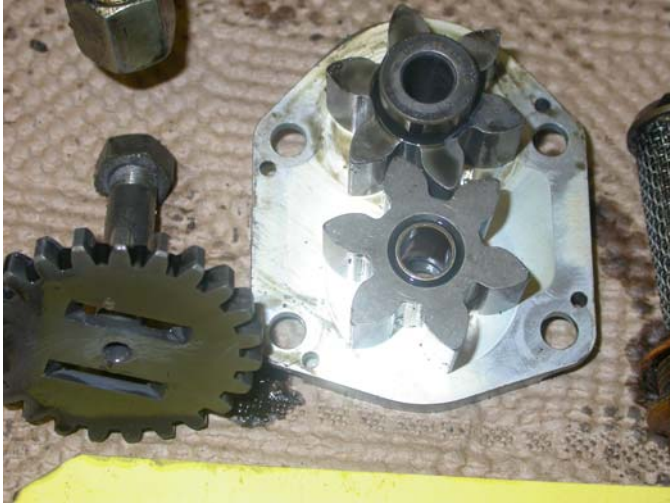
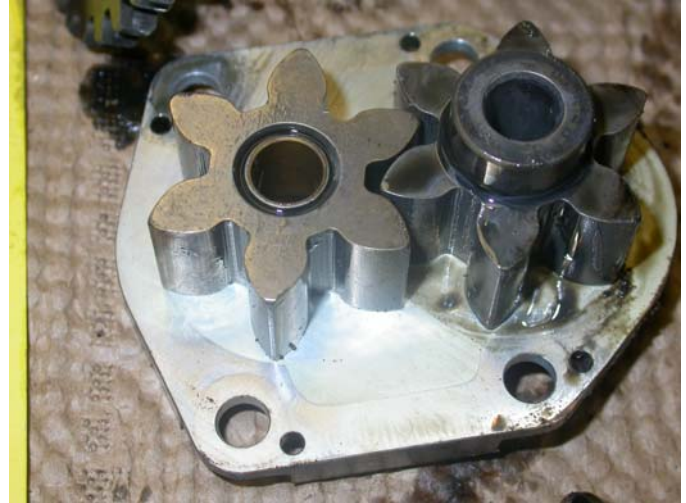
Oil Filter / Screen Manufacturer: Champion

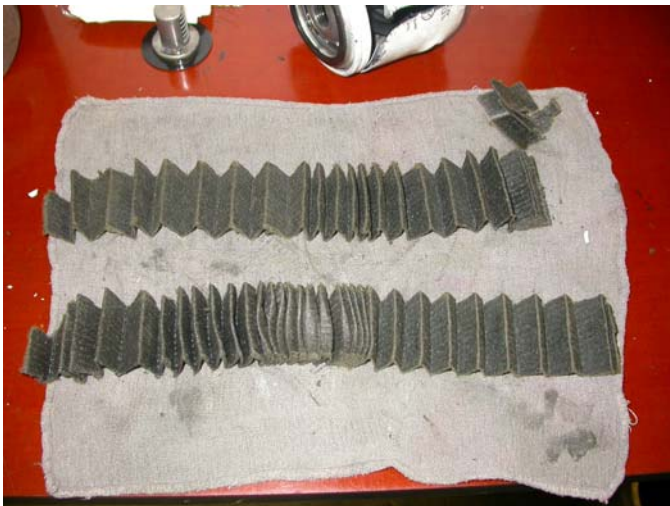
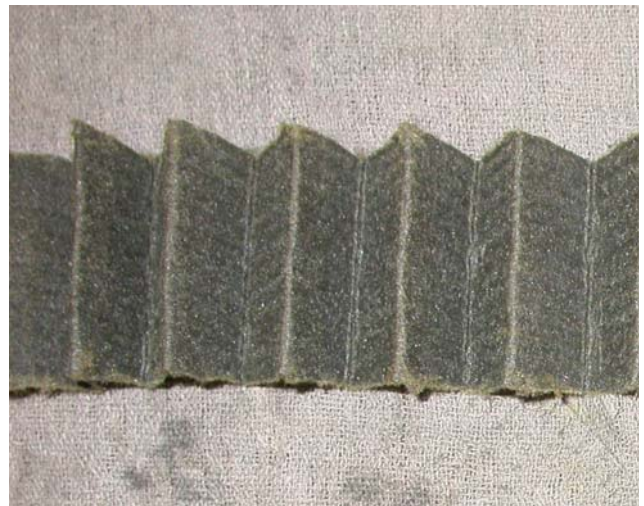
| Date | Engine Model | Engine Serial No. | Aircraft Registration | Page |

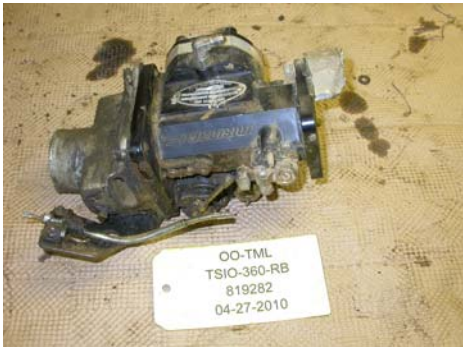
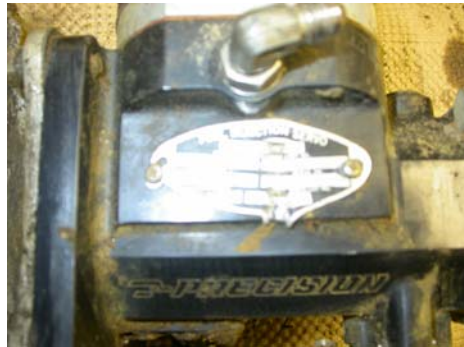
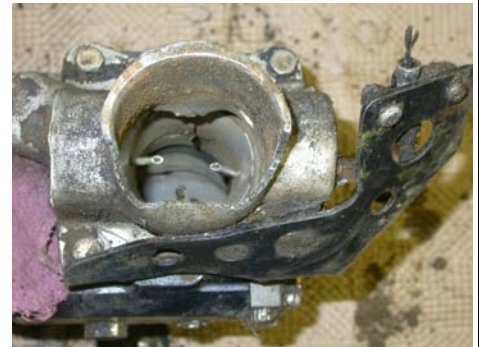
Fuel Pump Manufacturer: TCM Part Number: 654351-4A1 Serial #: B07EA052R

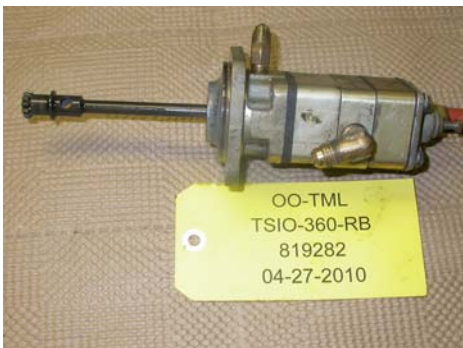
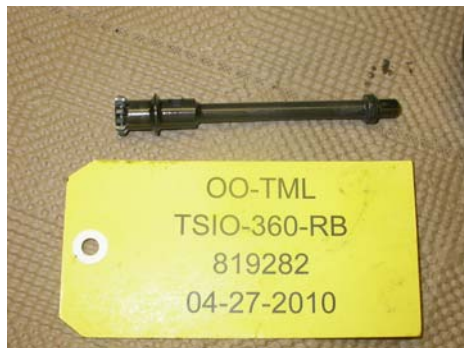
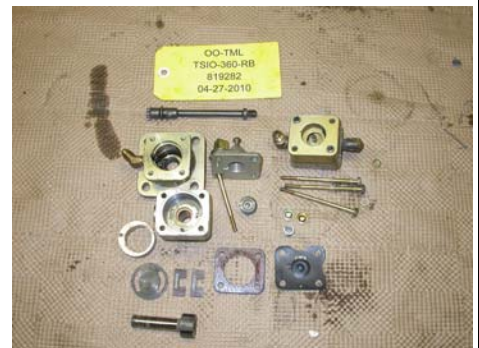
| Date | Engine Model | Engine Serial No. | Aircraft Registration | Page |

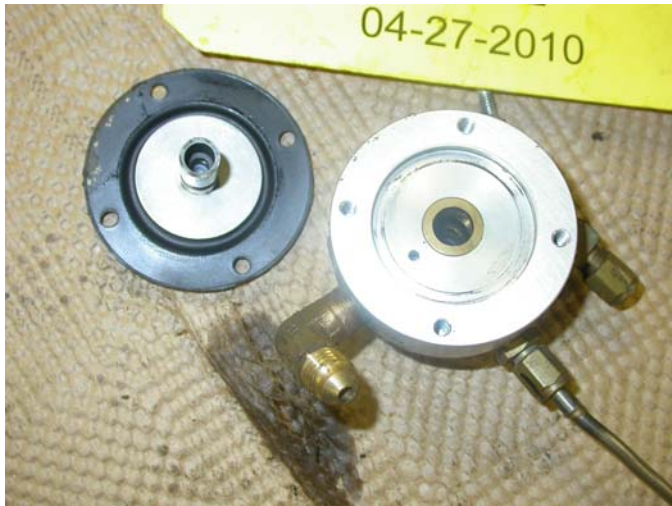
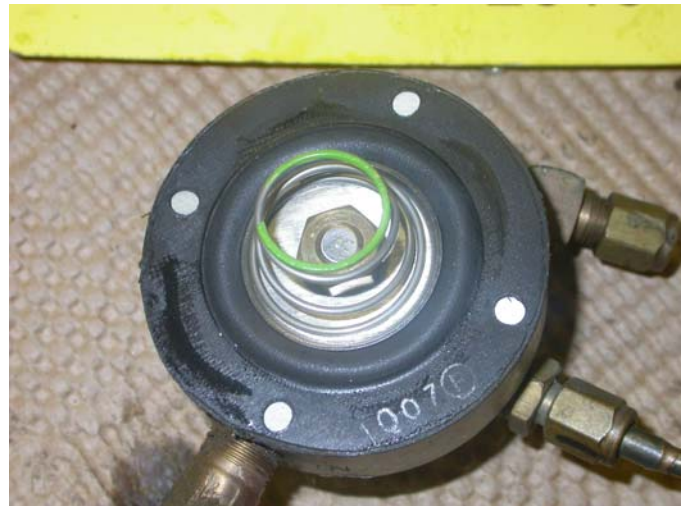
Fuel Nozzles and Lines Manufacturer: TCM

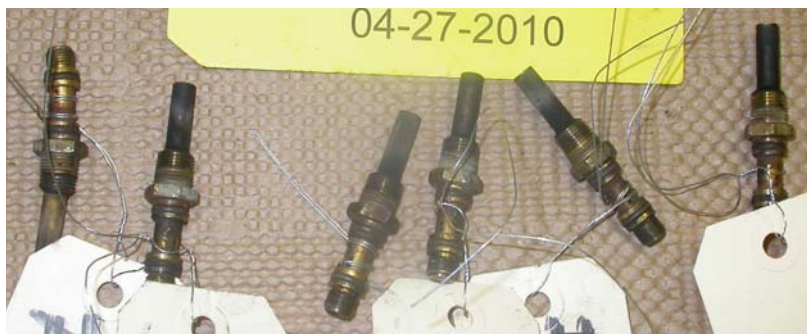
| Date | Engine Model | Engine Serial No. | Aircraft Registration | Page |

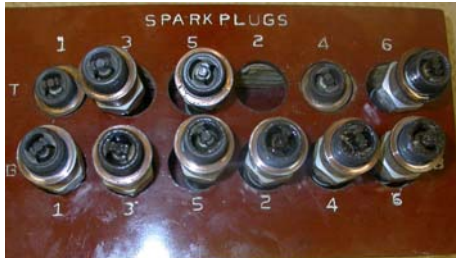
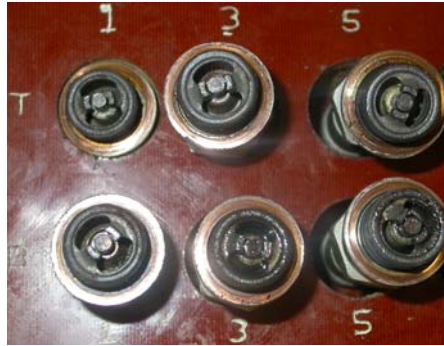
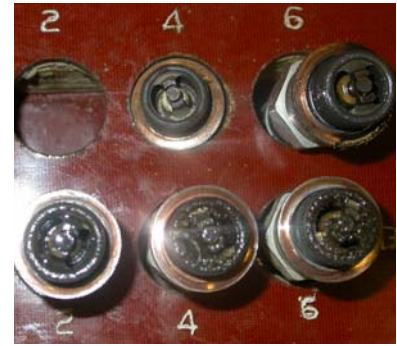
Alternator Manufacturer: N/A Part Number: N/A Serial #: N/A

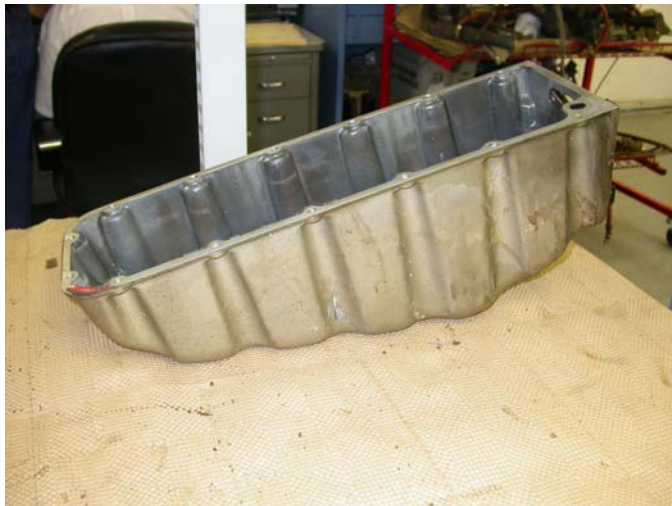
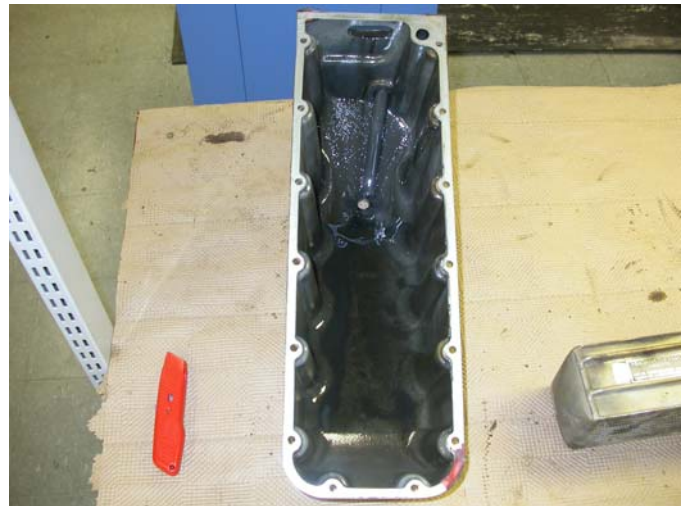
Oil Pick-up Tube & Screen Condition: The oil pick-up tube was undamaged. The oil suction screen was unrestricted.

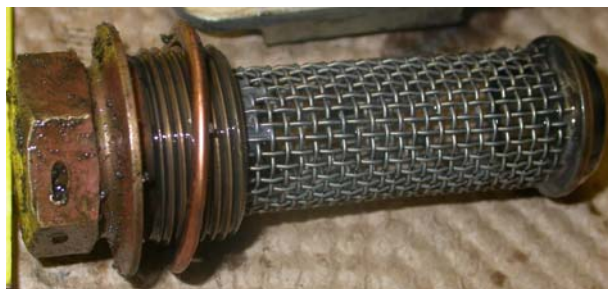
| Date | Engine Model | Engine Serial No. | Aircraft Registration | Page |

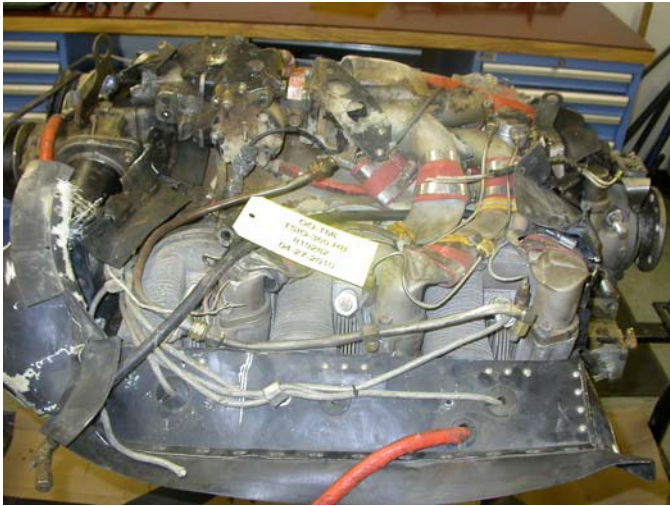
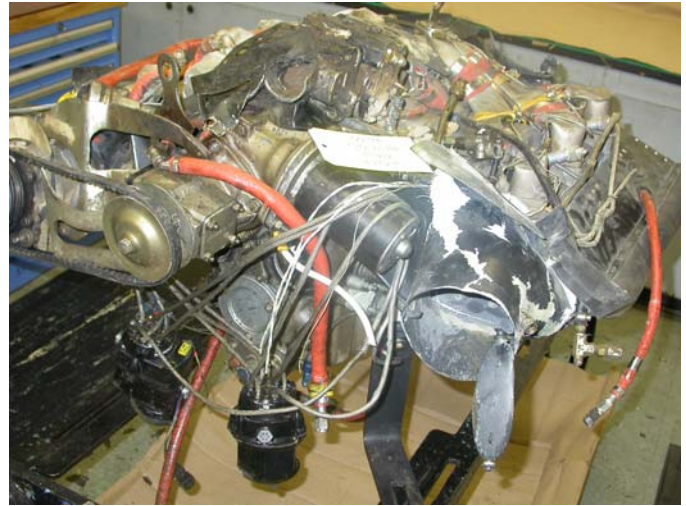
Condition: The induction system had heavy impact damage and was mostly crushed.

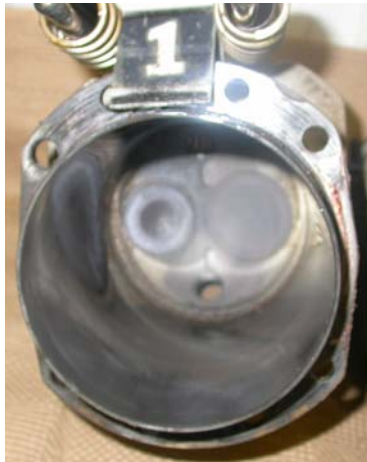
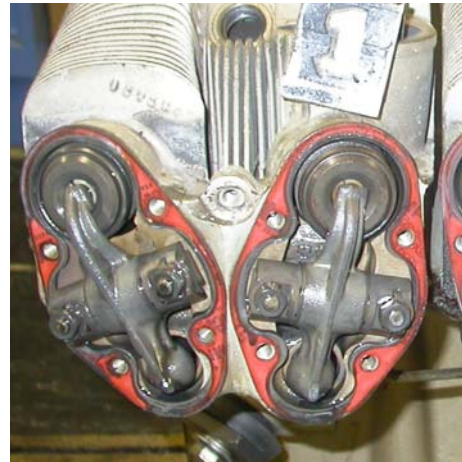
Cylinder #2 Part Number: 655479A11 Head Date: 3/07 Barrel Surface: Steel
Serial #: AC07BB108 Work Order Numbers: None

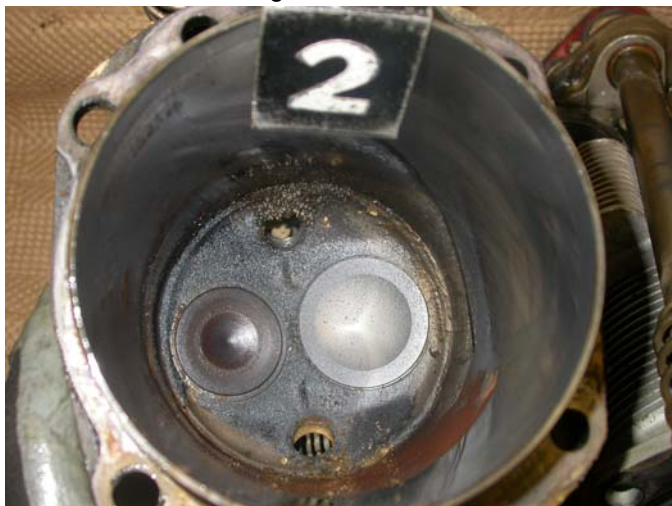
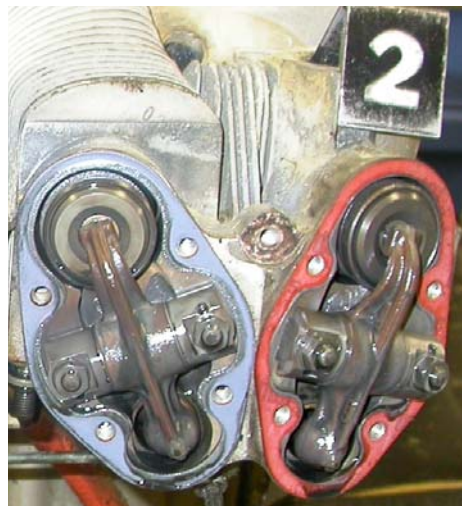
| Date | Engine Model | Engine Serial No. | Aircraft Registration | Page |

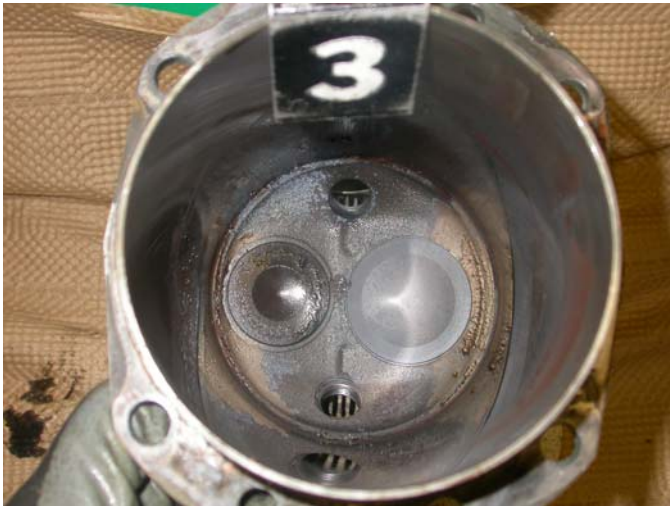
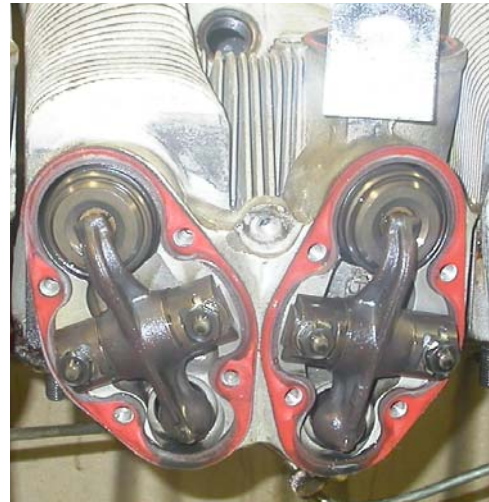
Cylinder #4 Part Number: 655479A11 Head Date: 3/07 Barrel Surface: Steel
 Serial #: AC07BB089 Work Order Numbers: None

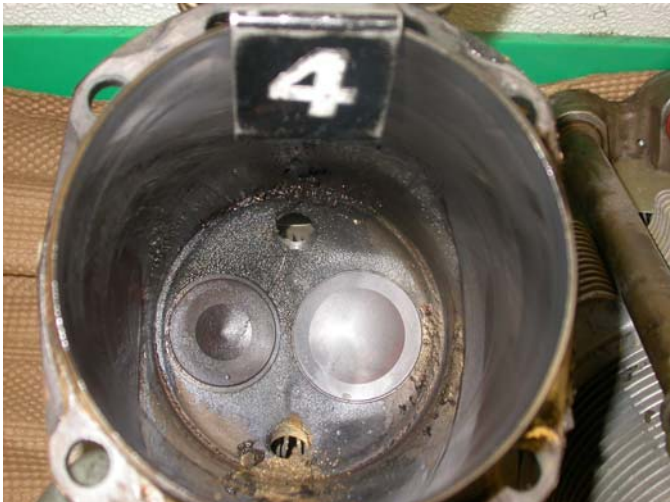
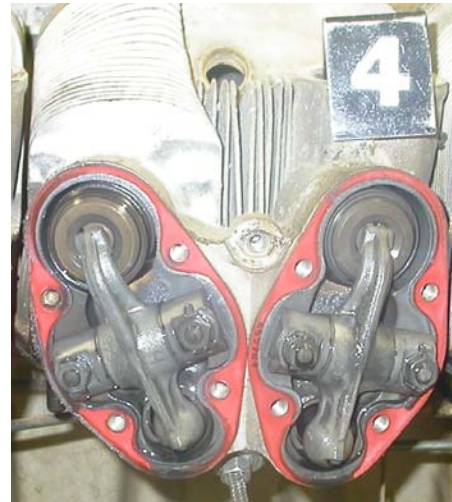
| Date | Engine Model | Engine Serial No. | Aircraft Registration | Page |

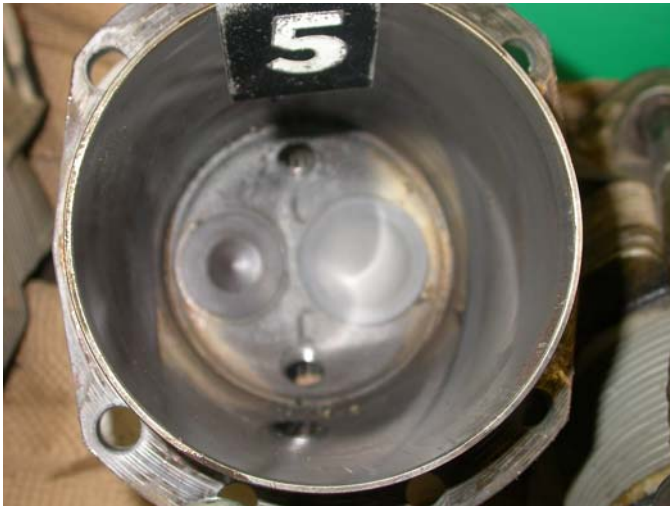
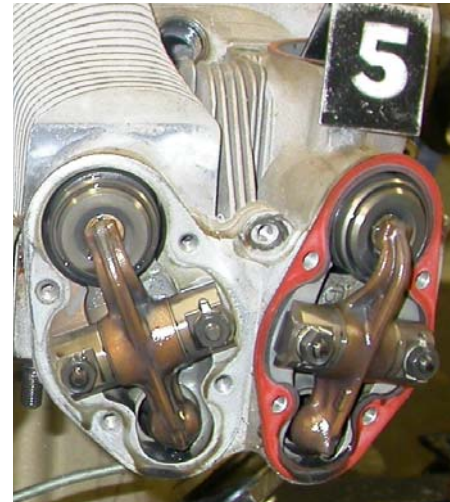
Cylinder #6 Part Number: 655479A11 Head Date: 4/07 Barrel Surface: Steel
 Serial #: AC07CB942 Work Order Numbers: None

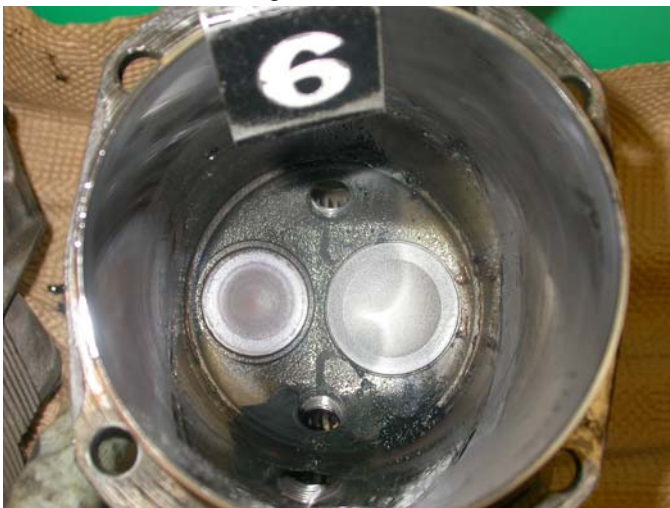
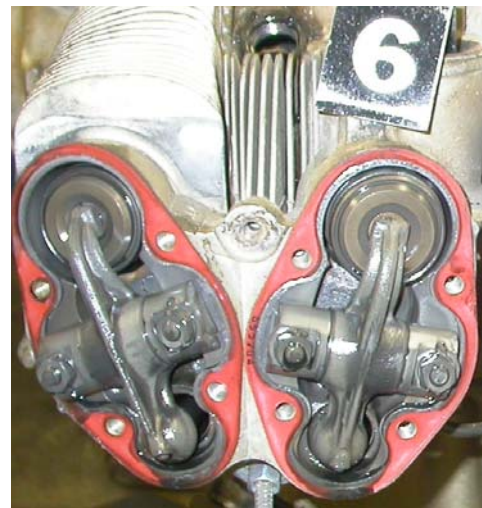
| Date | Engine Model | Engine Serial No. | Aircraft Registration | Page |

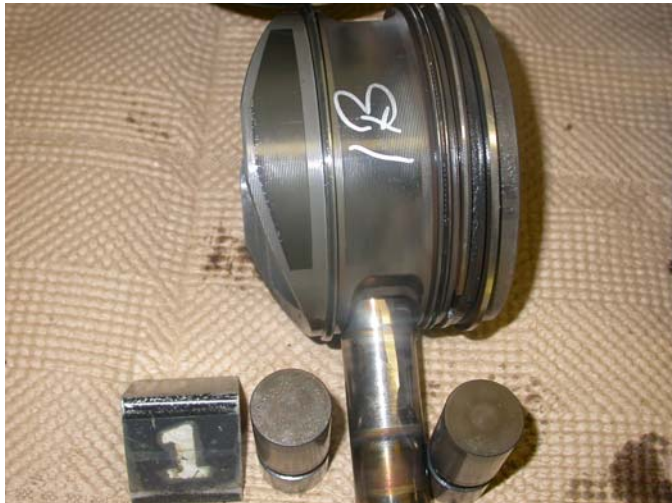
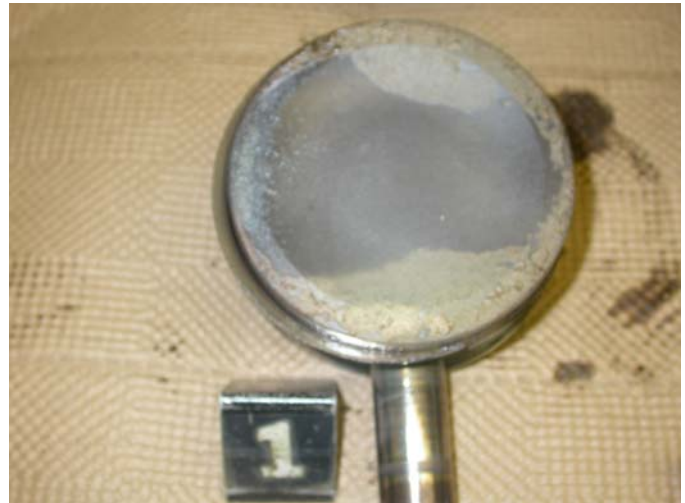
#2 Piston, Rings and Pin Piston Part Number: 654859

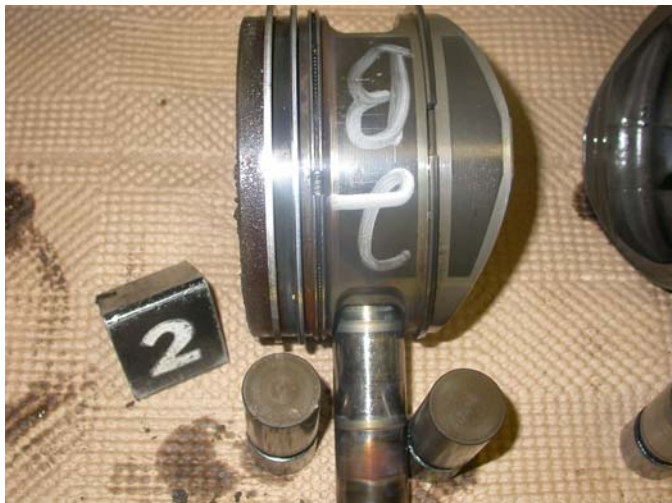
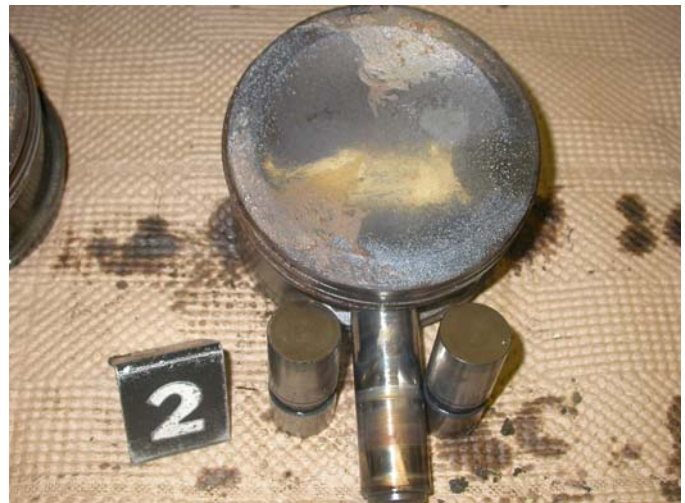
| Date | Engine Model | Engine Serial No. | Aircraft Registration | Page |
