MINISTÉRIO DA ECONOMIA E DO EMPREGO
GABINETE DE PREVENÇÃO E INVESTIGAÇÃO DE ACIDENTES COM AERONAVES
(GPIAA)

ACCIDENT FINAL REPORT

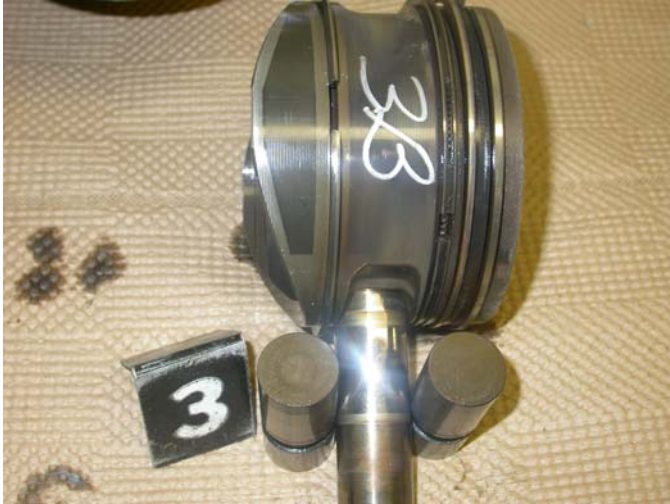
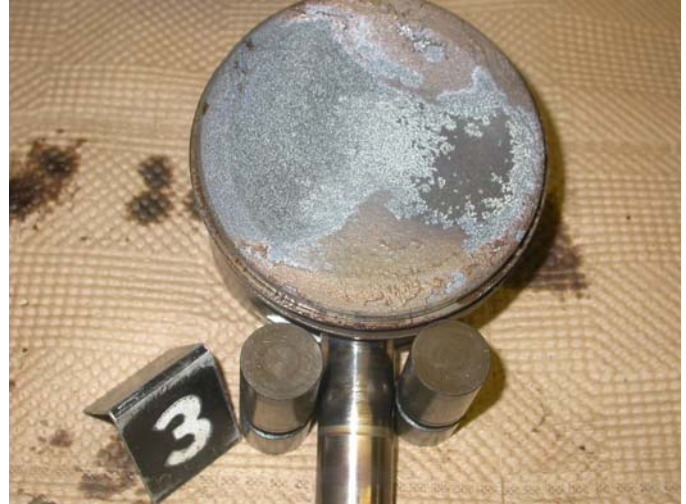
#4 Piston, Rings and Pin Piston Part Number: 654859

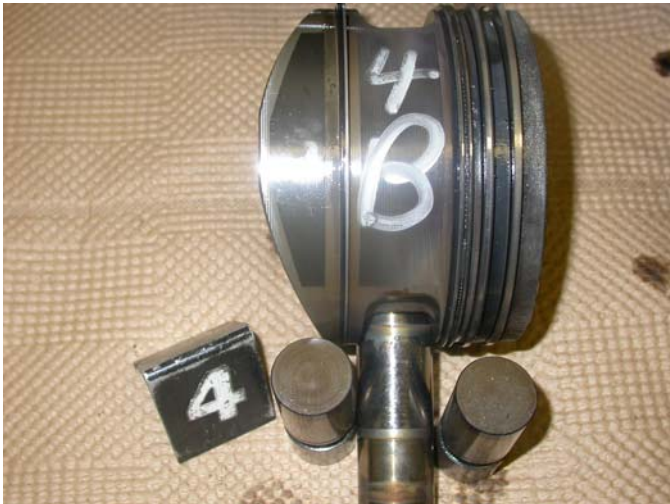
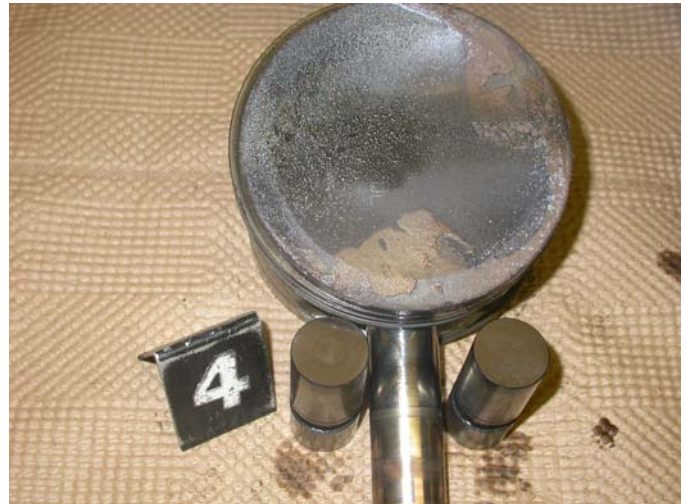
| Date | Engine Model | Engine Serial No. | Aircraft Registration | Page |

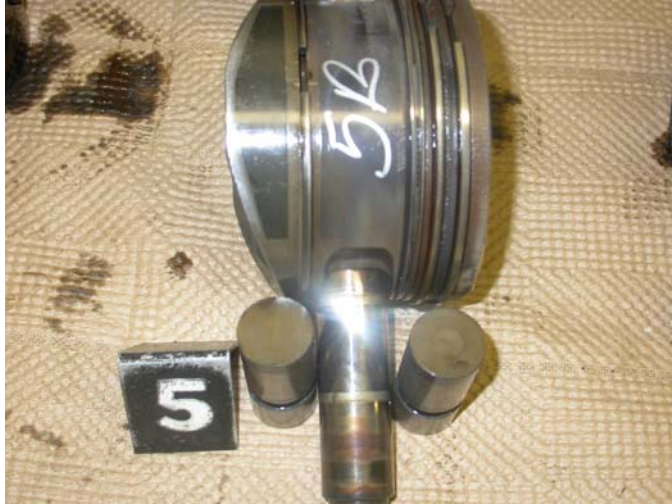
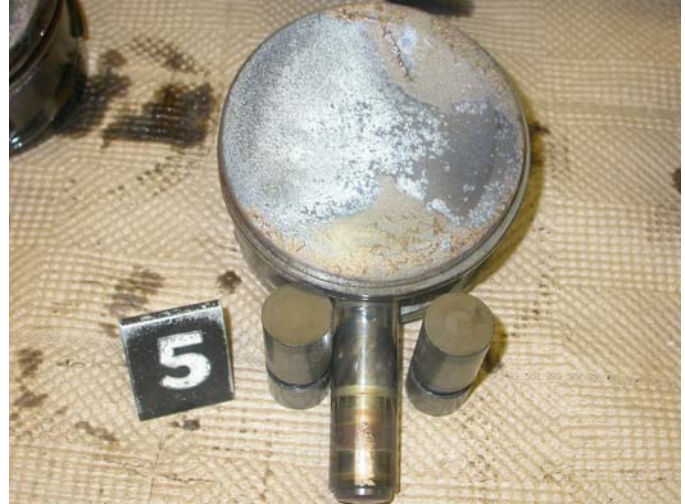
#6 Piston, Rings and Pin Piston Part Number: 654859

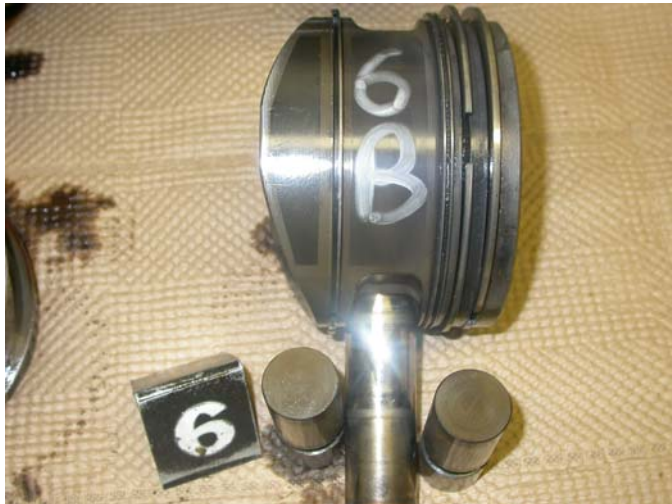
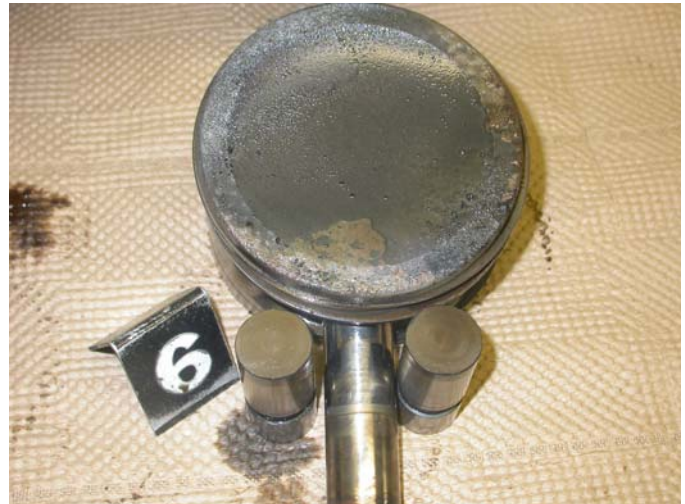
| Lifter | #1 | #3 | #5 | #2 | #4 | #6 |

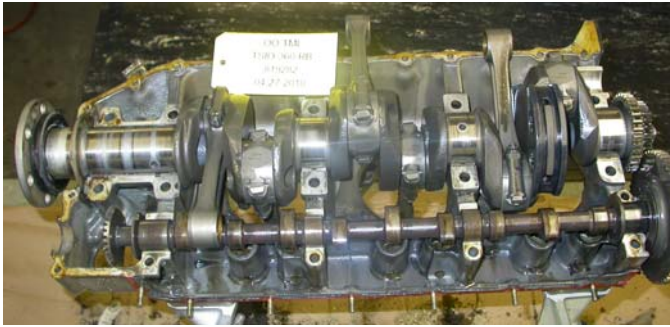
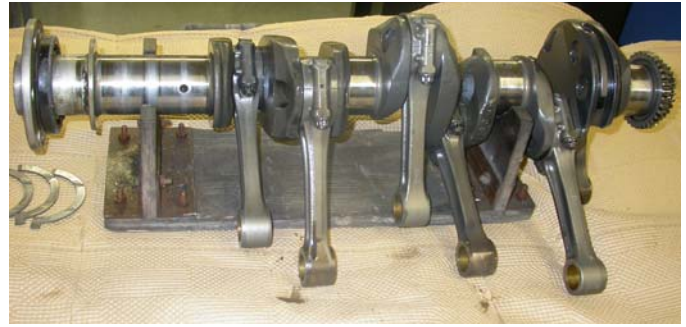
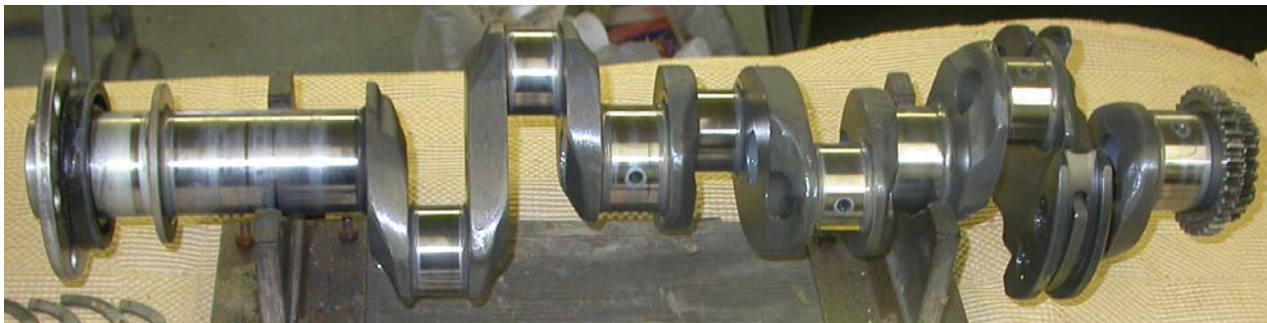
#1 Main Bearings Part #: 642337 Date Code: 02/07

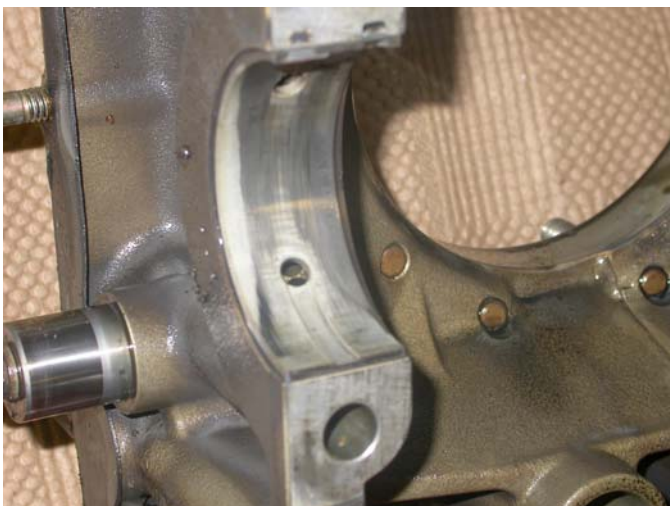
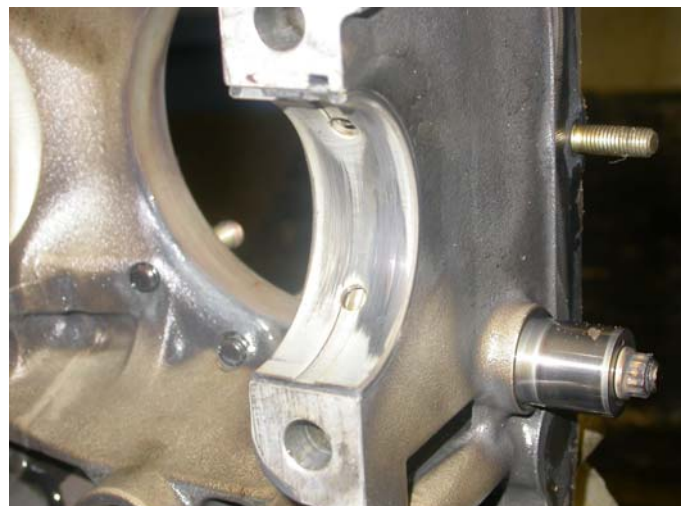
| Date | Engine Model | Engine Serial No. | Aircraft Registration | Page |

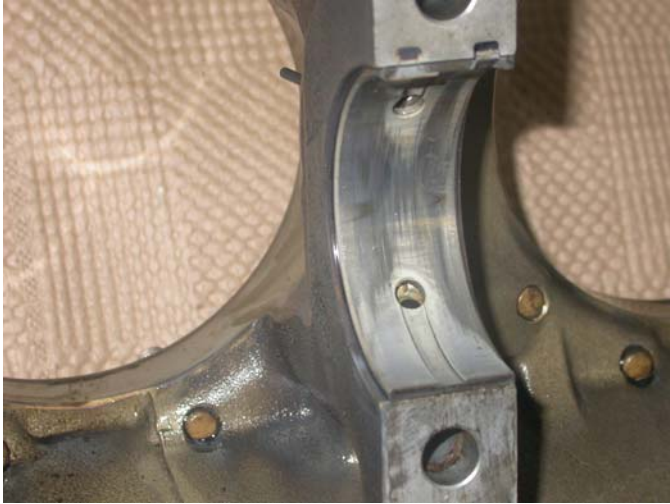
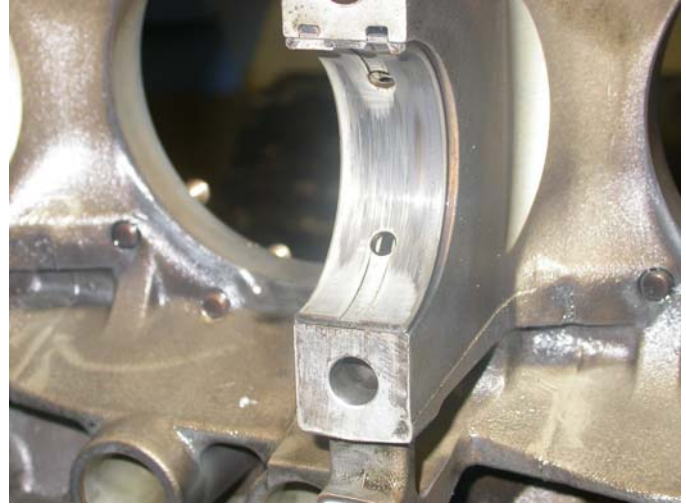
Condition The #2 (intermediate) crankshaft main bearings exhibited normal operating and lubrication signatures. The bearings were intact and exhibited an insignificant amount of contamination and hard particle passage. There were no signs of lubrication distress.

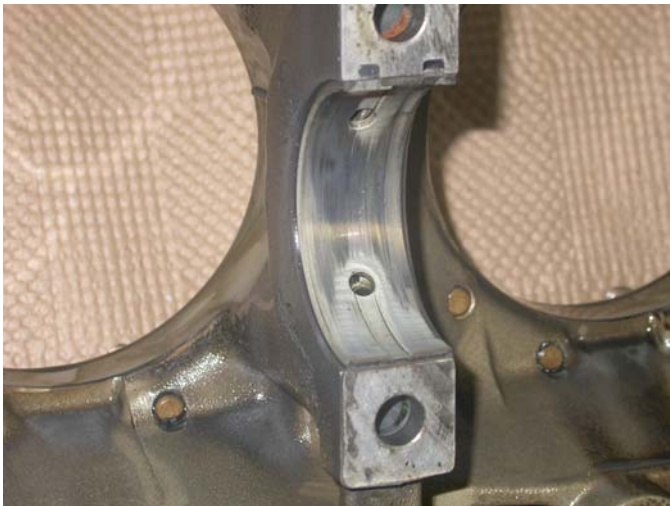
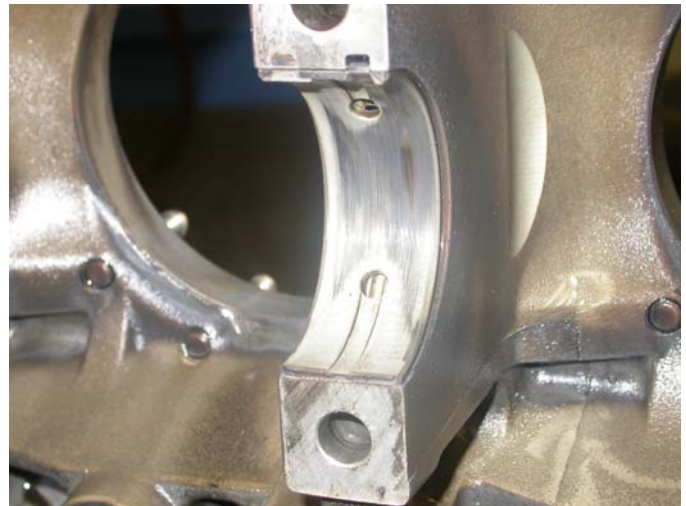
| Date | Engine Model | Engine Serial No. | Aircraft Registration | Page |

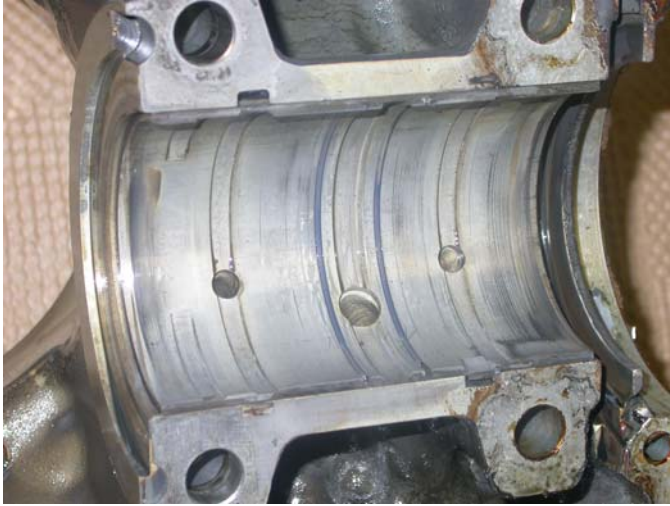
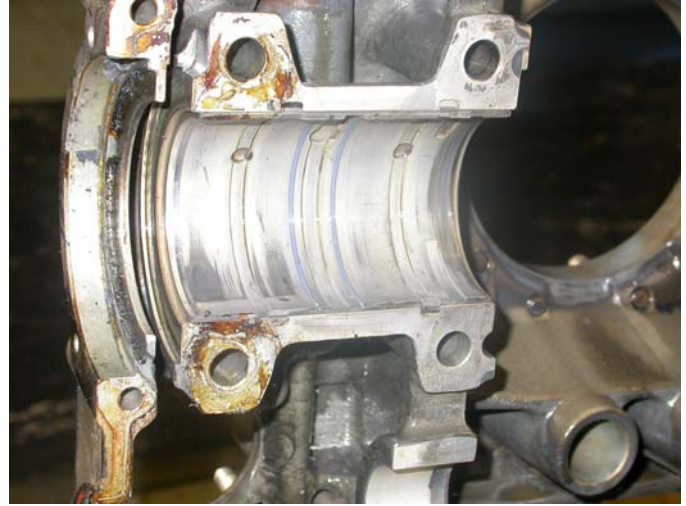
| Date | Engine Model | Engine Serial No. | Aircraft Registration | Page |

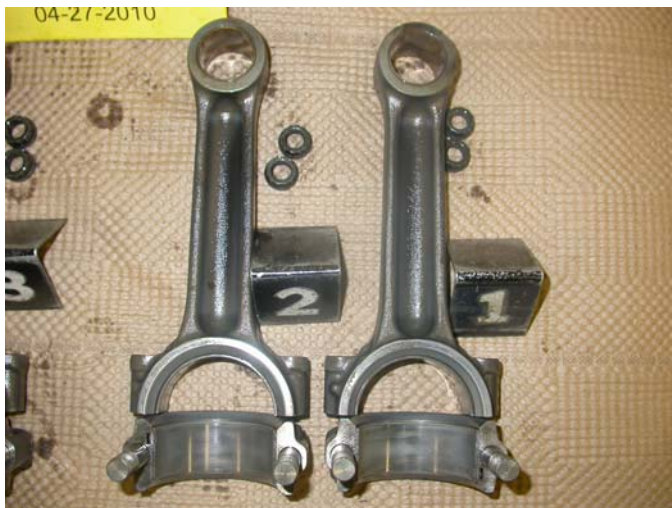
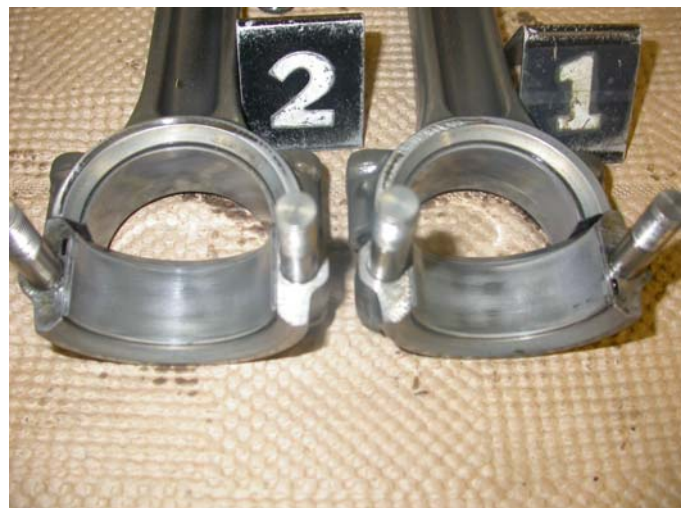
| Date | Engine Model | Engine Serial No. | Aircraft Registration | Page |

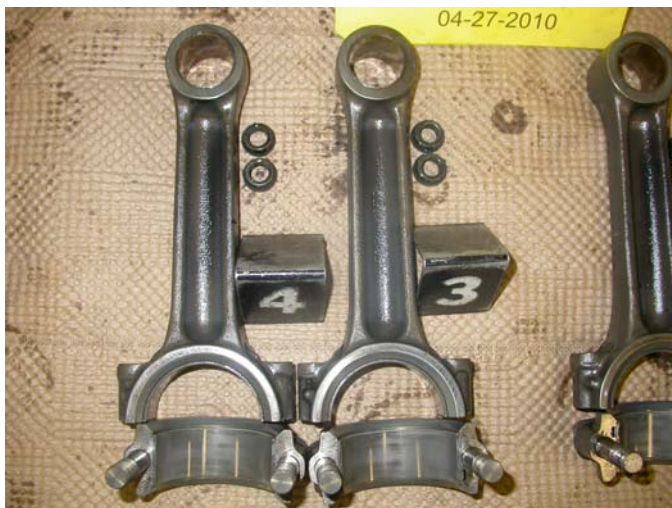
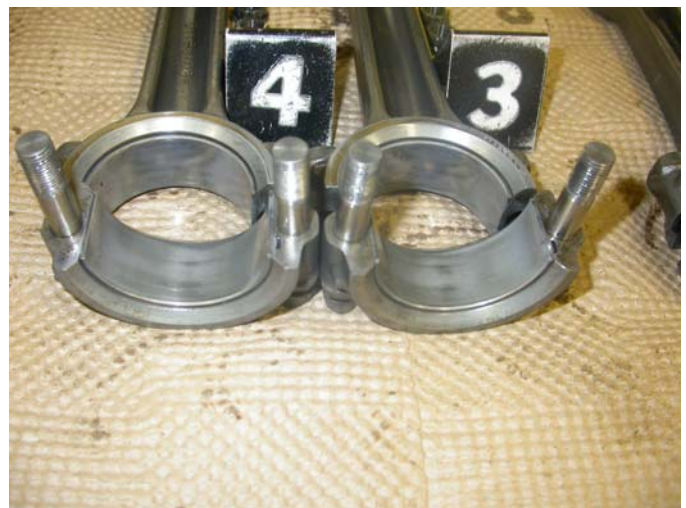
| Date | Engine Model | Engine Serial No. | Aircraft Registration | Page |

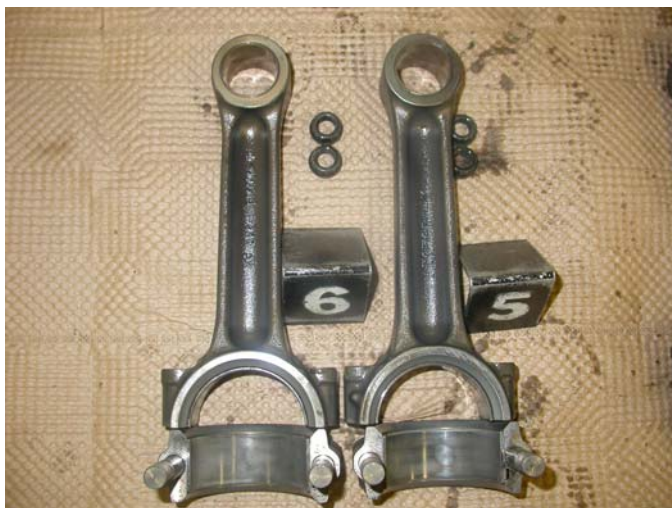
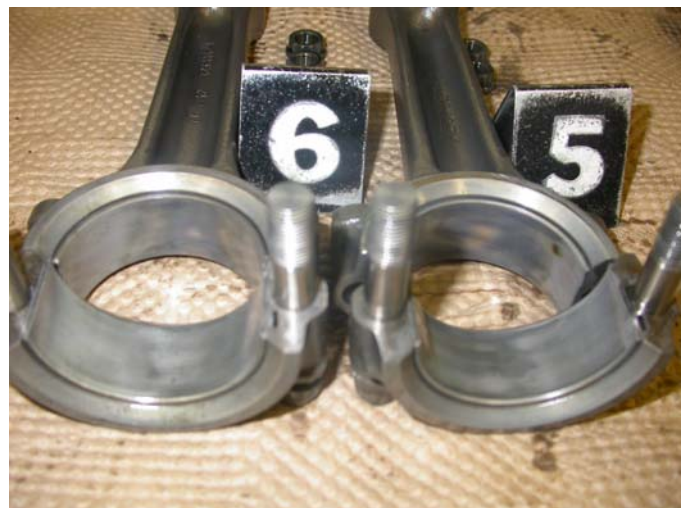
| Date | Engine Model | Engine Serial No. | Aircraft Registration | Page |

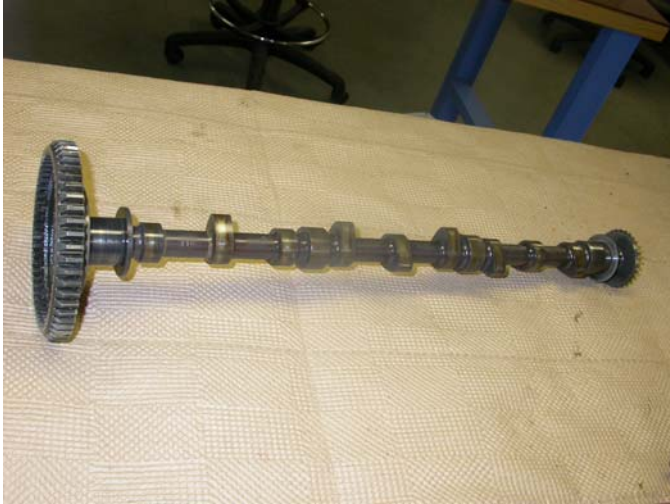
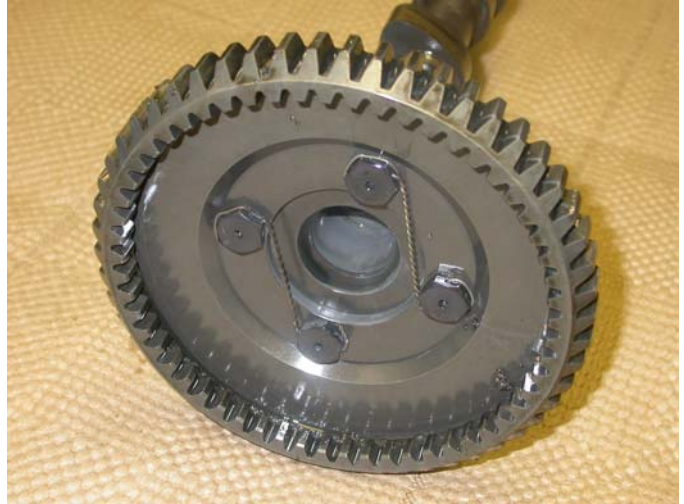
| Date | Engine Model | Engine Serial No. | Aircraft Registration | Page |

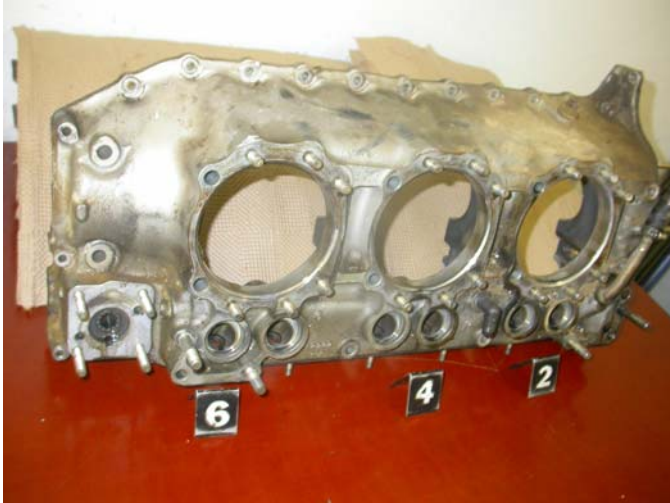
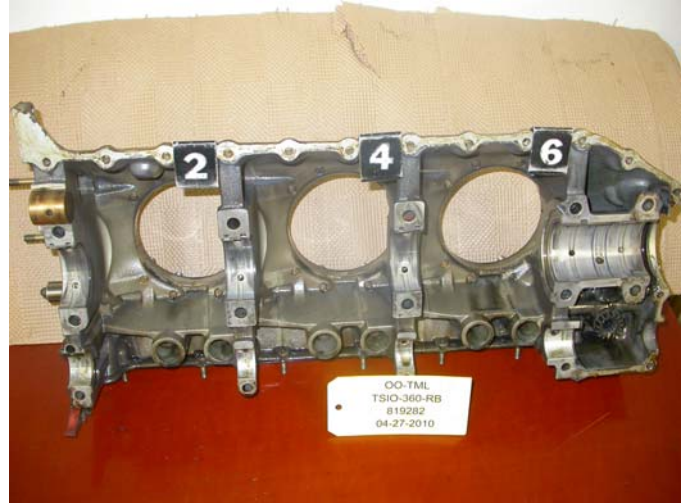
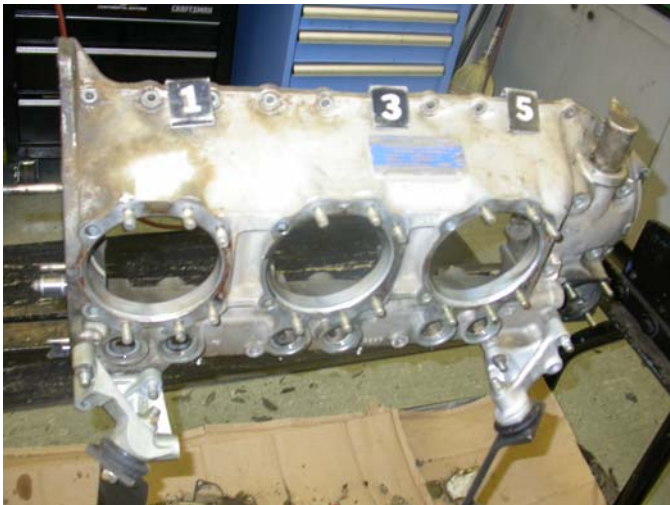
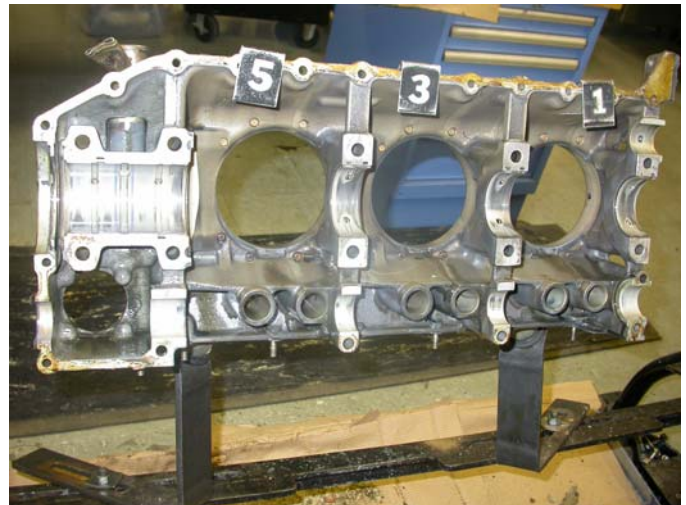
| Date | Engine Model | Engine Serial No. | Aircraft Registration | Page |

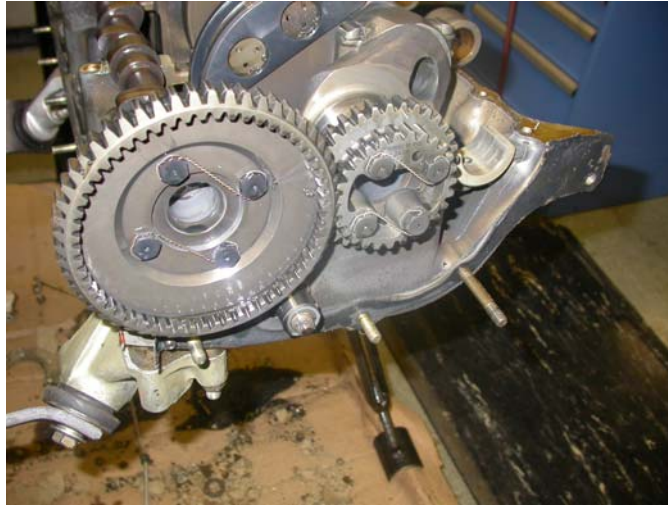
Condition: The accessory gears had continuity. The teeth were undamaged and exhibited normal operating signatures.

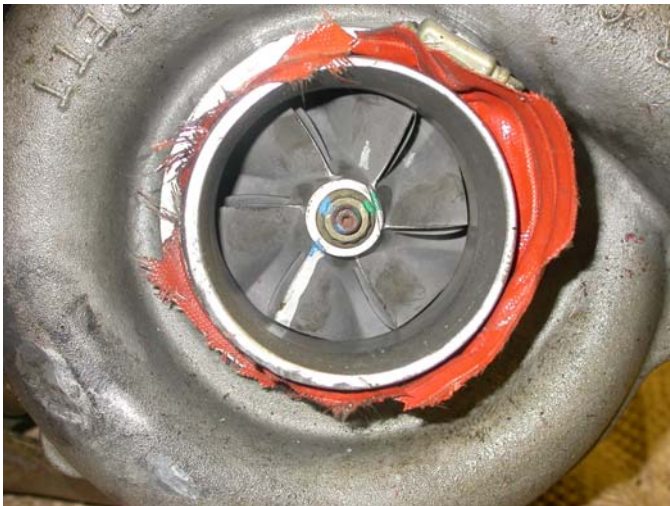
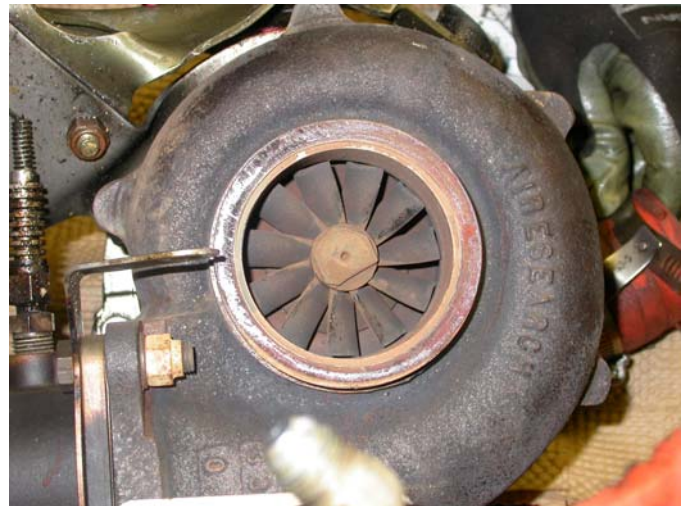
| Date | Engine Model | Engine Serial No. | Aircraft Registration | Page |

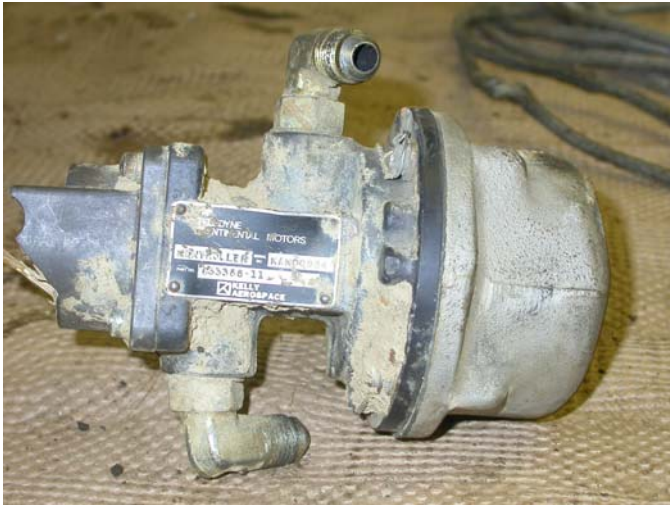
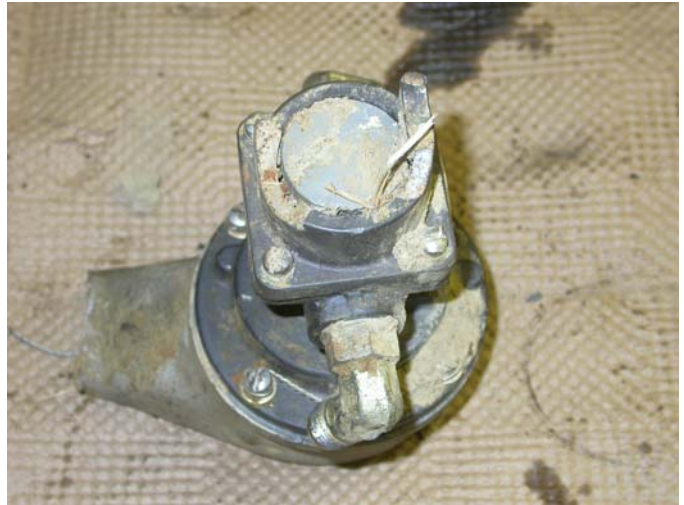
Condition: The controller exhibited impact damage and imbedded debris.

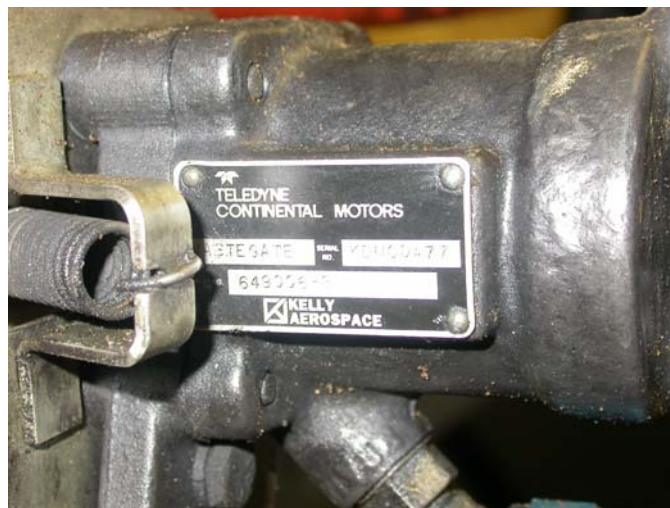
| Date | Engine Model | Engine Serial No. | Aircraft Registration | Page |

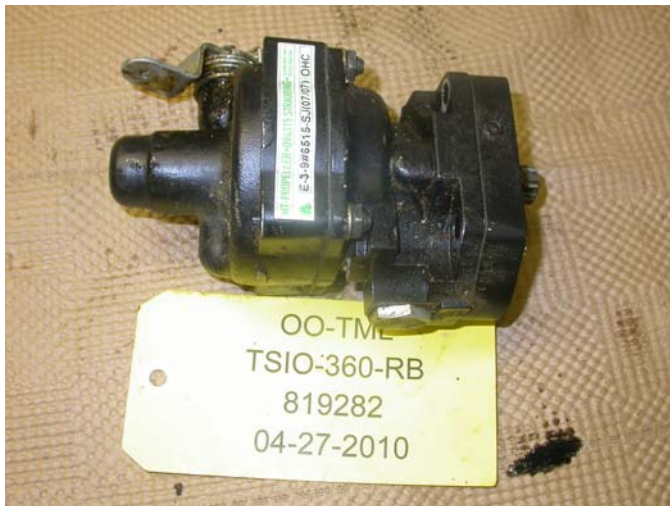
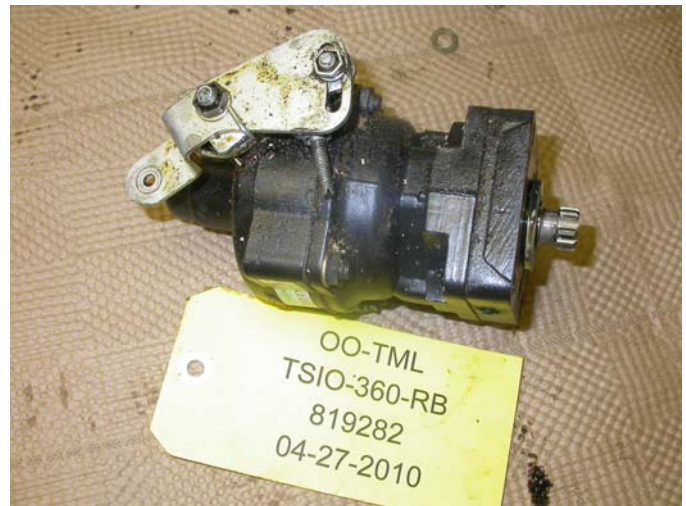
Vacuum Pump Part number: N/A

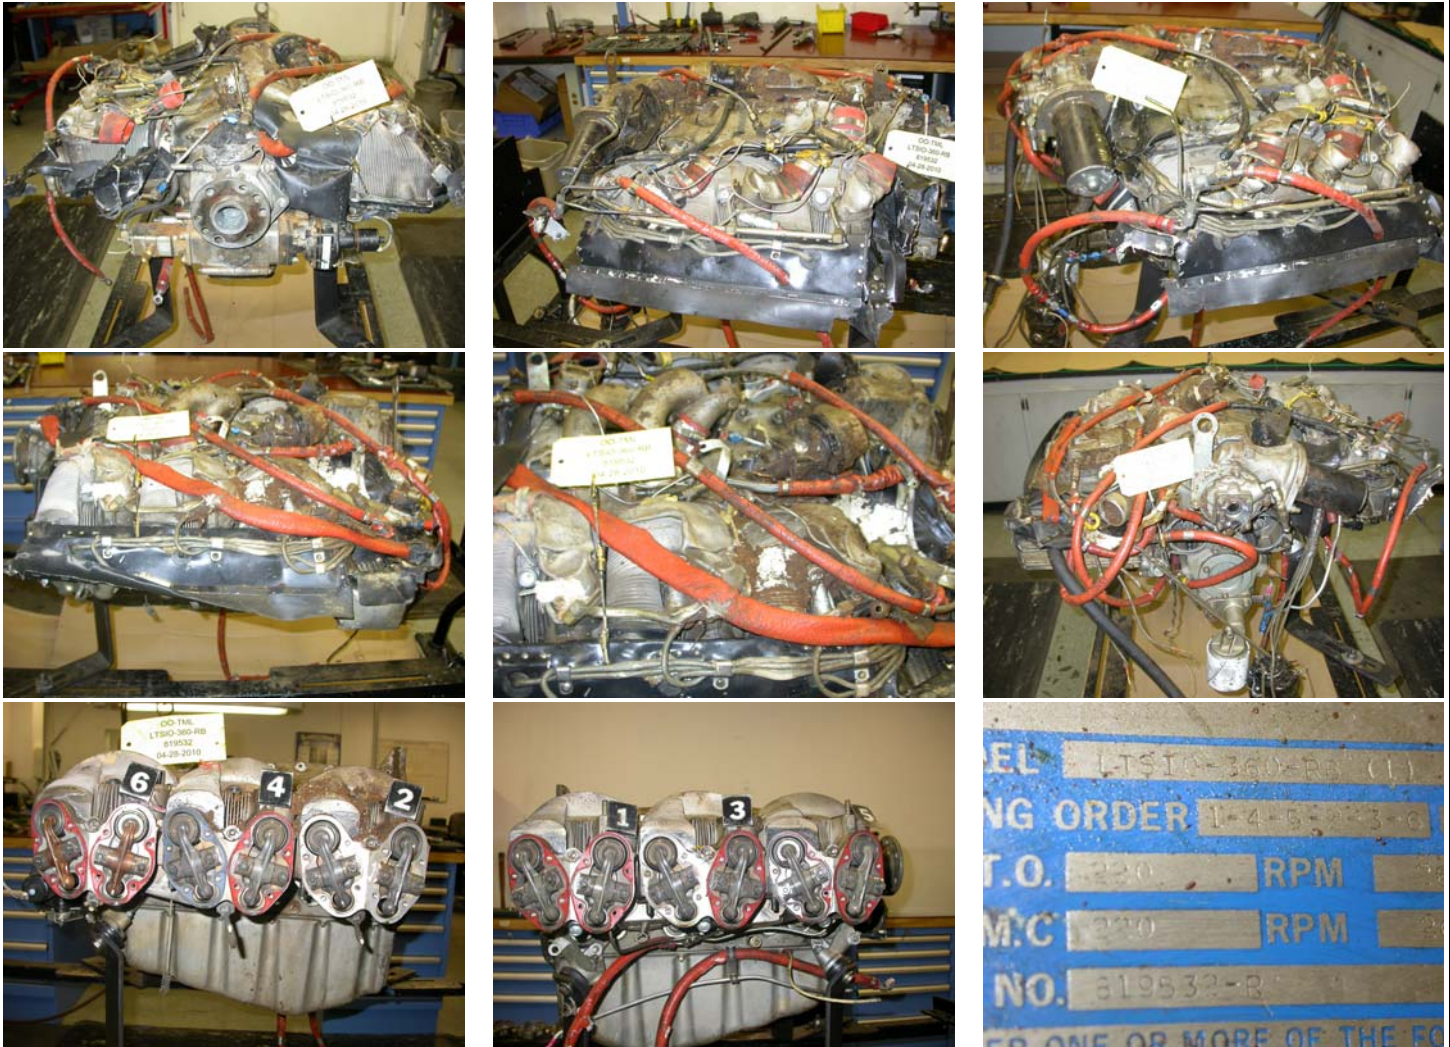
AIRFRAME PARTS RETURNED WITH ENGINE: Portions of control cables, cooling baffles, prop governor, vacuum pump flange, fuel flow transducer, breather tube/hose and related hardware, fuel lines and miscellaneous hoses and wiring.

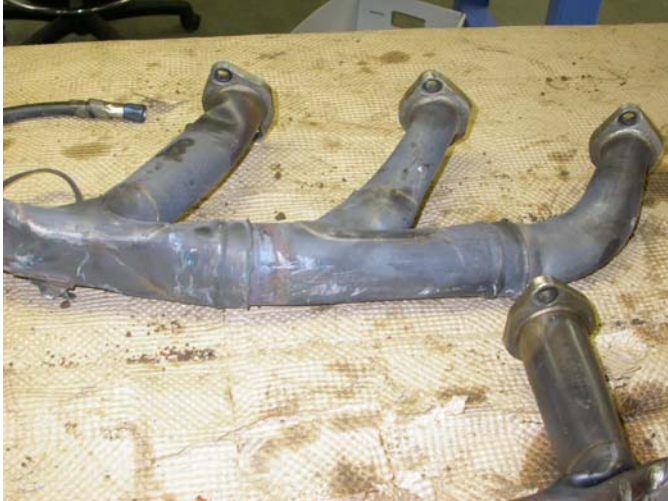
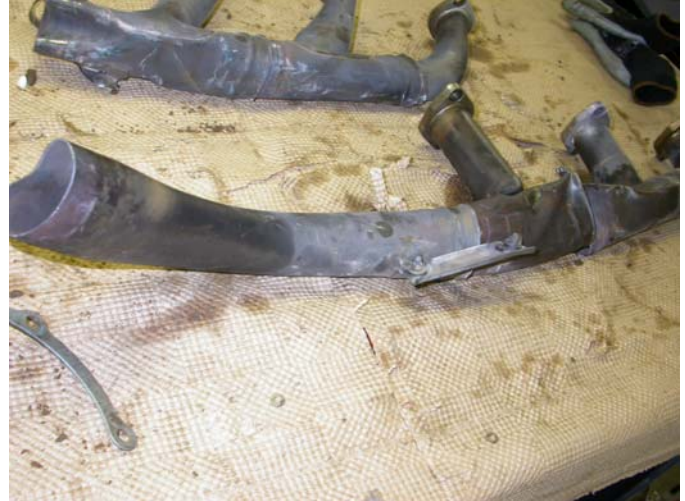
Condition: The exhaust system components were already disassembled and exhibited impact damage.

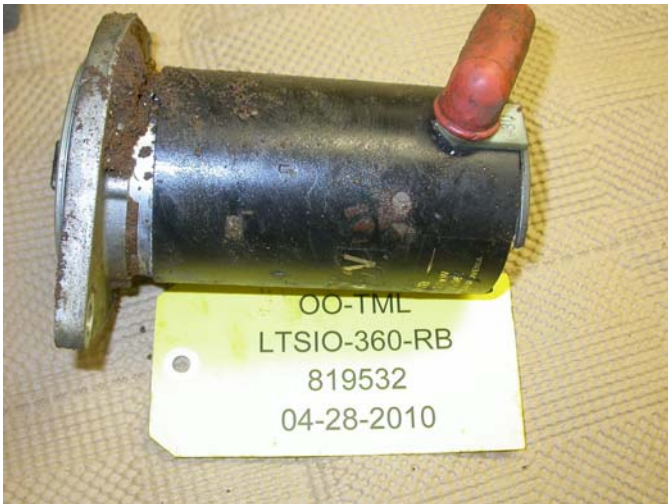
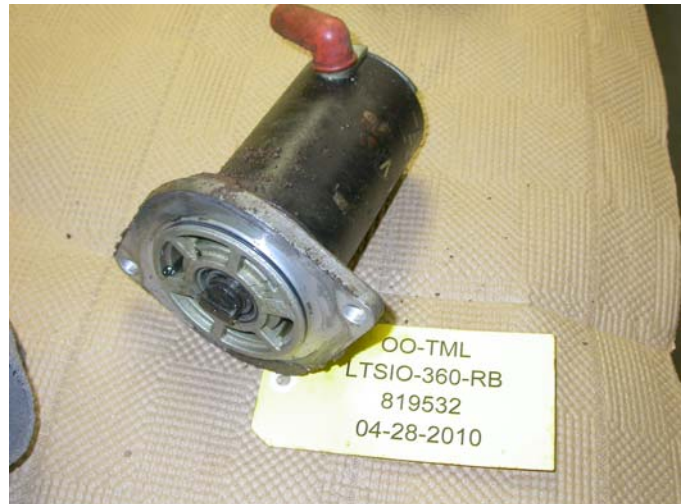
| Date | Engine Model | Engine Serial No. | Aircraft Registration | Page |

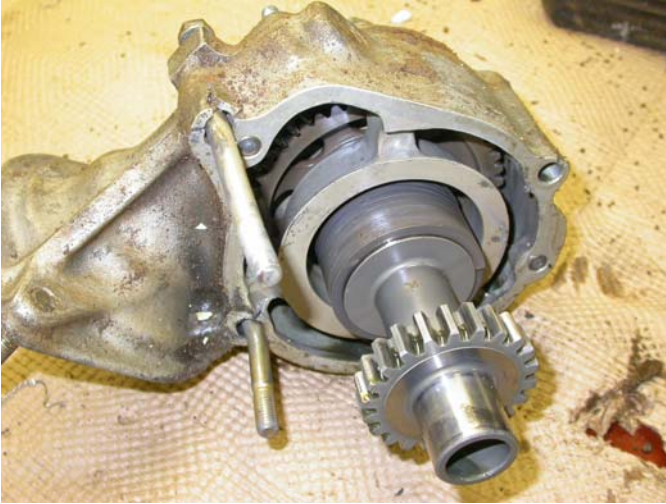
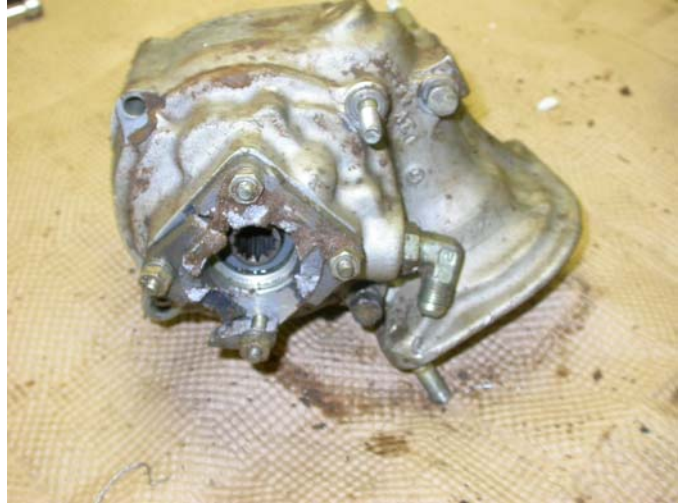
Crankshaft to Camshaft Timing

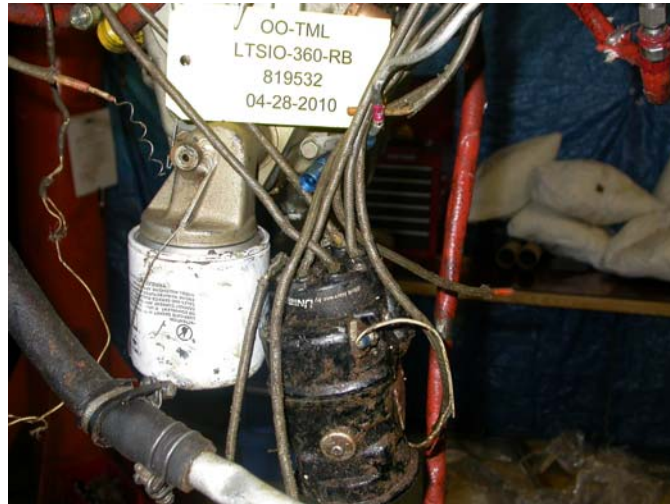
L/H Magneto Manufacturer: N/A Model/Part Number: N/A Serial #: N/A

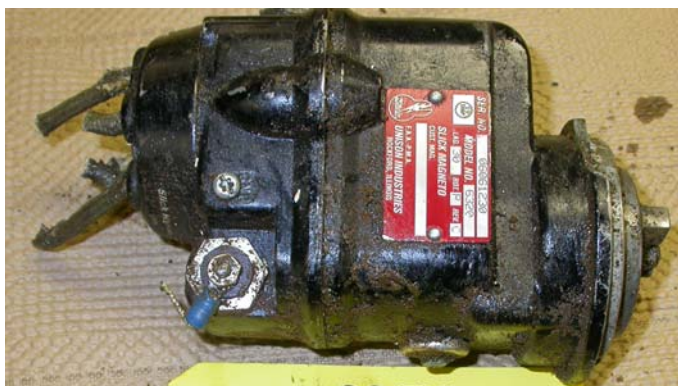
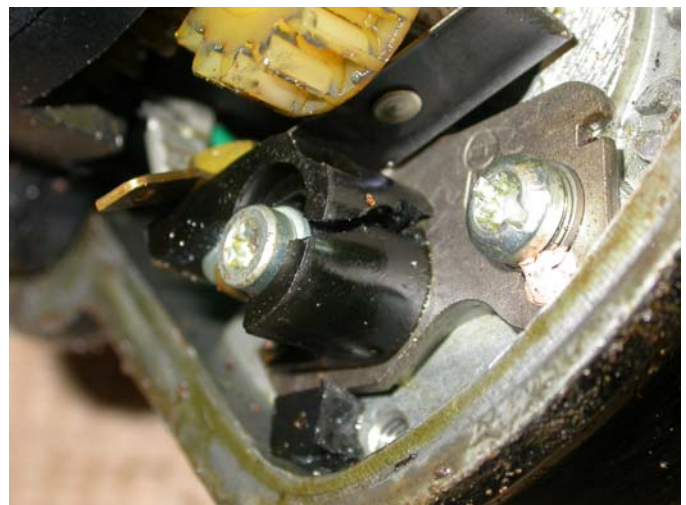
| Date | Engine Model | Engine Serial No. | Aircraft Registration | Page |

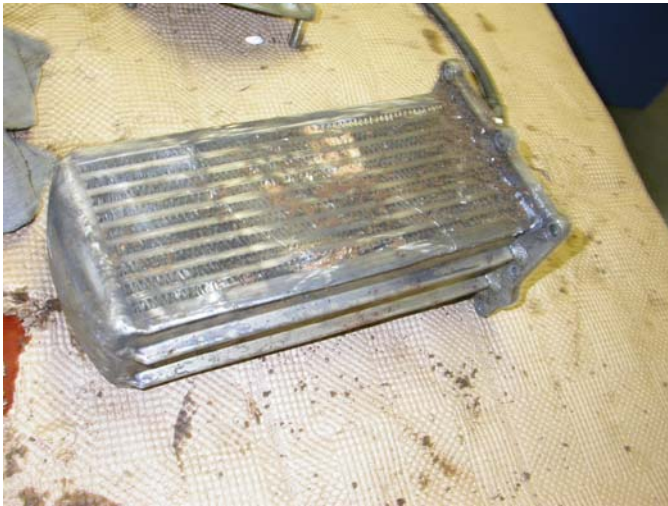
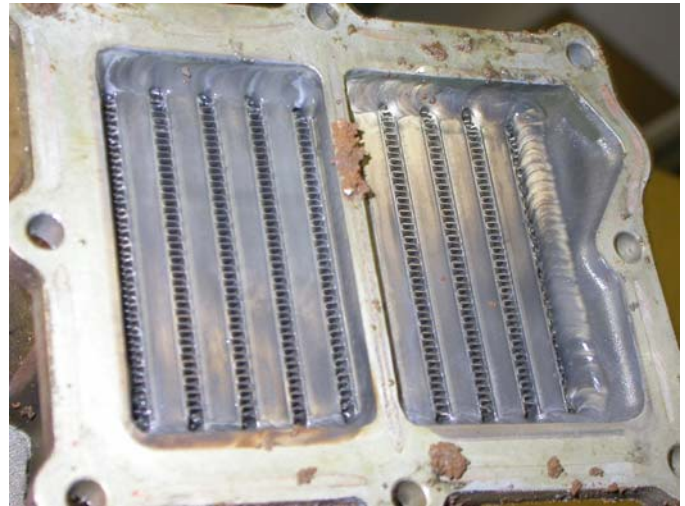
Condition: The oil cooler was undamaged and exhibited normal operating signatures.

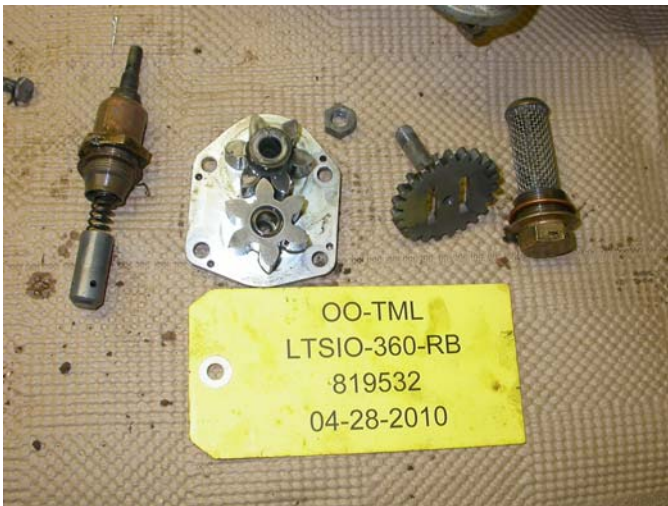
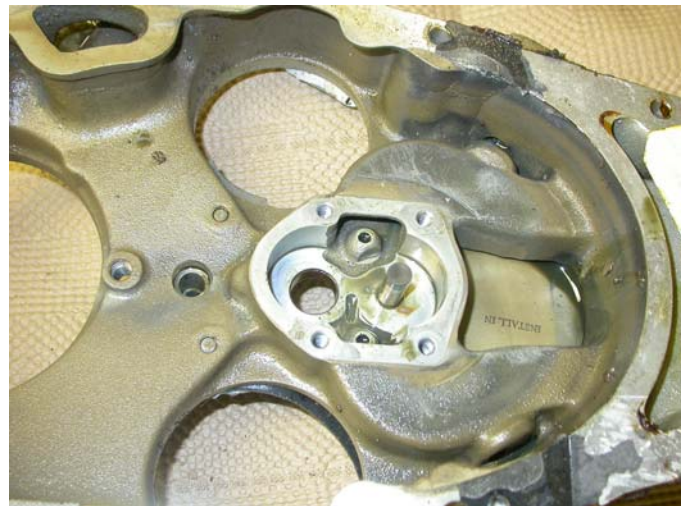
| Date | Engine Model | Engine Serial No. | Aircraft Registration | Page |

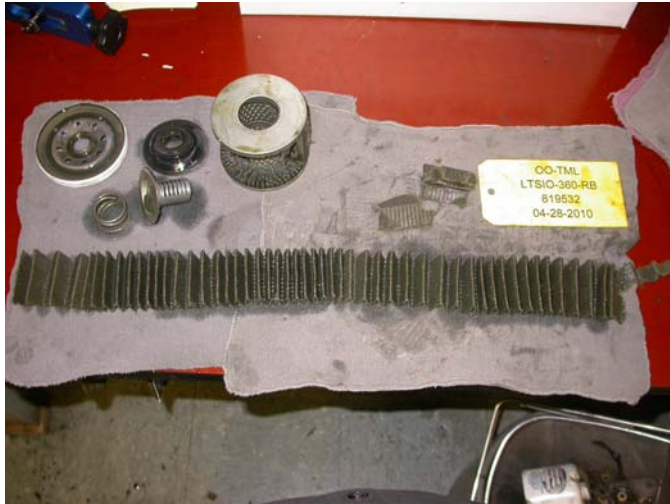
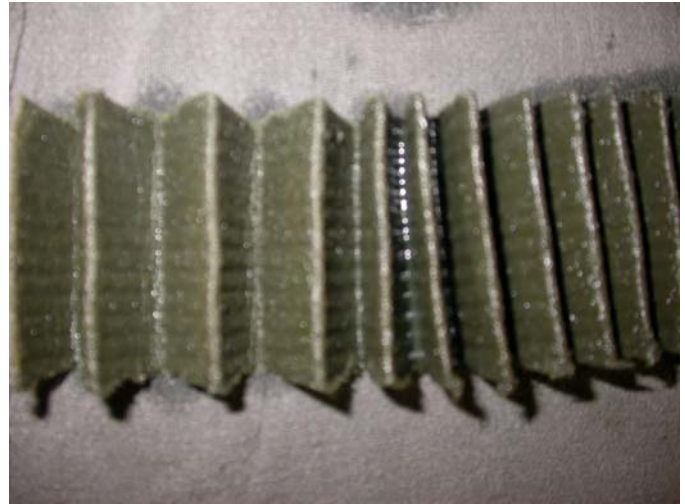
Throttle and Servo Assembly

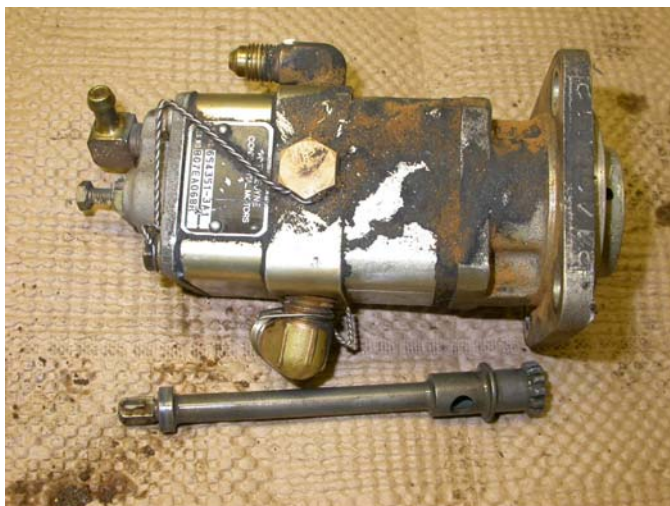
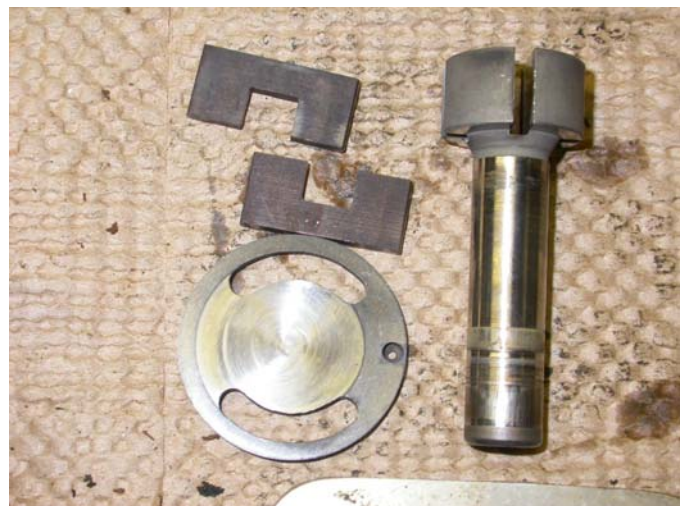
| Date | Engine Model | Engine Serial No. | Aircraft Registration | Page |

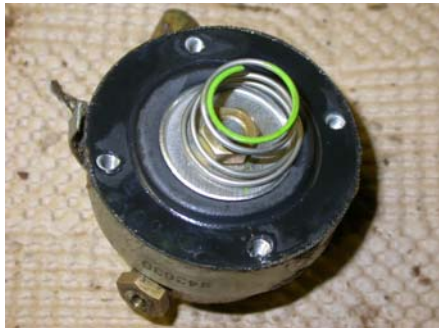
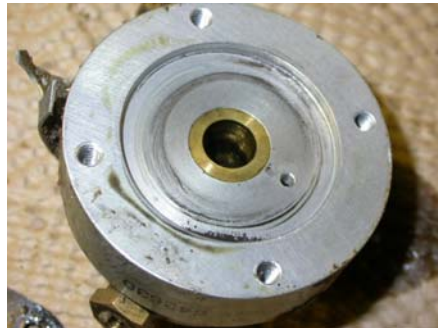
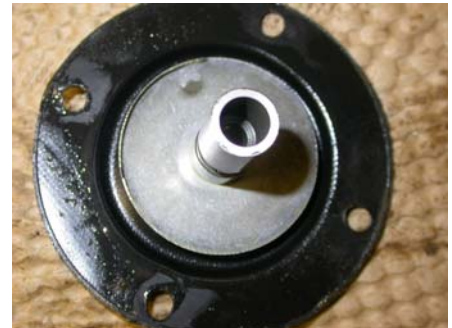
Fuel Nozzles and Lines Manufacturer: TCM

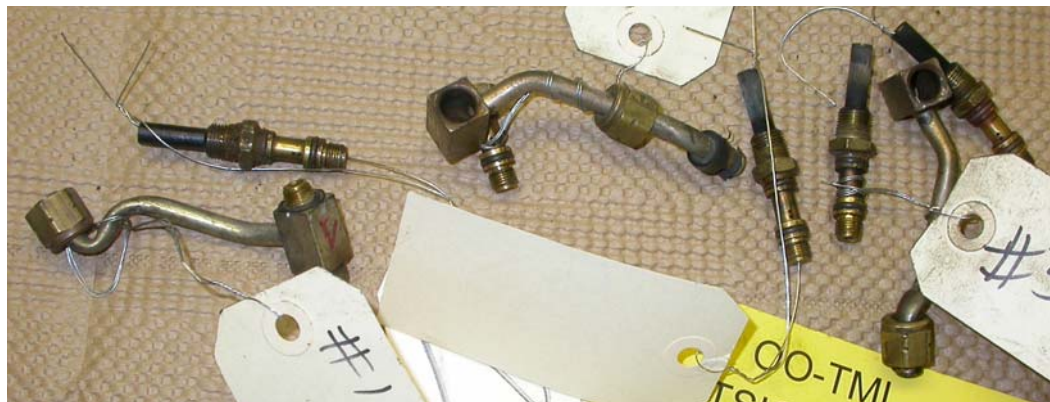
| Date | Engine Model | Engine Serial No. | Aircraft Registration | Page |

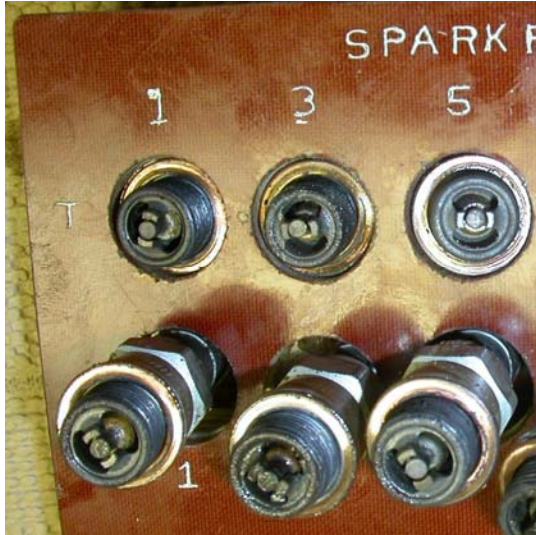
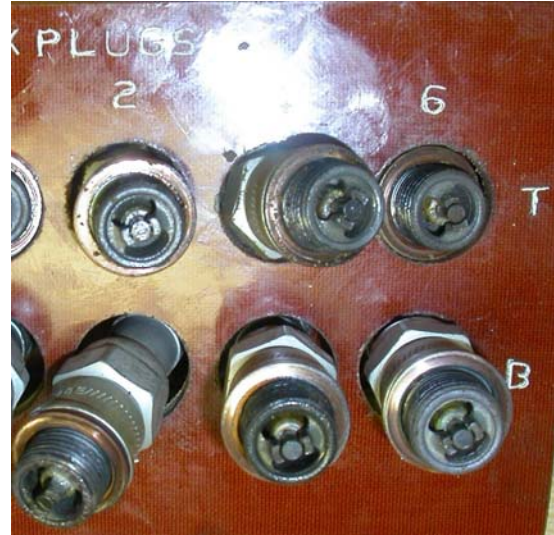
Alternator Manufacturer: N/A Part Number: N/A Serial #: N/A

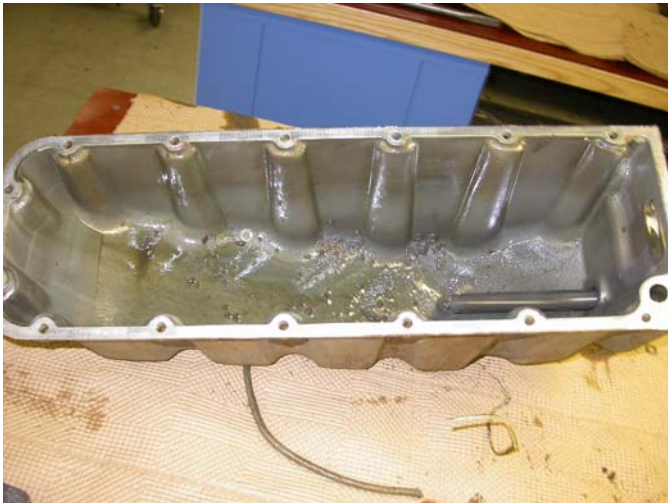
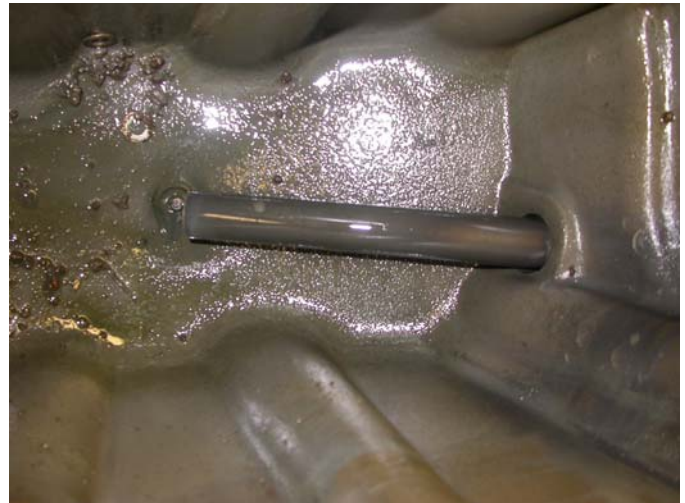
| Date | Engine Model | Engine Serial No. | Aircraft Registration | Page |
