MINISTÉRIO DA ECONOMIA E DO EMPREGO
GABINETE DE PREVENÇÃO E INVESTIGAÇÃO DE ACIDENTES COM AERONAVES
(GPIAA)

ACCIDENT FINAL REPORT

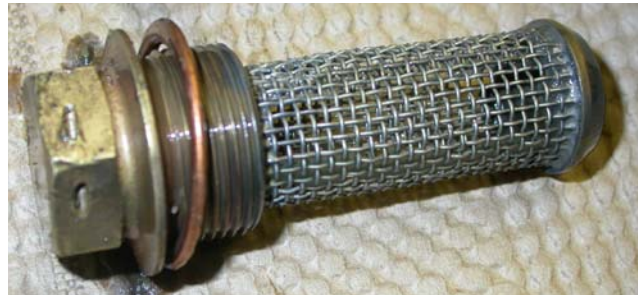
Condition: The oil pick-up tube was undamaged. The oil suction screen was unrestricted.

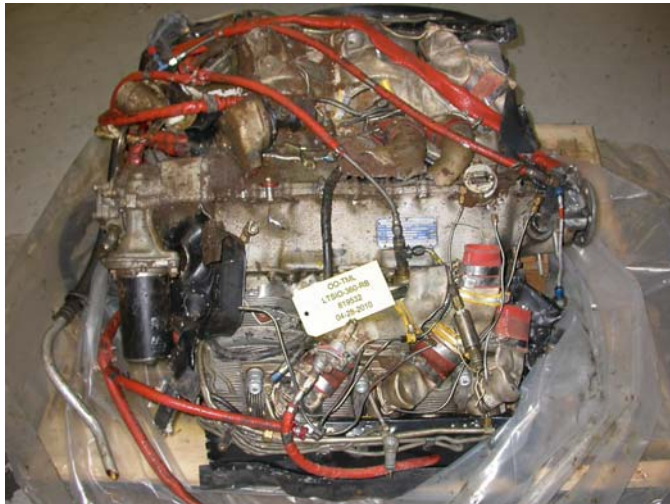
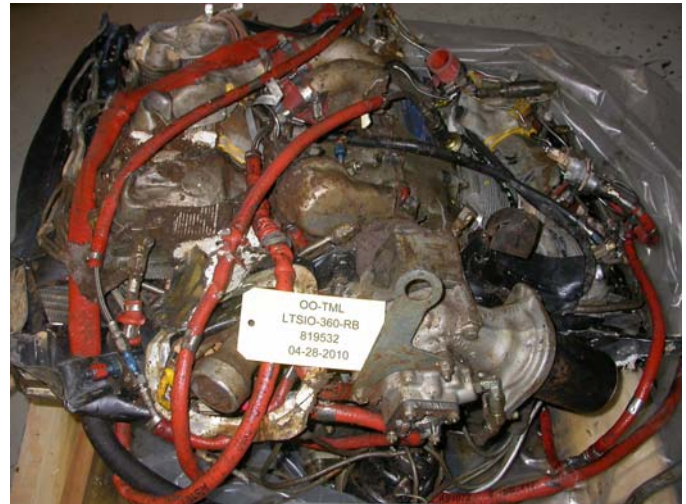
Condition: The induction system had heavy impact damage and was mostly crushed.

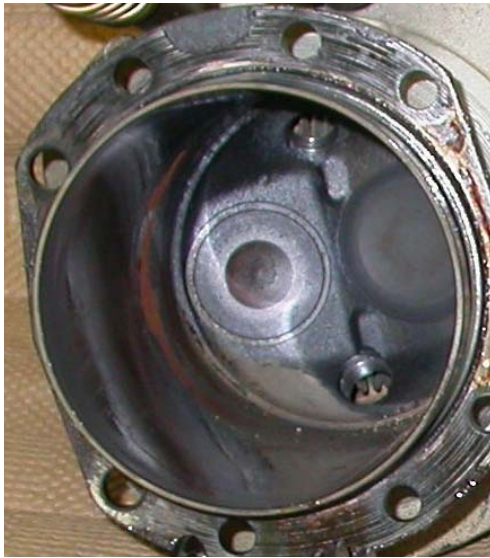
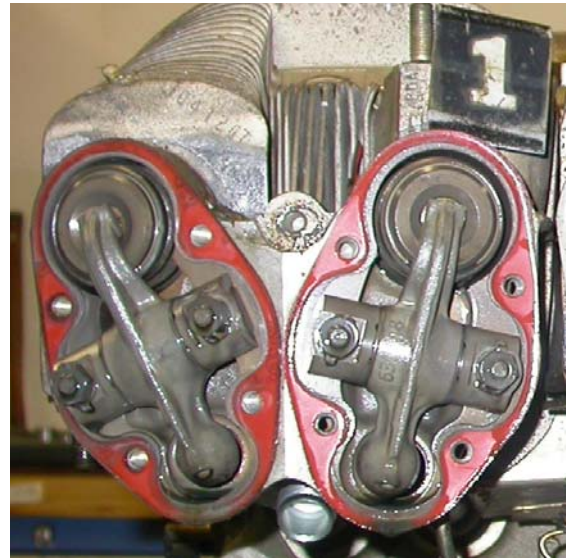
Cylinder #2 Part Number: 655479A11 Head Date: 3/07 Barrel Surface: Steel
 Serial #: AC07BB113 Work Order Numbers: None

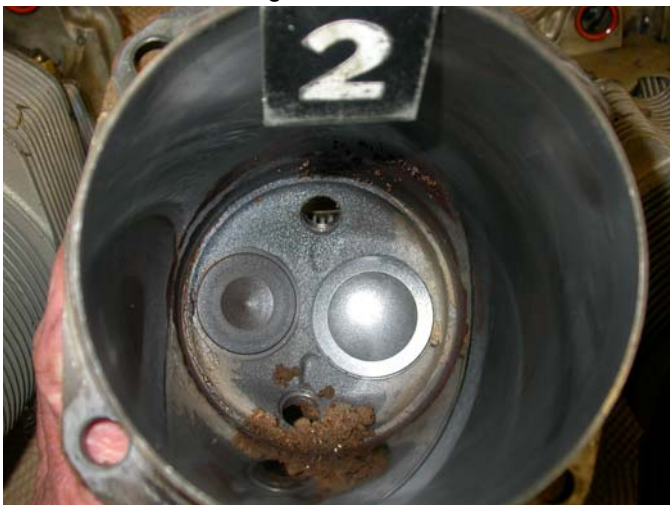
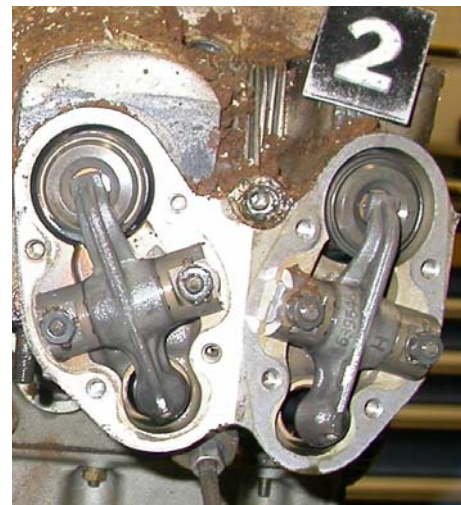
| Date | Engine Model | Engine Serial No. | Aircraft Registration | Page |

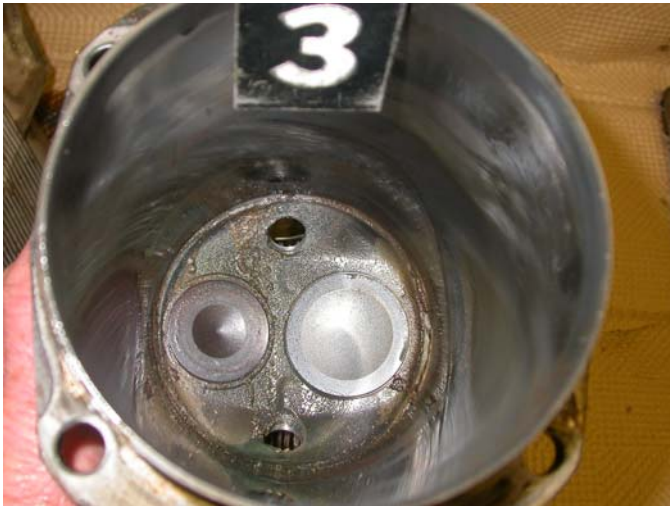
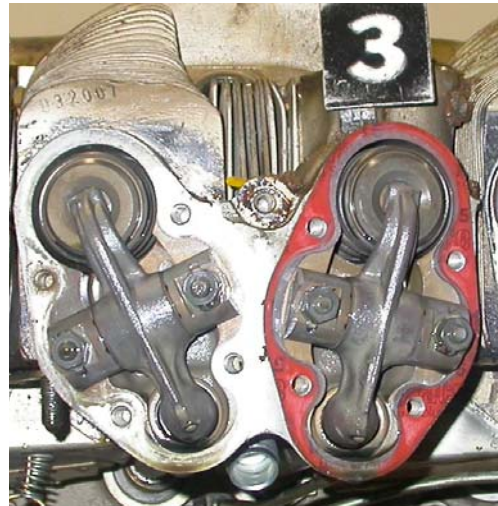
Cylinder #4 Part Number: 655479A11 Head Date: 3/07 Barrel Surface: Steel
 Serial #: AC07BA987 Work Order Numbers: None

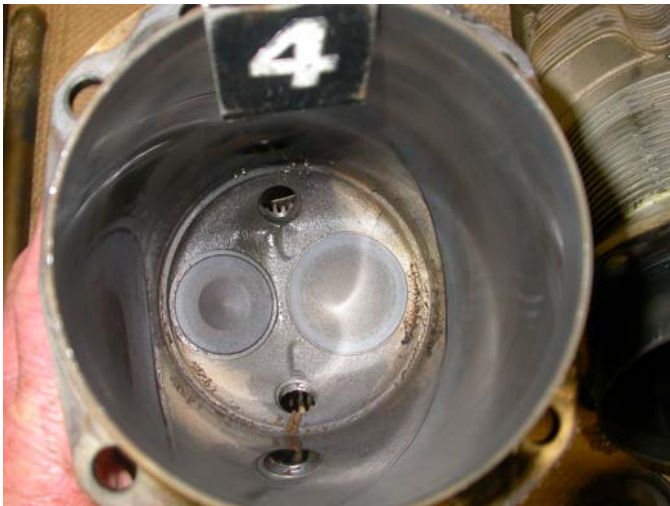
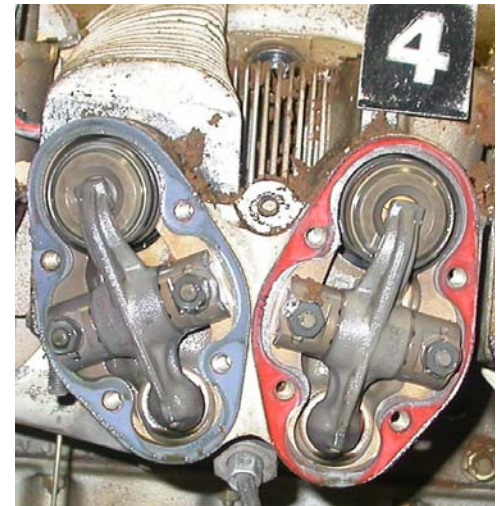
| Date | Engine Model | Engine Serial No. | Aircraft Registration | Page |

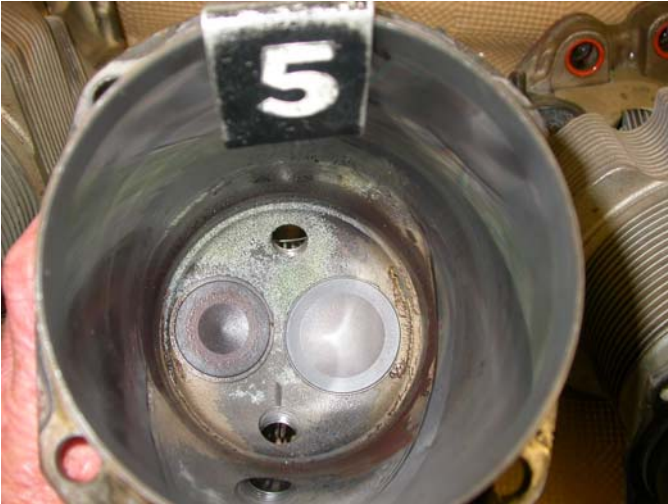
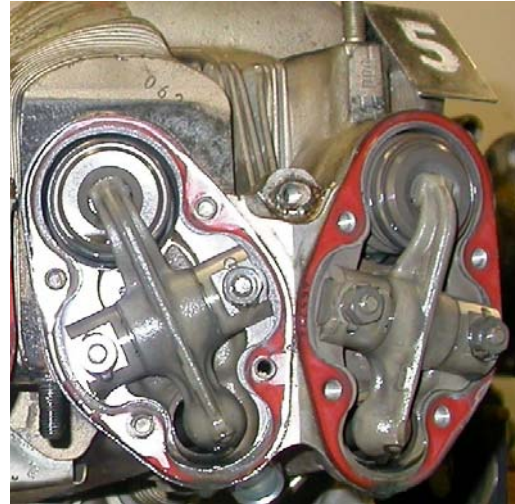
Cylinder #6 Part Number: 655479A11 Head Date: 4/07 Barrel Surface: Steel
 Serial #: AC07DA342 Work Order Numbers: None

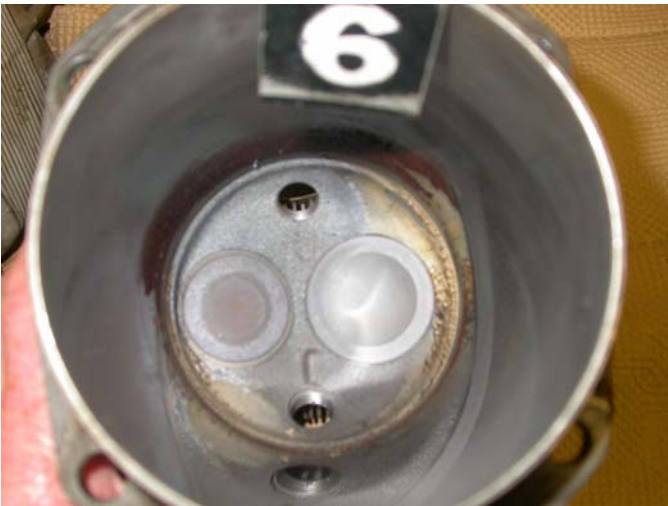
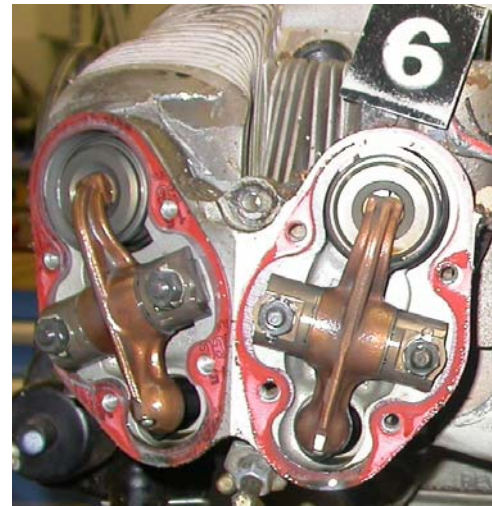
| Date | Engine Model | Engine Serial No. | Aircraft Registration | Page |

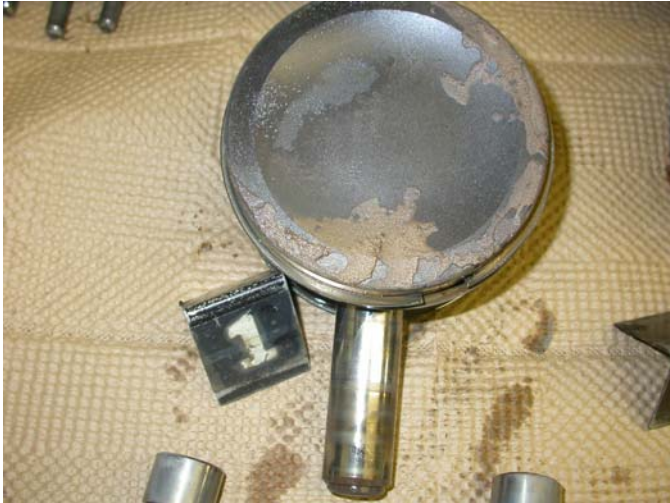
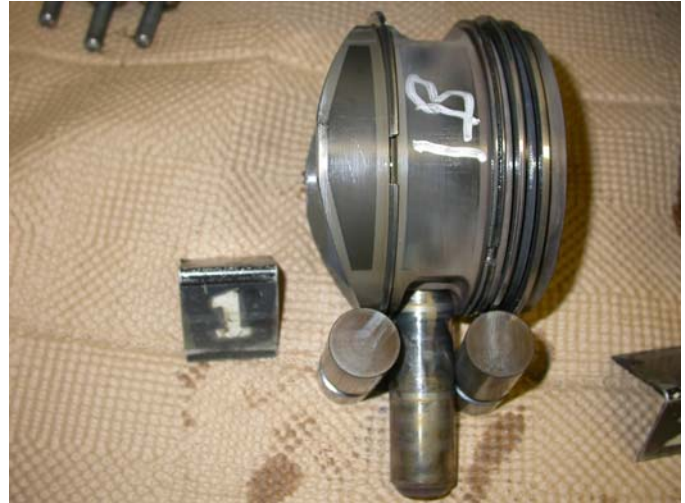
#2 Piston, Rings and Pin Piston Part Number: 654859

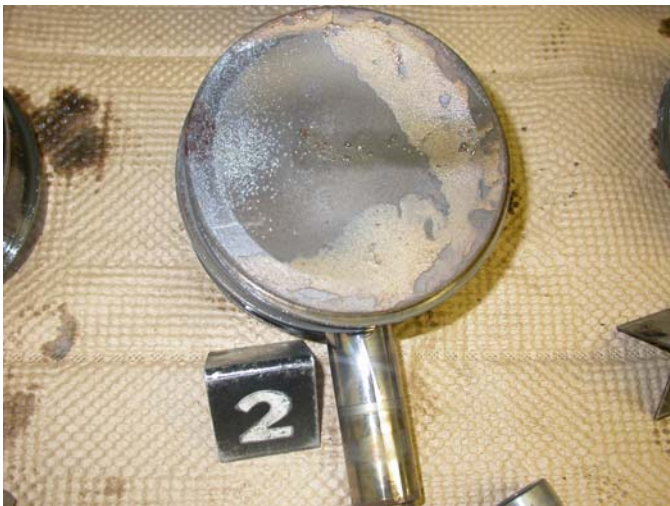
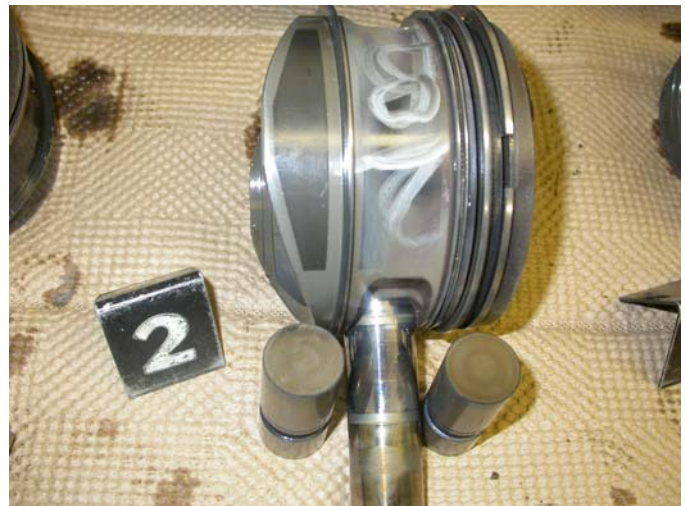
| Date | Engine Model | Engine Serial No. | Aircraft Registration | Page |

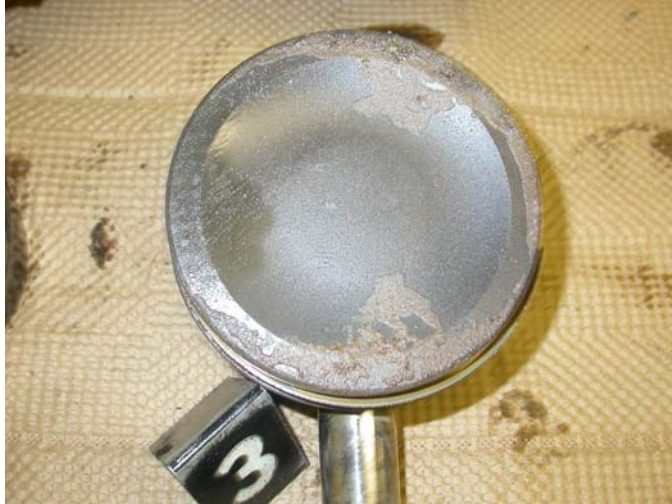
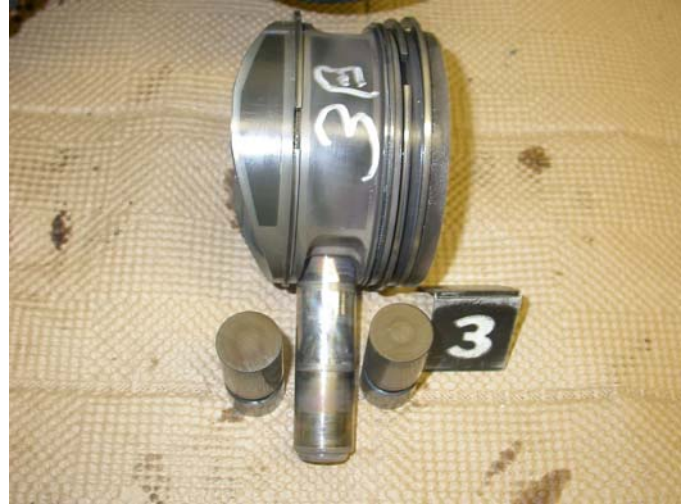
#4 Piston, Rings and Pin Piston Part Number: 654859

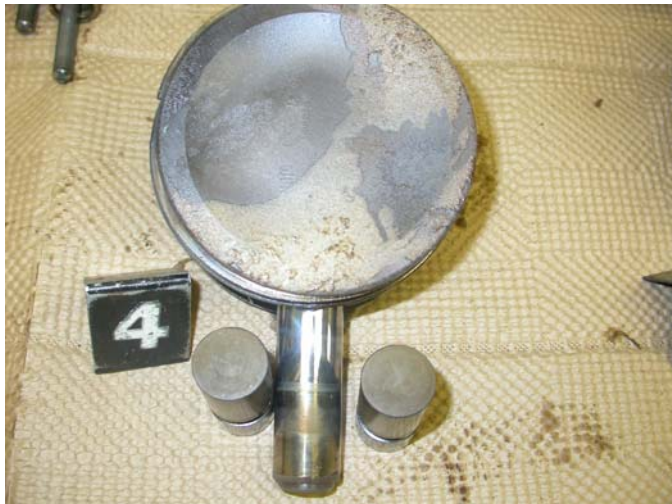
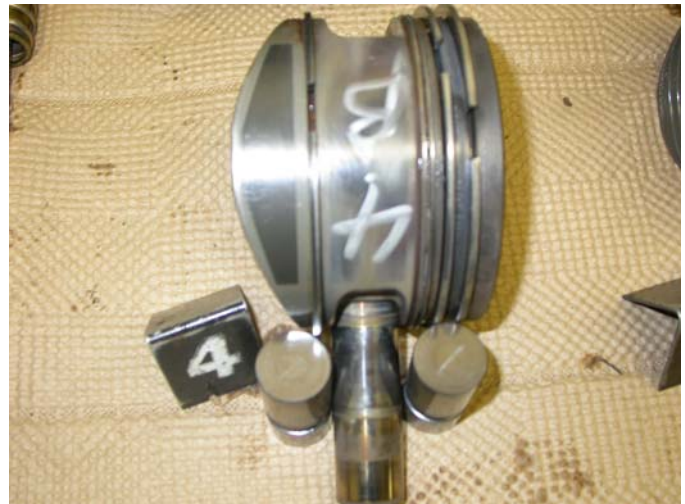
| Date | Engine Model | Engine Serial No. | Aircraft Registration | Page |

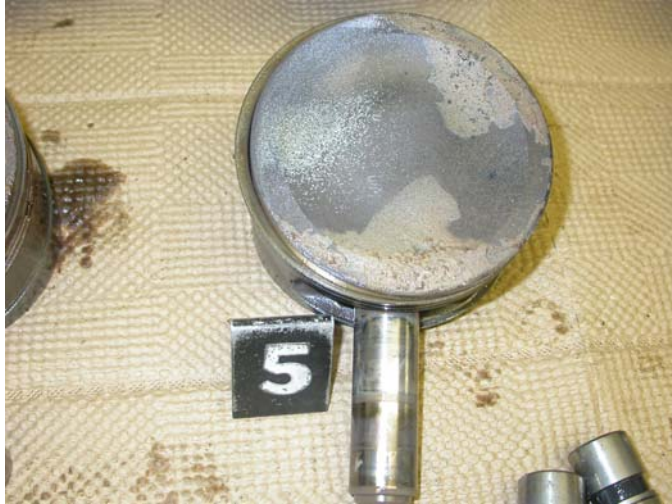
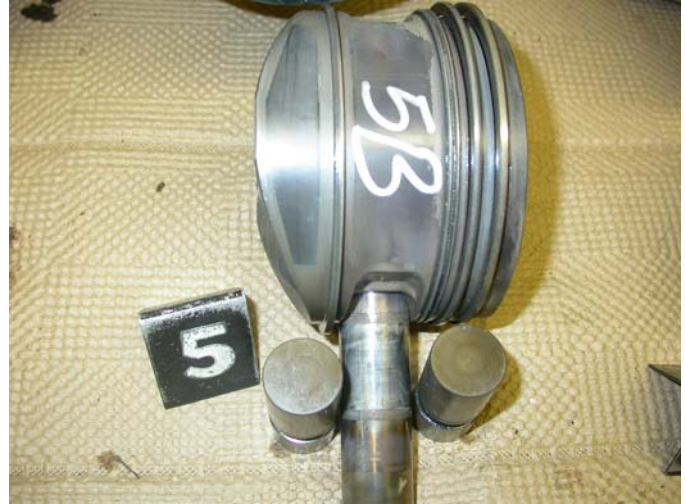
#6 Piston, Rings and Pin Piston Part Number: 654859

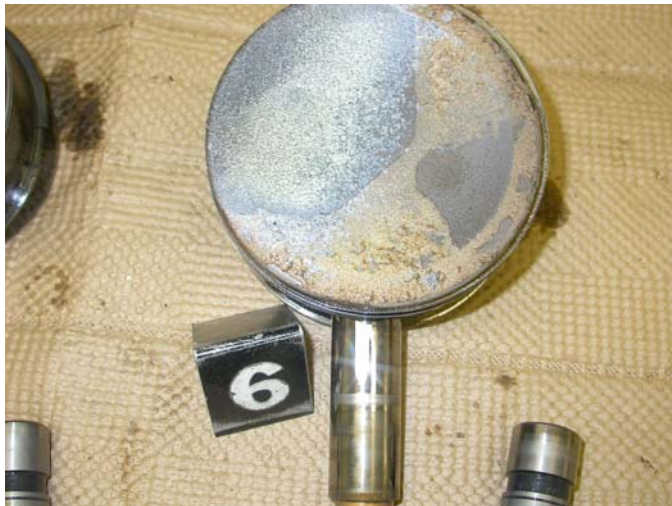
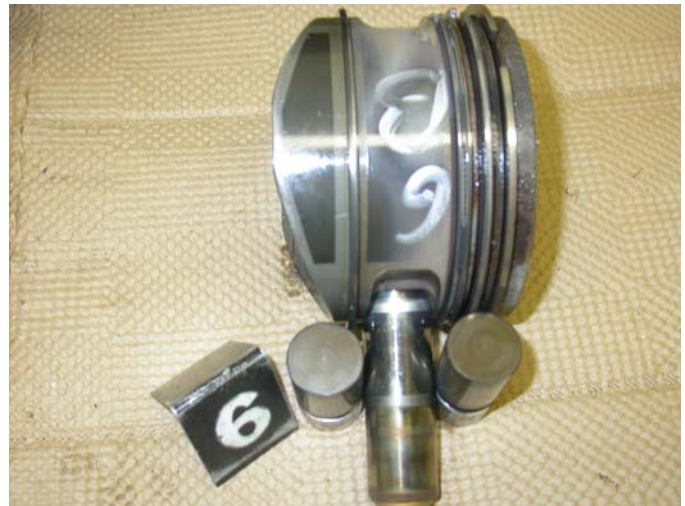
| Lifter | #1 | #3 | #5 | #2 | #4 | #6 |

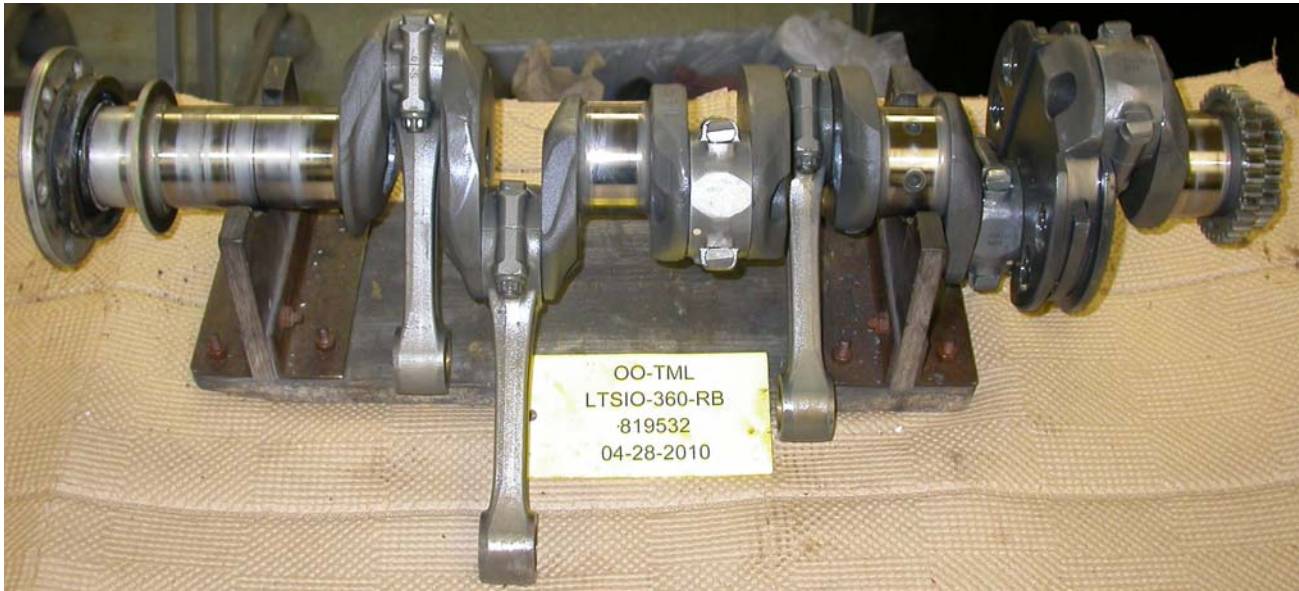
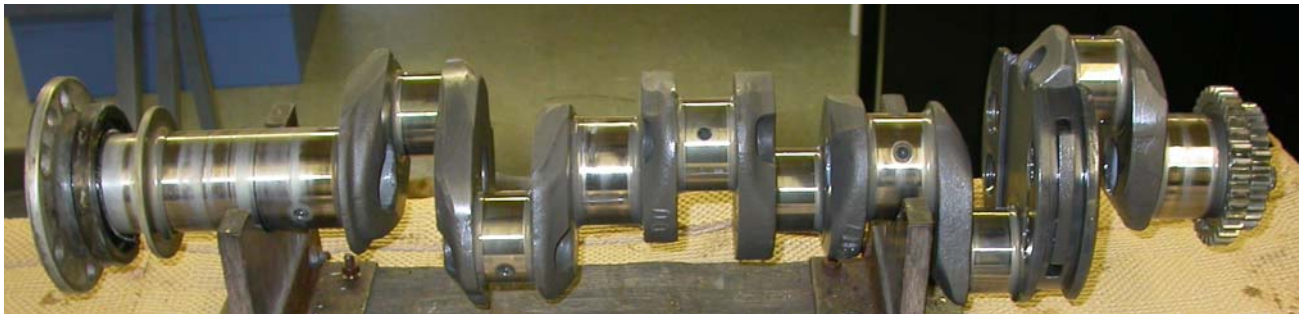
| Date | Engine Model | Engine Serial No. | Aircraft Registration | Page |

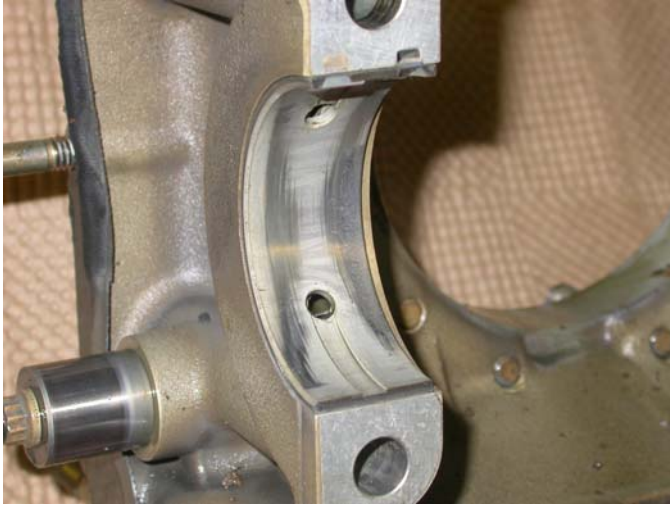
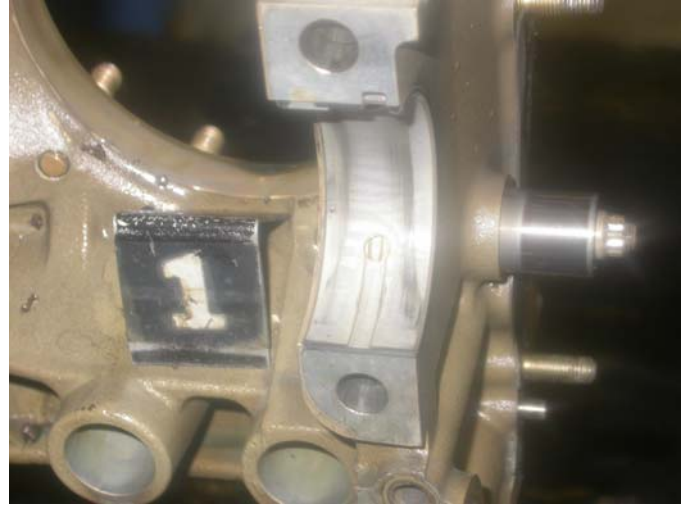
Condition The #1 (rear) crankshaft main bearings exhibited normal operating and lubrication signatures. The bearings were intact and exhibited an insignificant amount of contamination and hard particle passage. There were no signs of lubrication distress.

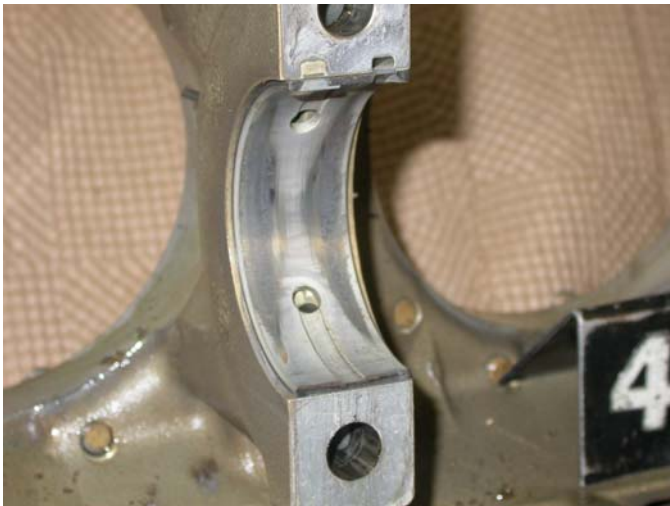
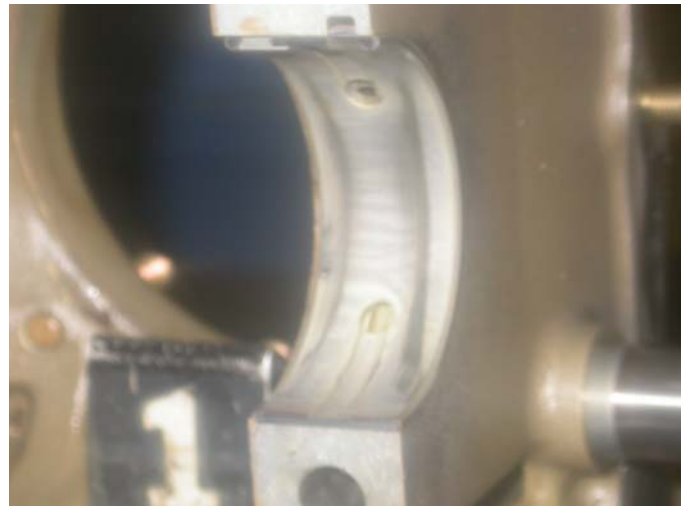
| Date | Engine Model | Engine Serial No. | Aircraft Registration | Page |

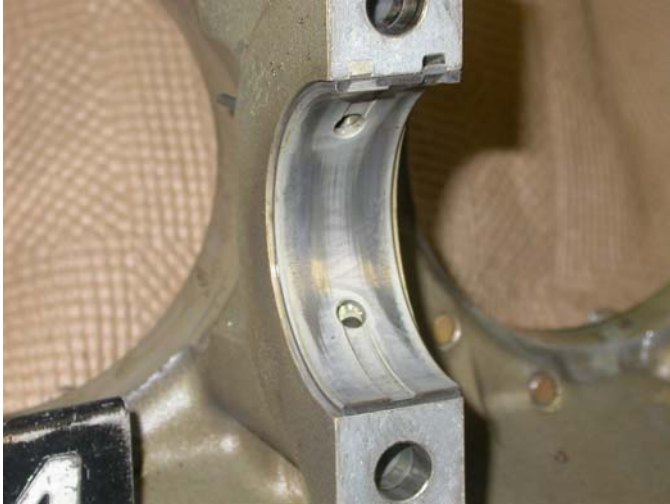
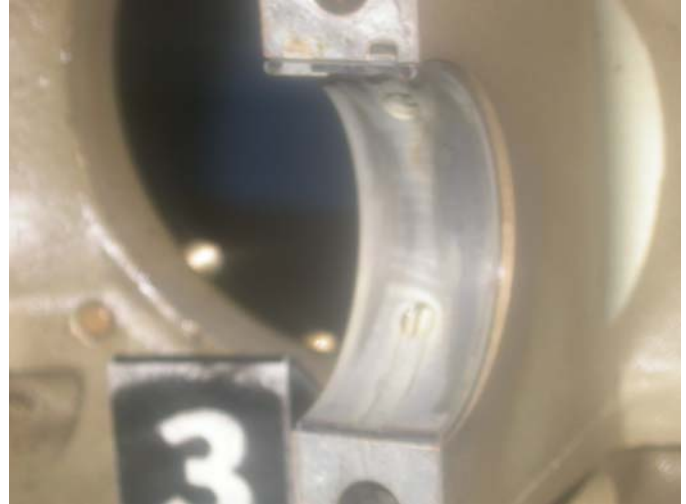
#4 Main Bearings Part #: 641992

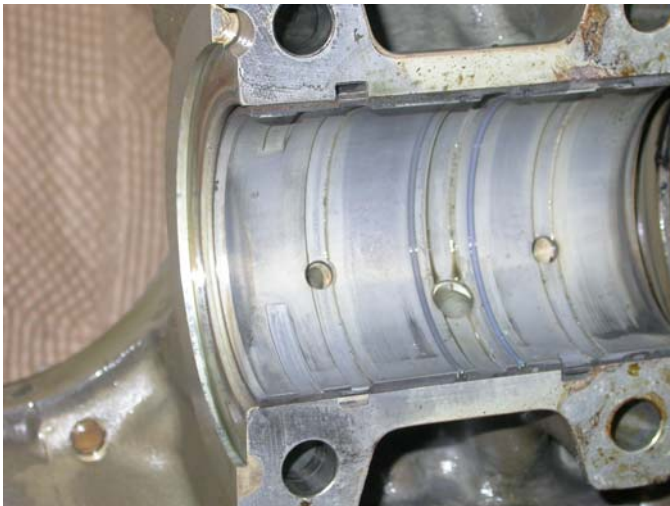
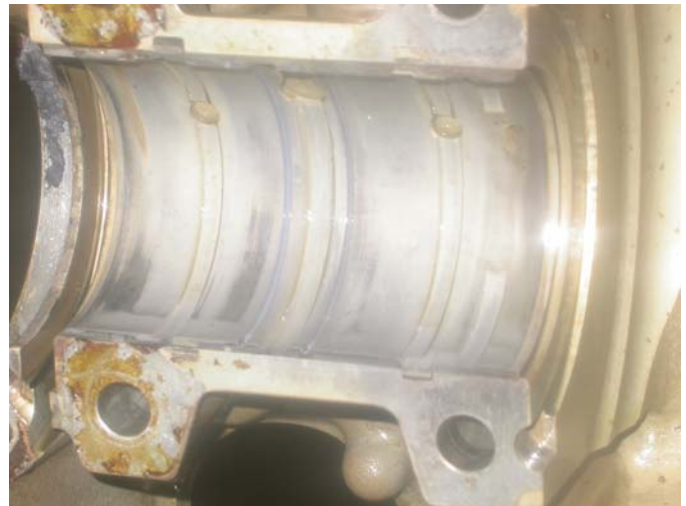
| Date | Engine Model | Engine Serial No. | Aircraft Registration | Page |

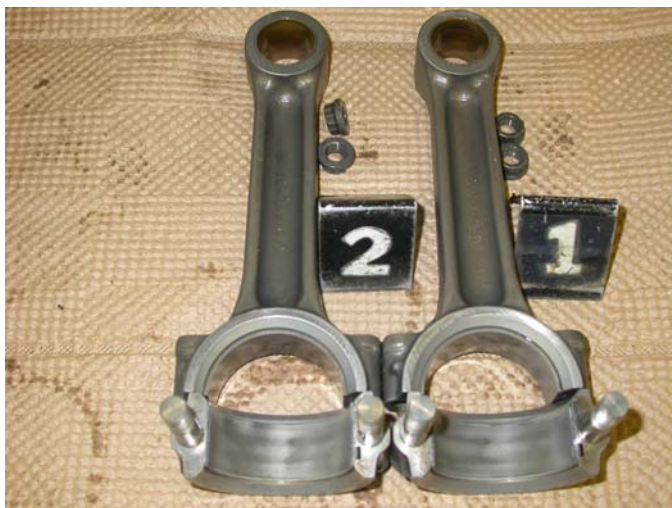
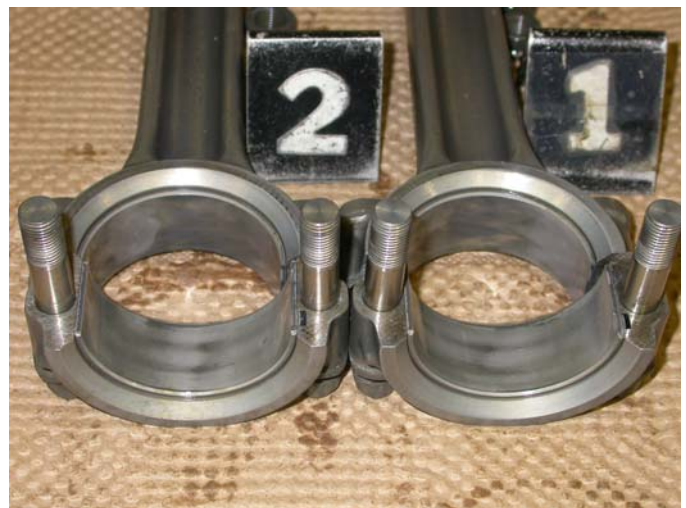
| Date | Engine Model | Engine Serial No. | Aircraft Registration | Page |

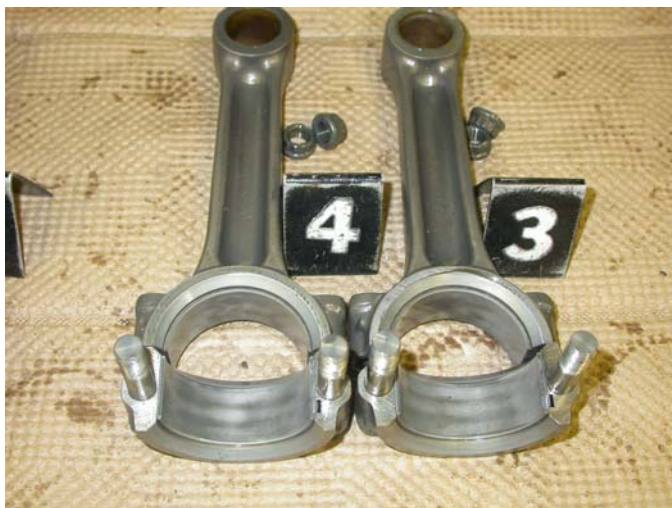
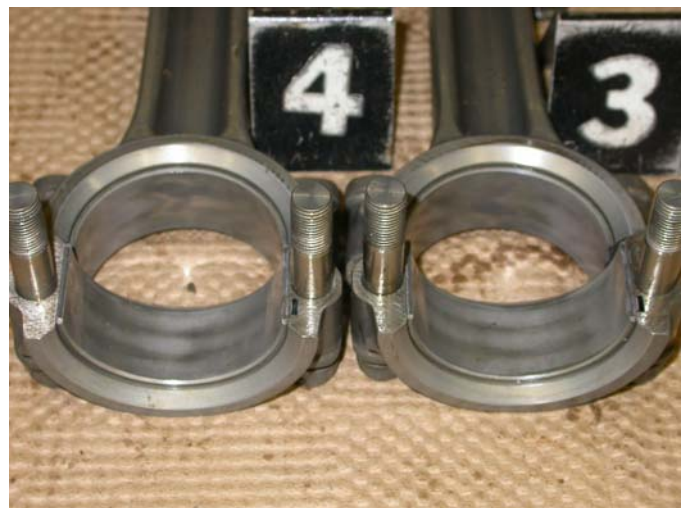
| Date | Engine Model | Engine Serial No. | Aircraft Registration | Page |

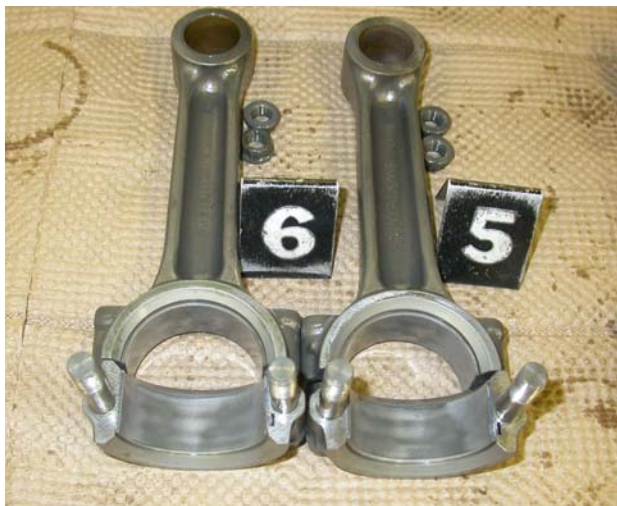
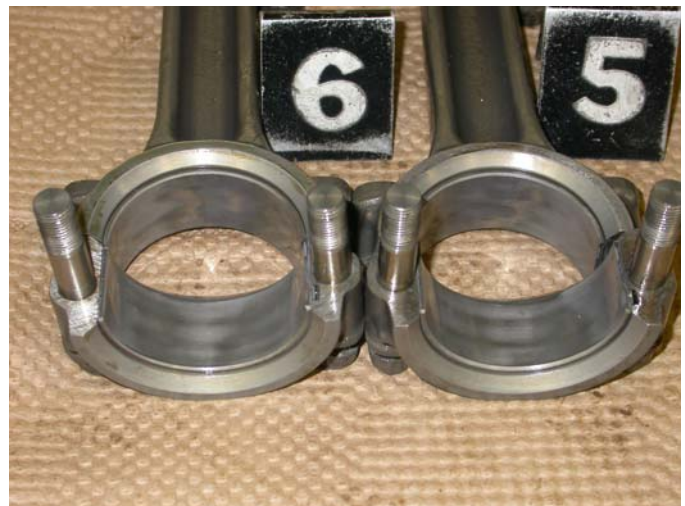
| Date | Engine Model | Engine Serial No. | Aircraft Registration | Page |

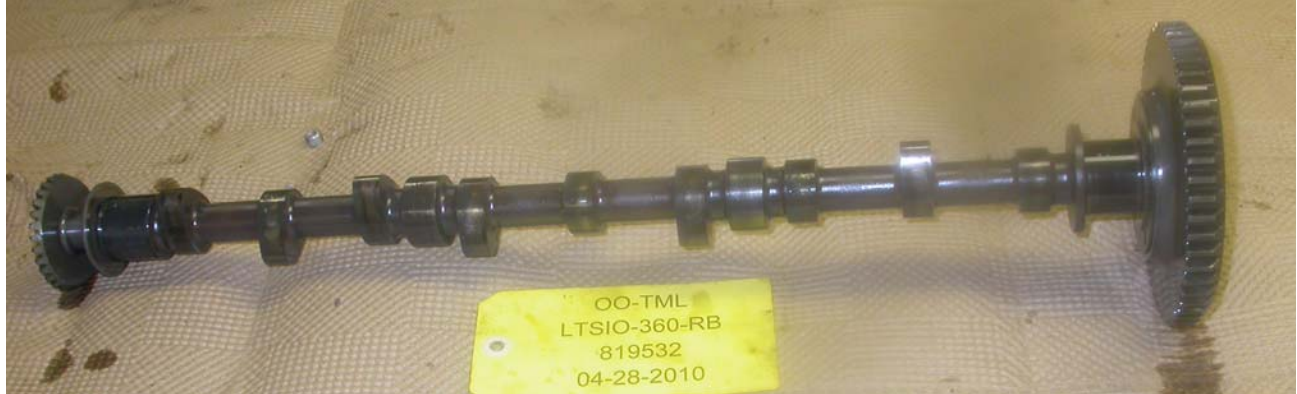
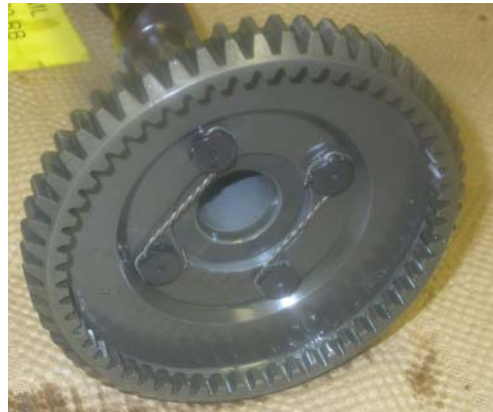
| Date | Engine Model | Engine Serial No. | Aircraft Registration | Page |

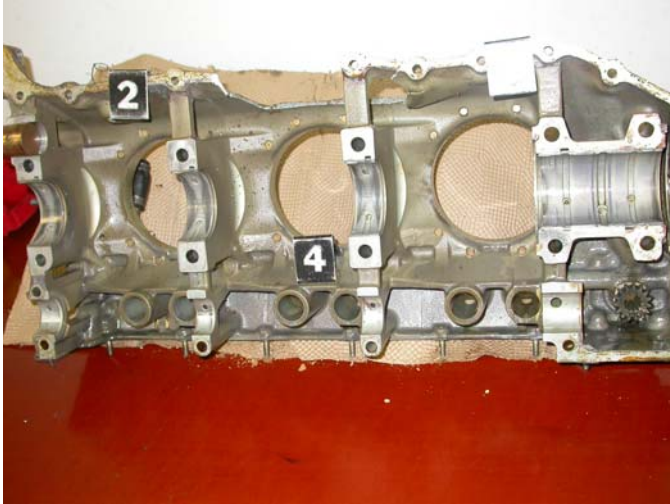
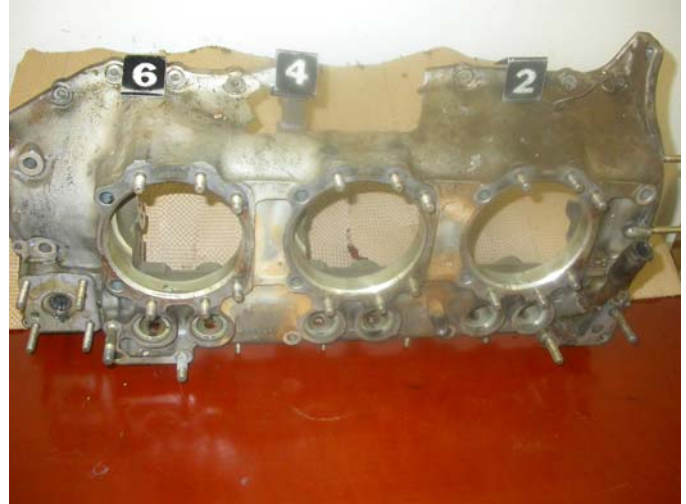
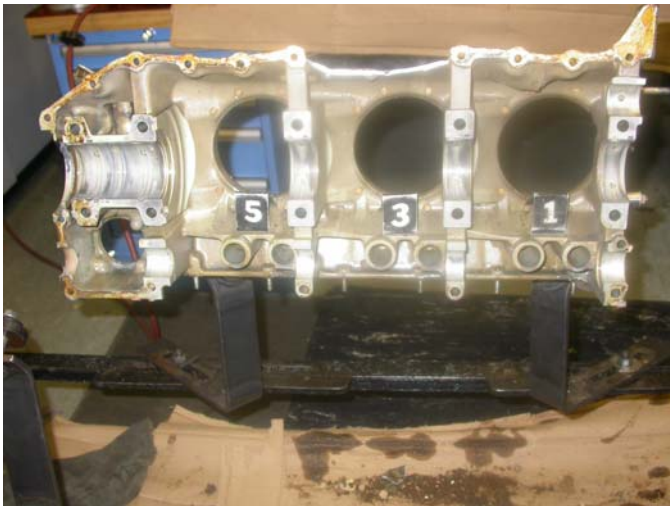
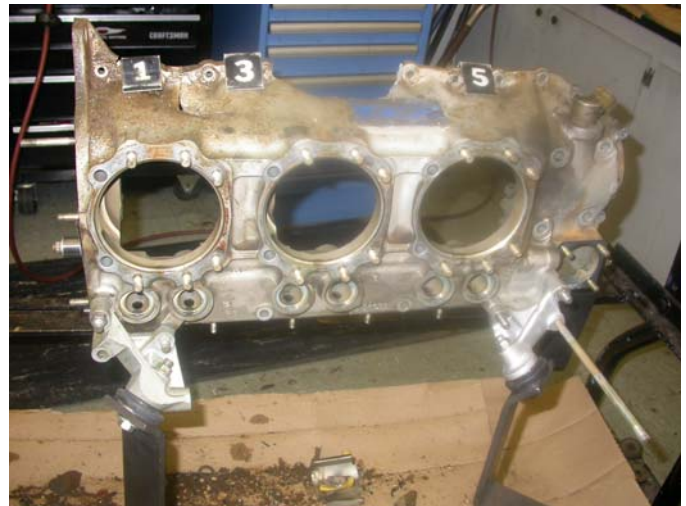
| Date | Engine Model | Engine Serial No. | Aircraft Registration | Page |

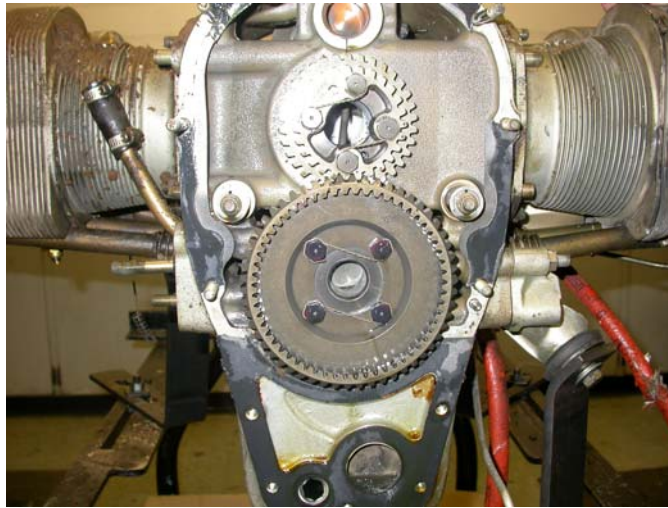
Condition: The accessory gears had continuity. The teeth were undamaged and exhibited normal operating signatures.

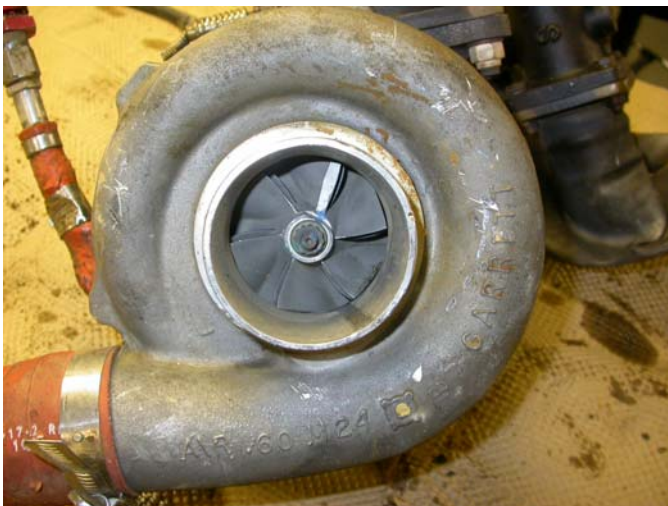
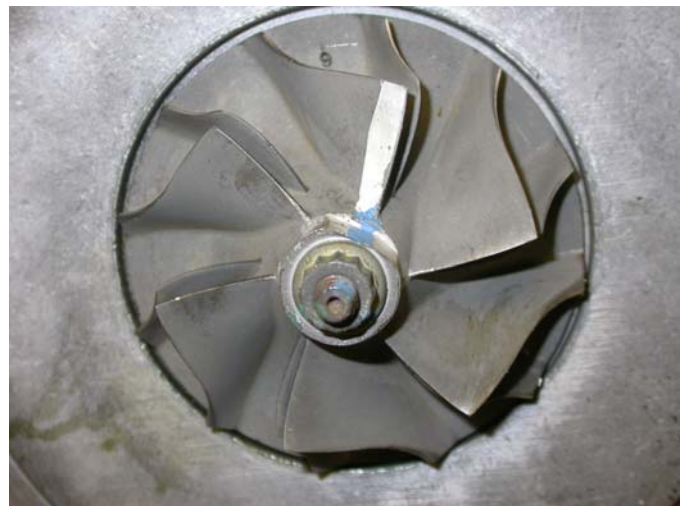
| Date | Engine Model | Engine Serial No. | Aircraft Registration | Page |

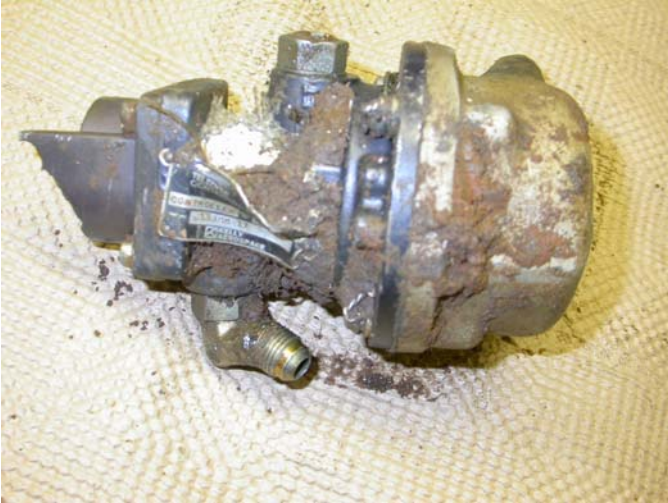
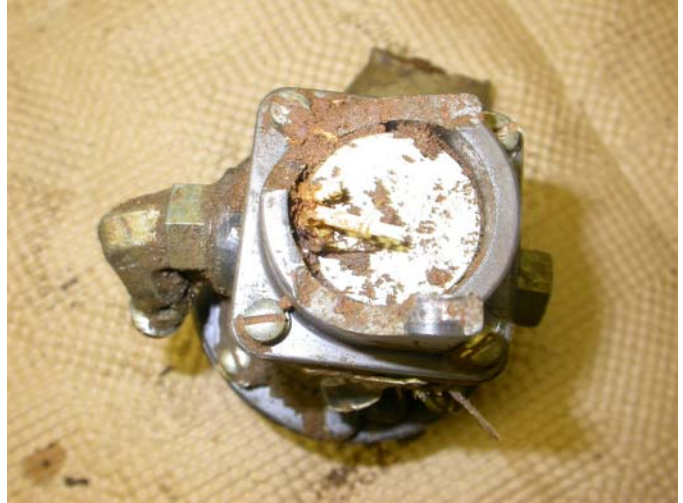
Wastegate Part number: 648006-8 Kelley Aerospace

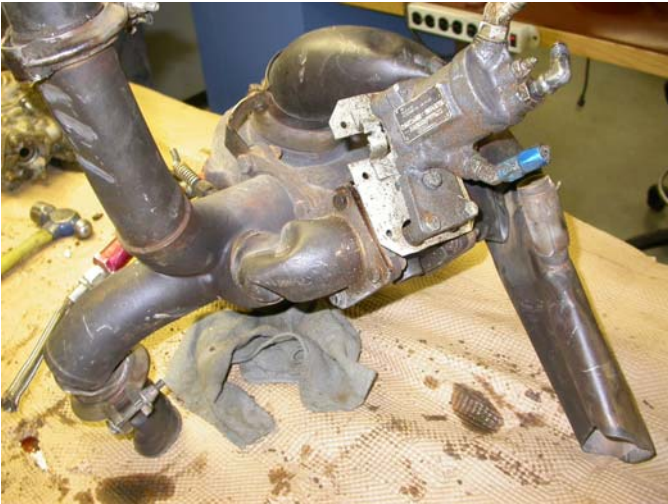
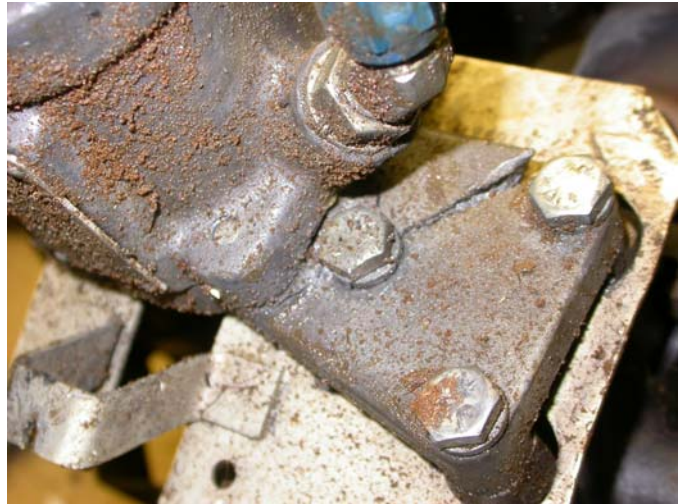
| Date | Engine Model | Engine Serial No. | Aircraft Registration | Page |

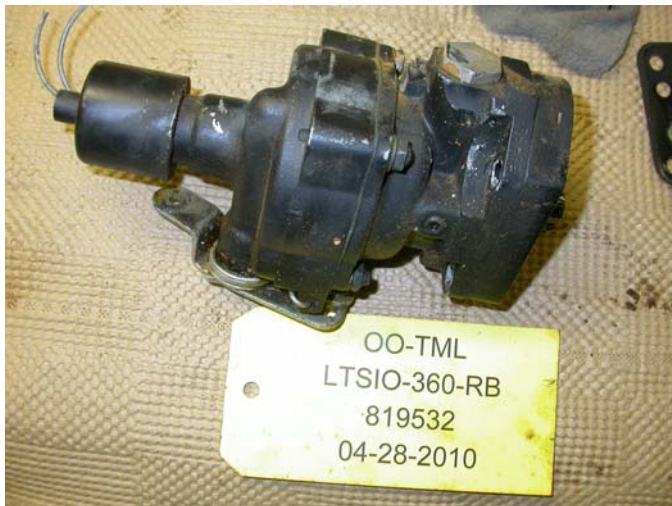
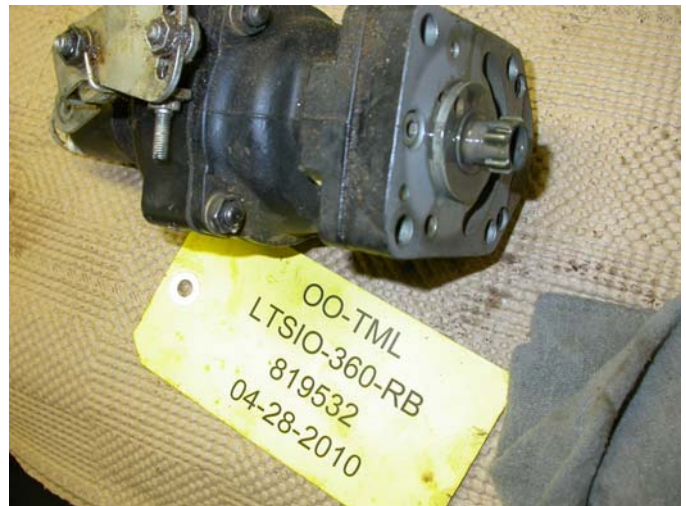
Vacuum Pump Part number: N/A
