## **FINAL ACCIDENT REPORT**

**Airbus A320  
SATA INTERNACIONAL**

**CS-TKO**

**REPORT Nr 33/ACCID/2009**

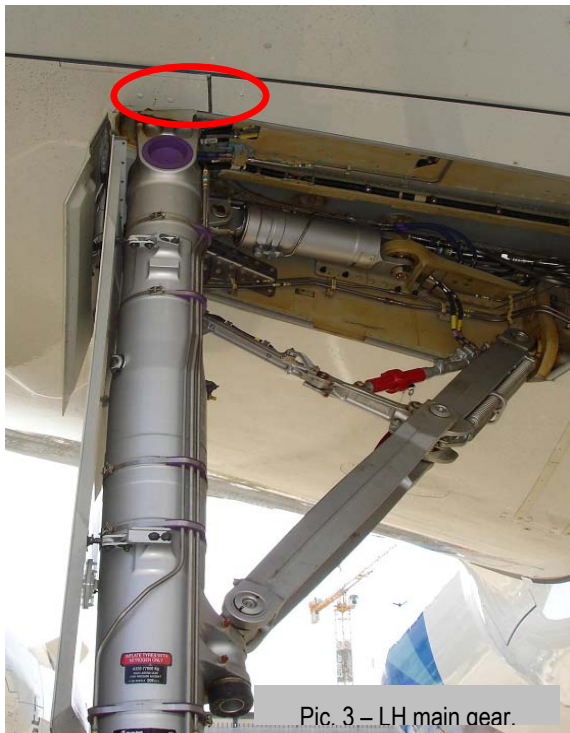
Pic. 3 – LH main gear.

*Wing Shroud Box Lower Panels*, on both sides, showed some damage (pic. 3, 4, 5 and 6). Some rivets on these panels popped out.

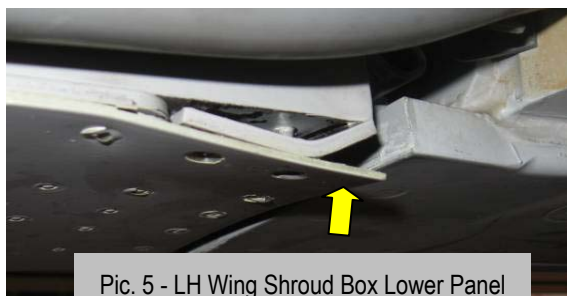
Pic. 5 - LH Wing Shroud Box Lower Panel

| CS-TKO Inspection Status | |
|---|---|
| <p><b>1. General Inspections (AMM 05-51-11 Inspection for Severe Hard Landing)</b></p> <ul style="list-style-type: none"> <li>Small damage in LH &amp; RH Wing Shroud Boxes Lower Panel - damage repaired.</li> <li>No further damage found.</li> </ul> <p><b>2. Fuselage - Sections 18 and 19.1</b></p> <ul style="list-style-type: none"> <li>NIL Findings.</li> </ul> <p><b>3. Fuselage - Sections 15, 16/17, 19, Keel Beam and rudder</b></p> <ul style="list-style-type: none"> <li>Small mark found on AFT cargo door lock fitting/fitting blended-out.</li> <li>Small gap found in a fitting in the aft cargo compartment/applied sealant to fill the gap.</li> <li>Some cracked sealant found in the aft cargo compartment/restored sealant.</li> <li>No further damage found.</li> </ul> <p><b>4. Fuselage - Section 21</b></p> <ul style="list-style-type: none"> <li>Found just one hi-lock broken - hi-lock replaced.</li> <li>No further damage found.</li> </ul> <p><b>5. Belly Fairings</b></p> <ul style="list-style-type: none"> <li>NIL Findings.</li> </ul> <p><b>6. Fuselage - Sections 11/12 and 13/14</b></p> <ul style="list-style-type: none"> <li>NIL Findings.</li> </ul> <p><b>7. Cockpit</b></p> <ul style="list-style-type: none"> <li>NIL Findings.</li> </ul> <p><b>8. Pylons and engine mounts</b></p> <ul style="list-style-type: none"> <li>Sealant in pylon-to-wing #1 aft attachment fitting found damaged - sealant to be restored.</li> </ul> | <ul style="list-style-type: none"> <li>Small crack found in a pylon #1 inboard panel - panel will be replaced.</li> <li>No further damage found.</li> </ul> <p><b>9. Thrust reversers and Nacelles</b></p> <ul style="list-style-type: none"> <li>NIL Findings.</li> </ul> <p><b>10. Wing structure</b></p> <ul style="list-style-type: none"> <li>Lack of sealant at aft edge of reinforcing plate - RH wing bottom skin - seal repaired.</li> <li>Some fasteners found with head dishing - fasteners to be replaced.</li> <li>Some fasteners found with cracked paint around head - paint to be restored.</li> <li>Slight ovality in MLG rib lugs with no further findings - lugs reworked.</li> <li>Small damage in LH &amp; RH Wing Shroud Boxes Lower Panel - damage repaired.</li> <li>No further damage found.</li> </ul> <p><b>11. Trimmable Horizontal Stabiliser (THS)</b></p> <ul style="list-style-type: none"> <li>Paint peeled off over a rivet head and over a sealant area in THS - will be repainted.</li> <li>Slight waviness in panel 4 of the upper skin THS - waviness Ok according with Airbus.</li> <li>Hinge arm #6 with small lack of material - hinge smoothly blended-out and reprotected.</li> <li>No further damage found.</li> </ul> <p><b>12. Engines</b></p> <ul style="list-style-type: none"> <li>NIL Findings.</li> </ul> <p><b>13. APU</b></p> <ul style="list-style-type: none"> <li>NIL Findings.</li> </ul> |

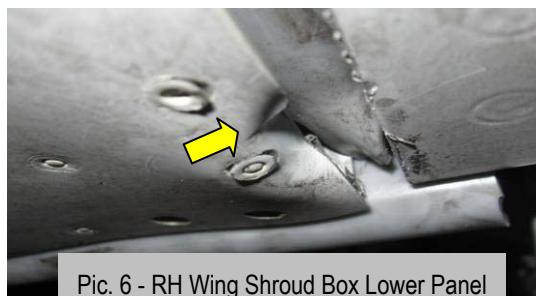
Pic. 6 - RH Wing Shroud Box Lower Panel

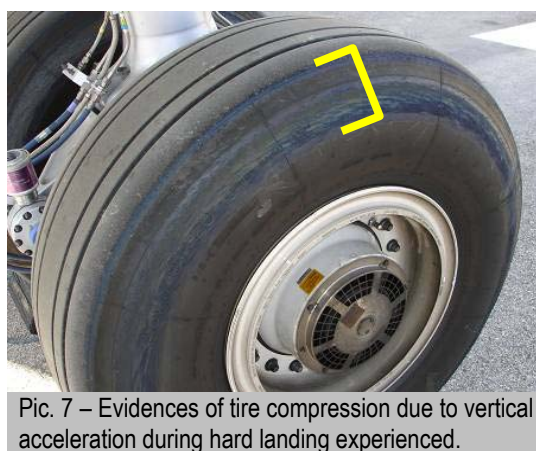
It was found compression marks on the main gear tires (pic. 7) due to the impact on the RWY.

Pic. 7 – Evidences of tire compression due to vertical acceleration during hard landing experienced.

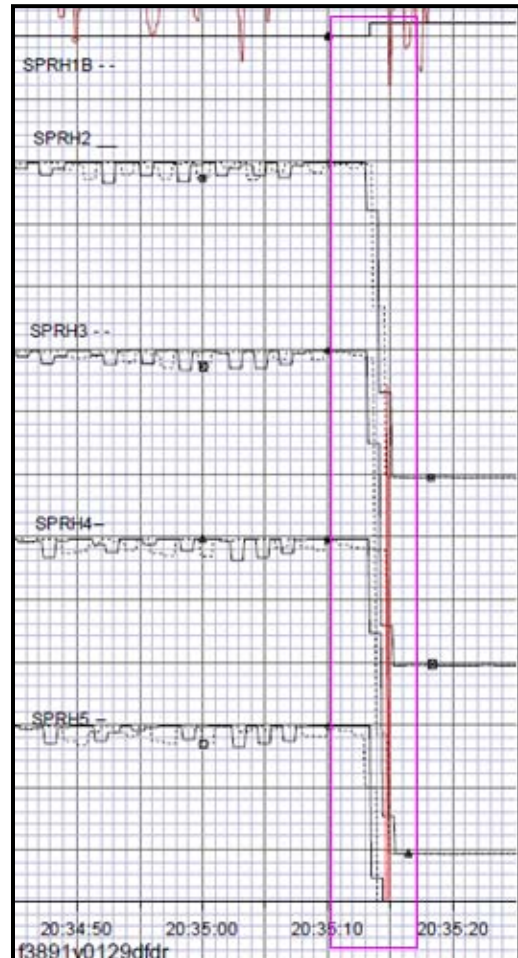
- At 20:35:12 hours:
  - During the bounce, PF ordered some alternate pitch up/pitch down inputs that changed the attitude to 3.7 degrees up;
  - Being A/THR active and speed decreasing, automatism reacted suitably and power was increased on both engines;
- At 20:35:13 hours:
  - Aircraft bounced up to 12ft RA;
  - PF ordered full nose-up input and pitch started to increase again.
- At 20:35:13,5 hours:
  - THR levers were set to *IDLE* notch and this action led to the A/THR disconnection (pic. 13) and a power decreasing;
  - Simultaneously, Ground Spoilers were extended, causing drag leading to a vertical speed acceleration increment of the aircraft towards the ground (pic16).
- At 20:35:14 hours:
  - Action applied on the rudder pedal was maintained during the whole bounce which lasted for about 5 seconds.

Pic. 16 – Spoilers extension graphic

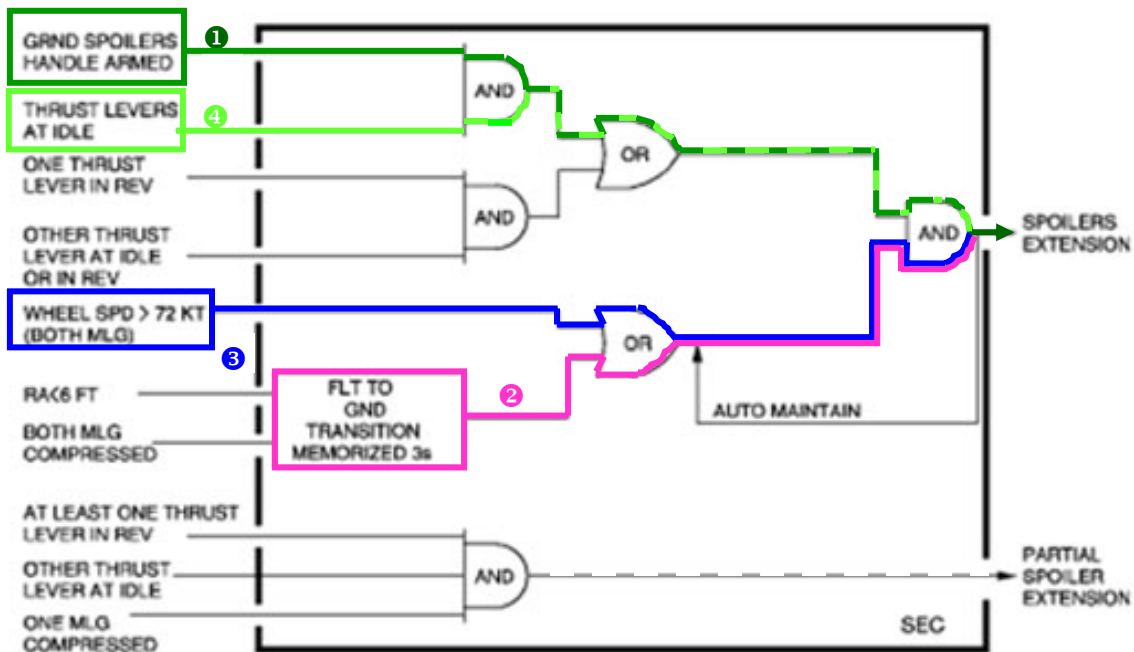
Pic. 31

In fact, consulting FCOM 1.27.10 (pic. 31), necessary conditions for ground spoilers' deployment are possible not only on the ground but in the air during a bounce, if the crew has not retarded the thrust levers for touchdown and retards the thrust levers during the bounce.

- The aircraft came for landing with spoilers “ARMED”, fulfilling condition ①;
- When it touched down both main landing gear struts were compressed and condition ② remained active for 3s; Both main wheels started rotating and its speed attained >72kt, giving condition ③ as a backup for condition ②;
- When the pilot reduced thrust levers to “IDLE”, condition ④, associated with condition ①, provided the necessary signal for the system to command ground spoilers' extension in the air.

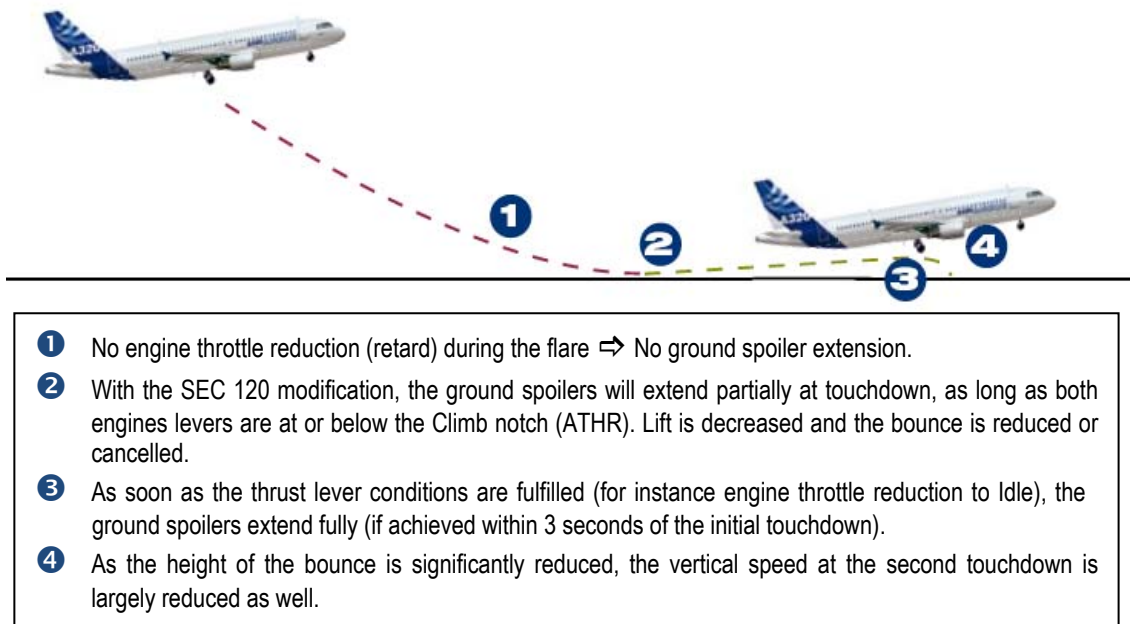
Pic. 34

If new PLD logic was already implemented on CS-TKO, the bounce height on this event would have been significantly reduced and the impact at the second touchdown would have been considerably lighter (about +1,7g instead of the experienced +4.86g, as stated by Airbus).

So, Airbus expects to overcome eventual runway overrun events – with the Ground Spoilers automatic deployment even if speed brake lever is not retracted and thrust levers are above *IDLE* position – and to reduce the bounces' frequency and amplitude in hard landings situations – with the Ground Spoilers Partial Lift Dumping (PLD) at the
