**MINISTÉRIO DAS OBRAS PÚBLICAS, TRANSPORTES E COMUNICAÇÕES
GABINETE DE PREVENÇÃO E INVESTIGAÇÃO DE ACIDENTES COM AERONAVES**

FINAL ACCIDENT REPORT

**COSTA BLANCA FLIGHT TRAINING CENTRE, S.L.
BEEHCRAFT 77**

FINAL ACCIDENT REPORT Nr. 26/ACCID/2009

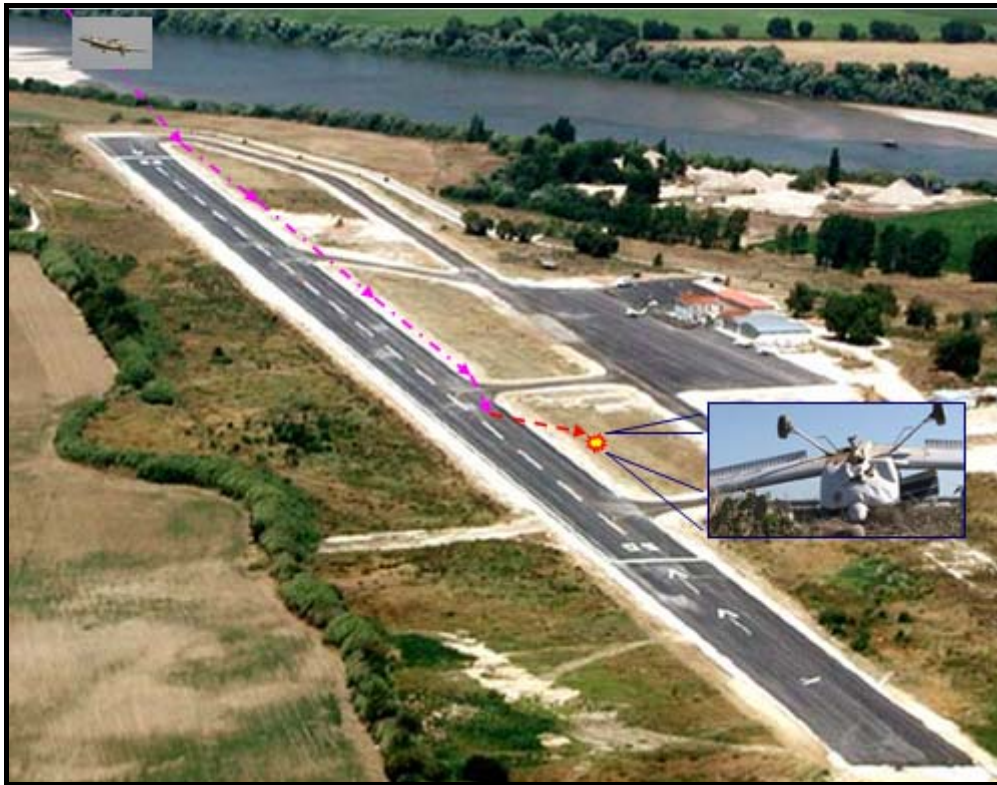
Picture Nr. 1

It entered the unpaved area, the nose wheel penetrated in the sandy soil (breaking-up) and the aircraft capsized, resting on its top, about five metres offset of the runway and facing 020° approximately (*picture nr. 1*).

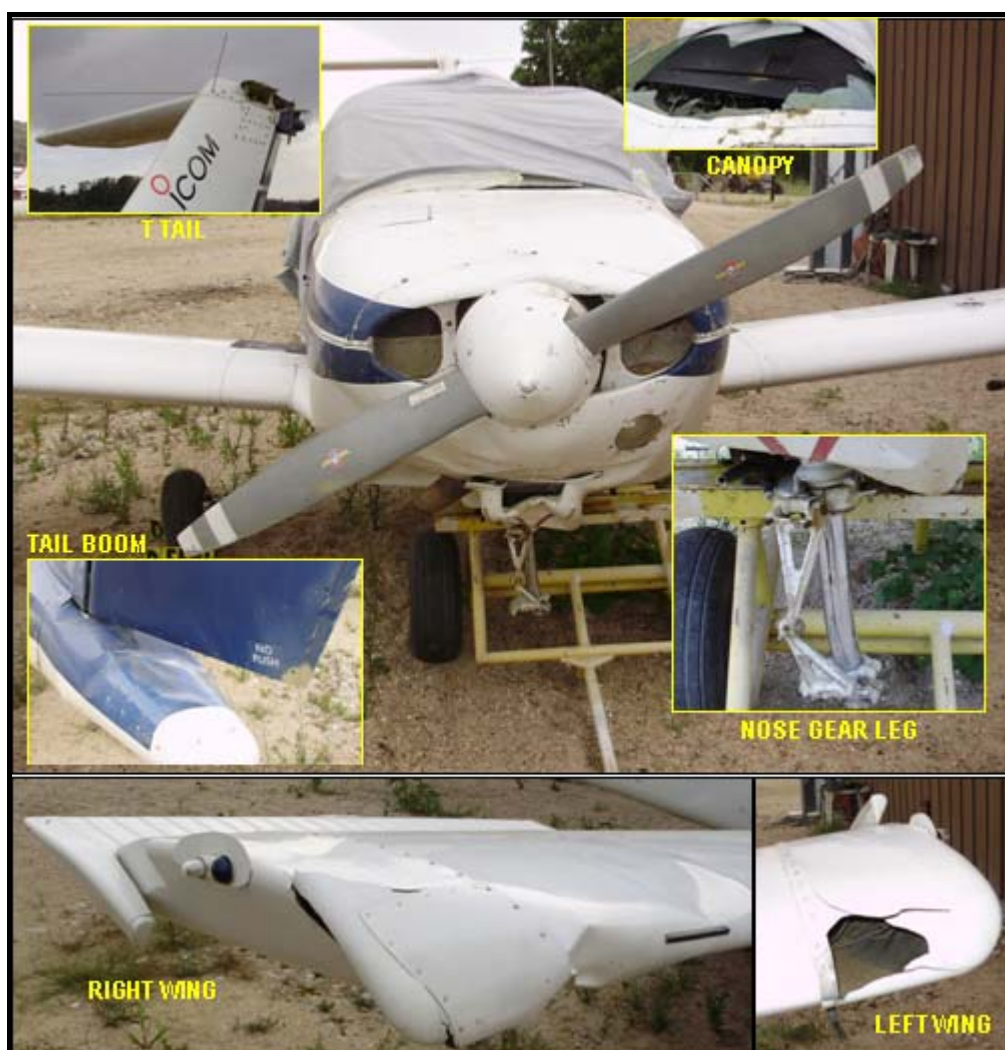
Picture Nr. 2

The aircraft suffered heavy damage on nose gear, canopy & cabin top, right & left wings, tail and propeller (*picture nr. 2*).

Leaving the asphalt surface the aircraft run about 30m prior the nose wheel penetrated in the sandy soil and broke apart. Animated with inertial energy, when the nose hit the ground, the aircraft capsized and became upside-down, with right wing hitting hard the soil and becoming wrinkled, while cabin top crushed and broke the windscreen and canopy. The tail struck the ground and left stabilizer was separated. At same time the impact forced the vertical stabilizer and ruder against tail boom, creasing it.

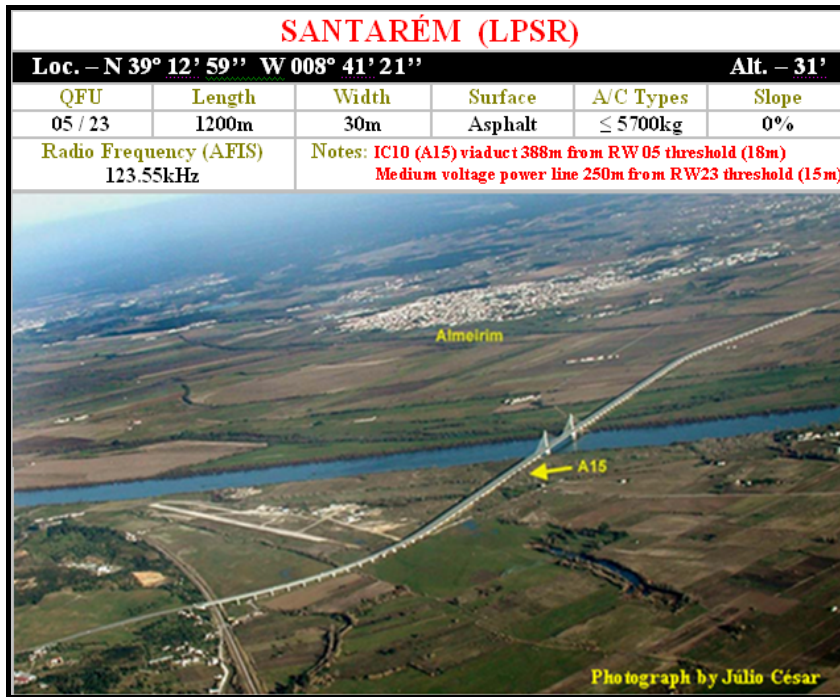
Picture Nr. 3

The privately owned Santarém aerodrome (Cosme Pedrógão) is located near Tagus river, 2NM south of the city and it is served by a single 1205m long runway (*picture nr. 3*).

Due the presence of IC10 (A15) viaduct on the approach path for runway 05, threshold has been displaced in order to give greater clearance over the obstacle, thus reducing landing distance available on RW05 to 980m while maintaining landing distance for RW23 at 1125m.
