**MINISTÉRIO DAS OBRAS PÚBLICAS, TRANSPORTES E COMUNICAÇÕES
GABINETE DE PREVENÇÃO E INVESTIGAÇÃO DE ACIDENTES COM AERONAVES**

FINAL ACCIDENT REPORT

CS-HFB

FINAL ACCIDENT REPORT Nr. 18/ACCID/2009

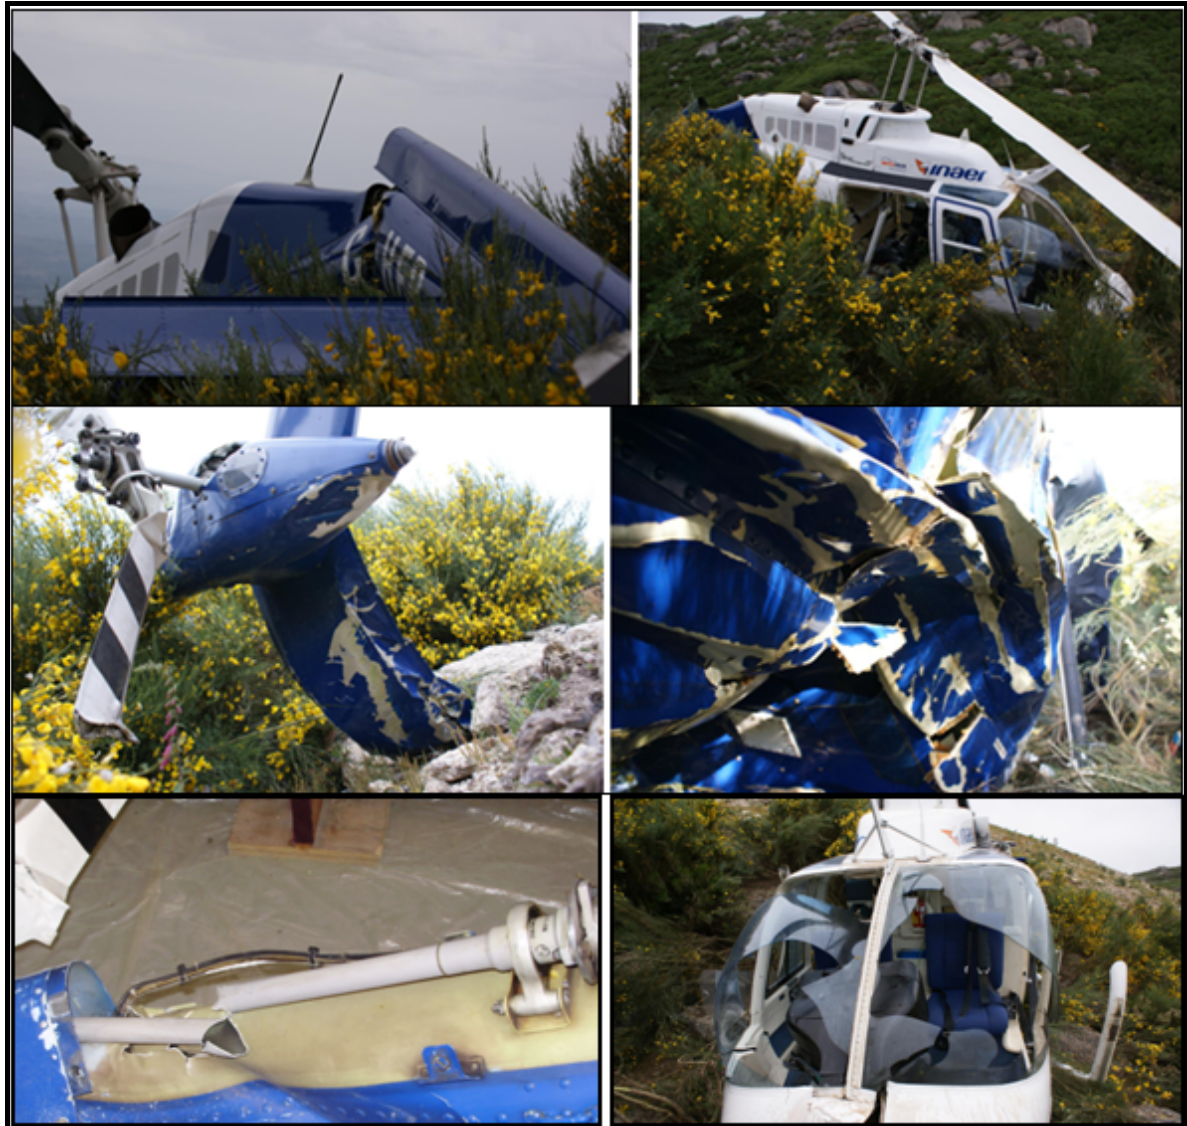
Picture Nr. 2

Cabin impact with the rock was very hard and its underneath became smashed. The tail cone broke near the body attachment and vertical stabilizer and tail rotor blades hit the ground, suffering substantial damage, with broken blades and rear transmission torque tube. Skids were broken, on both sides. Number 5 Main Gear Box mounting broke and main rotor mast moved forward. Windshields cracked (*picture nr 2*).

As it was a vertical fall of the aircraft on the ground, all parts remained together. Even detached parts, like windshield fragments, were kept inside the cabin. The other broken parts, like skids or tail boom, vertical stabilizer and tail rotor, were not detached from main structure, as seen in picture nr 2, confirming the absence of translational speed.

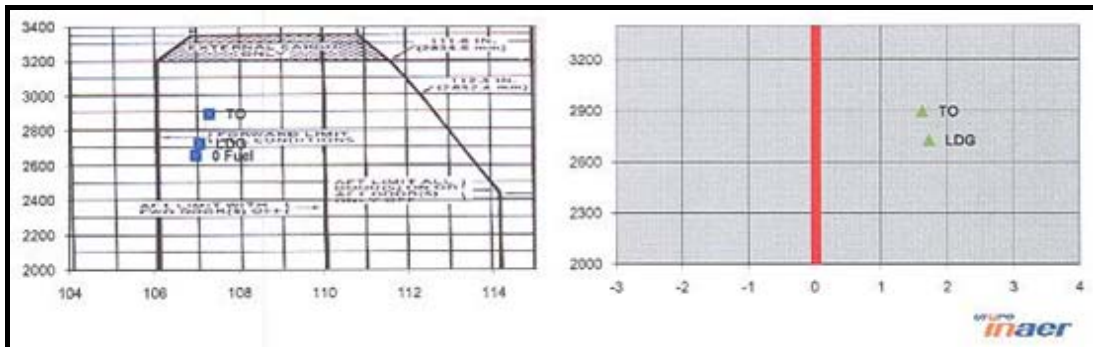
Picture Nr. 7

Applying respective arms & moments a Balance chart was drawn, with a Longitudinal Centre of Gravity (CG) of 107.3in for take-off and 107.1in on accident occasion and a corresponding Lateral CG of 1.6in and 1.7in, well inside the approved envelope (*picture nr 7*).

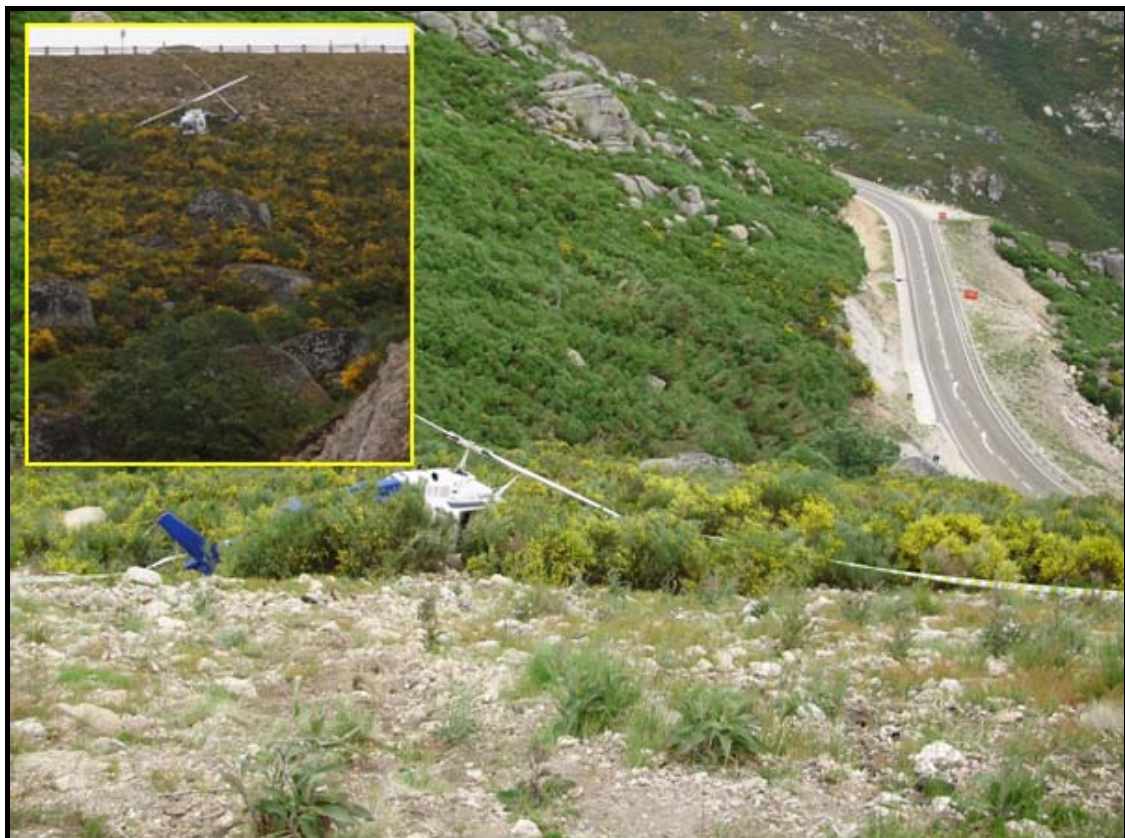
Picture Nr. 9

When the accident took place construction works were finished and the place showed like on picture nr 9, where we can see the helicopter, after the accident, from above (in the main picture) or from bellow (in the inserted picture).

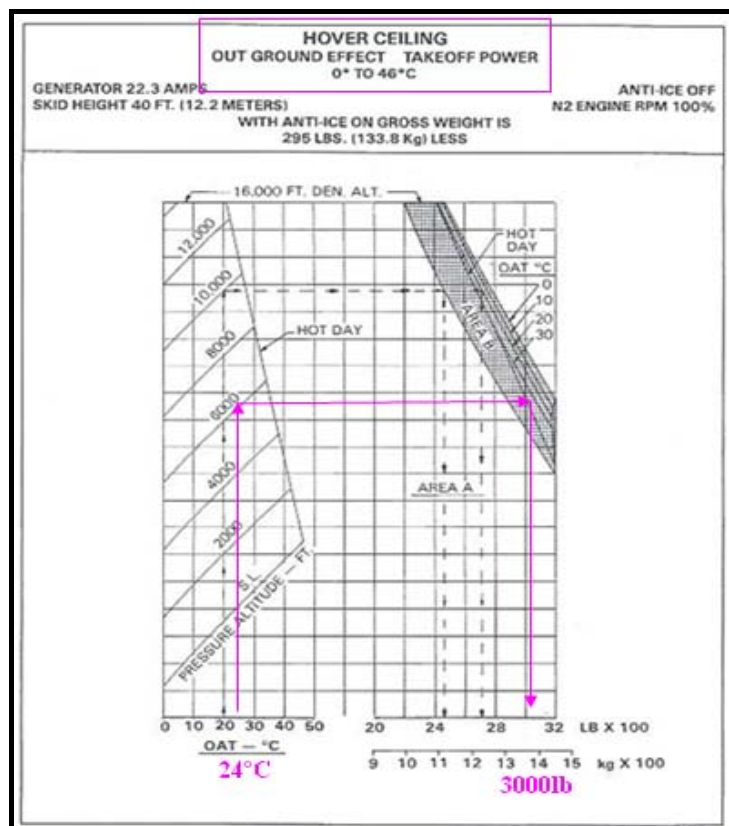
Picture Nr. 10

Performance table, on Aircraft Flight Manual (AFM), regarding aircraft hover performance, out of ground effect, was used (*picture nr 10*) to determine if the aircraft could comply with altitude limited performance. Considering an outside temperature of 25°C and a pressure altitude of 6000ft, the table showed that Total Mass could be up to 3000lb (1360kg). Going back to 1.6.2, Actual Mass of 2730lb (1238kg) was confirmed, though bellow the Maximum Mass allowed for those conditions.
