MINISTÉRIO DA ECONOMIA E DO EMPREGO
GABINETE DE PREVENÇÃO E INVESTIGAÇÃO DE ACIDENTES COM AERONAVES
GPIAA

AIRCRAFT INCIDENT INVESTIGATION

Date/time: 12/07/2010 @ 21:00 UTC ¹		Proc. N° 10 /INCID/2010
Handling Operator: Portway	Type of Incid.: Pushback truck struck aircraft	
Aircraft: Airbus A319, G-EZIV, EZY256G, s/n 2565. MTOM = 64 000 kg		
Local: Lisbon Airport (LPPT)		
Flight Type: Transport	Operation : pushback	
Persons on board: 102	Pax: 96	Injuries: NIL
Damage to Aircraft: The aircraft suffered damage in nacelle and casing of engine #2.

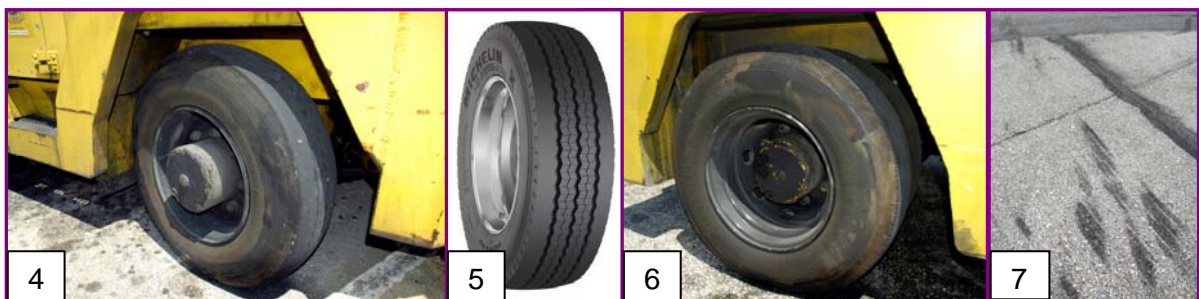
The entrainment of the tug has left brands on asphalt with about three meters long.

Fig N°4–right front tire. Fig N°5–original tire. Fig N°6–right rear tire. Fig N°7–ground brands.

The sum of these vectors would have to be countered by the tug driver, towing in reverse a tug whose weight was at the lower limit of the minimum specifications to tow this type of aircraft. Also the fact the tug to have tyres in bad condition and the towbar hitched on front decreased its ability to grip.

6. The tyres of the tug had excessive wear suggesting a decrease in their ability to grip;
7. At the beginning of the pull ahead the tug made a sharp turn to the right;

It is recommended to the National Civil Aviation Authority that ensures, in the national airports, the application of standards and recommended practices to all vehicles and mobile equipment used in the vicinity of aircraft. **Safety Recommendation N° 11/2011.**
