**MINISTÉRIO DAS OBRAS PÚBLICAS, TRANSPORTES E COMUNICAÇÕES
GABINETE DE PREVENÇÃO E INVESTIGAÇÃO DE ACIDENTES COM AERONAVES****AIRCRAFT INCIDENT SUMMARY REPORT**

Date/Time: 2010 / 05 / 29 @ 16:16 UTC ¹	Proc. Nr.: 06 / SUM / 2010
Operator: Norwegian Airshuttle ASA Brussels Airlines	Type of Incid.: Loss of Separation
Id. of aircraft: Boeing B-737/800, registration LN-DYA , flight NAX-1782 Boeing B-737/400, registration unknown, flight BEL-52F	
Local: Faro Airport (LPFR)	
Type of flight: Passengers Transport	Phase of flight: Landing
People on board: Crew / Pax: 6/NA	Injuries: Nil
Aircraft Damage: Nil	
Other Damage: Nil	
Synopsys: The aircraft was flying from Oslo (Gardermoen) (ENGM) to Faro (LPFR), operating a passenger's transport flight (NAX-1782), and received radar vectors, in order to intercept localizer, for landing at Faro runway 28. About to capture localizer, with traffic 6NM ahead (BEE-8HW), TWR requested to reduce speed to 160kt, intending to intercalate a departure between both landing aircrafts. At about 2000ft RA, NAX-1782 was instructed to reduce to minimum approach speed, but, when the preceding aircraft landed and BEL-52F was cleared to line up, it was about 3NM far

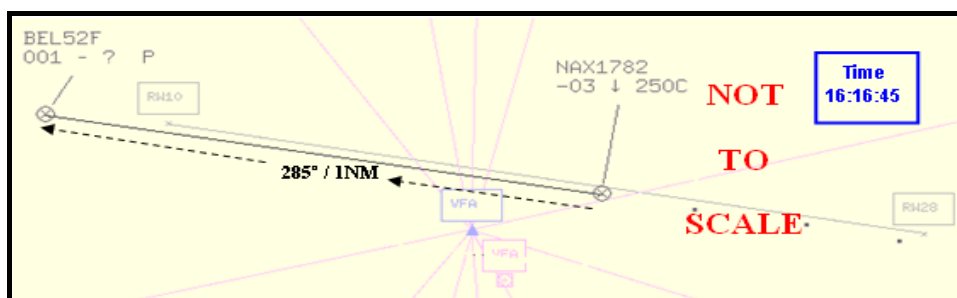
Picture Nr 7

The first image where both aircrafts are present on a snapshot relate to time 16:16:45 (picture nr 7) and show the first one on ground and the other airborne (passing ±100ft). By that time NAX-1782 had covered ≥800m on runway, from runway threshold.

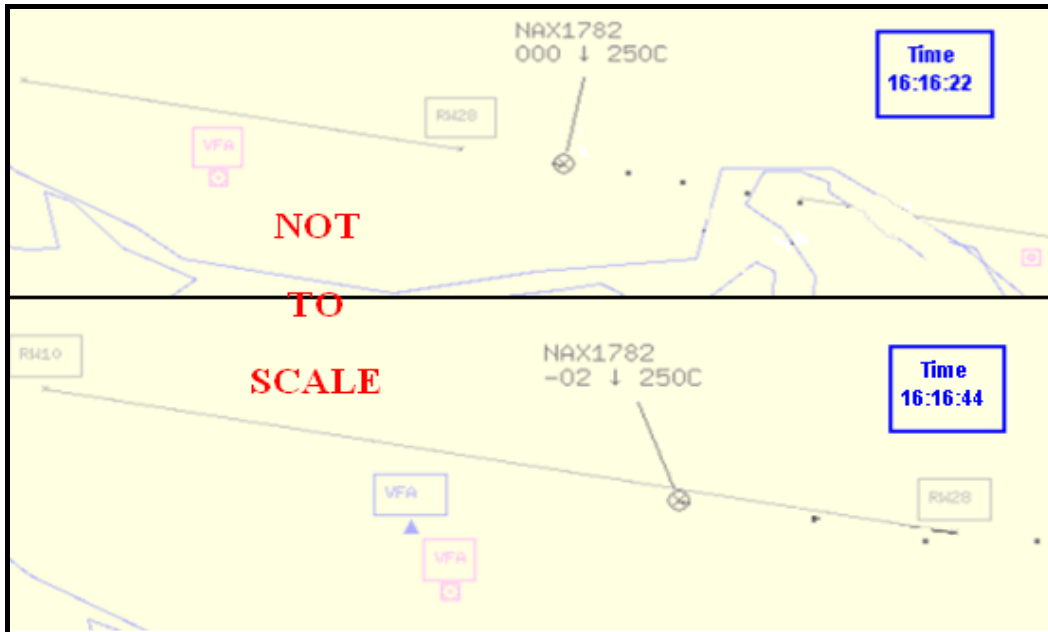
Picture Nr 8

When landing clearance for NAX-1782 was issued (16:16:22), supposedly after BEL-52F take-off, NAX-1782 was near runway threshold, below 100ft (*picture nr 8*).

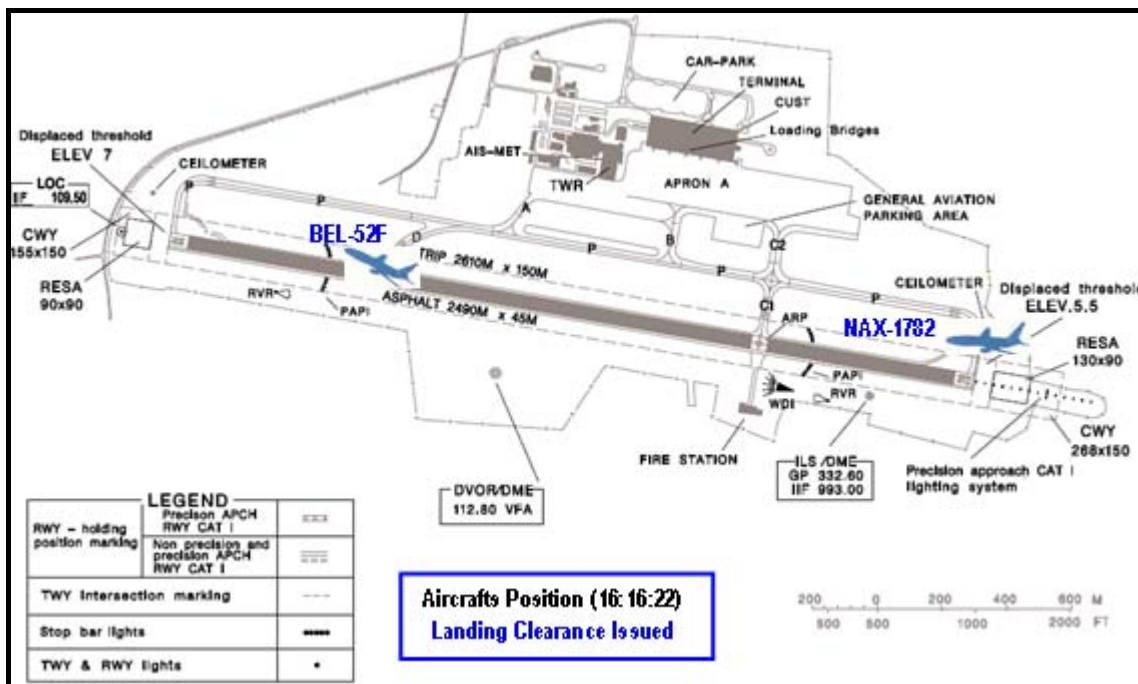
Picture Nr 9

Starting take-off run at 16:15:50, BEL-52F became airborne at 16:16:22, when TWR cleared NAX-1782 to land on RWY28 (picture nr 9).

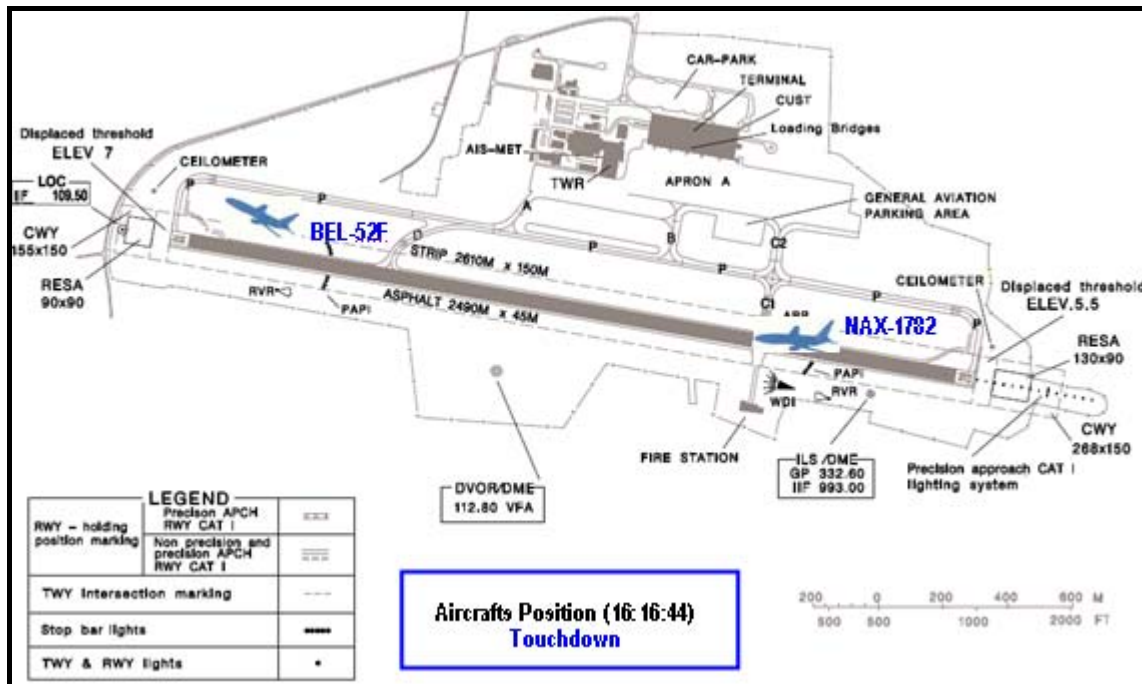
Picture Nr 10

When landing clearance was issued NAX-1782 was approaching runway threshold and, when PNF finished the readback, the aircraft was touching-down. Distance between aircrafts was ± 1750 m, well below minimum referred in § 7.11.7 and § 7.10.1 (picture nr 10).
