**MINISTÉRIO DA ECONOMIA E DO EMPREGO**  
**GABINETE DE PREVENÇÃO E INVESTIGAÇÃO DE ACIDENTES COM AERONAVES**  
**(GPIAA)**

## **FINAL ACCIDENT REPORT**

**Aircraft – BINGO**

**EC-EG4**

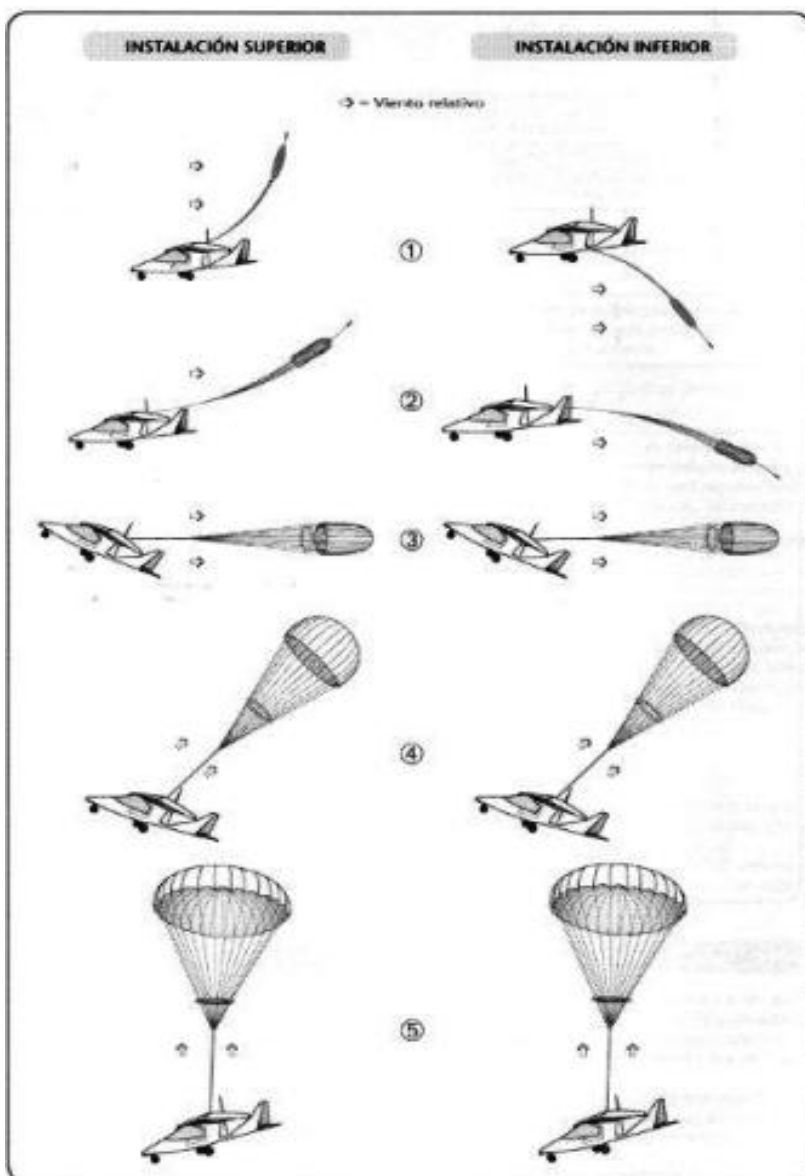
Figure Nº 1 - Parachute

The plane was equipped with an emergency parachute "ALPHA" (fig. nº 1) developed for use in ultra light aircraft and some light aircraft. The equipment had 9 kg of mass and was limited to 475 kg payload and speed of 250 km/h. The Manual of the equipment (Spanish version) says that the parachute should be installed in a location that does not adversely affect the Centre of gravity of the aircraft.

The parachute must be installed in a position that does not affect the centre of gravity of the aircraft, in accordance with the Manual. Although the Manual does not specify the reason for this installation we believe that is related to the aircraft flight envelope and, ultimately, with his control in flight. On the other hand, if the parachute is installed away from the centre of gravity the aircraft will tend to descend leaning to the side of the CG.

Investigation admits that the parachute was installed for the condition of the aircraft flying with only pilot. It turns out that, with two occupants, the aircraft's CG moved closer to the front that resulted in a nose down attitude, during the descent assisted by parachute. Adjusting the position of the parachute to a position closer to the Centre of gravity would have countered the tendency of the aircraft put the nose down what would be more favorable for the two occupants.

Nevertheless, the investigation highlights that the installation of the parachute should be made in accordance with the manufacturer's recommendations. Indeed, the manufacturer recommends that the parachute be installed near the centre of gravity, certainly for the sake of balance, but also to allow better conditions to landing – with the aircraft in a landing attitude – which is more favourable to the (s) its occupant (s).

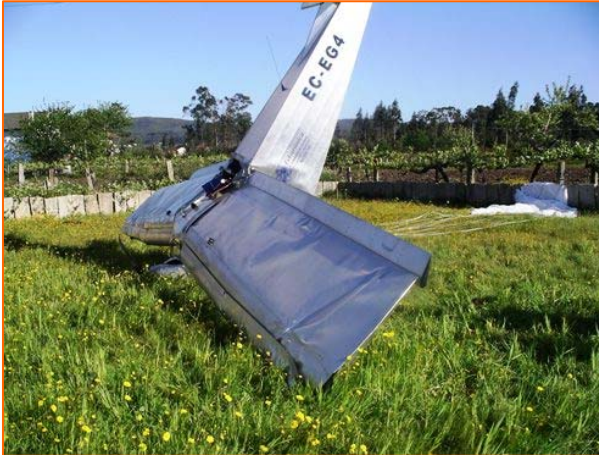
The aircraft "landed" on the backyard of a Villa, a place where there were nearby, high trees, powerlines and latticework doors vineyards.

Figure nº 2 – position of the aircraft.

The aircraft struck the ground in a nose down attitude.

The attitude of the aircraft during the contact with the soil can be related with the installation of parachute in a position behind the centre of gravity, a fact admitted by the pilot.

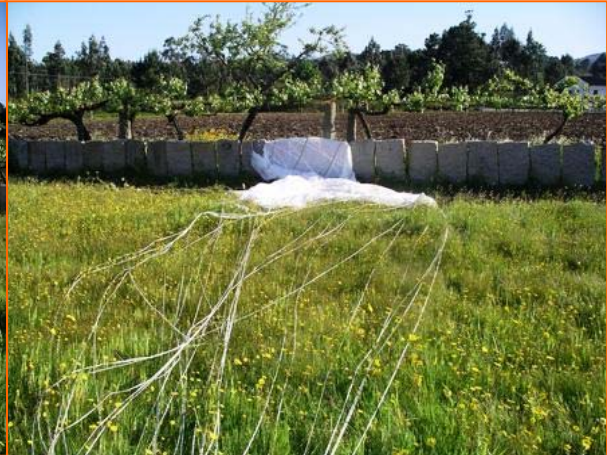
Figure nº 3 – detail of parachute.

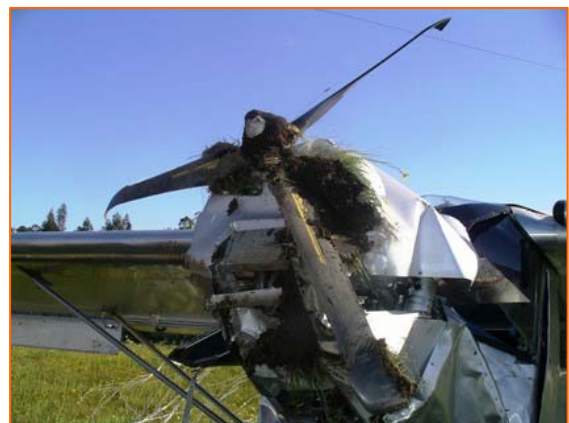
The tips of the propeller blades were slightly bent indicating windmill motion.

The engine lacked the spark plug of the right cylinder. The fairings had been damaged.

Figura nº 4 – grupo moto propulsor.

The spark plug of the right cylinder was not found at the scene of the accident and has been concluded that jumped during the flight. The absence of the spark plug caused the lack of ignition and the consequent failure of the engine.

The failure of the engine occurred after 45 minutes of flight, accompanied by sharp lowering of the temperature of the cylinder. During the observation of the engine, done at the place of the accident, has been detected that lacked the spark plug of the right cylinder. The absence of the spark plug caused the decompression of the cylinder, the lack of ignition and the consequent failure of the engine.

The investigation considers that the spark plug had jumped due to poor grip, in conjunction with vibrations from the engine.
