FINAL ACCIDENT REPORT

Alon A2-A (Aircoupe)

CS-AIG

FINAL ACCIDENT REPORT Nr. 01/ACCID/2010

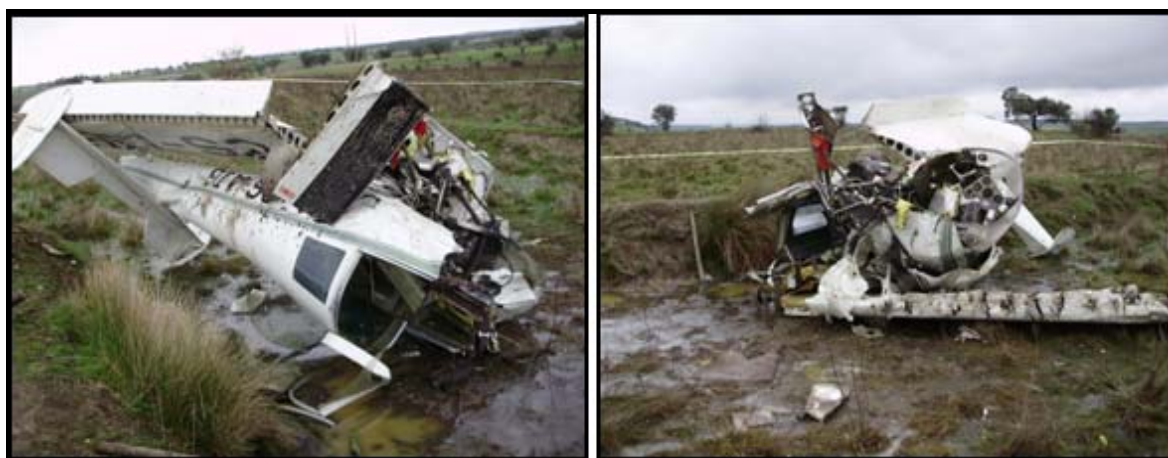
Picture Nr 2

The aircraft was destroyed (*picture nr 2*).

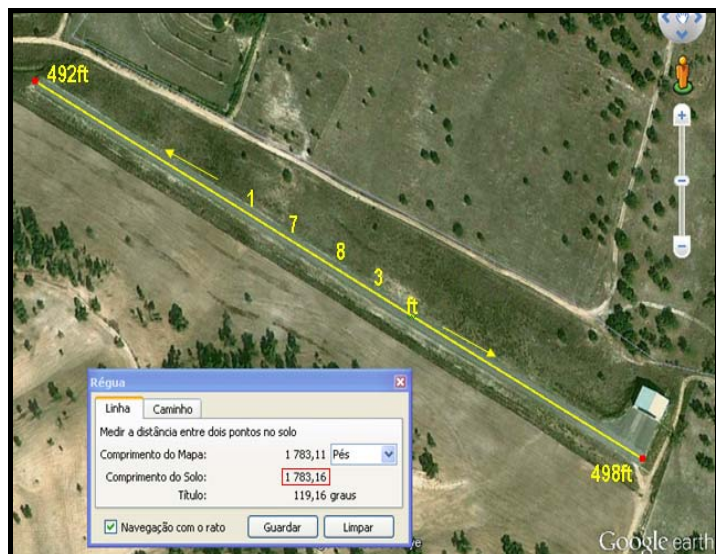
Picture Nr 7

Checking in loco it was discovered that runway length was not correct, being a bit shorter, just 1780ft long only (picture nr 7).

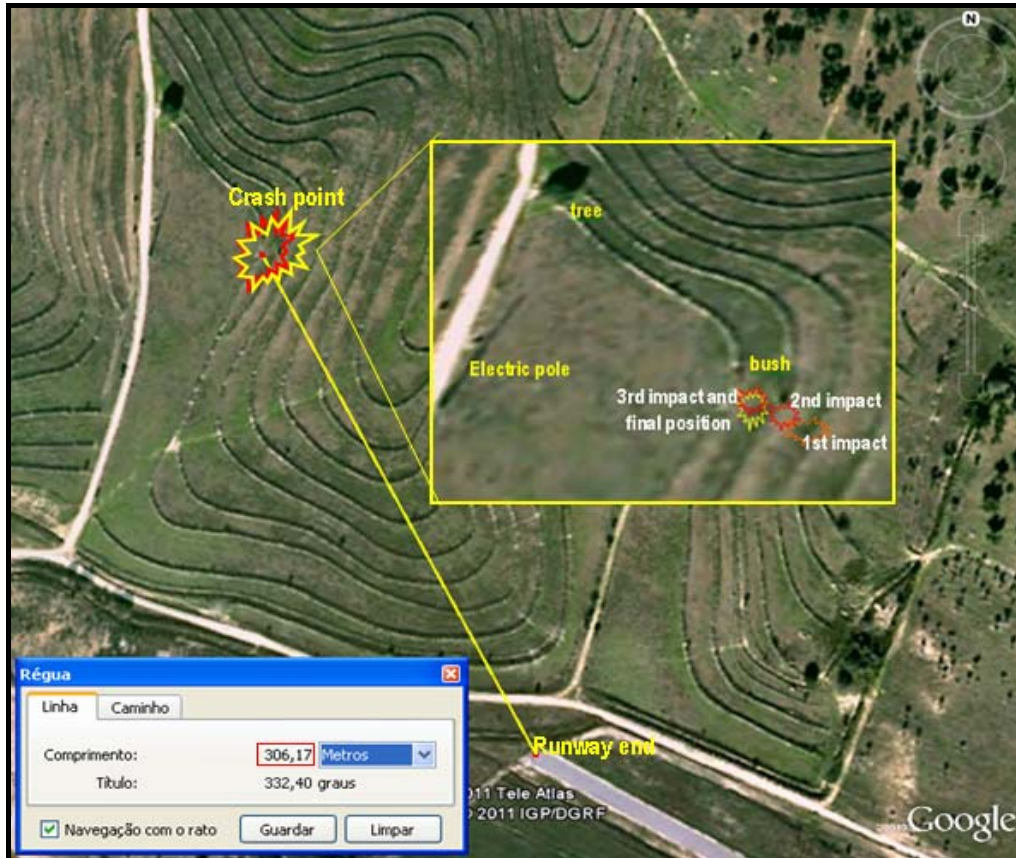
Picture Nr 8

The aircraft impacted the ground at 300m (1000ft) from runway end, 30° to the right of runway axis (*picture nr 8*). Three different impact marks were well recognized, about 5m apart, denoting a relatively slow horizontal speed and an attitude of wings levelled with a small pitch angle.

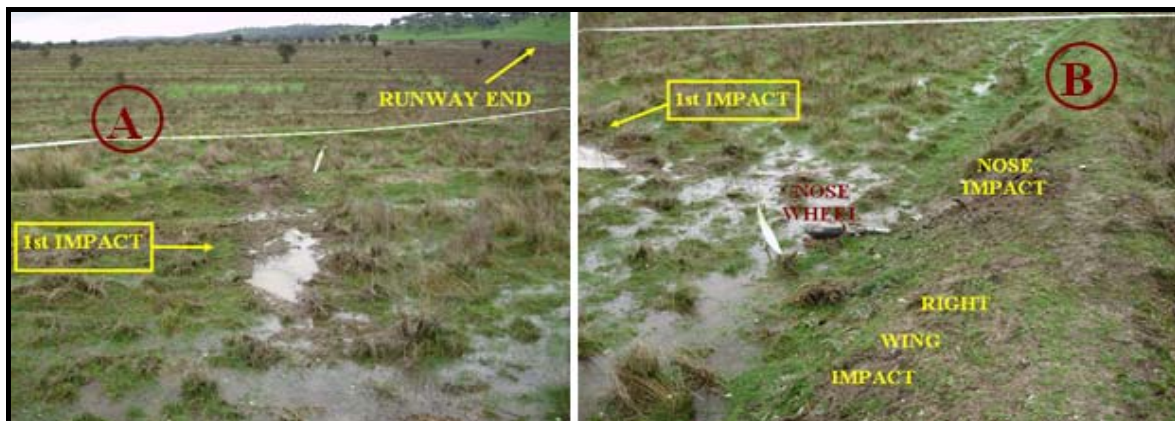
Picture Nr 9

First impact (*picture nr 9A*) was on its belly and almost levelled, making it jump into the air again and, gaining a nose down attitude, the aeroplane impacted a small bank frontally on its nose and right wing leading edge (*picture nr 9B*), losing the nose wheel.

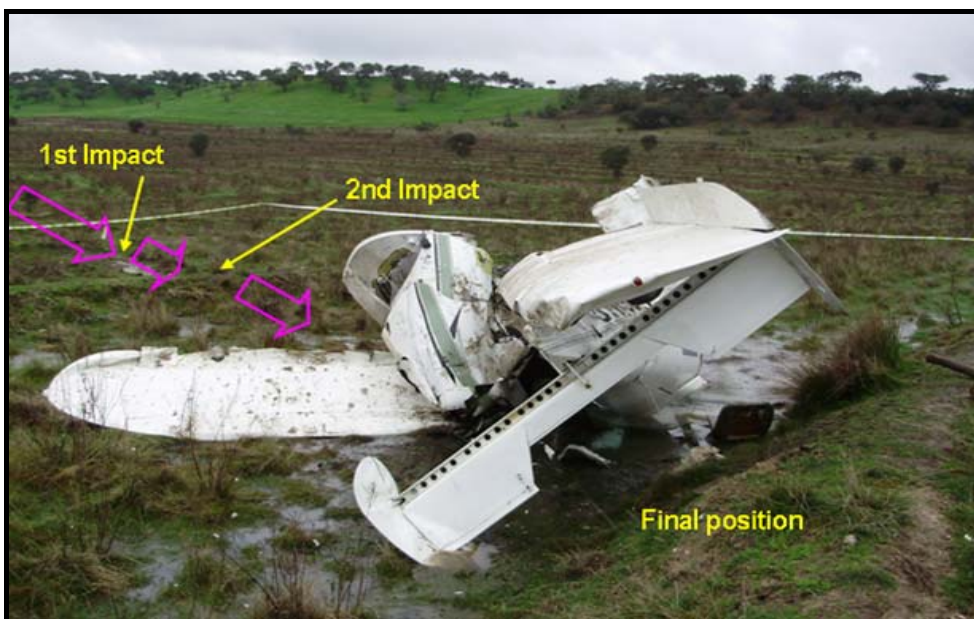
Picture Nr 10

After this second impact it nosed over and came to a rest, upside down, broken in several parts (*picture nr 10*), about 10m far from first impact point, heading about 130° left of initial track.

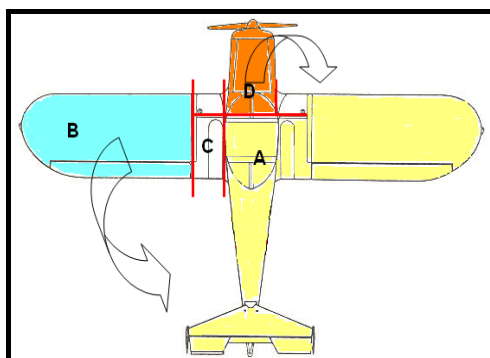
Picture Nr 11

The aircraft was destroyed when it broke along several breaking lines (*picture nr 11*):

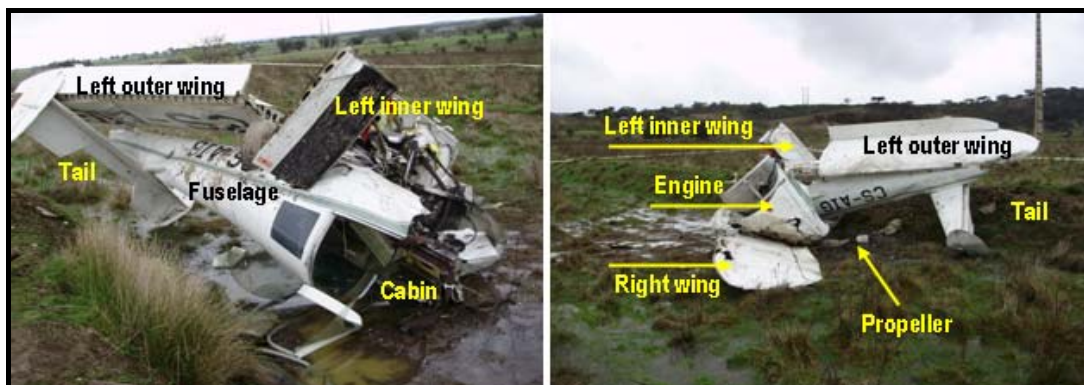
Picture Nr 12

Fuselage and right wing remained connected but upside down (A); Left wing broke up along two different lines, folding inside, becoming the outer wing (B) on top of fuselage and inner wing (C) positioned vertically in front of it; the cabin broke behind windscreen, with instrument panel following the engine block (D) and folding over right wing lower surface (*pictures nr 11 & 12*).

Tail and rear fuselage (behind cabin) suffered minor damage, but the cockpit became destroyed. Main landing gear remained connected to the fuselage, but nose leg broke-up and was separated on second impact. The engine seemed to be in good condition but propeller had both blades bent rearwards.

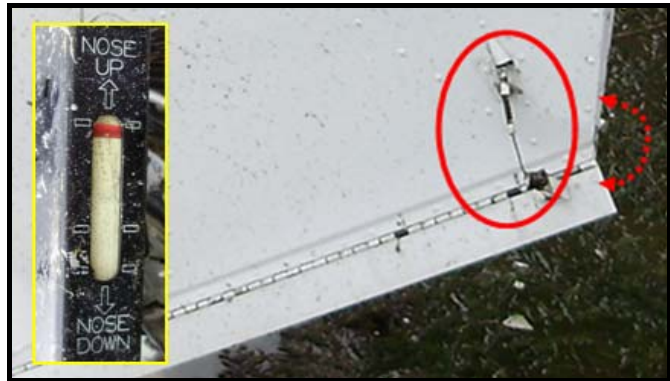
Picture Nr 13

The only granted indication was stabilizer trim position, which has been selected to the extreme forward position (FULL NOSE UP) and confirmed by respective surface position and actuating cable (*picture nr 13*). This forced the aircraft towards a pitch-down tendency, requiring higher pulling forces to overcome it.

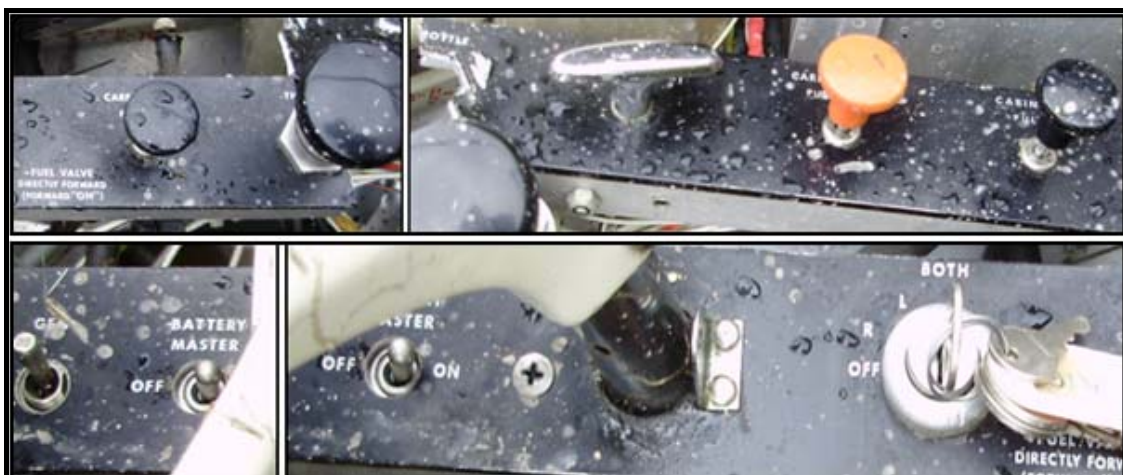
Picture Nr 14

Inside cockpit it could be seen that fuel shutoff valves (main and secondary) were opened, allowing fuel feeding of fuselage tank and carburettor; throttle was fully forward (*full power*) like mixture control (*full rich*); ignition switch was selected "BOTH", with battery and generator switched "ON" (*picture nr 14*).

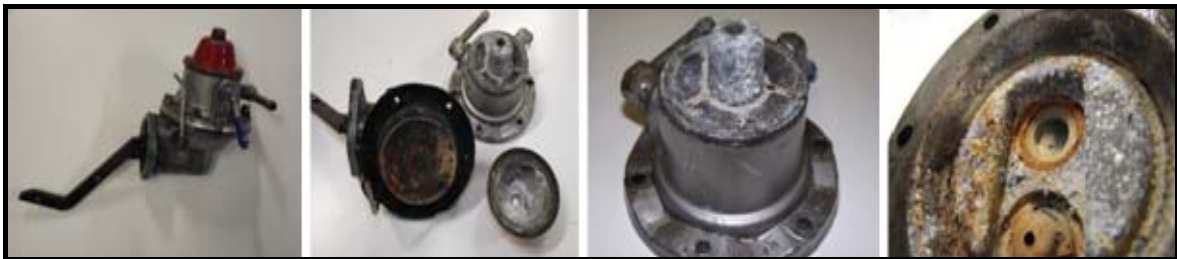
Picture Nr 15

Engine fuel feeding system was checked for continuity and possible leaks and nothing was found that could restrict fuel passage, except the presence of corrosive material inside fuel pump, which prevented fuel passage. Considering the aircraft stood in the water for some hours and more than one year time stored without any preservation treatment, fuselage tank fuel line to the carburettor was clean and there was some fuel in it, it's admissible that corrosion was not present at accident time and it have developed later (*picture nr 15*).

- 1st Fuel pump was found completely blocked by internal corrosion, which should be caused by the long period it was exposed to atmospheric elements, after the event, but could have been initiated before. At accident time, its fuel delivery rate could be reduced. Even so, considering the engine is fed directly from fuselage tank, a fuel shortage would be sensed after a certain period of operation only (after depleting fuselage tank), which was not the case, as the event occurred immediately after take-off;

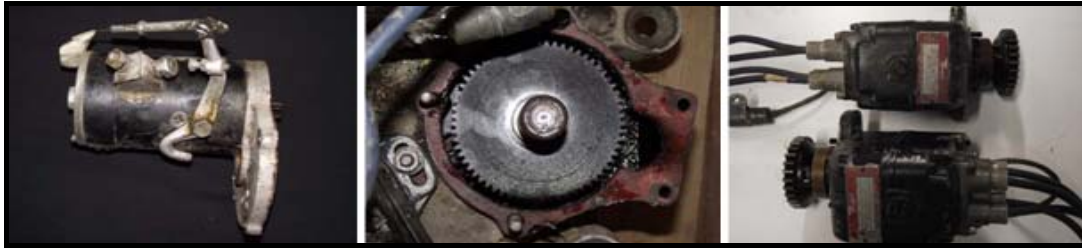
Picture Nr 16

Engine starter was running well, with coupling mechanism operating as expected and magnetos were in good condition and delivering (*picture nr 16*). Spark plugs and ignition cables were checked for condition and continuity. All spark plugs showed normal wear, consistent with its operating time. Ignition cables presented some damage near candle sockets, caused by ground impact. Otherwise its connectivity and continuity were normal.

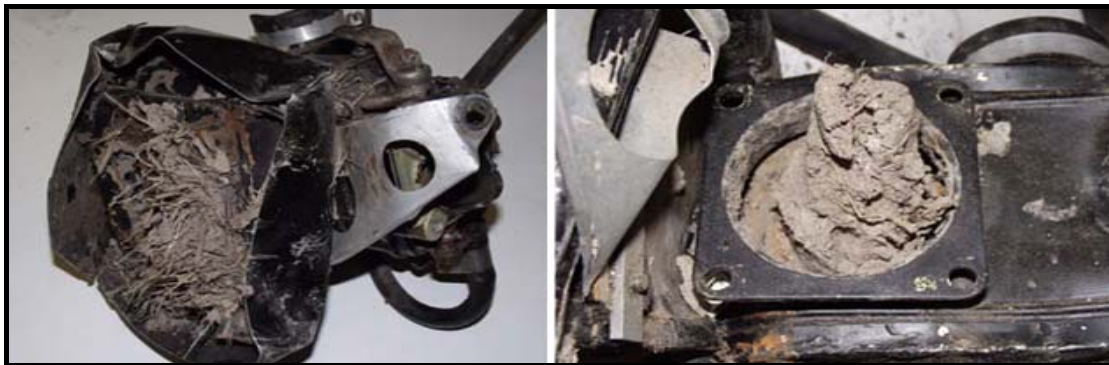
Picture Nr 17

Air intake and air filter were obstructed by mud and straws (being too much present on site of accident) and even carburettor mixing chamber was full of dry mud, signalling the engine was aspirating when hitting the ground (*picture nr 17*).

In fact, engine was running when the aircraft collide with the ground for the first time, as mud and straws found in air intake and carburettor chamber confirm and engine control's position shows that full power was applied, but the aircraft was not climbing as expected.

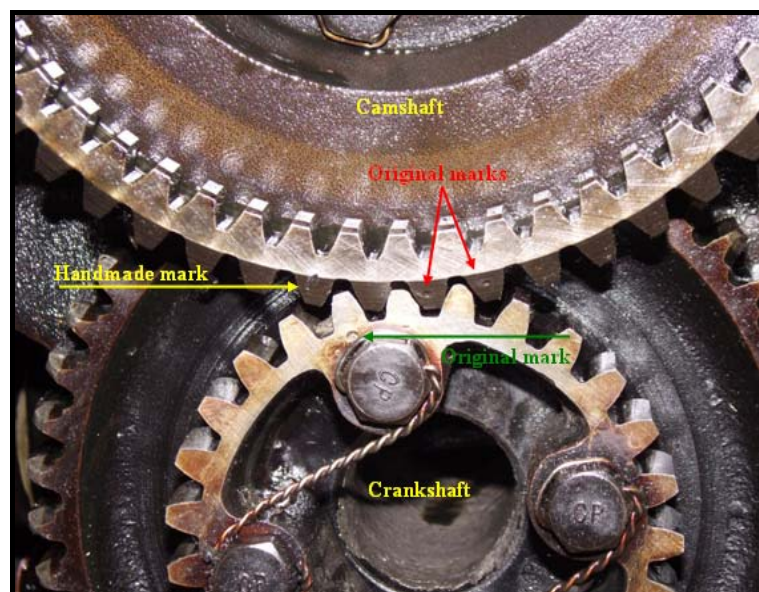
Picture Nr 18

A check was made to ascertain engine synchronization and it was discovered, on crankshaft / camshaft synchronization gear, that the original marks were misaligned by two teeth and there was a new handmade mark (*picture nr 18*). Contacted an engine expert, he explained that sometimes it is due to a fuel grade change, in order to avoid detonation, it becomes necessary to alter valve opening timings.

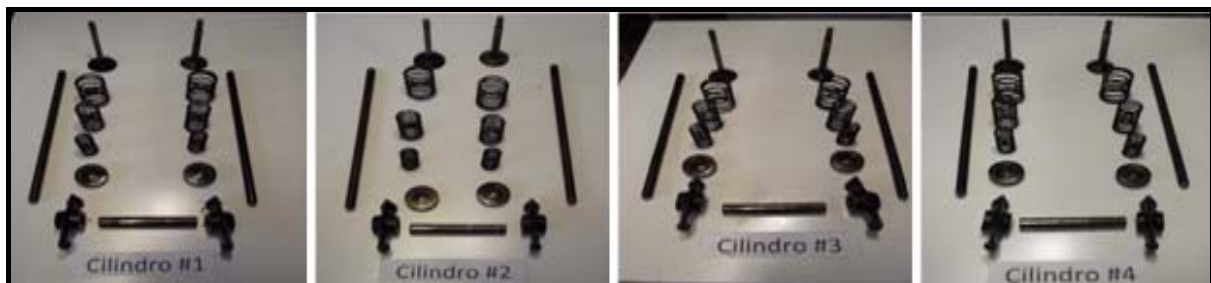
Picture Nr 19

Dismantling and detailed inspection of valves showed they were in good operating condition, with some light leakage through their seats and only exhaust valve #4 presented some rod corrosion (*picture nr 19*).

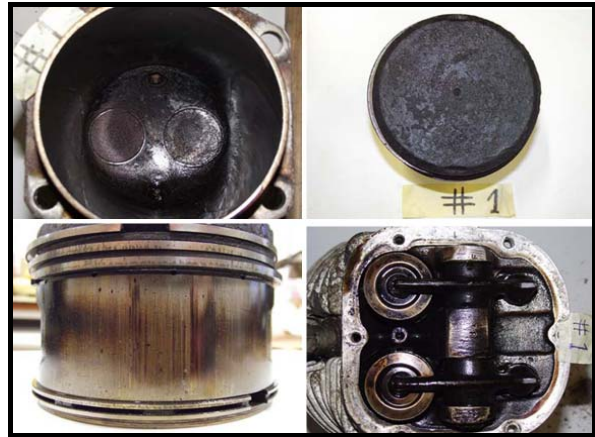
Picture Nr 20

Cylinder nr 1 (*picture nr 20*) was well tight and combustion chamber showed normal deposits, uniformly distributed on its wall and piston head, without signs of overheating &/or detonation. The amount of deposits was greater than in the other cylinders. Piston wall had no sign of friction or abnormal wear and the segments were in good shape, moving freely and showing normal wear. Cylinder head parts were well lubricated and operating properly.

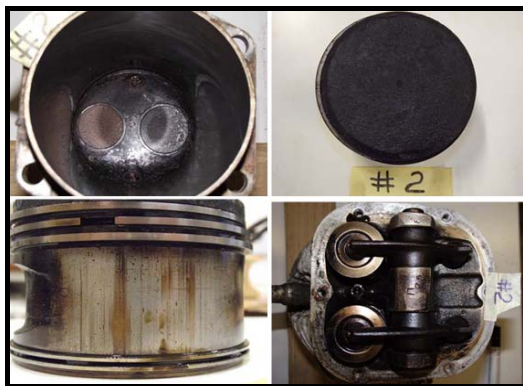
Picture Nr 21

Cylinder nr 2 (*picture nr 21*) was well tight, combustion chamber and piston head showed normal deposits, uniformly distributed, and there were no signs of overheating &/or detonation. Cylinder wall was in good condition but some wear could be noticed by touching, on its lower surface. Segments showed no defect and were moving freely. Cylinder head parts were well lubricated and no damage was found.

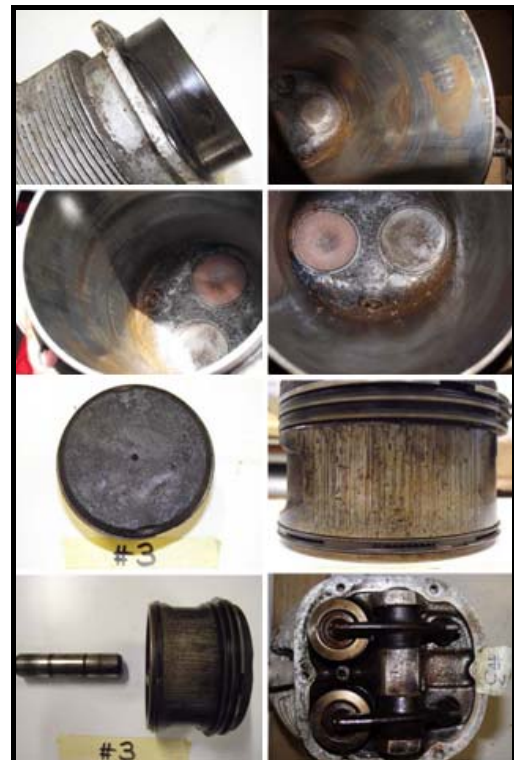
Picture Nr 22

Cylinder nr 3 (*picture nr 22*) was well tight but a silicon bushing was found on its base. Cylinder wall was significantly oxidized with a great amount of severe corrosion, creating some deep craters, identified visually and by touch. Corrosion distribution and piston made wear pointed for an extended process that has been started before the accident. Wall perimeter on lower neutral point shows deep groove, associated with piston mechanical impact. Inside combustion chamber was found a great amount of a sticky brown/reddish deposit (similar to iron oxide) and an abnormal quantity of oil, contaminated with some drops of a non-miscible liquid (water?) flowed from exhaust line. There were no signs of overheating &/or detonation, with piston head showing a uniform layer of carbon deposits. Piston wall showed signs of scuffing, due its friction with chamber wall.

Pressure segments were intact but all of them had half of its depth blackened along all its length. Additionally, the lubrication segment (lower one) was different from all the others (in this and other cylinders). Cylinder head parts were well lubricated and showed no damage.

- 3rd The inspection revealed an inadequate compression ratio on all cylinders, with compression values well below the minimum recommended values, especially on cylinder nr 3, which showed marks of friction wear on cylinder walls and piston, together with signs of evident corrosion and piston segments with wear and soot marks, being the lower one different from all the others. In such conditions it was not possible for the engine to deliver the expected and rated power.

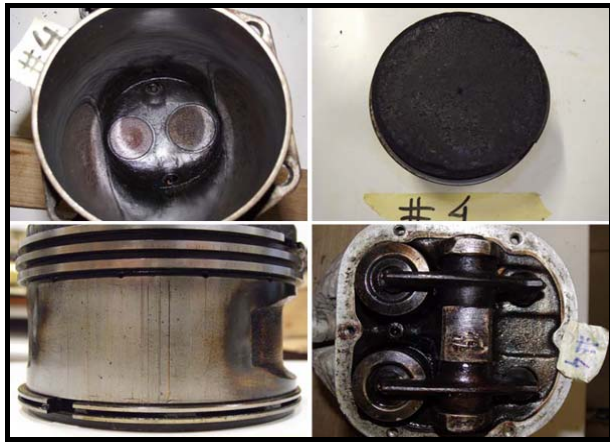
Picture Nr 23

Cylinder nr 4 (*picture nr 23*) was well tight, combustion chamber and piston head showed normal deposits, uniformly distributed and there were no signs of overheat &/or detonation. Segments showed no defect and were moving freely. Admission valve seating presented a greater amount of solid deposits than the other ones. Cylinder head parts were well lubricated and no damage was found.

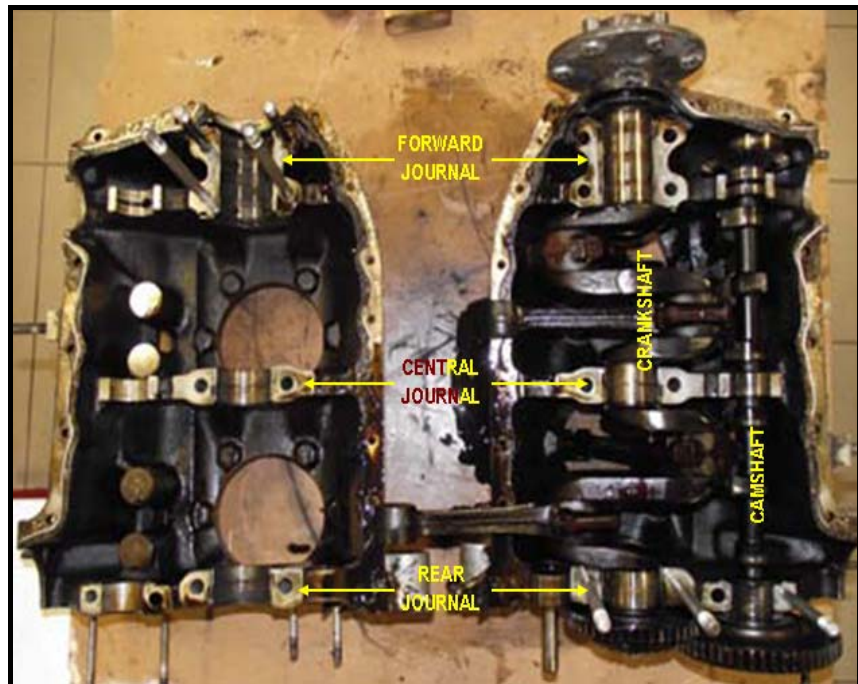
Picture Nr 24

Crankcase disassembly gave access for checking crankshaft, camshaft and connecting rods conditions, together with respective bearings (*picture nr 24*).

All bearings seemed to be adequately lubricated and be operating normally, only crankshaft showed some corrosion marks from bearings on forward journal (3) and central & rear journals (1 each). Flanges showed signs of a continuous process of oil contamination by solid particles as if the engine was operating without a paper oil filter.

Camshaft and accessory gears looked in good condition and were expected to be operating normally, but also showing signs of being operating on contaminated oil with solid particles, for quite a long time.

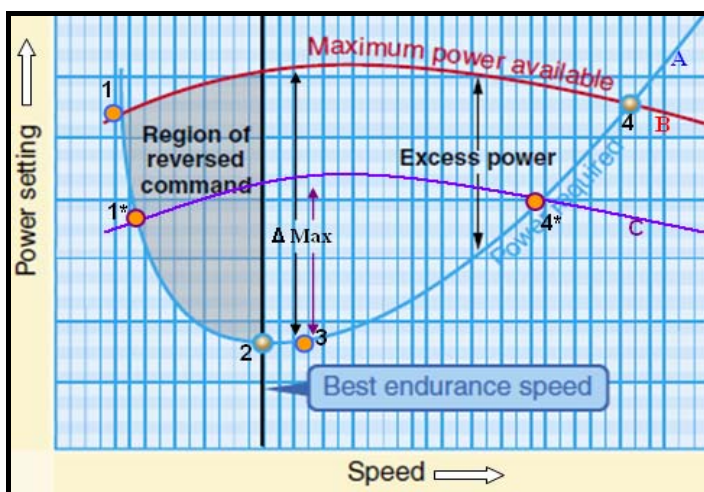
Picture Nr 30

Transposing to power curves' chart an aleatory value for engine power degradation, we draw curve "C" which will represent the new Maximum Power Available (*picture nr 30*), determining new airspeeds 1* (minimum sustainable speed) and 4* (maximum cruise speed), but keeping the same 3 (best rate of climb speed), even if rate of climb becomes lower.

In the presence of less power available, maximum cruise speed, situated in the normal side of the curve (to the right of best endurance line) suffers an equivalent reduction, while minimum speeds, situated in the region of reversed command (to the left of best endurance line), suffer a correspondent increase, which means that in case of speed decrease after take-off, entering the reversed region, there will be no power available to come out of the situation without an altitude loss. Speeds 2 and 3 suffered no change but respective climb rate will be less then before, meaning the aircraft lost manoeuvring capacity.

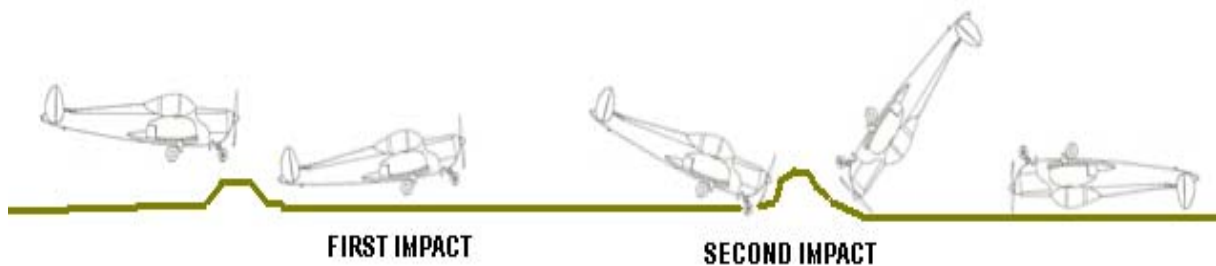
Picture Nr 33

Instead, the aircraft was kept fluctuating in the air with the pilot struggling to gain control, either sinking, or climbing, covering about 300m until it impacted the ground on one of the several swings it was performing, on a landing attitude, with wings levelled. After that first impact it jumped into the air, put nose down and collided frontally with an embankment, flipped over and rested upside-down, about 10m far from first impact point (*picture nr 33*).
