Report No : ARAIB/AIR1005

AIRCRAFT SERIOUS INCIDENT REPORT

RUNWAY EXCURSION DURING LANDING ROLL

L410UVP-E20, HL5234

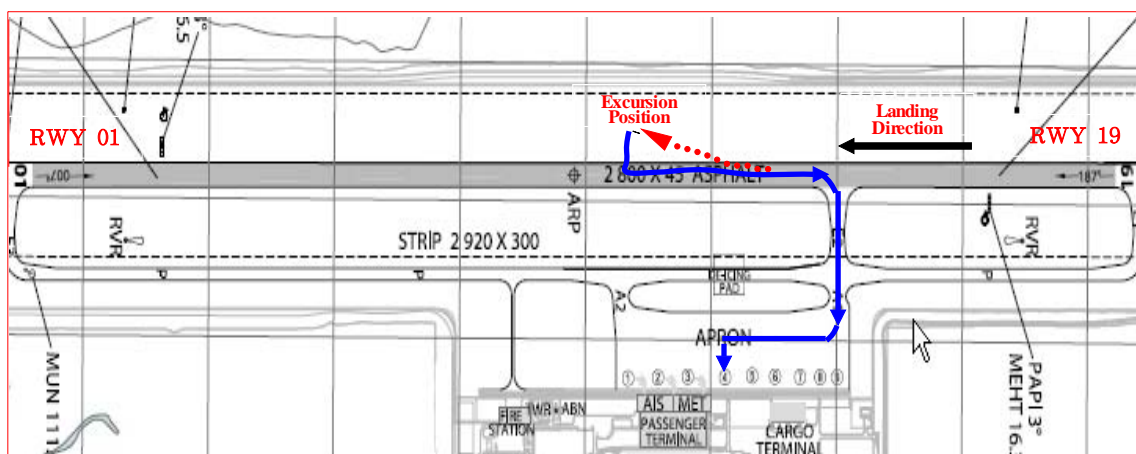
[Fig. 1] Runway excursion and self-moved path

After the aircraft touched down on the runway, the copilot operated the reverser, when the nose of aircraft turned right sharply (at a point of about 941 m from the threshold of runway 19).

The captain and copilot immediately stopped operation of the reverser and kicked the left rudder pedal to maximum, but the aircraft nose did not turn back to left. Eventually the aircraft veered off to right at an angle of about 20° and stopped on the grass at about 1,220 m from the threshold of runway 19 and about 48 m from the shoulder of runway.

When the aircraft stopped, the copilot deplaned to check the exterior of the aircraft and confirmed no damage, and with the permission by Muan Control Tower, the aircraft returned to the runway by its own power and moved to the parking spot 4 via taxiway E2, as shown in [Fig. 1].

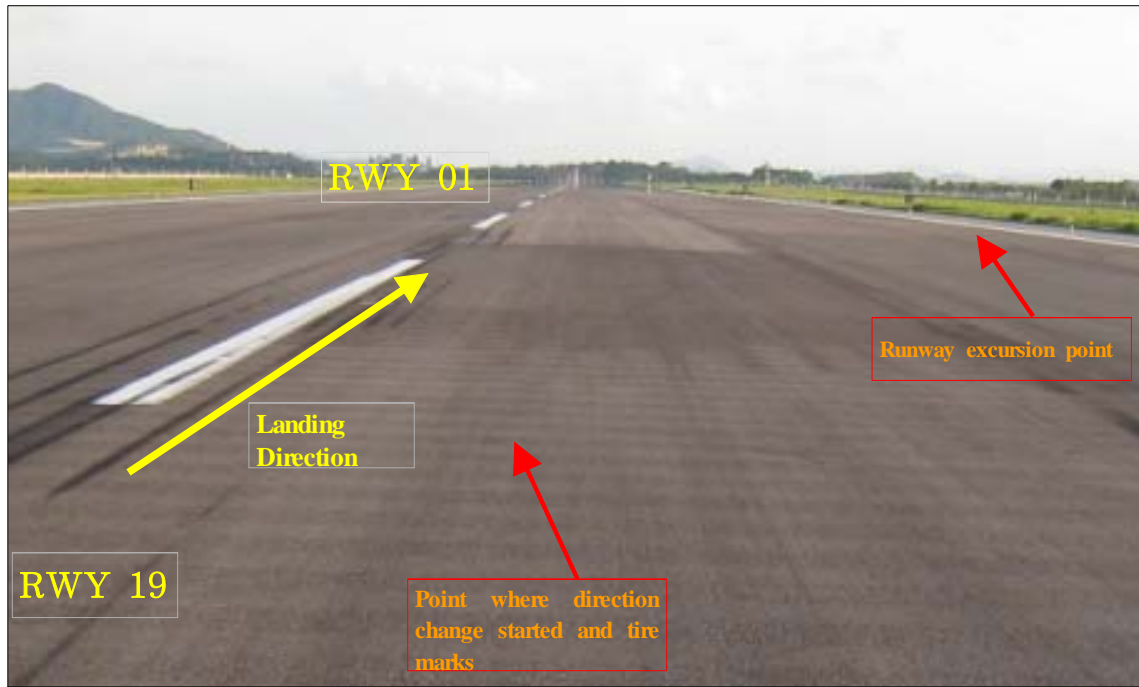
[Fig. 4] Tire marks and excursion direction shown on the runway

The point where HL5234 started to veer off to right after touchdown on the runway was about 940 m from the threshold of runway 19, and the point where it excursed from the runway was about 1,034 m, and the trace and place of excursion are as shown in [Fig. 4] and [Fig. 5].

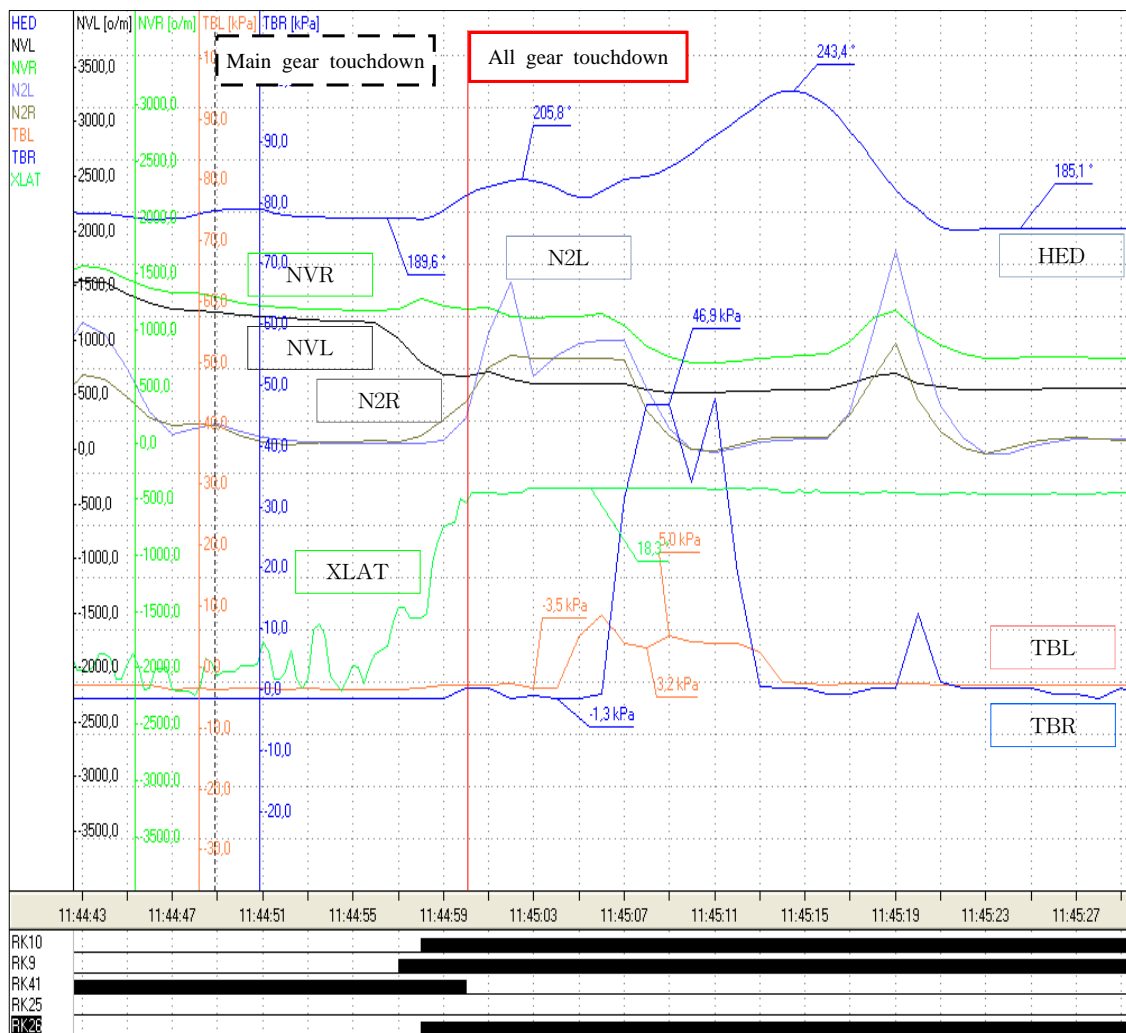
[Fig. 6] Major parameters of the flight data recorder

If we take a look at RK9 and RK10 in [Fig. 5], the left propeller control lever (PCL) went to the feather position at 11:45:57, and the right propeller control lever went to the feather position¹⁵⁾.

In the RK25 and RK26 parameters, we can see that the right BETA control signaling came on¹⁶⁾ at 11:44:58 and the left BETA control signaling did not come on from the

In the XLAT parameter, from the time when the main landing gear touched down, the rudder began to be used to the right, and from the time when the front landing gear touched down to the time when the aircraft touched down, it was continuously used¹⁸⁾ to the left to maximum.

In the HED parameter, the initial touchdown was made in the direction of runway (189°), but when the reverse thrust was used, the aircraft nose turned to right, and immediately after the reverse thrust lever returned, but the aircraft nose continued to turn right again as the brake was working strongly.

In the TBL and TBR parameters, the left brake operated weakly from 11:45:04 to 11:45:14, and the right brake operated very strongly from 11:45:06 to 11:45:13.

In the NVL and NVR parameters, the left propeller RPM started to drop rapidly from 11:44:56, which is 7 seconds later after the main gear landing touched down, and when the front landing gear touched down, the left propeller RPM was 666 and the right propeller RPM 1190.
