SERIOUS INCIDENT

Aircraft Type and Registration:	BAE Systems (Operations) Ltd ATP, SE-MHE	
No & Type of Engines:	2 Pratt & Whitney Canada PW126 turboprop engines	
Year of Manufacture:	1989 (Serial no: 2012)	
Date & Time (UTC):	14 February 2018 at 0700 hrs	
Location:	In flight from East Midlands to Guernsey Airport	
Type of Flight:	Commercial Air Transport (Cargo)	
Persons on Board:	Crew - 2	Passengers - None
Injuries:	Crew - None	Passengers - N/A
Nature of Damage:	None	
Commander's Licence:	Airline Transport Pilot's Licence	
Commander's Age:	42	
Commander's Flying Experience:	8,500 hours (of which 6,500 were on type) Last 90 days - 84 hours Last 28 days - 22 hours	
Information Source:	AAIB Field Investigation

Synopsis

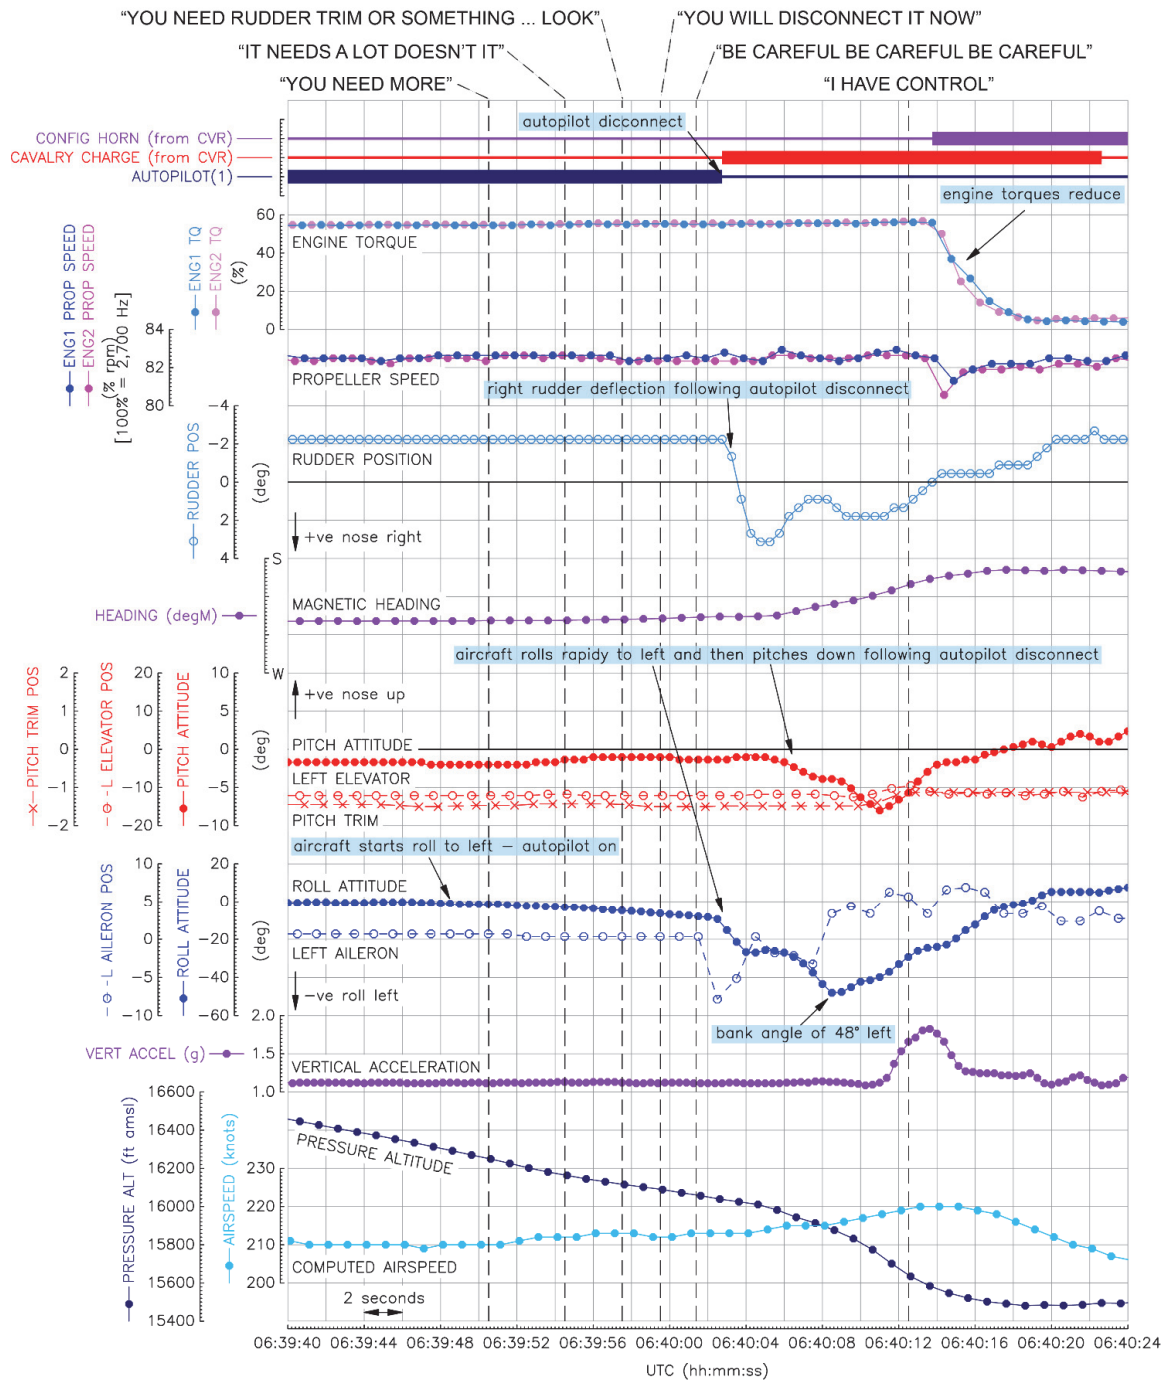
Figure 1 starts with the aircraft stable on descent towards Guernsey, with the autopilot engaged, passing through 16,500 ft amsl, with the propeller speed at about 82% (of the maximum 1,200 rpm), and engine torques of about 55%. In summary, the data indicates the following:

UTC (hh:mm:ss)	Event
06:39:48	Aircraft starts to roll slowly to the left - aileron movement was not observed in the data until about 6 seconds later ¹ . No movement in rudder position.

06:39:51	Commander states "YOU NEED MORE [TRIM]" Over the following 12 seconds, the aircraft continues to roll to the left.
06:39:55	Pilot Under Training states "IT NEEDS A LOT DOESN'T IT"

06:39:57	Commander states "YOU NEED RUDDER TRIM OR SOMETHING ... LOOK"
06:39:59	Commander states "YOU WILL DISCONNECT IT NOW"
06:40:01	Commander states "BE CAREFUL BE CAREFUL BE CAREFUL"

06:40:03	Autopilot disconnects – continuous cavalry charge sounds in cockpit – with aircraft 9.3° left wing down, 1.4° pitch nose-down, vertical acceleration 1.1g, airspeed 213 kt, altitude 16,039 ft amsl. Rudder immediately moves to the right and aircraft pitches down and rolls to the left reaching a peak value of 48° five seconds later.

06:40:11	Aircraft begins to pitch up from 8° nose-down. 1.8g recorded vertical acceleration during pitch up.
06:40:13	Commander states "I HAVE CONTROL"
06:40:14	Engine torque (and N_H and N_L ²) reduce. Propeller speed momentarily reduces before recovering back to about 82%. Landing gear config horn sounds in cockpit (for the next 24 seconds).

06:40:23	Cavalry charge stops sounding.
06:40:38	Config horn stops sounding (not shown).
06:40:42	Engine torques nominally zero (where they remain until 06:43:22) – propeller speed still about 82% (not shown).

06:41:02	Propellers taken in and out of beta range over eight seconds (not shown).

Salient parameters during the event with extracts from the CVR relating to use of trim
