**SERIOUS INCIDENT**

| <b>Aircraft Type and Registration:</b> | BAE Systems (Operations) Ltd ATP, SE-MHF | |

**Synopsis**

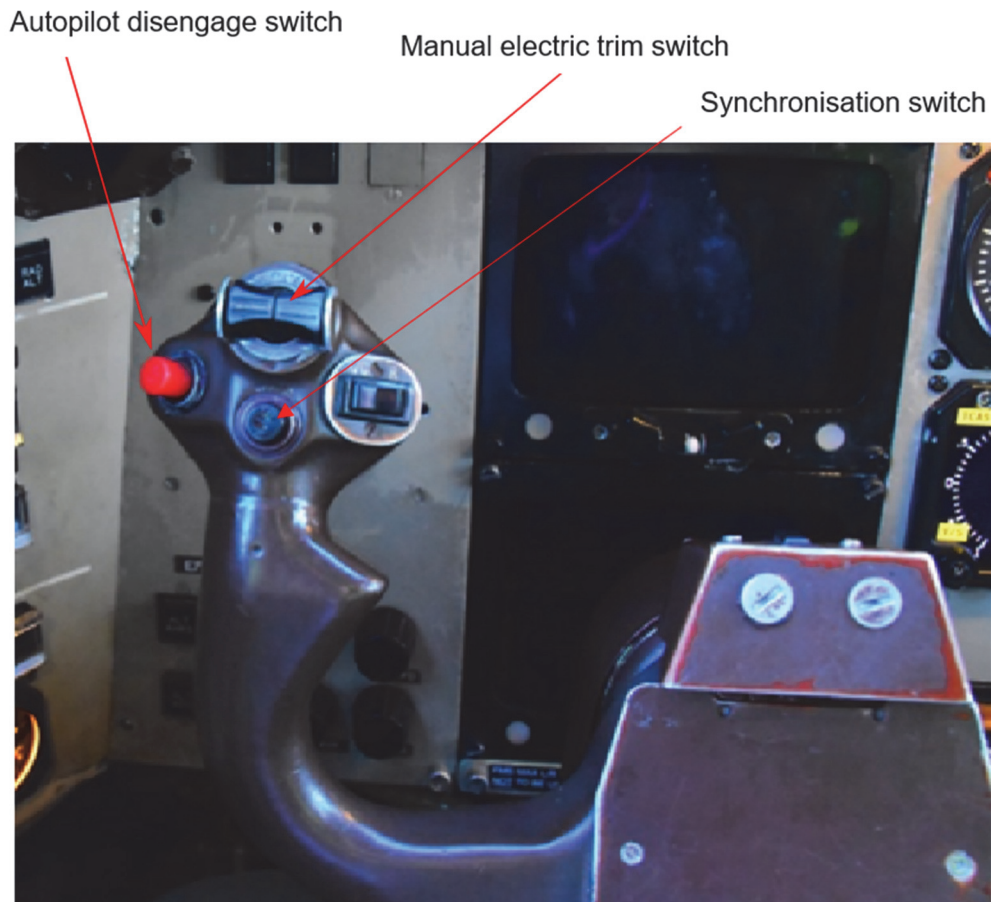
**Figure 1**

Control wheel switches (captain's control wheel)

The co-pilot noted afterwards that he had been confused by not being able to disconnect the autopilot and by an apparent lack of concern from the commander. He reported that for a while he was focussed on repeatedly trying to disconnect the autopilot and became absorbed by the problem. Although he anticipated he would have to go around, he was not sure how to achieve this. Then, when the commander prompted him for the before-landing actions, and realising that the approach should by now be stable, he again voiced his inability to disconnect the autopilot. The commander called for a go-around and the co-pilot, recalling having practised using the sync switch in training after the previous event in one of the operator's aircraft<sup>4</sup>, pressed and held the sync switch and gained control to carry out the go-around.

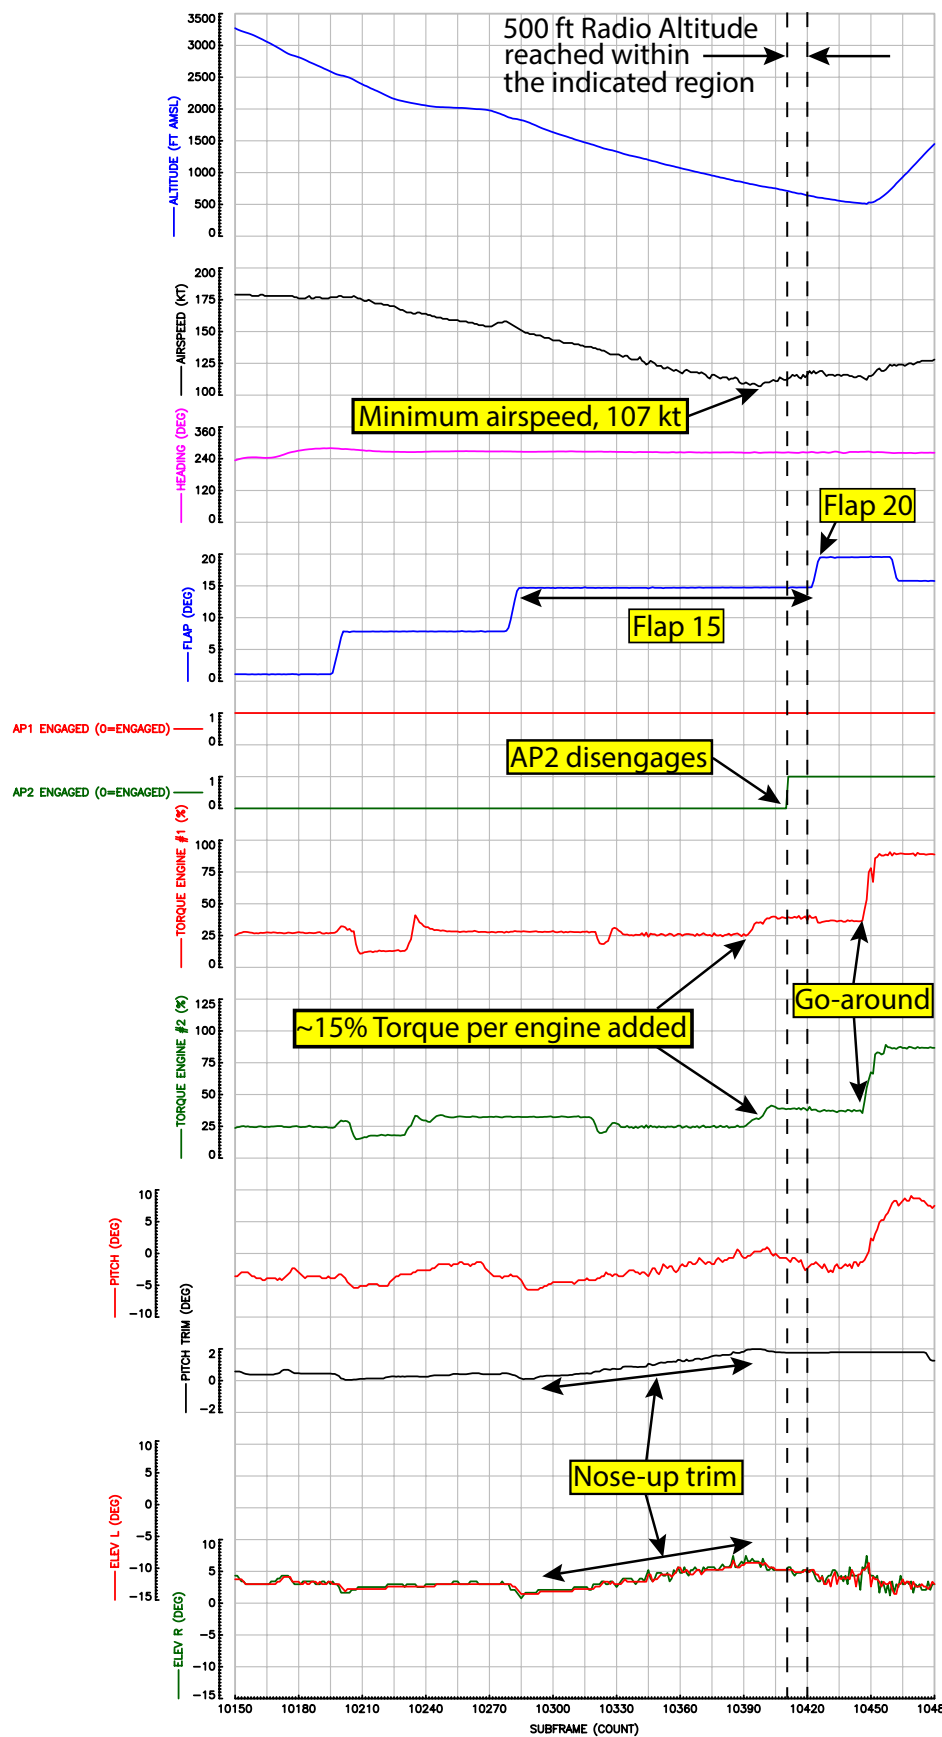
Figure 2

The FDR data for SE-MHF's approach and go-around, is shown below in Figure 2.

The data showed that AP2 was engaged with the aircraft in a gradual descent approaching 2,000 ft amsl as it aligned with the inbound course for Runway 27 at EMA. Flap 7 was selected with the airspeed reducing towards 154 kt and engine torque at 27.5% and 32.5% for engines 1 and 2 respectively. SE-MHF's pitch attitude then decreased, and a descent was started<sup>5</sup>. Engine power remained unchanged and, after a temporary increase in airspeed as the aircraft began to descend, Flap 15 was selected. SE-MHF's airspeed then began to reduce, reaching a minimum of 107 kt at 500 ft aal recorded after a period of 113 seconds. During this time, as the airspeed reduced, both the elevators and the pitch trim provided increasing nose-up inputs. An additional 13-14% of torque

The initial approach and go-around at East Midlands Airport

per engine was applied just prior to the point of minimum airspeed and, subsequently, the airspeed increased to 113 kt. The data then shows that AP 2 disengaged<sup>6</sup> at 425 ft aal (approximately 500 ft radio altitude (RA)) and, thereafter, that the airspeed stabilised around 117 kt. The increase in airspeed of SE-MHF was accompanied by a corresponding decrease in aircraft pitch, but after AP2 disengaged no further pitch trim activity was seen in the data. Flap 20 was selected at 350 ft aal and a go-around was initiated at 230 ft aal.
