# **Technical Report 096/2011**

**Accident that occurred on 18 May 2011**

**Aircraft Saab 340 A, LV-CEJ. Location: Caltrauna,  
between Los Menucos and Prahuaniyeu, province of Río  
Negro**

**Civil Aviation Accident  
Investigation Board (JIAAC)**

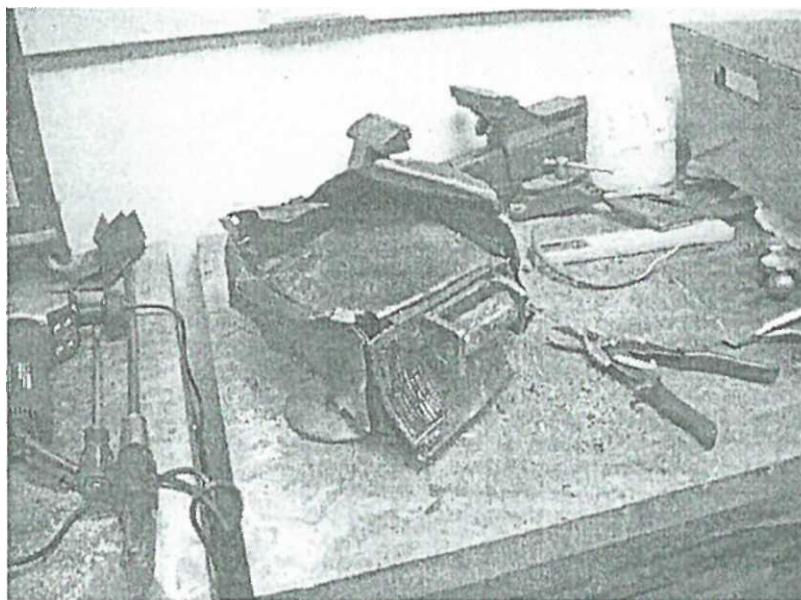
1.11.4.1.1 The CVR showed signs of severe impact shock and impact penetration, with the destruction of the external structure (impact and penetration) and the internal protection (resistant structure and thermal protection). There was evidence that the equipment had been on fire for a considerable period of time. The Underwater Locator Beacon (ULB) was found to be damaged; however, it withstood the impact and was still attached to the equipment.

*The state of the CVR equipment at the time of the retrieval.*

1.11.4.1.3 Upon the removal of the magnetic tape, it was found to be torn; one part was detached from the rest, but recovered. The damages to the tape ( "Mylar®" polymer tape coated with ferromagnetic material)

were found close to the recording heads, and the impact had left the tape entangled.

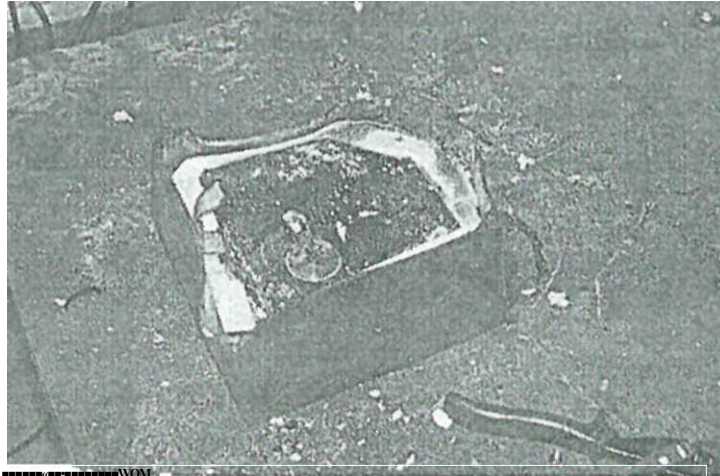
1.11.5.1.1 The FDR equipment was damaged by the impact and the fire; however, it was in better condition than the CVR. During the impact, the protective internal module - in which the tape was located - became detached. Despite becoming detached, the recording medium was protected.

1.11.5.1.2 When opening up the equipment, it was revealed that the tape around the recording heads was damaged and torn. This occurred due to the violence of the impact. It resulted in the tape tearing and stopping in the final recording position.

*The state of the FDR equipment at the time of the*

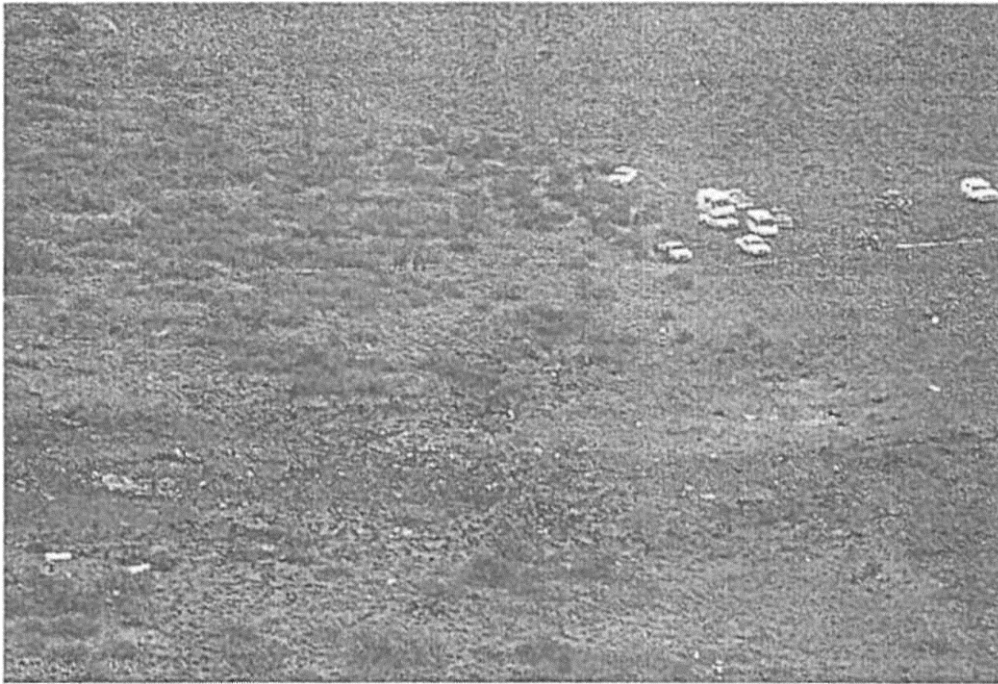
1.12.2 Most of the wreckage was spread out, starting at the site of the first impact, with a heading that formed a scattering angle, ranging from 300° to 350° with a minor amount of wreckage spread out in a radius of about 200 m around the main point of impact. There was no evidence of the aircraft components detaching before impact.

1.12.3 The components of the right engine and the propeller blades were scattered about 130 m from the main impact point with the same heading. The components of the left engine and propeller blades were 90 m from the impact and with a recovery degree (R°) of 350. The remaining propeller blades were found 70 m from the main impact and with R°350.

*Aerial view of the impacted area.*
