**SERIOUS INCIDENT**

<b>Aircraft Type and Registration:</b>	Saab-Scania SF340B, G-LGNB	
<b>No &amp; Type of Engines:</b>	2 General Electric Co CT7-9B turboprop engines	
<b>Year of Manufacture:</b>	1990 (Serial no: 340B-216)	
<b>Date &amp; Time (UTC):</b>	5 June 2017 at 1415 hrs	
<b>Location:</b>	During climb after departure from Edinburgh Airport	
<b>Type of Flight:</b>	Commercial Air Transport (Passenger)	
<b>Persons on Board:</b>	Crew - 3	Passengers - 33
<b>Injuries:</b>	Crew - None	Passengers - None
<b>Nature of Damage:</b>	None	
<b>Commander's Licence:</b>	Airline Transport Pilot's Licence	
<b>Commander's Age:</b>	34 years	
<b>Commander's Flying Experience:</b>	6,638 hours (of which 6,387 were on type) Last 90 days - 109 hours Last 28 days - 49 hours	
<b>Information Source:</b>	AAIB Field Investigation

**Synopsis**

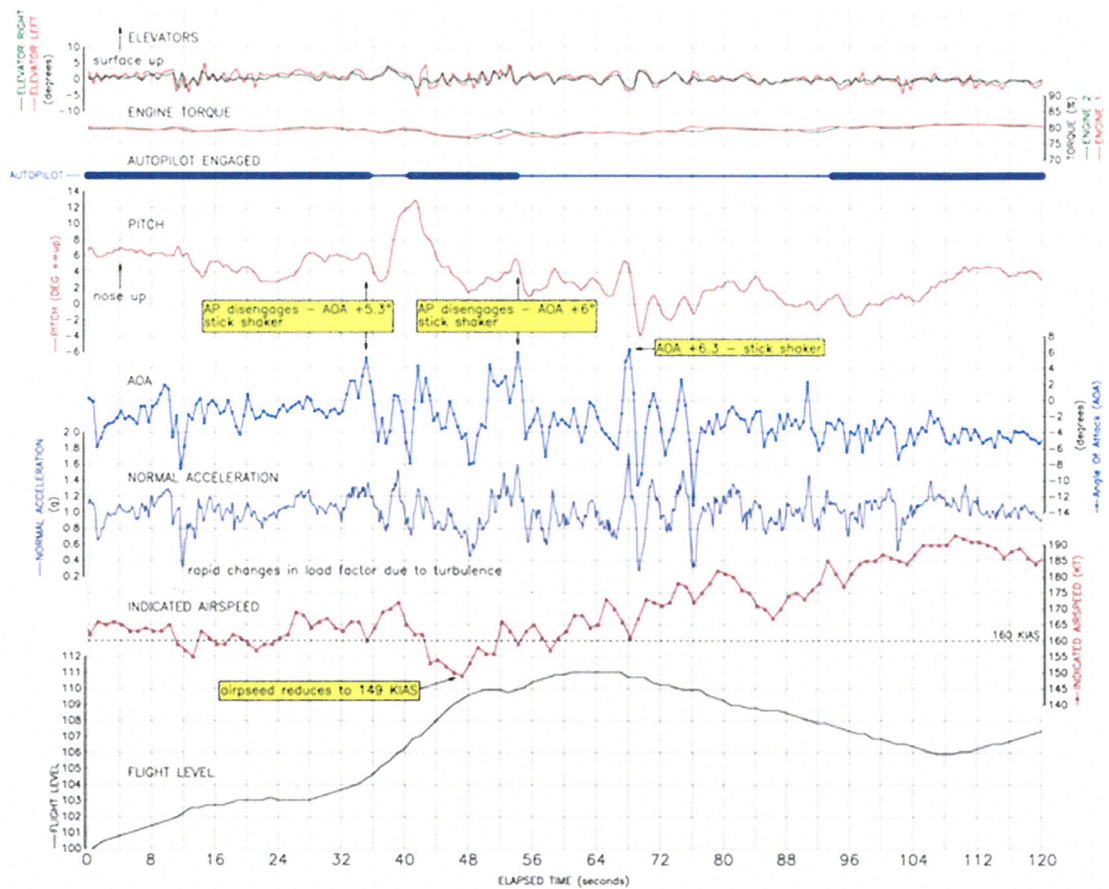
Figure 1 shows salient parameters during the period when the aircraft experienced an increase in turbulence during the climb and the autopilot disconnected.

About eight minutes after takeoff, as the aircraft climbed through FL100, perturbations of normal acceleration started to increase, consistent with the aircraft encountering light turbulence. The OAT was  $-5^{\circ}\text{C}$ . The turbulence then continued to increase in intensity, with variations in AOA that closely correlated with changes in load factor, pitch attitude and airspeed; the average airspeed was 162 KIAS at this time. The aircraft then briefly levelled off at FL103, before climbing again. Shortly afterwards, the AOA increased rapidly over one second from just over  $0^{\circ}$  to a recorded value of  $+5.3^{\circ}$ , which coincided with the autopilot disconnecting; the airspeed was 160 KIAS and the pitch attitude was  $6.3^{\circ}$  nose-up. The coincident disconnection of the autopilot meant that the peak AOA value was in excess of the  $5.3^{\circ}$  recorded.

The pitch attitude then reduced quickly to  $2.8^{\circ}$  nose-up, before increasing to  $13^{\circ}$  nose-up in four seconds. During this period, the recorded AOA also varied rapidly, reducing to a minimum of  $-7^{\circ}$ . The autopilot was then re-engaged and the pitch attitude reduced to about  $2^{\circ}$  nose-up. The airspeed reduced to 149 KIAS, after which it started to increase towards 160 KIAS.

Thirteen seconds later the aircraft pitched up quickly to  $5.6^{\circ}$ , the recorded AOA also increased rapidly, reaching a recorded  $6^{\circ}$ , and the autopilot disconnected again; the airspeed was 159 KIAS. The aircraft then briefly levelled off, during which the pitch and AOA both increased rapidly again, with the recorded AOA peaking at  $6.3^{\circ}$ . The aircraft then descended about 500 ft to FL105, during which the airspeed progressively increased to about 190 KIAS. At no time during this period of the flight was engine power increased to the 'maximum continuous' setting. The autopilot was then re-engaged, which coincided with a reduction in turbulence, and the aircraft climbed to its cruise altitude of FL170.

FDR data overview of event

The FDR data was provided to the aircraft manufacturer for analysis. It was concluded that the rapid changes in pitch attitude and AOA were caused by turbulence. The aircraft did not enter an aerodynamic stall at any point, and the activation of the stall warning system was triggered by the AOA threshold being momentarily exceeded.

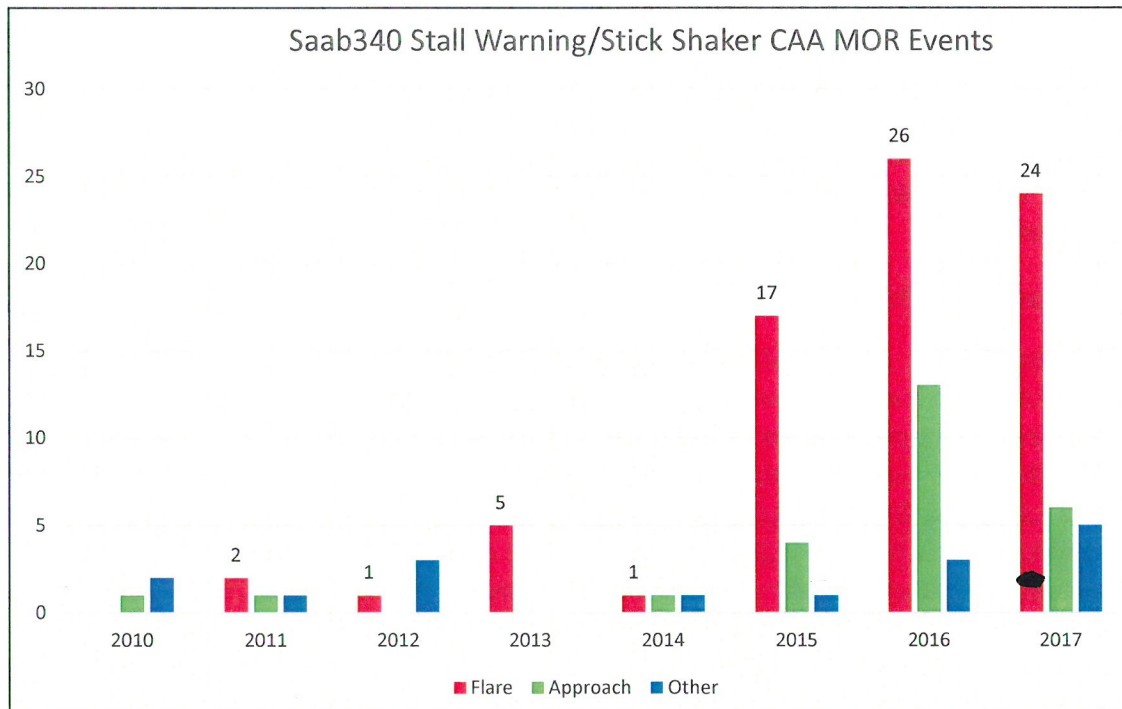
**Figure 2**

Analysis of Saab340 stick shaker events reported to the CAA via the MOR<sup>4</sup> system revealed that, after the introduction of the stall warning modification, the number of reported events increased from an average of 3.8 per year between 2010 and 2014 to 22 in 2015, 42 in 2016 and 35 in 2017 (Figure 2). These events were particularly prevalent in the approach and landing phase of flight.

The operator believed that this increase in events was directly related to the requirements of the stall warning computer modification and the trigger AOA being significantly lower than before. If the aircraft is in turbulence, or there is a sudden gust of wind at touchdown, the pitch of the aircraft can alter rapidly, triggering the stick shaker.

Saab340 Stall Warning/Stick Shaker CAA MOR Events 2010 to 2017

EASA, the operator and the manufacturer considered making deactivation of the ICE SPEED logic independent of the requirement to maintain the engine anti-ice system on for five minutes after leaving icing conditions. This change, considered feasible by the manufacturer, would address the concerns about repeated activation of the stick shaker in the latter stages of an approach and in the flare.

EASA expected to mandate the implementation of this improvement to address the safety concern.

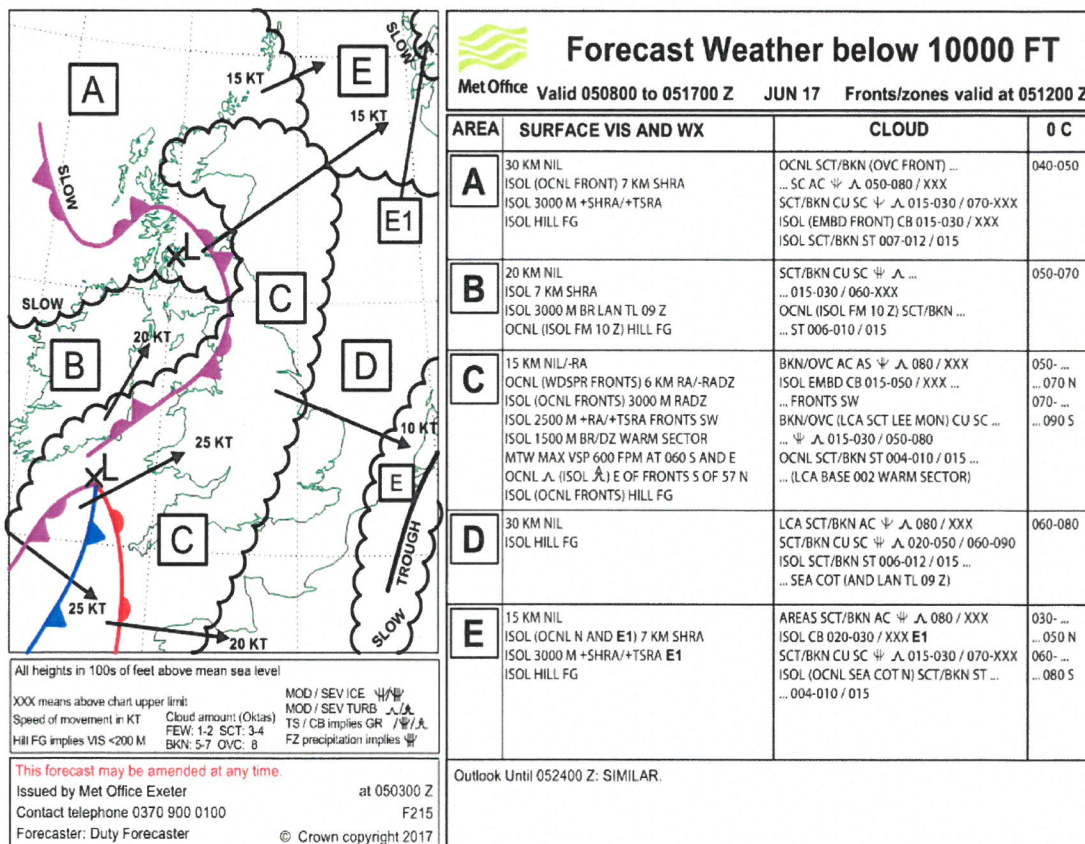
Figure 3

The crew received a briefing pack when they reported for duty. This pack included the route, NOTAMS, weather at departure and destination as well as charts of wind, weather and temperature along the intended route. The Met Office chart F215 details the weather in the UK below 10,000ft. The chart for 0800 hrs to 1700 hrs issued on the day of the incident is shown at Figure 3.

Chart F215 Valid 1200UTC on 5 June 2017 produced by the UK Met Office

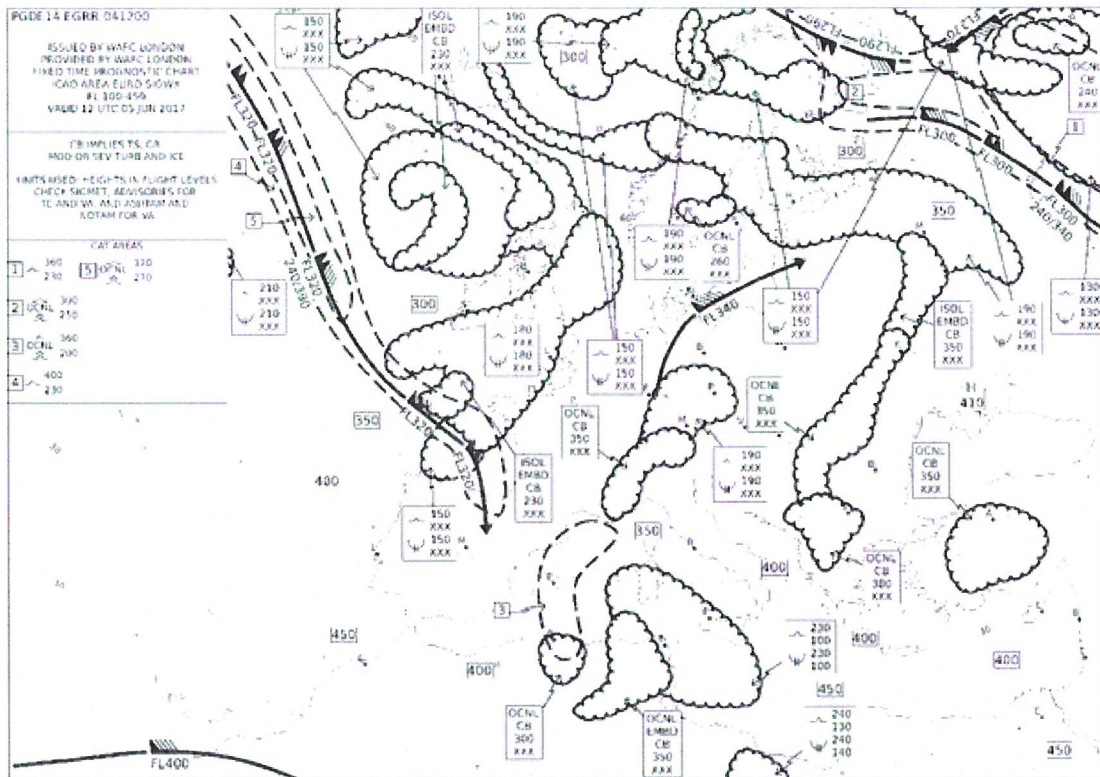
The crew received a significant weather chart which was supplied by the operator's flight planning contractor. This chart shows weather which may have affected the aircraft such as icing, turbulence or CB activity from FL100 to FL450. Although the chart the crew had

access to was not produced by the UK Met Office, it was generated from the data supplied by them. Figure 4 shows the Met Office chart for 5 June 2017.

Significant Weather Chart Valid 1200UTC on 5 June 2017 supplied by the UK Met Office
