Landing gear retraction overspeed involving Saab 340B, VH-ZRJ

Sydney Airport, New South Wales | 4 December 2014

ATSB Transport Safety Report
Aviation Occurrence Investigation
AO-2014-189
Final – 7 June 2016

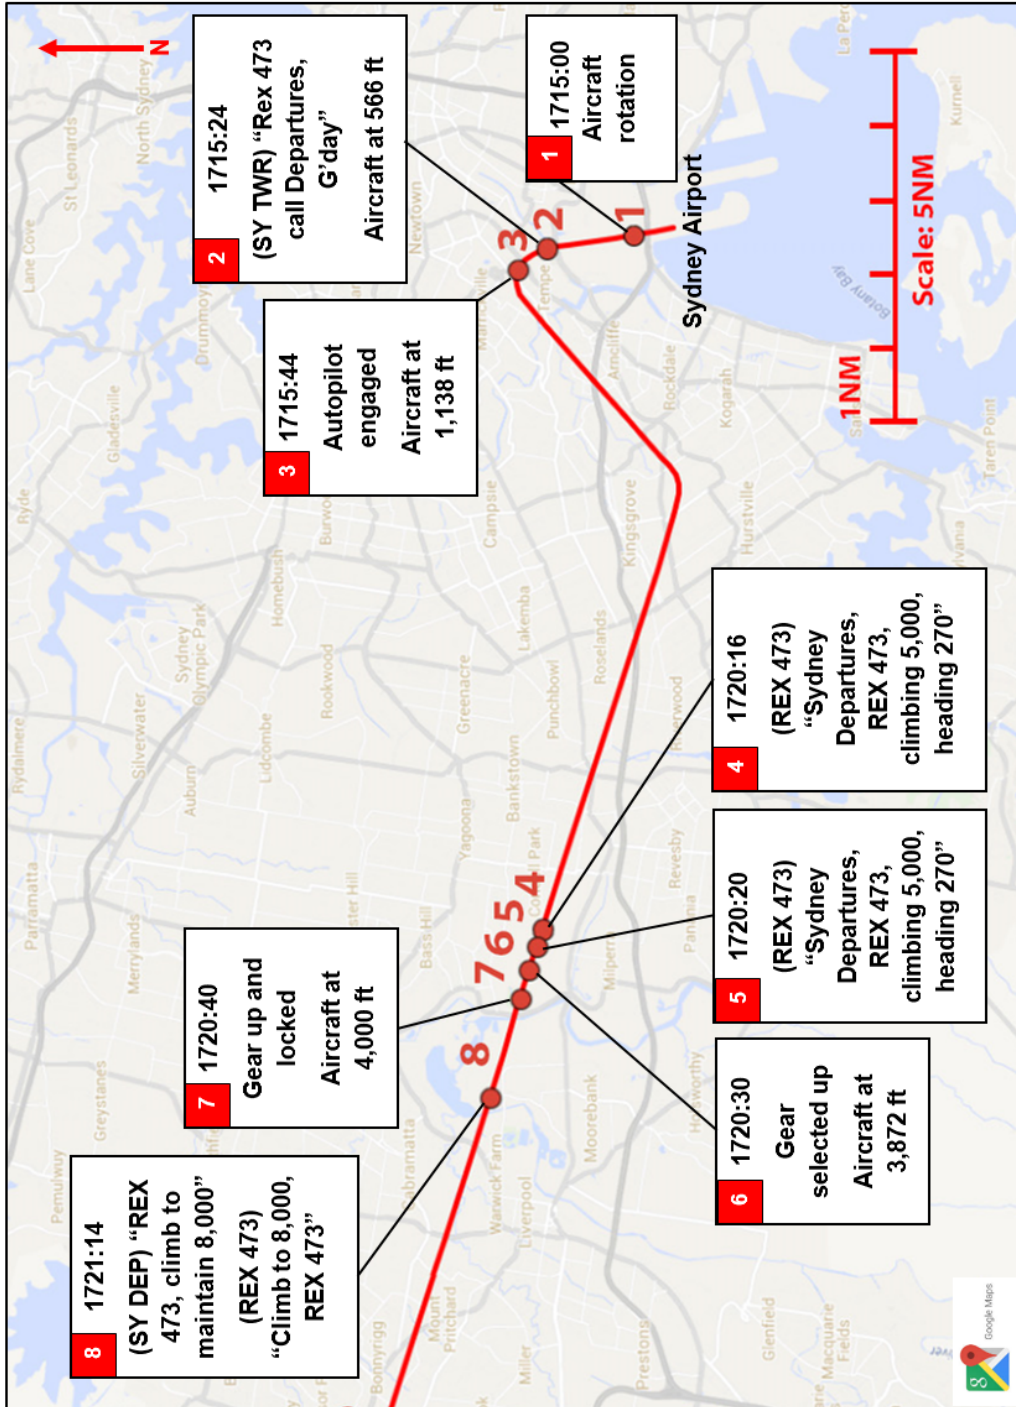
Figure 1: ZRJ (REX473) departure track (in red) from Sydney towards Narrandera, with the key actions annotated

At about 1715, the aircraft departed from runway 34L (Figure 1). The captain reported that, after becoming airborne they⁴ called 'positive rate, gear up'. The captain expected that on this command the first officer (FO) would retract the landing gear, and so looked out to the left of the aircraft to observe the thunderstorms to the west and north of the airport. The FO did not recall hearing the captain's call and the landing gear was not retracted, nor was the subsequent standard call 'selected' made by the FO. The FO reported also focusing on the weather in the area and, due to the FO's relative unfamiliarity with Sydney departures, on the requirement to turn at 600 ft. The FO selected the yaw damper⁵ ON and recorded data indicated that the flaps were selected to zero and the flight director engaged.

Climbing through 3,800 ft, the captain called for the climb checklist and the FO read the first item, 'gear'. At that time, the crew identified that the gear was still down. The captain started to respond by saying 'up', but immediately revised their words to 'not up'. At the same time, the FO instinctively selected the gear up and then realised that the aircraft's airspeed was above the maximum landing gear retraction speed of 150 kt. The crew reported that the gear retracted normally.

Information from the flight data recorder showed that the landing gear retracted and locked into position about 5 minutes after take-off while climbing through 4,000 ft. The airspeed at that time was 182 kt, 32 kt above the maximum landing gear retraction speed.

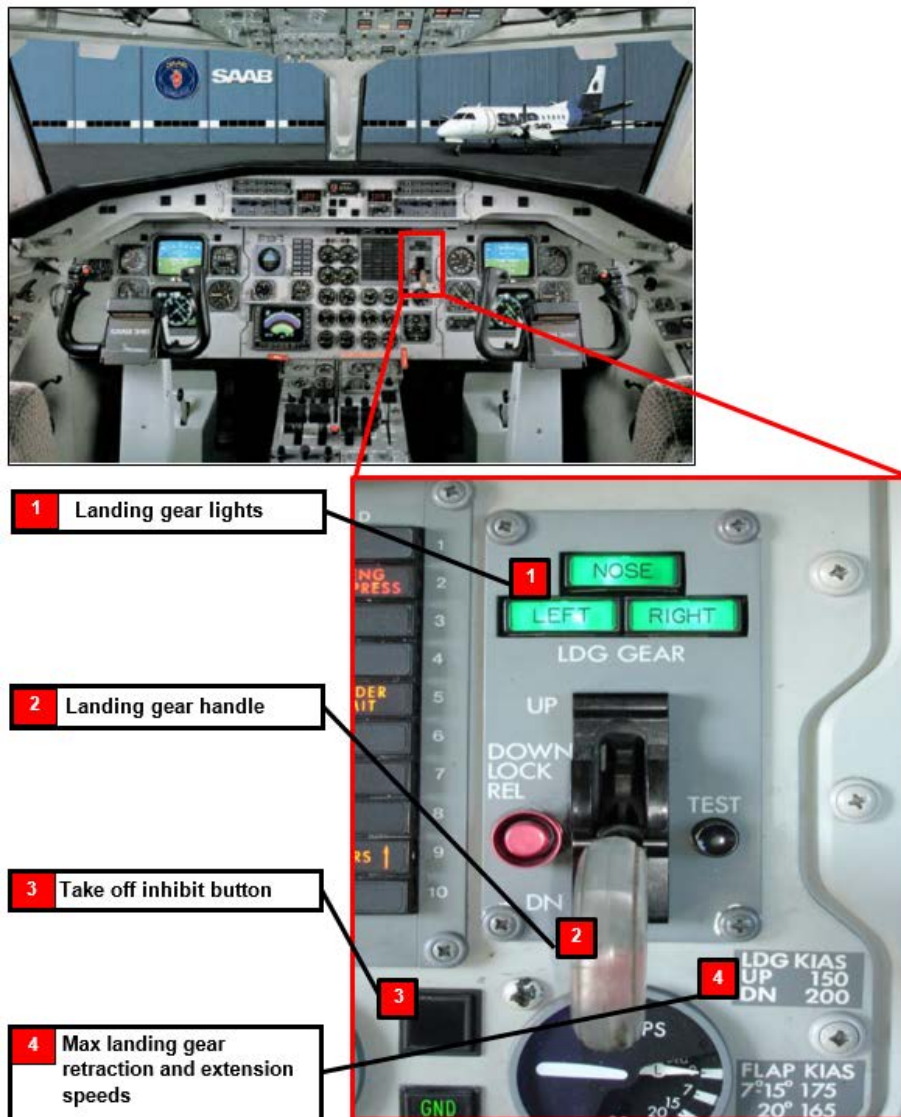
The aircraft is equipped with a retractable landing gear with the main and nose wheel gears retracting forward. The landing gear control panel is to the left of the FO (Figure 2). The panel incorporates three green indicator lights and the landing gear handle. When the landing gear is in the 'down' (DN) position, all three green down lock lights illuminate. The panel also displays the maximum landing gear retraction and extension speeds.

Prior to departure, the take-off inhibit button, which is located on the centre instrument panel is selected and illuminates blue to indicate its selection (Figure 2). This mode inhibits non-essential warnings and cautions during take-off. It also inhibits some lights, including illumination of the bleed valve push-button on the overhead panel.

Amongst other methods, the take-off inhibit mode is reset automatically when the landing gear is retracted. The crew then confirm that the take-off inhibit light is extinguished as part of the climb checklist. As the landing gear remained extended after take-off on the occurrence flight, the take-off inhibit mode also remained active and the associated blue light illuminated.

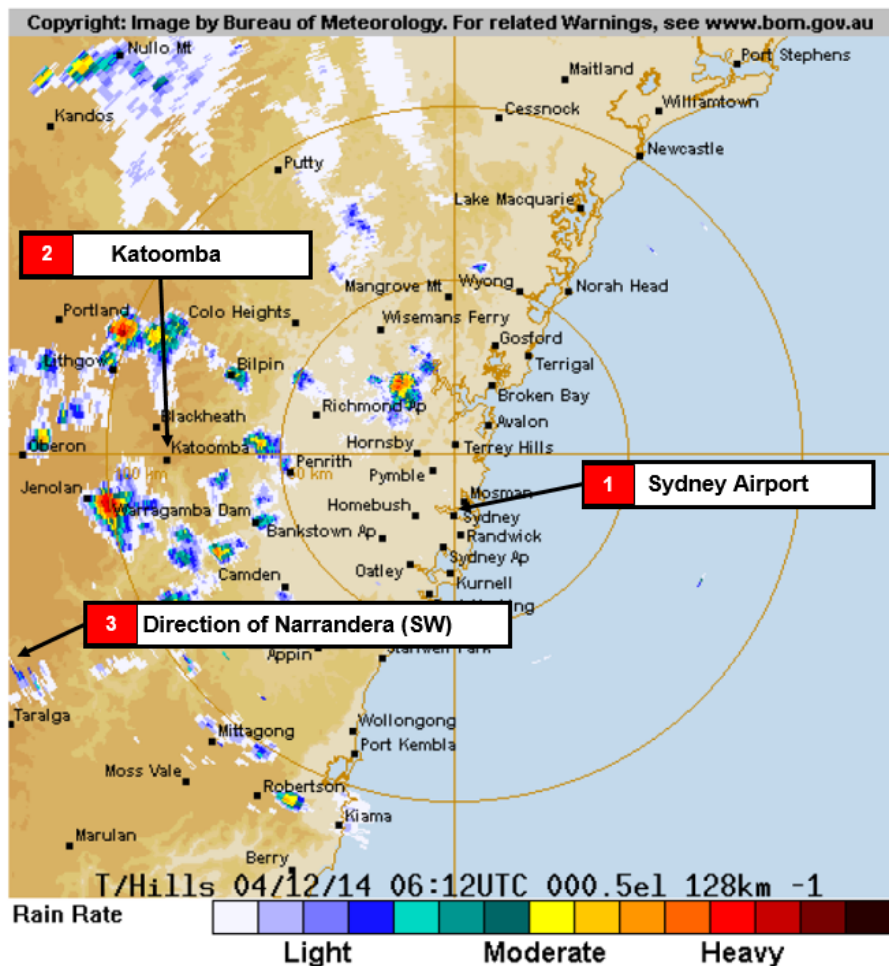
Figure 3: Bureau of Meteorology radar image at 1712 showing rain to the west and north-west of Sydney Airport

Sydney automatic terminal information service (ATIS)⁶ ‘Alpha’, issued at 1634, indicated that thunderstorms with rain showers were present to the west and north-west of the airport. This was consistent with the Bureau of Meteorology radar image at 1712, which showed areas of light to heavy rain in the same area (Figure 3).

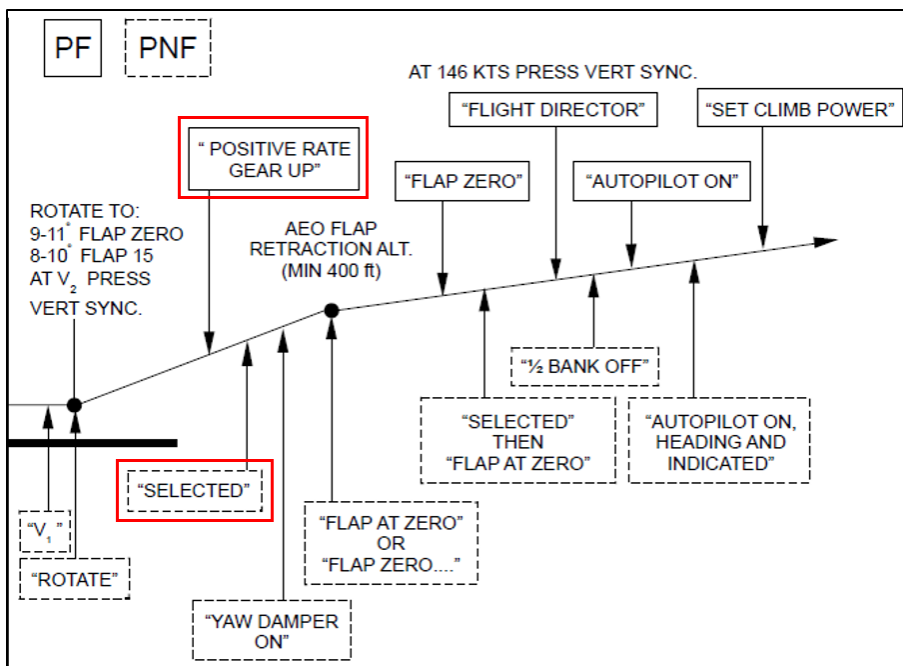
Figure 4: The Rex normal take-off profile showing the actions to be taken by the PF (shown in a solid-lined box) and the PNF (shown in a dash-lined box) The PF calls 'positive rate, gear up', followed by the PNF calling 'selected' once the gear is up (both calls outlined in red)

The Rex Flight Crew Operations Manual detailed the actions to be completed by the crew for a normal take-off sequence and climb (Figure 4). These actions included:

On the occurrence flight, the captain reportedly made the call 'positive rate, gear up', but the FO reported not hearing it or recall calling 'selected'. Through flight data and crew recollections, it appeared that all other calls and actions associated with the take-off sequence were completed. This included the retraction of the flaps, engaging the flight director and autopilot and setting climb power. The ATSB could not determine whether the call 'yaw damper on' was made or whether the heading bug was adjusted.
