**Havarikommisjonen**  
Accident Investigation Board Denmark

# **BULLETIN**

**BAE AVRO RJ100**

**AIRBUS A340**

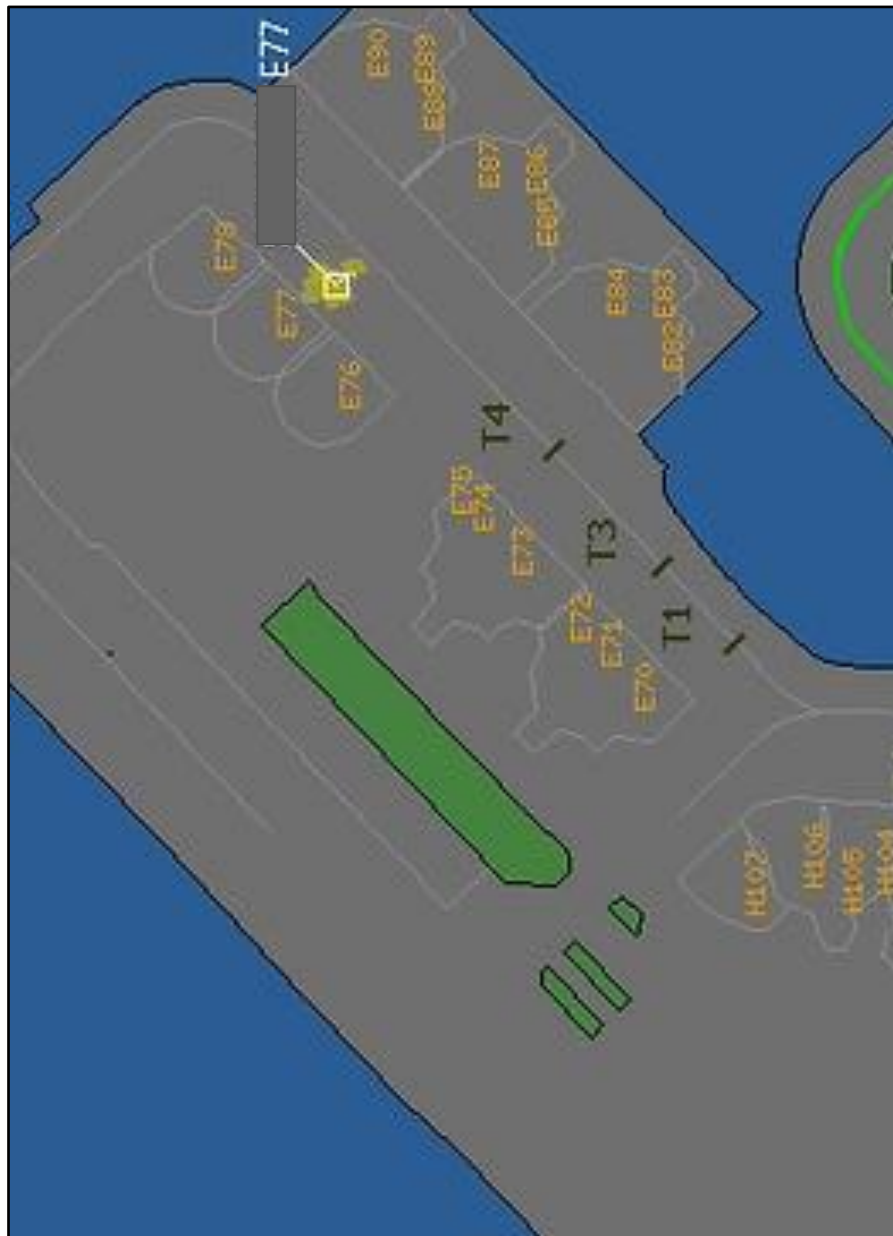
Time: 14:57 hours

Arriving at aircraft stand E77 at 14:57 hours, the flight crew of SE-DST noticed that the ground handling personnel had not yet arrived at the aircraft stand. By radio in order to request ground handling assistance, the flight crew of SE-DST several times contacted their handling agent.

[See appendix 1.](#)

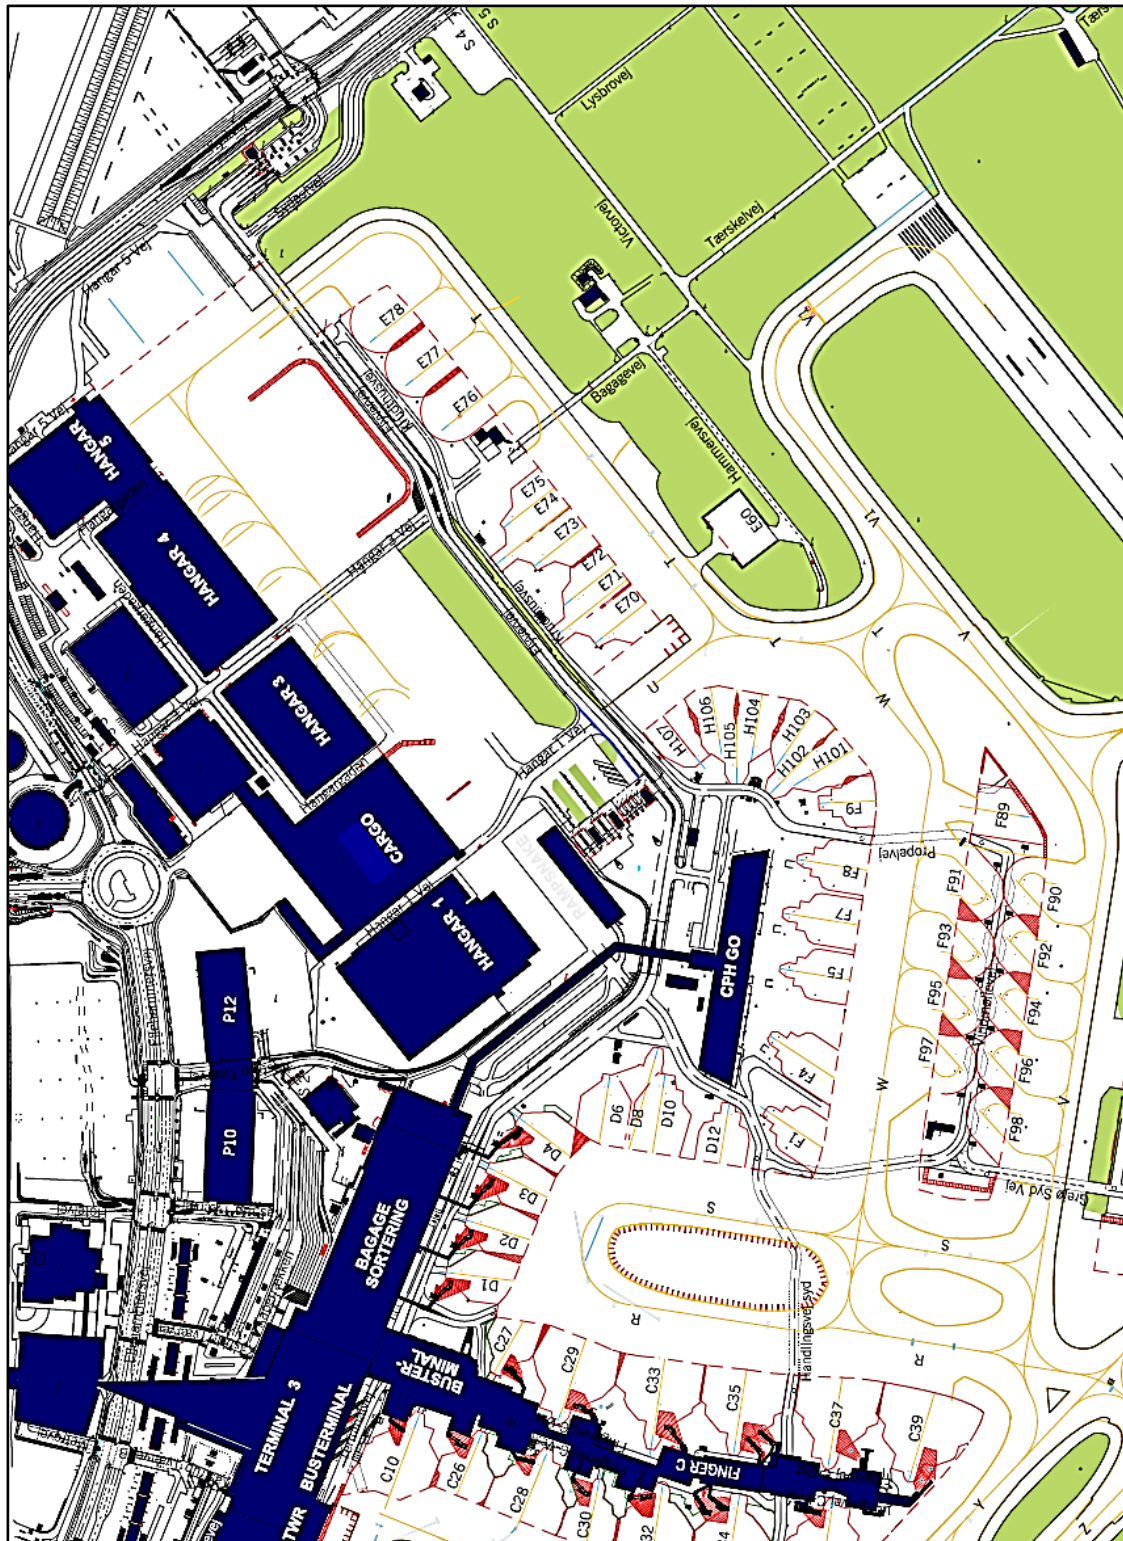
At 15:07:50 hours, Kastrup Apron instructed the TBL driver to tow OY-KBC to aircraft stand C29 via taxiway T, taxiway V and to hold short of taxiway S. The TBL driver read back the towing instructions.

[See appendix 2.](#)

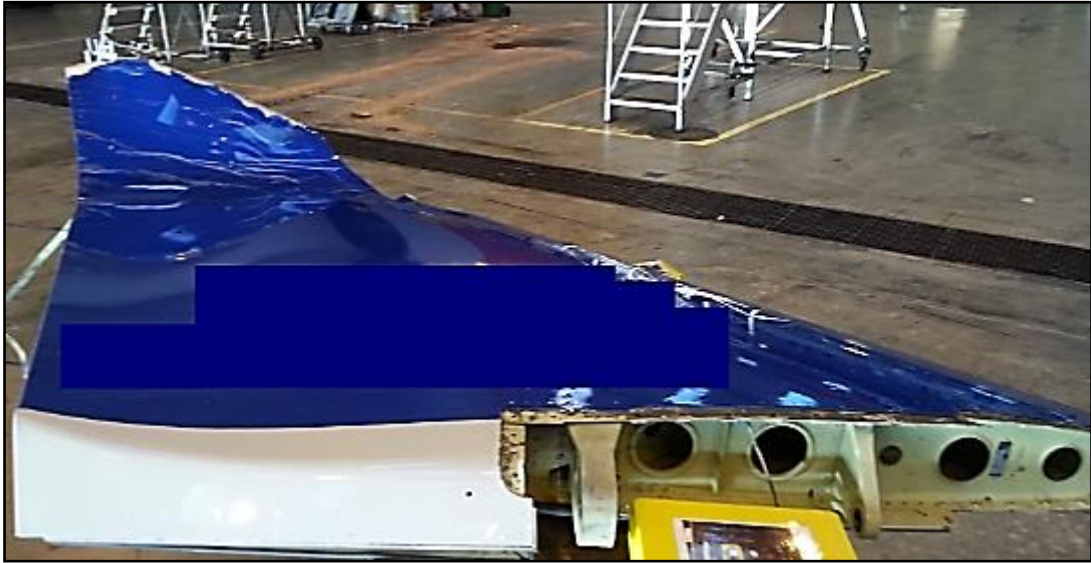
Picture 1

The right winglet of OY-KBC suffered minor damages

[See appendix 3 picture 1.](#) The AIB removed the name of the operator.

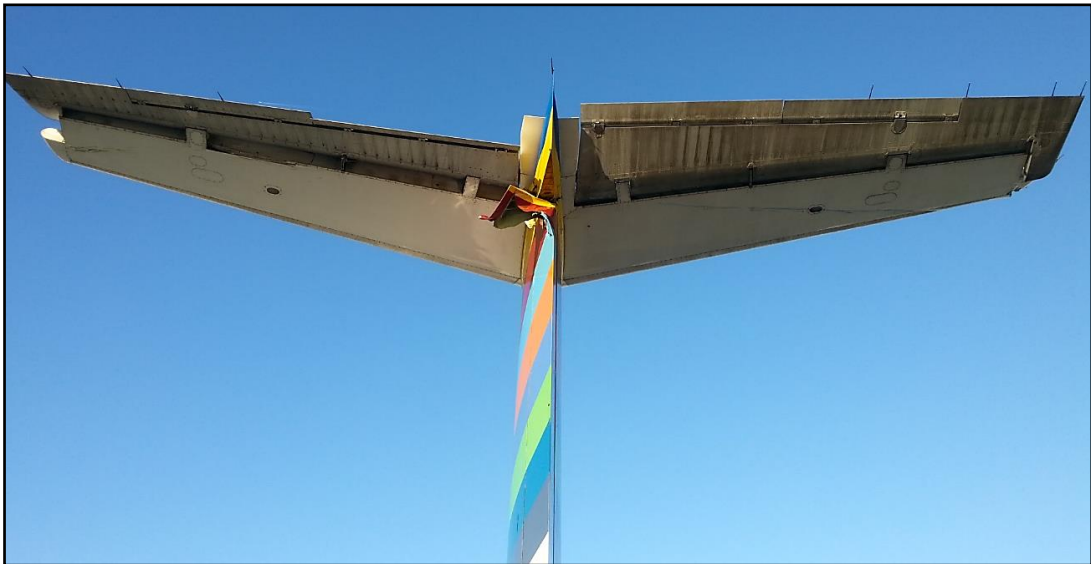
Picture 2

The horizontal stabilizer, the elevator and the rudder of SE-DST suffered substantial damages.

[See appendix 3 picture 2.](#)

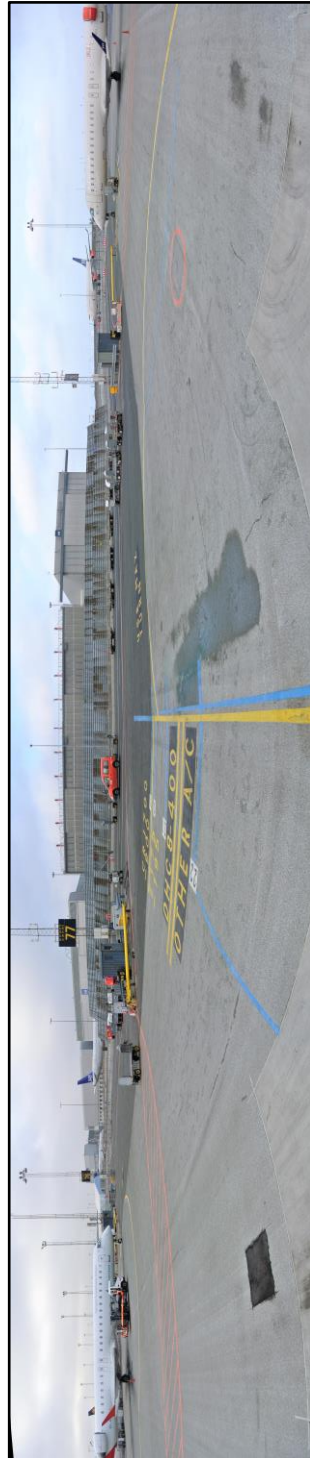
A panoramic view of aircraft stand E77 - [see appendix 7](#).

When moving the aircraft onto aircraft stand E77, the flight crew of SE-DST stopped the aircraft approximately 14 metres in front of the aircraft stand stopping mark (“OTHER AIRCRAFT”).

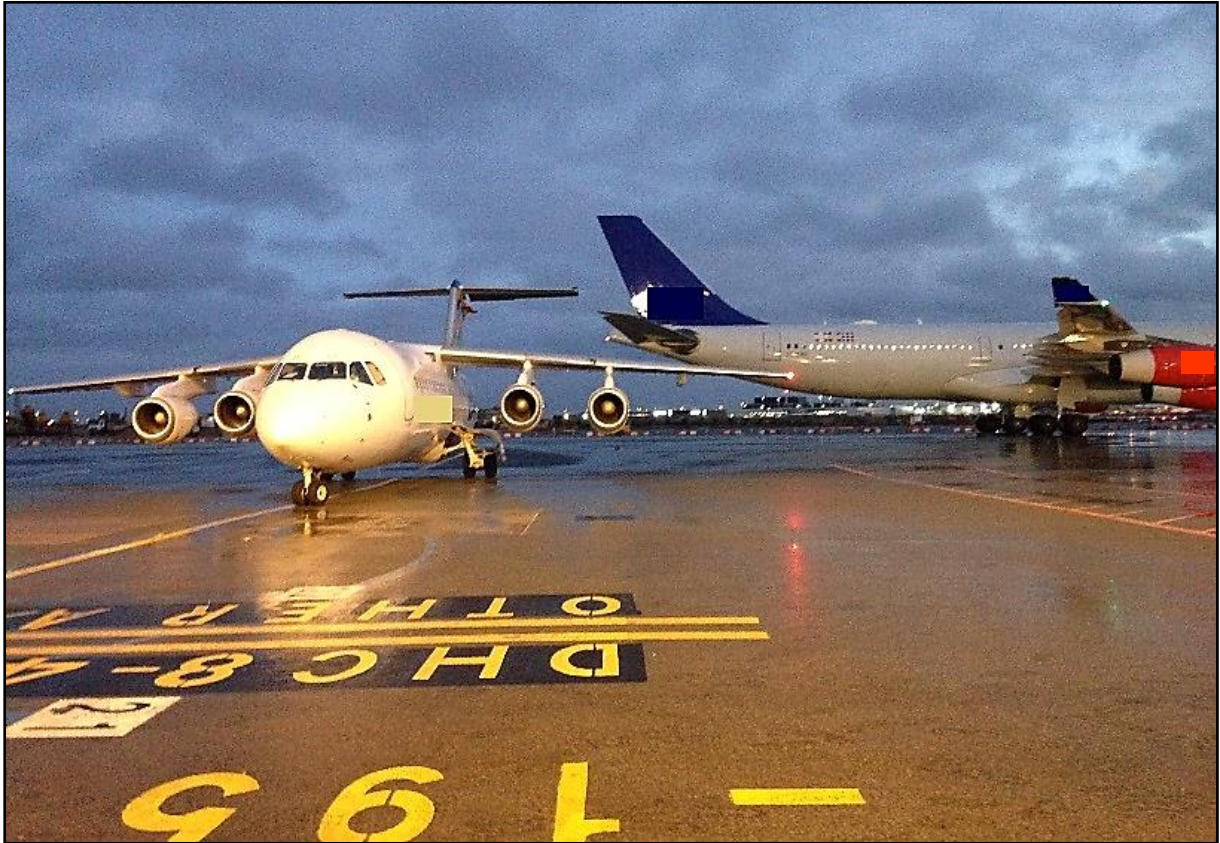
At the time of the accident, the hangar area north and the aircraft stand E77 were fully illuminated.

[See appendix 8](#). The AIB removed the names of the operators.

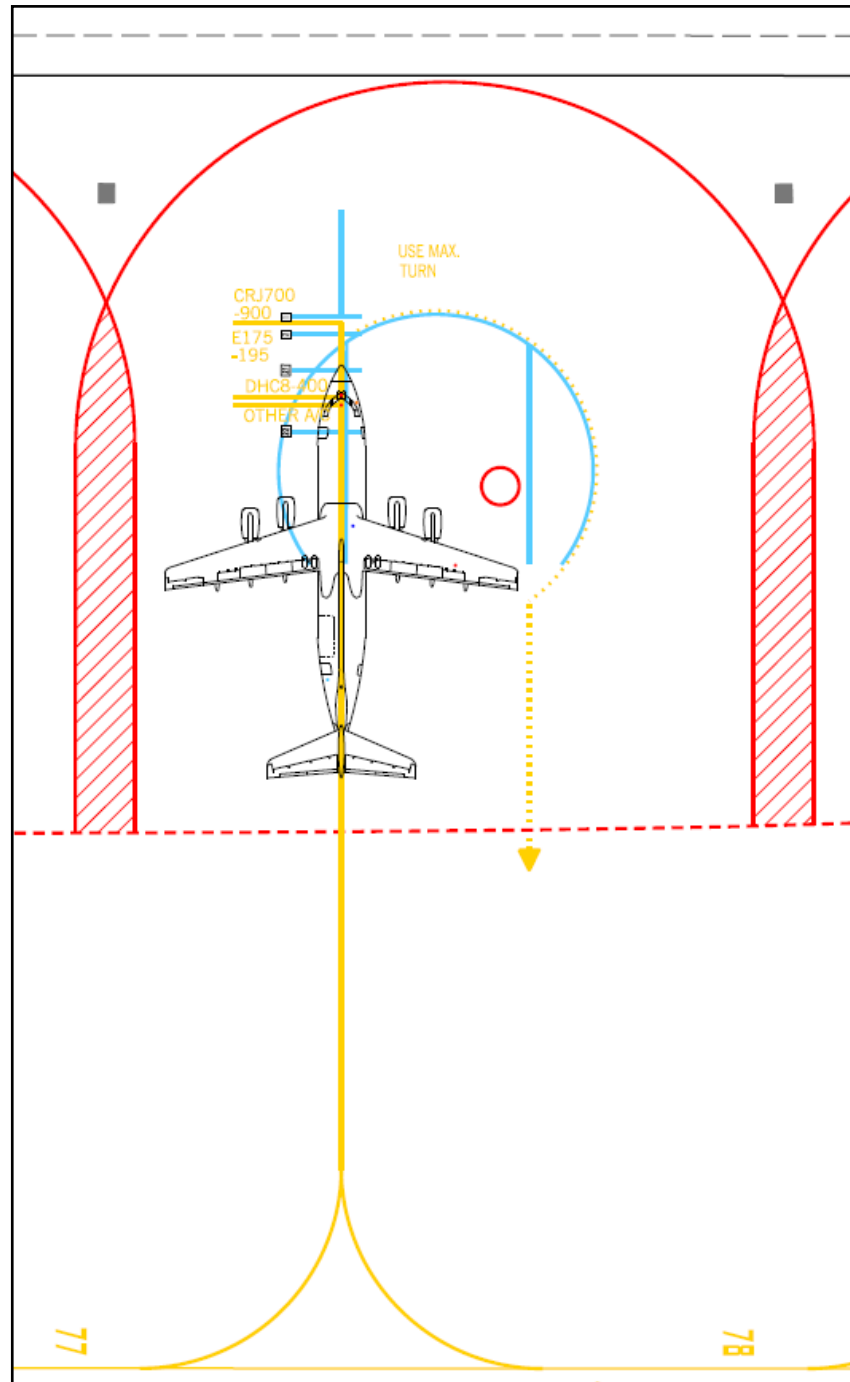
The position of an Avro RJ100 optimum parked at aircraft stand E77 - [see appendix 9](#).

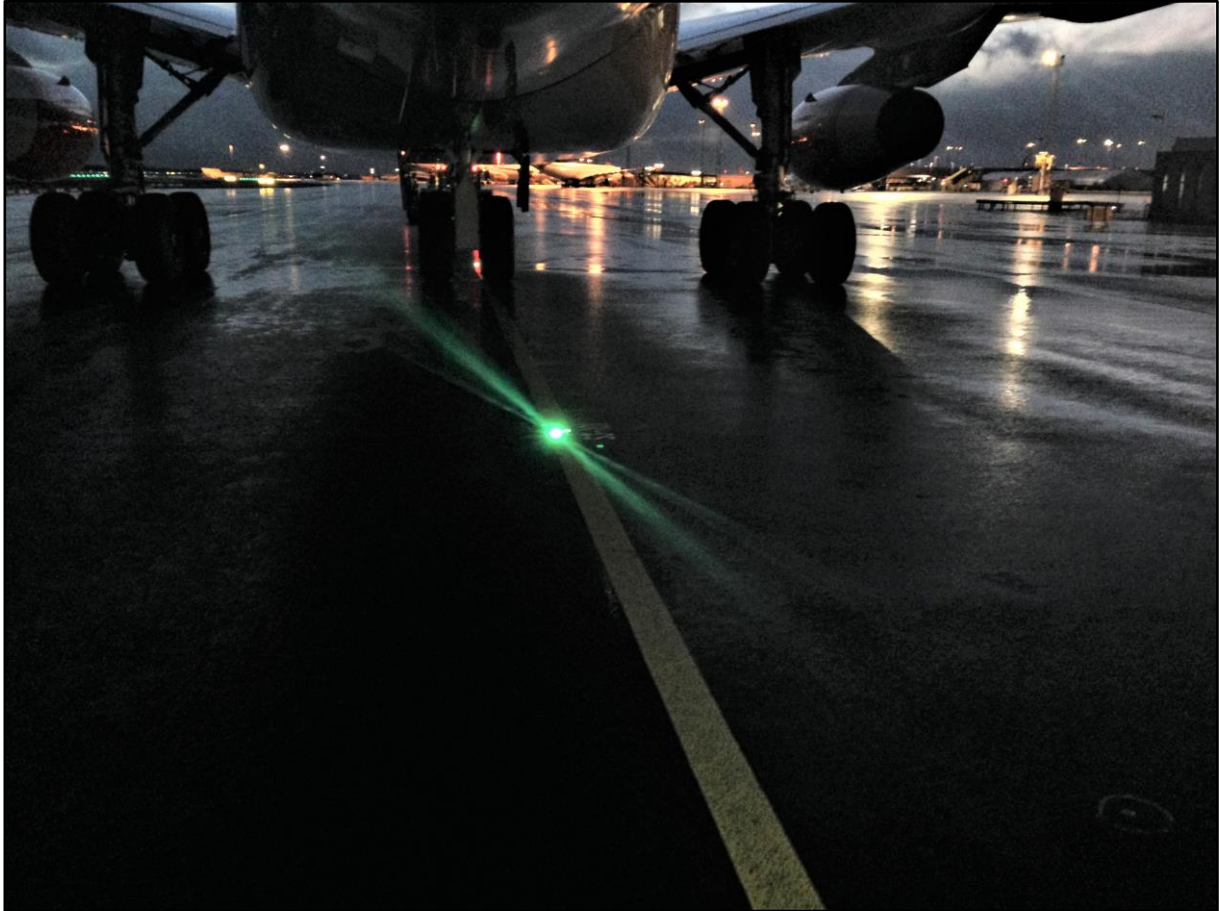
The TBL towed OY-KBC on the green illuminated and distinctly yellow painted taxiway centerline.

[See appendix 10](#).

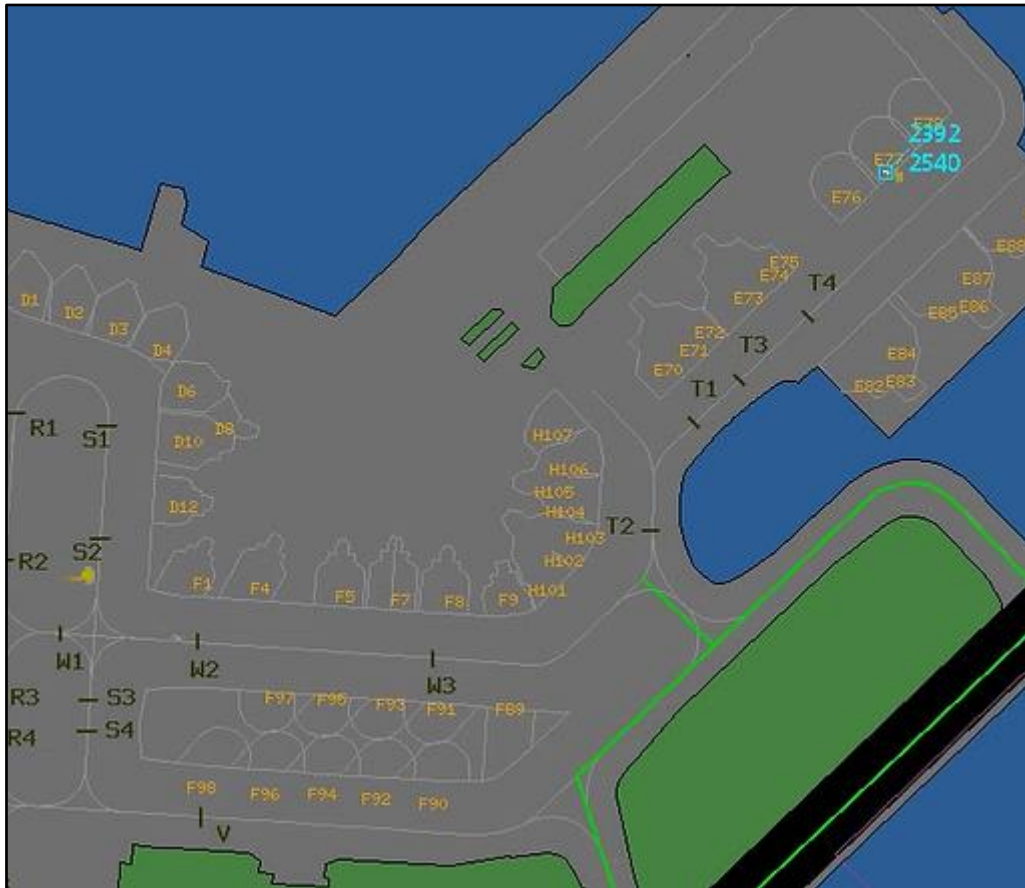
Time: 15:07:02 hours

At 15:07:02 hours, the white S-MGCS radar label (mode S radar information) of SE-DST changed colour from white to blue (primary radar information and in this particular case the assigned transponder code of SE-DST).

[See appendix 11](#).

In the period between 15:06:56 hours and 15:07:50 hours, the S-MGCS radar label of SE-DST changed colour from white (mode S radar information) to blue (primary radar information). S-MGCS still presented the assigned transponder code of SE-DST.
