## *Final report RL 2017:08e*

**Serious incident at Malmö Airport on 29 September 2016 involving SE-DSP of the model AVRO 146-RJ100, operated by Braathens Regional Aviation AB.**

File no. L-101/16

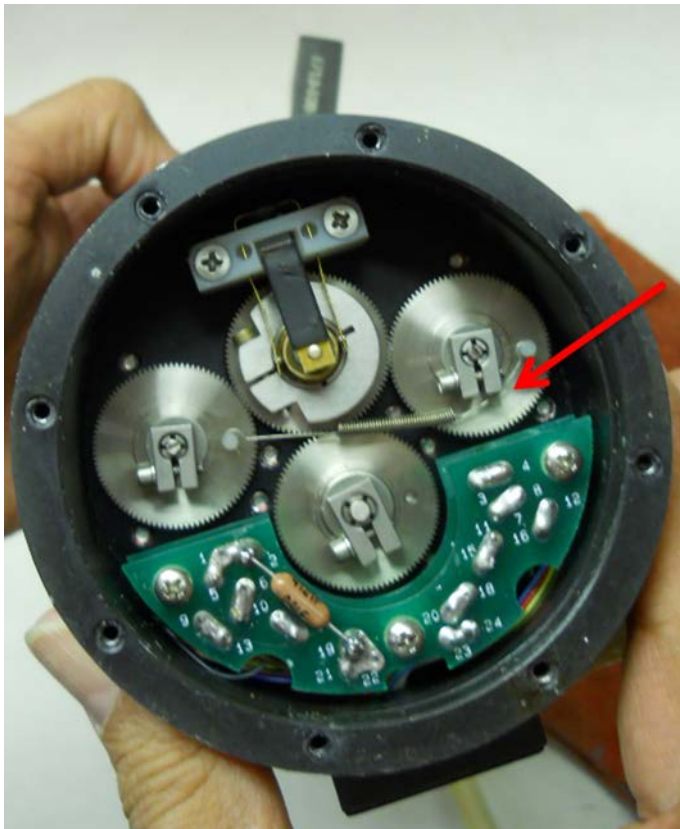
At the examination it was noted that the vane shaft gear clamp was tight but was not oriented per the drawing. In addition, the two potentiometer shaft gear clamps were tight but not oriented correctly. One of the potentiometer clamps was interfering with the spring that connects the two potentiometer gears when the vane was moved to the corresponding stop (See fig. 10 and 11). This resulted in the spring stretching, and returning the vane gear to a neutral position when the vane was let go. When the spring was removed, the vane shaft appeared to balance normally.

Figure 10. Airflow sensor at the examination, right potentiometer clamp interfering with the spring.

At the examination the unit was found to be 45 to 50 degrees out of specification on all the angle readings.

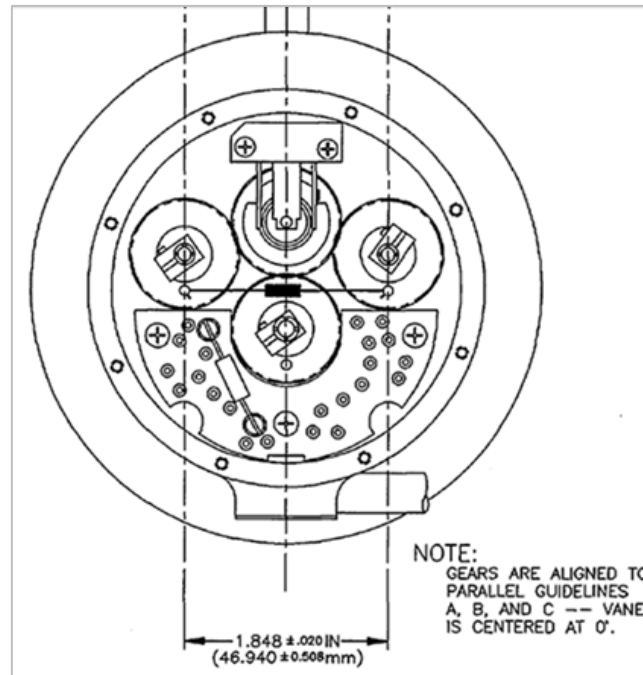
Figure 11. Correct orientation of gears, clamps and spring according to the manufacturer manual.

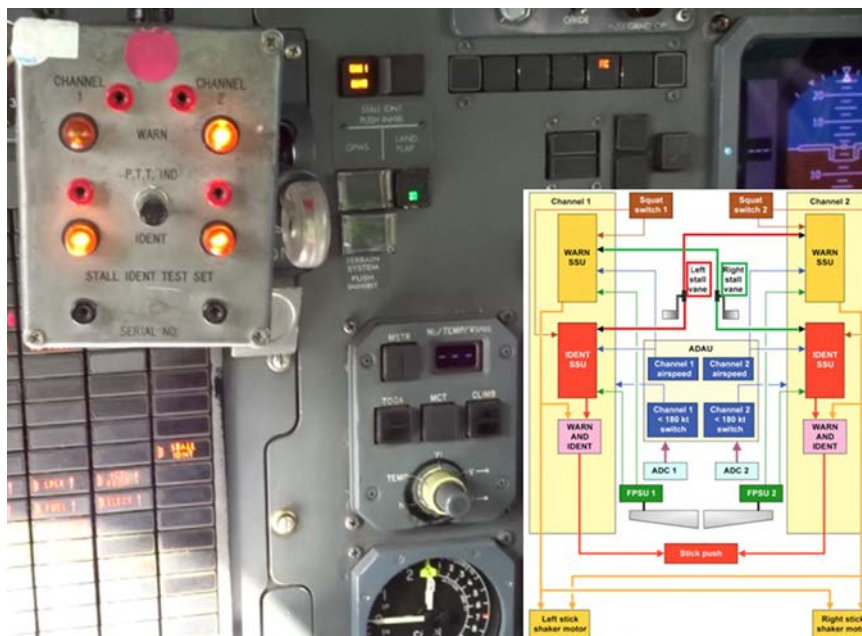
This resulted in annunciators illuminated Ident 1 for channel 1 and channel 2 warning on the test equipment. On the instrument panel, the annunciators IDNT 1, STALL IDNT on CWP illuminated and stick shaker was activated, (see fig. 12). The IDNT 1 button was pressed and the INHIB part of the button lit.

Figure 12. Annunciators on the instrument panel and test equipment with left air-flow sensor in position 45 degrees and right in an angle around 0 degrees.

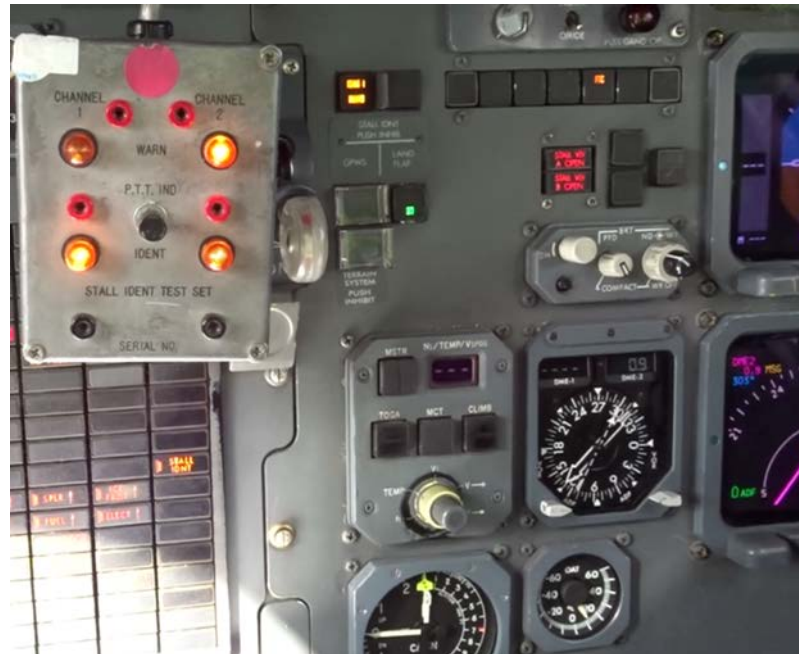
The ident annunciator for channel 2 flashed and the stick push was activated while the “STALL VLV A and B OPEN” annunciators were lit on the instrument panel, figure 13.

Figure 13. Annunciations on the instrument panel and test equipment, at stick push.
