Statens haverikommission
Swedish Accident Investigation Board

Report RL 2010:03e

Accident to aircraft SE-GUP at Uddevalla
Rörkärr airfield, Västra Götaland county,
on 1 June 2009

Case L-06/09

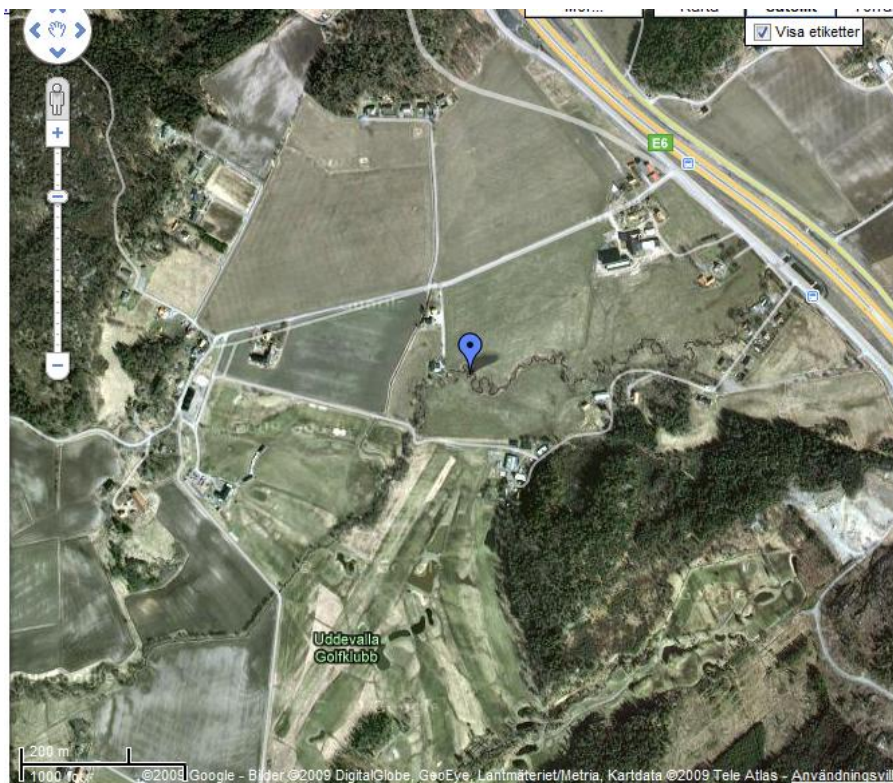
The site of the accident is located about 150 metres north-north-east of the beginning of runway 21 at Uddevalla Rörkärr airfield, Figures 2 and 3, in Västra Götaland at position N58° 22.2', E011° 46.7', 36 metres above sea level.

Fig. 3. The accident site.

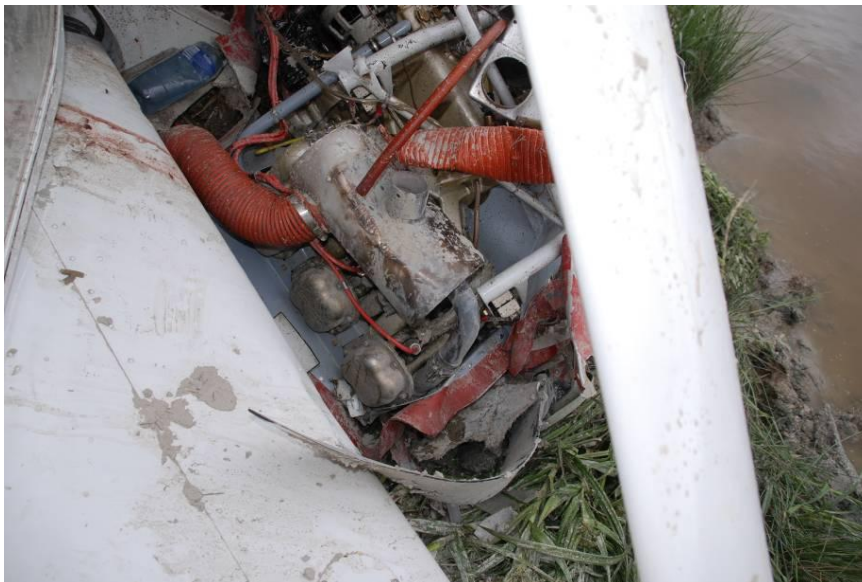
The front part of the aircraft and the engine installation were severely deformed. The engine had broken away and laid on the north bank of the brook, to the left of the direction of flight at impact. The propeller was still attached to the engine and one blade was visible, while the other was embedded and hidden in the ground. The visible outer part of the blade was bent backwards in the direction of flight and laid up against the front edge of the left wing, see Figure 5. The propeller blade had cut an approximately 20 mm deep gash in the front edge of the wing.

Fig. 5. Engine and propeller blade.

The propeller blades were bent back at 60 and 30 degrees respectively with respect to the direction of flight.

The propeller was rotating on impact with the ground, and the damage to the propeller blades had occurred during the accident. The blades had bent backwards in relation to the direction of flight, probably due to the aircraft forward speed being high relative to the propeller rotation speed. The blade that had bent the most had first hit the ground and braked the aircraft movement and engine rotation. Both braking and rotational forces had been applied to the engine during the accident and caused it to break free to lie beside the aircraft wreckage.

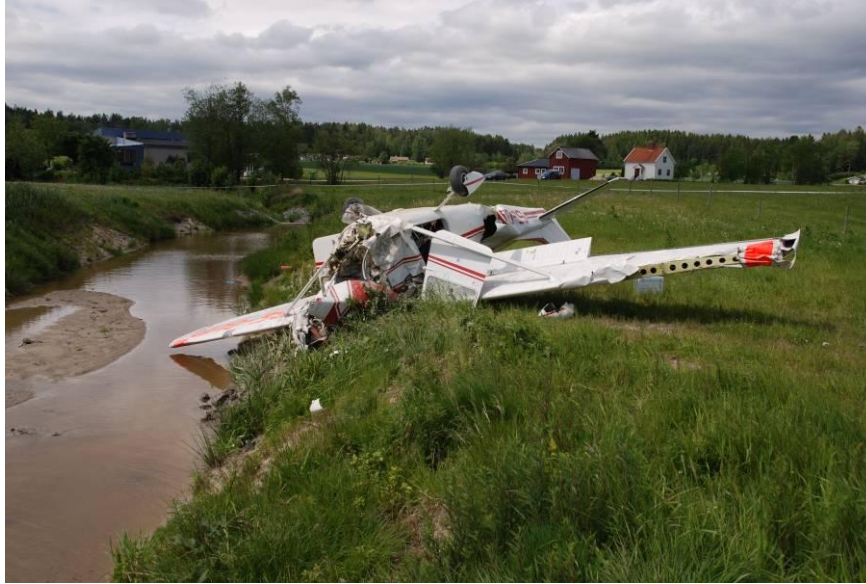
The left landing gear had detached from its fastening to the fuselage. The firewall had been pushed about 10 cm backwards. The fuselage was broken behind the cabin. In this area there was creasing all around, see Figure 6. The pilot's seat mounting rail on the left side had detached from its floor fixing, while the rail on the right side and longitudinal latching mechanism were undamaged. The shaft of the right hand control column was broken off.

Fig. 6. Aircraft wreckage

The cabin structure of the aircraft was relatively undamaged after the accident. The pedal mountings and fuel tank selector panel were however damaged and had shifted about 10 cm back from their normal positions, but not to such an extent that they would have caused serious crushing

danger to the pilot. It was concluded that the broken shaft of the right side control column was caused by the foldable backrest of the right hand pilot's seat striking the control column wheel during the collision of the aircraft with the ground.

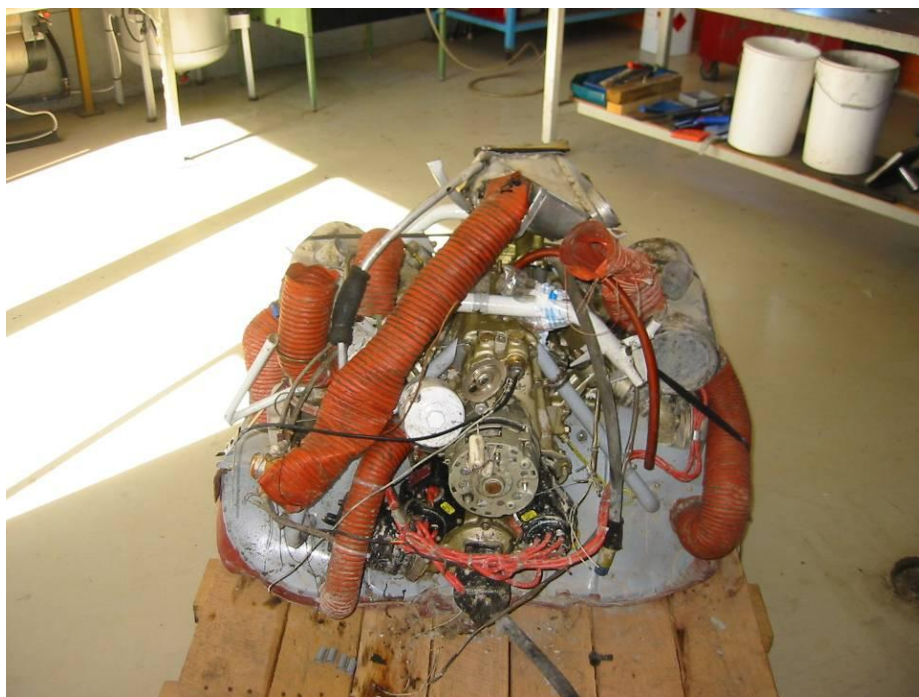
The engine had crushing and fracture damage to certain external components in connection with the impact, see Figure 7.

The engine oil filter was damaged and had broken free from its mounting. Both the silencers and the air cleaner housing had crush damage.

Fig. 7. The engine seen from the front.

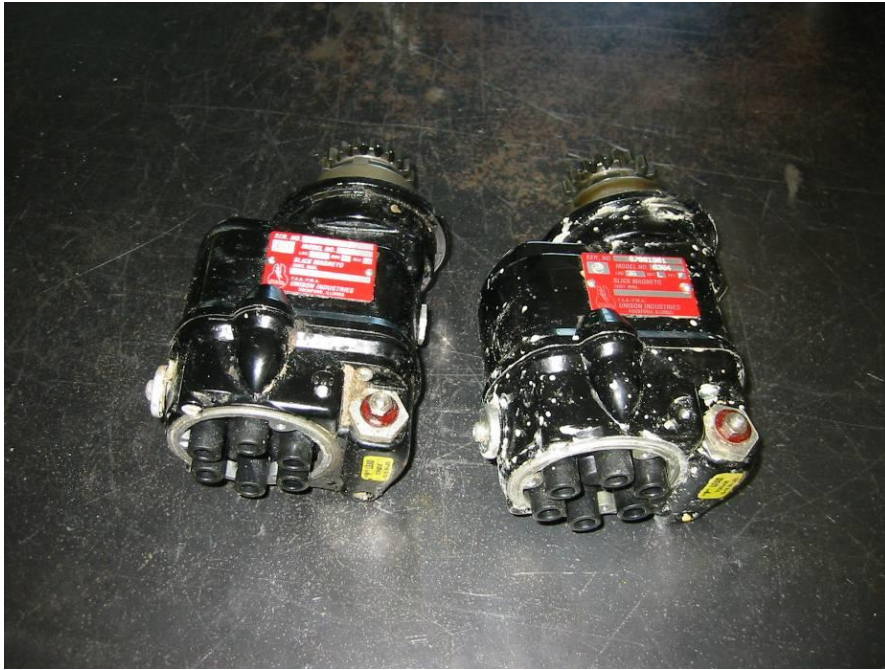
Both the engine magnetos, Figure 8, were tested on a test bench at various speeds, between zero and the maximum permitted speed. The start pulse function was also tested. Both magnetos delivered powerful sparks to all the ignition cables at all speeds, and the start pulse function operated normally.

Fig. 8. Magnetos.

SHK therefore had both the aircraft magneto ignition systems examined. The examination showed that both systems worked properly when bench-tested. The deposits of lead and carbon on the spark plugs were of normal extent for an engine that had run about 60 hours since its last inspection, which was the case for this particular engine. The layer of soil on one of the spark plugs had probably been deposited during the impact, when soil and clay were sucked into the engine. No technically related explanation has been found for why the magneto selector was in the LEFT position when the
