Final report RL 2013:09e

**Accident on 11 August 2012
involving the aircraft N-84142
on the lake Hultebräan, Kalmar County.**

Ref no L-83/12
2013-04-25

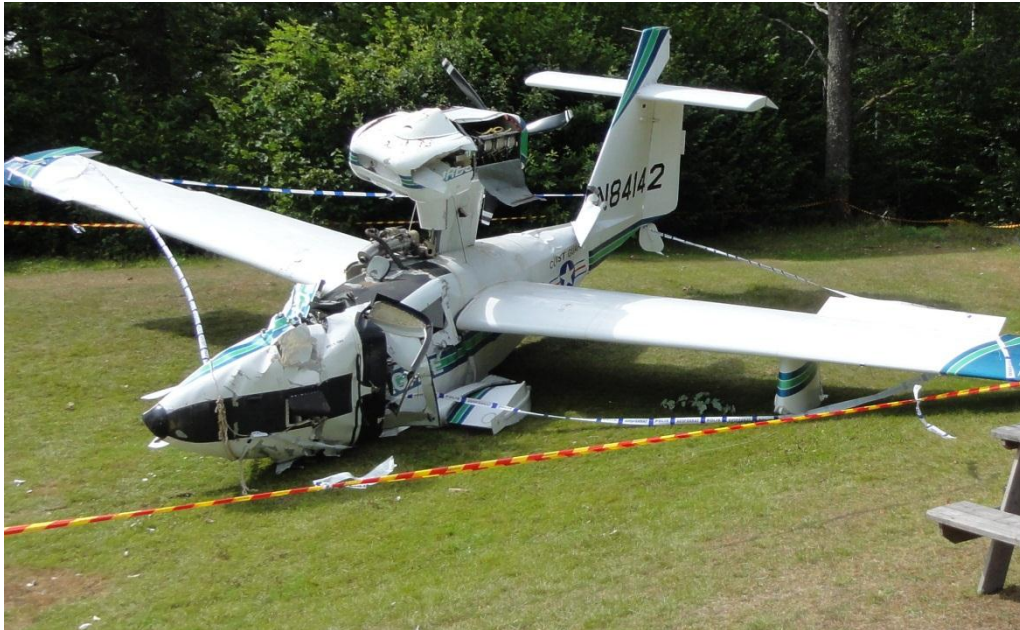
Substantially damaged. The nose section is broken off level with the backrests of the front seats. The right-hand support float is detached from the wing.

Fig. 1. Aircraft following salvage.

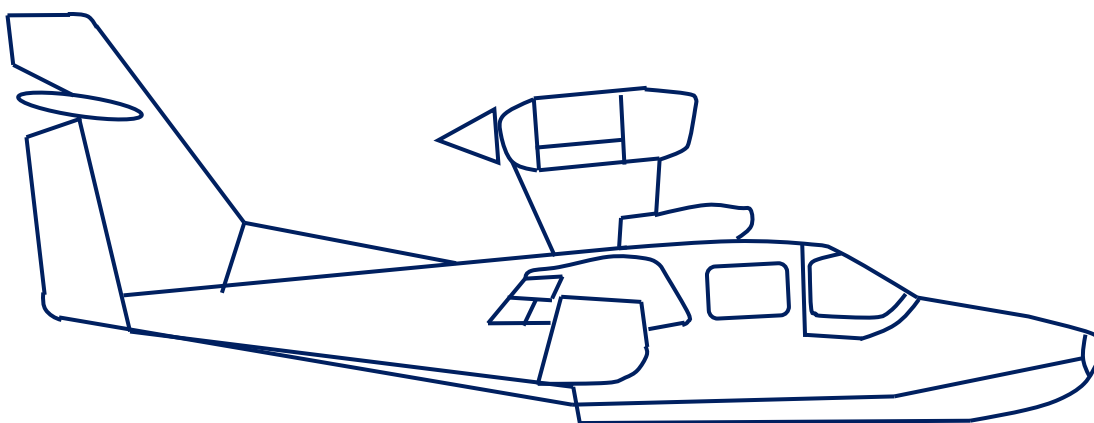
Fig. 2. Side view of the aircraft type.

Fig. 2 and fig. 11 show that the underside of the fuselage has a long, level section which is horizontal in a normal flight position. This means that an abnormal flight position is not necessary in order for the step to be in the air when contact is made with the water.

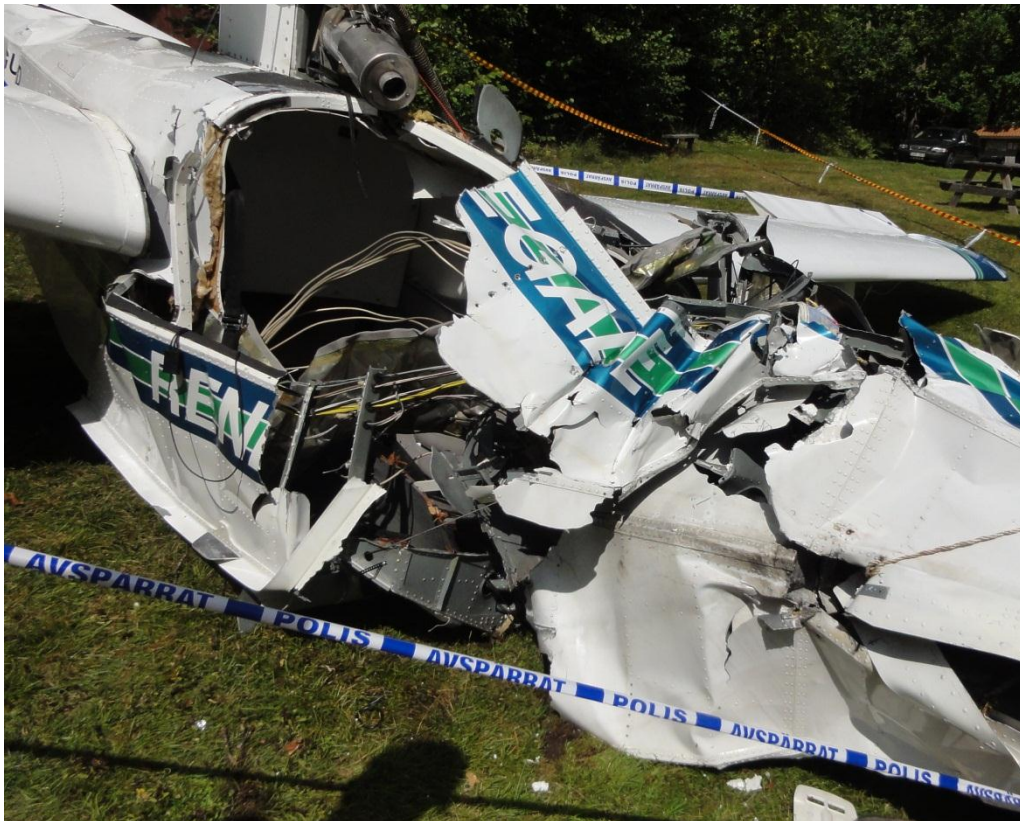
The front of the aircraft was almost entirely severed level with the front seats. On the left-hand side some structure remained, holding the parts together. The panels on the underside of the aircraft at the point of the break showed signs of tensile failure and the topside of the nose had compression folding. Overall, the break showed that the nose had been bent upwards and to the left.

Fig. 4. The nose was broken off and no structure remained around the front, right-hand seat.

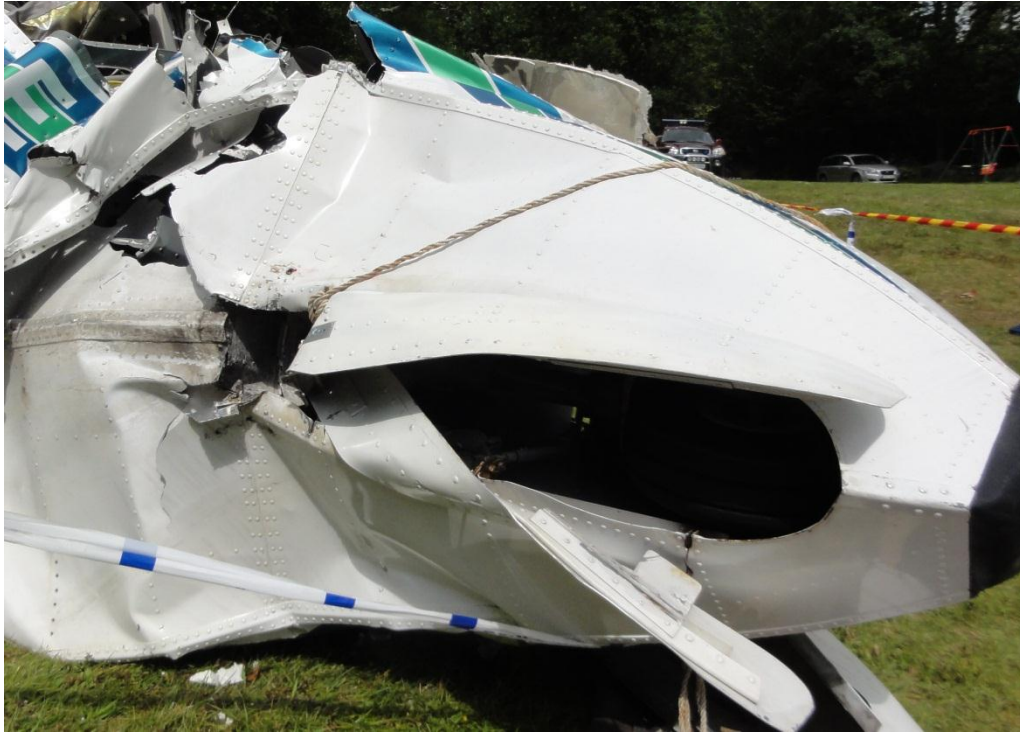
The panels on the underside of the nose had soft but large indentations. The lacquer was intact and had no marks from contact with an object.

Fig. 5. The underside of the nose, with soft indentations.

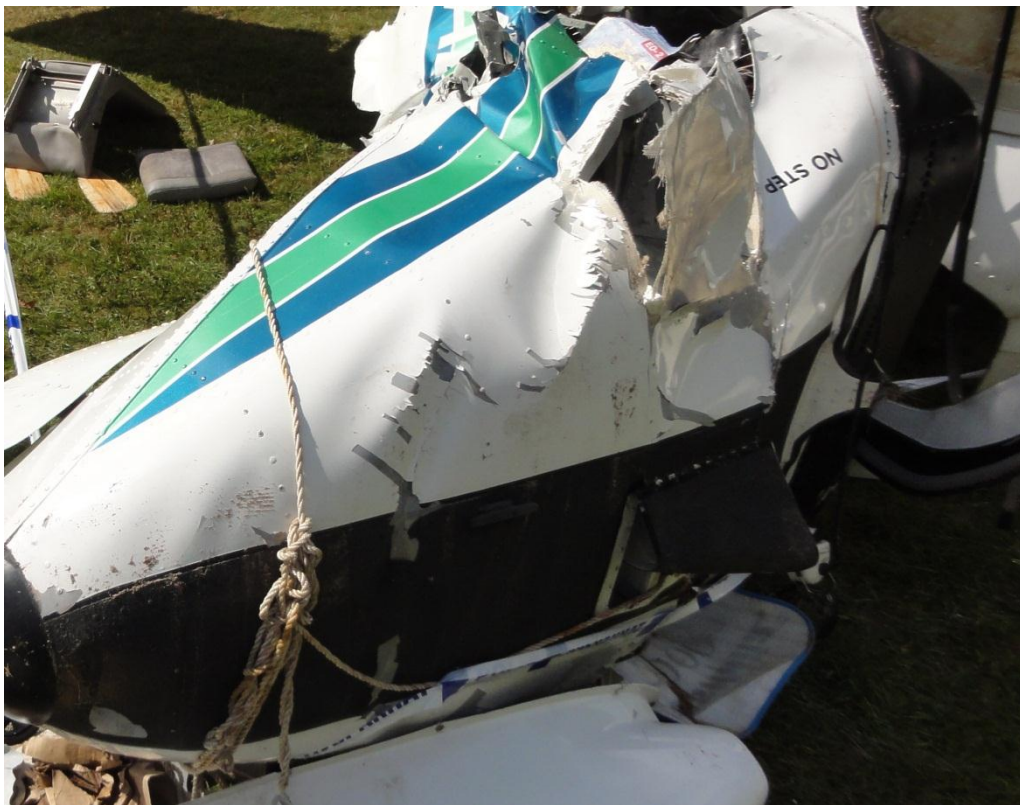
Fig. 6. The topside of the nose had compression folding.

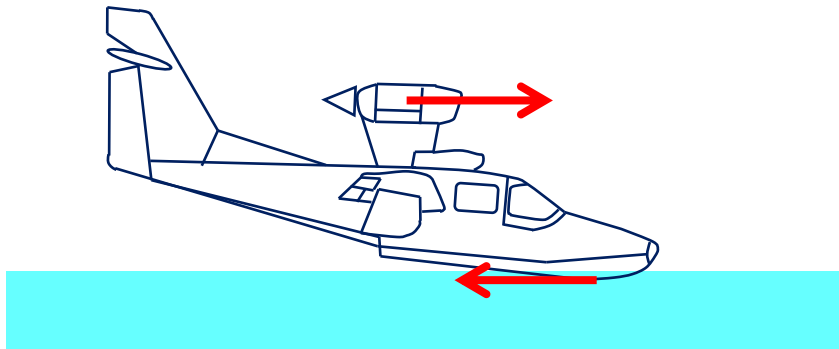
The step breaking the water surface is crucial to the aquaplaning functioning as intended. If the underside of the aircraft makes contact with the surface of the water without the step breaking the surface of the water, the water will be led upwards, along the fuselage. The reaction force from the water acting upwards will pull the aircraft downwards and deeper into the water. This in turn means that the area of contact with the water increases, which increases the friction, thus producing a greater braking force against the water.

Fig. 11. The step does not break the water surface.

In the case where the front part of the bottom achieves water contact without the step breaking the water surface, the nose will be sucked down into the water in the manner described in chapter 1.16.2. When the wet surface increases, so does the water drag, which in turn causes the aircraft to tip forwards as a result of the heavy engine which is positioned high up. The engine with its mounting weighs approximately 350 kg, which is close to 30 % of the total mass. When the aircraft tips forward, the nose is pushed deeper into the water, which results in a further increase in water drag. Furthermore, the wings' lifting capacity declines as the angle of attack decreases. The force on the nose that is pushed down in the water may then result in the forebody breaking up.

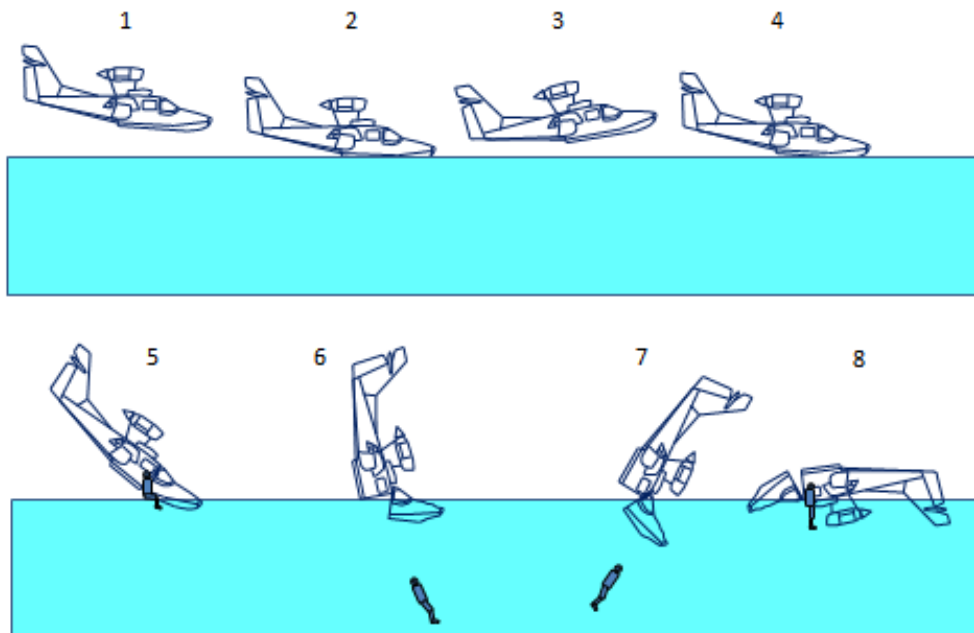
1. A normal approach.
2. A first water contact that resulted in a bounce.
3. The aircraft briefly left the water.
4. A second water contact with the nose slightly too low so that the step did not break the surface of the water. As the right support float is broken off and the nose shows signs of being bent to the left, it is likely that the aircraft was drifting slightly to the right when touching down.

5. The nose was sucked down into the water, resulting in a great drag. The engine's mass and high position resulted in the aircraft beginning to tip forward at the same time as the nose was broken off.

Fig. 12. This series of images provides a likely sequence of events in schematic form.
