Report RL 2002:02e

***Incident involving aircraft OY-MUG
at Ronneby airport, K County, Sweden,
on the 8th of December 2000***

Case L-008/01

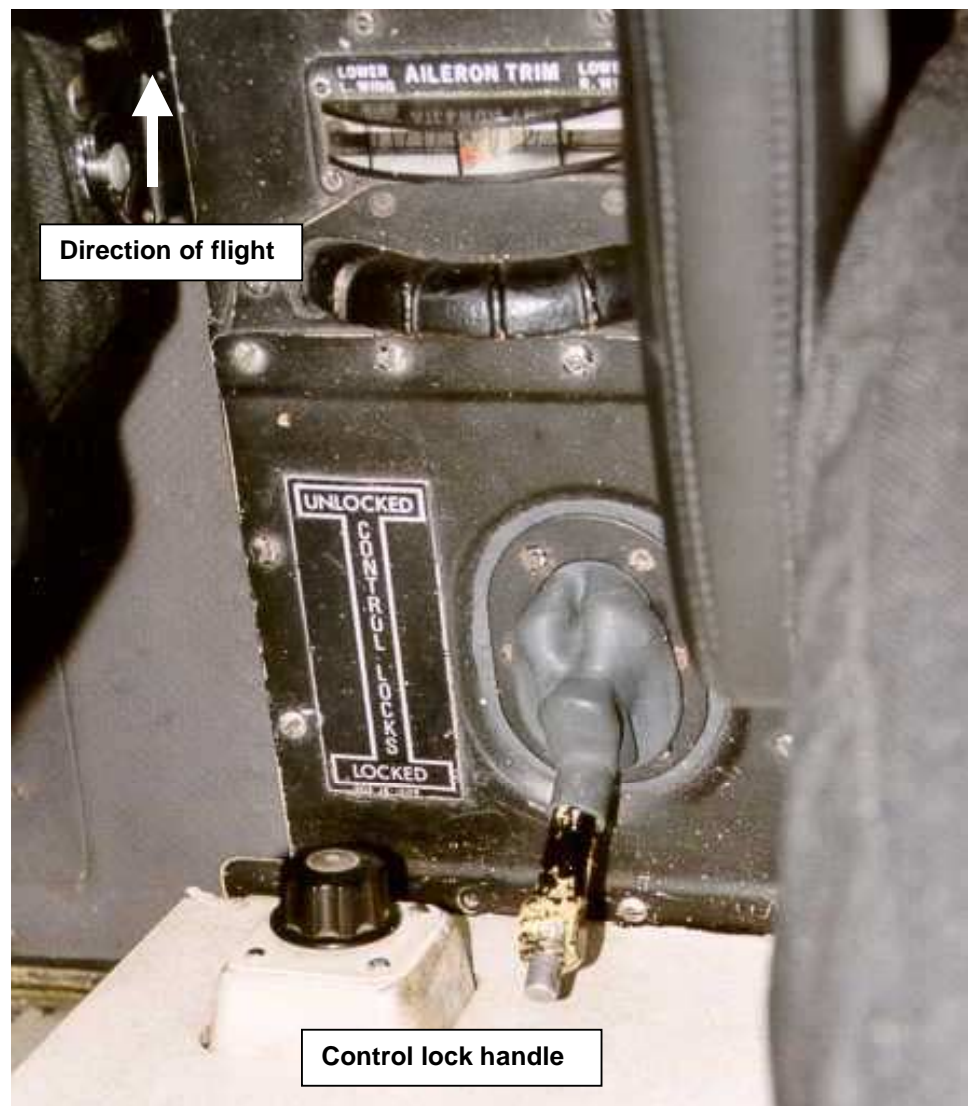
This aircraft type is equipped with an electro-mechanical rudder locking system (Gust Lock System) through which all flight control surfaces can be locked when the aircraft is on the ground. The system is controlled with the help of a handle, "Control Lock Handle", placed on a console between the pilot seats, behind the seat backs. The handle has two detent positions, "UNLOCKED" and "LOCKED". In order to move the handle from one position to the other one must first depress a button on the end of the handle. The handle is not spring loaded to either position. It must be manually moved to the respective stop before it will lock in the selected position. The position of the throttles does not affect the movability of the handle.

A red warning light in the middle of the instrument panel is illuminated when the control lock handle is not in the "UNLOCKED" position or when the rudder lock actuator is in the "LOCKED" position.

It is therefore plausible that the control lock handle, in connection with switch-over, was not completely and correctly moved to the full detent position (UNLOCKED). Because of the handle not being spring-loaded in either direction it could subsequently, under the influence of aircraft vibrations during taxi, spontaneously move aft in the direction of detent position (LOCKED). When the handle reached a certain position the proximity switch for the rudder locking function was activated which caused the rudder to become locked. The co-pilot also remembers that the warning light for the rudder lock illuminated at about the same time that the rudder locking occurred.

This and similar previous incidents that have occurred indicate that the control lock handle's somewhat "out of the way" placement, design and locking function can give rise to mistakes being made in connection with the moving and locking of the handle. As such a mistake can result in a spontaneous locking of the rudder during takeoff, possibly before the pilots have managed to perceive that the warning light has been illuminated, this constitutes a flight safety risk. The aviation company's measure, to introduce a special checklist item regarding the locking of the handle prior to takeoff, is therefore well-founded and to be recommended.

Subsequent to the incident the aviation company has complemented the MUK AIR Normal Checklist, SD 360 OY MUG. In the section "Before take off" the following point has been introduced:

"Control Lock Handle..... ckd"
