**Statens haverikommission**  
Swedish Accident Investigation Board

ISSN 1400-5727

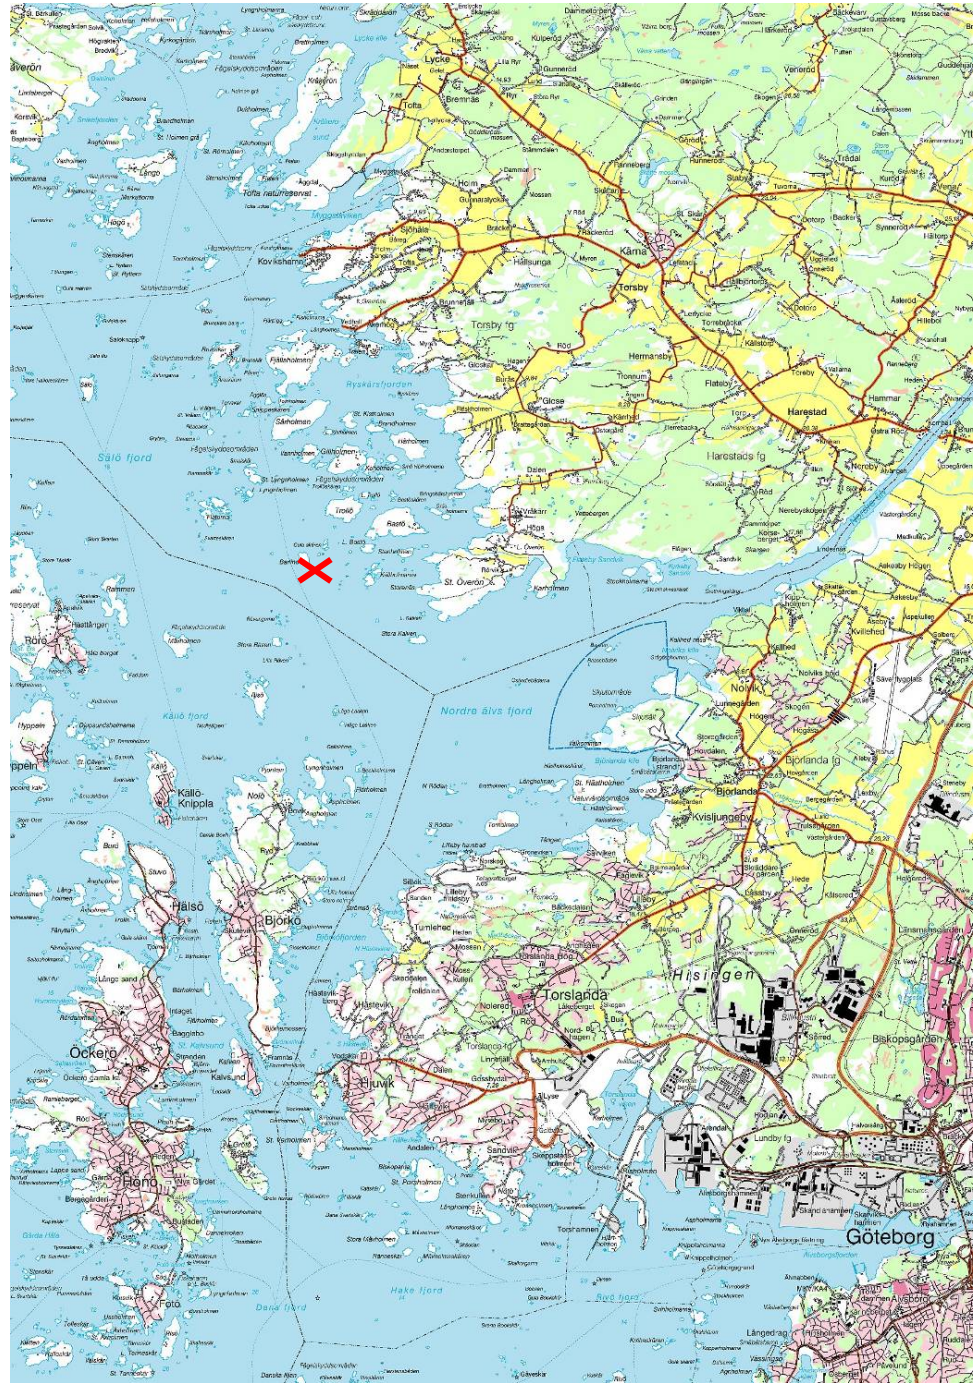
**Fig. 1:** The accident location, marked by a red cross, was about 18 km northwest of Göteborg.

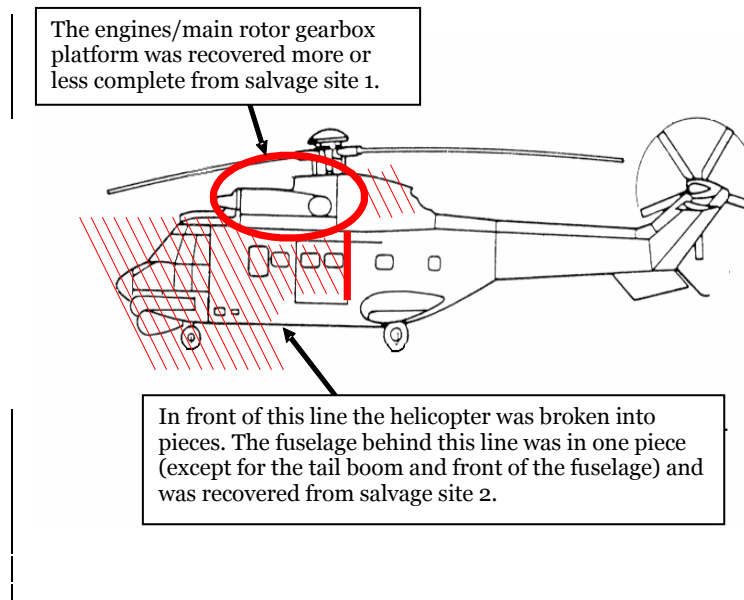
**Fig. 2:** The helicopter's main division into the two major sections.

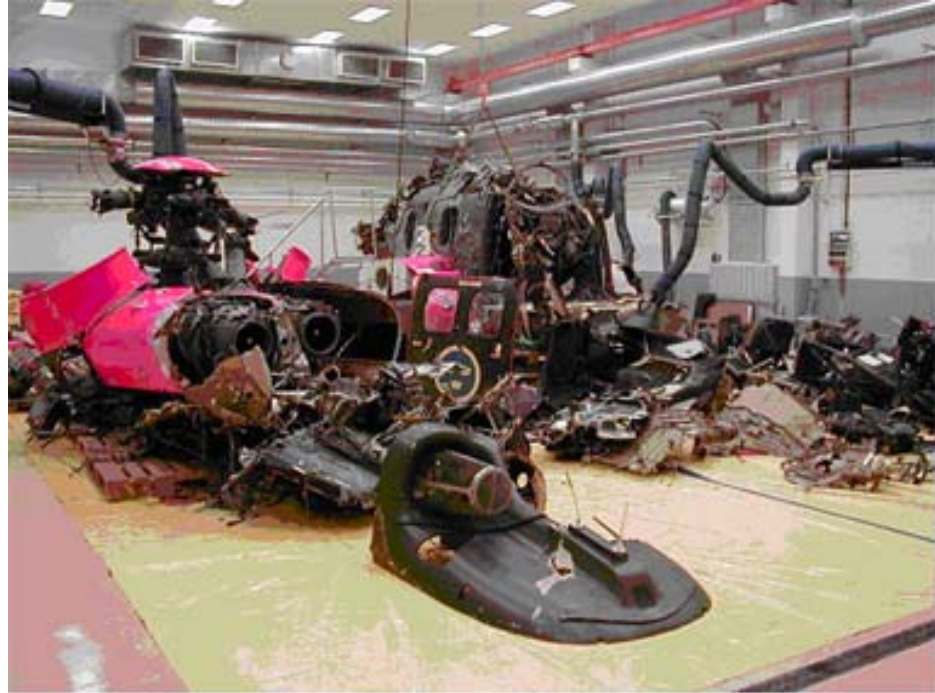
**Fig. 3:** The helicopter seen from the front. At the left are the engines, the MGB with the main rotor hub, and at the very front the casing with the air intake screen for the right hand engine. At the right are the front and rear fuselage parts.

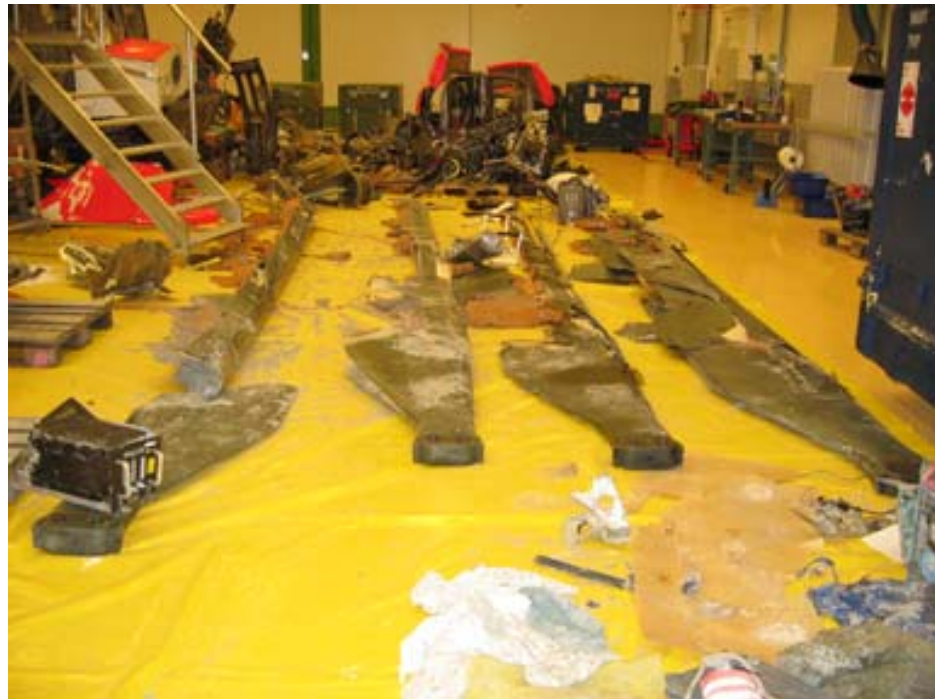
**Fig. 5:** The four main rotor blades of the helicopter.

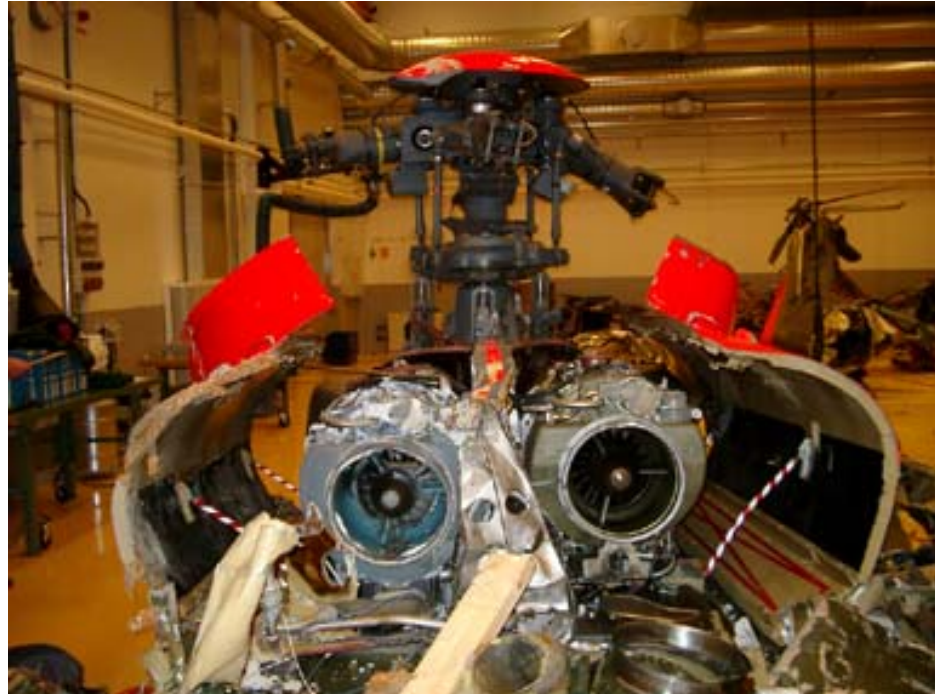
**Fig. 7:** The helicopter's engines seen from the front (right hand engine, #2, at the left in the photograph).

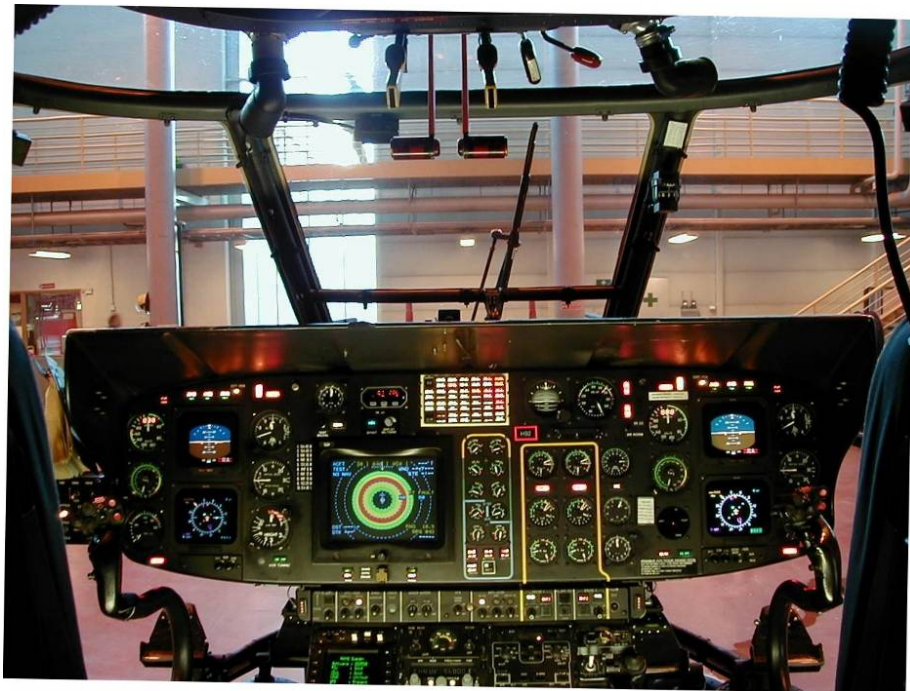
**Fig. 8:** Main instrument panel in the HKP10 cockpit. First pilot sitting at the right and the second pilot in the left pilot's seat.

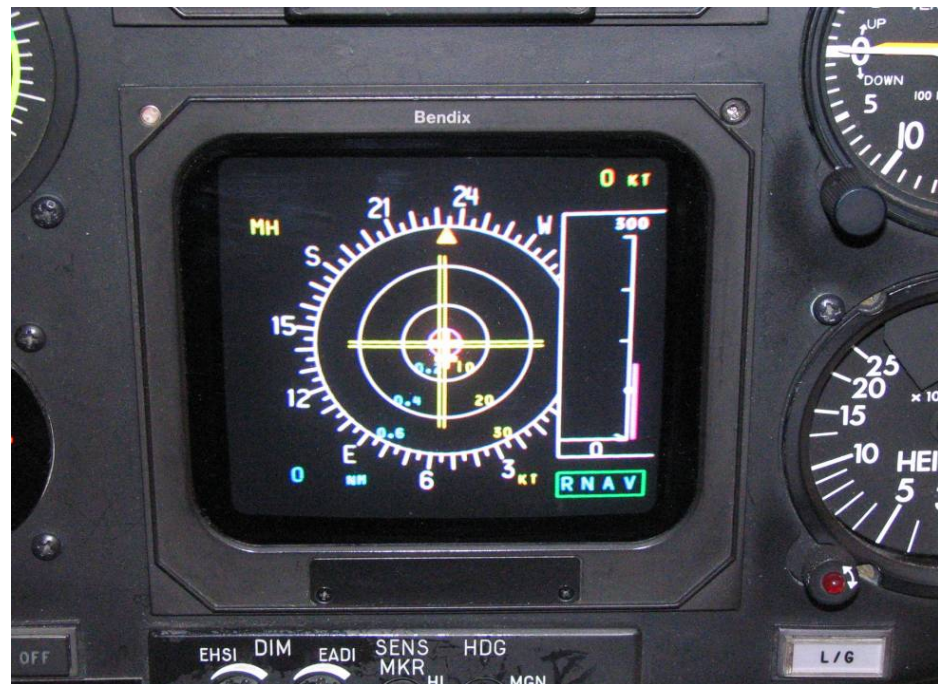
**Fig. 9:** The HSI for the first pilot, with hovering indication. The presentation shows that the helicopter is stationary, providing the DOPMEM light is not lit. If the wind is less than 10 knots and CALM SEA has not been selected, exactly the same presentation can be shown as above, despite the fact that the helicopter may be moving in any direction.

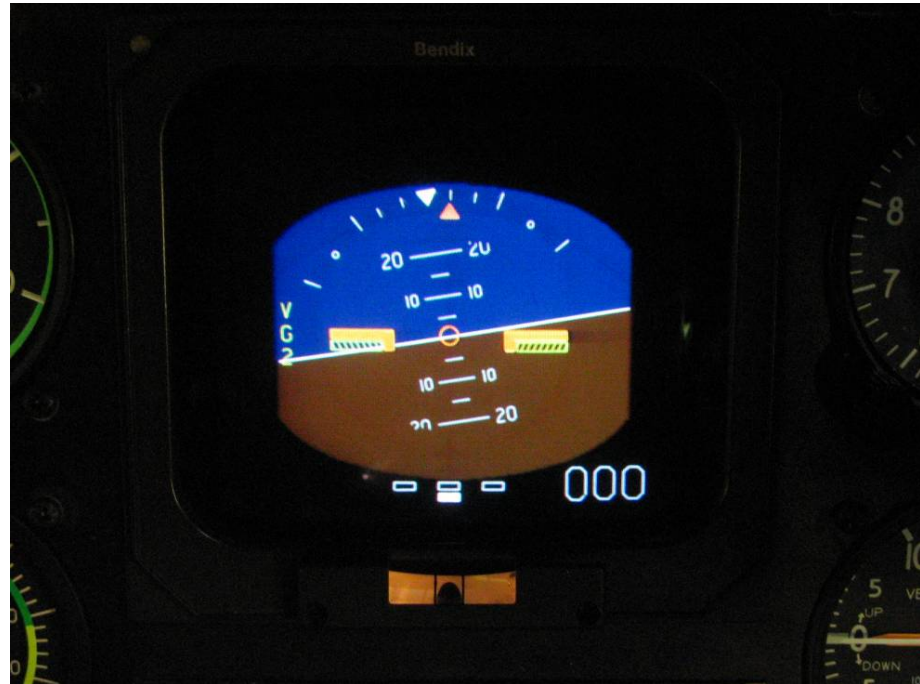
**Fig. 11:** ADI, with the bank angle pointer at the top edge. Here the helicopter is banking about  $10^\circ$  to the right. The bank angle pointer is aircraft-related.

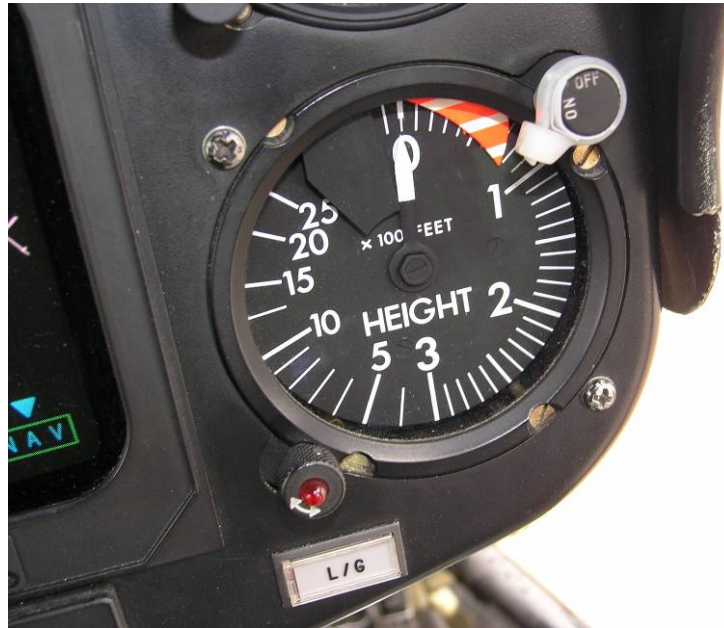
**Fig. 12:** The first pilot's RHM. The switch is set to OFF and the red/white flag indicates OFF. The Decision Height (DH) is selected by the knob with the red light at the instrument's 7 o'clock. The DH index marker is behind the red/white flag. On the photograph can be seen the non-sanctioned modification of a cable tie on the ON/OFF knob.

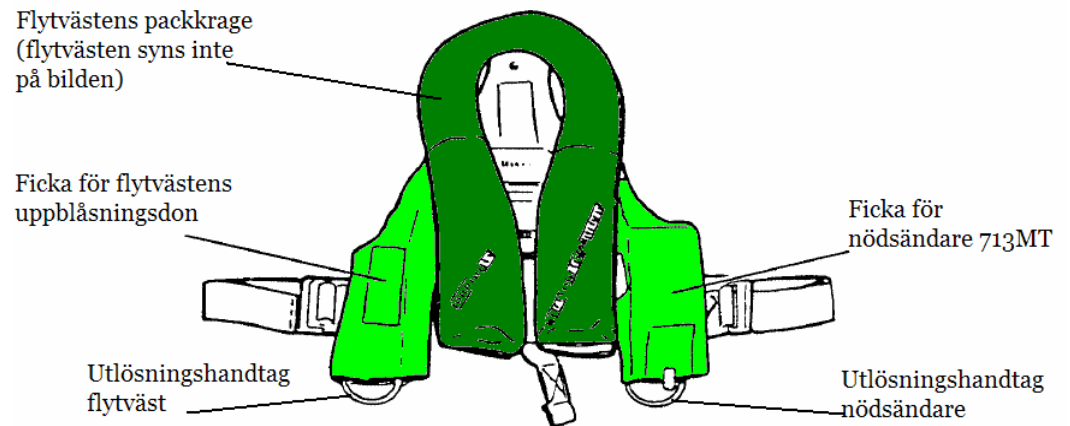
**Fig. 13:** Flotation vest worn by all the crew except the student rescue swimmer.

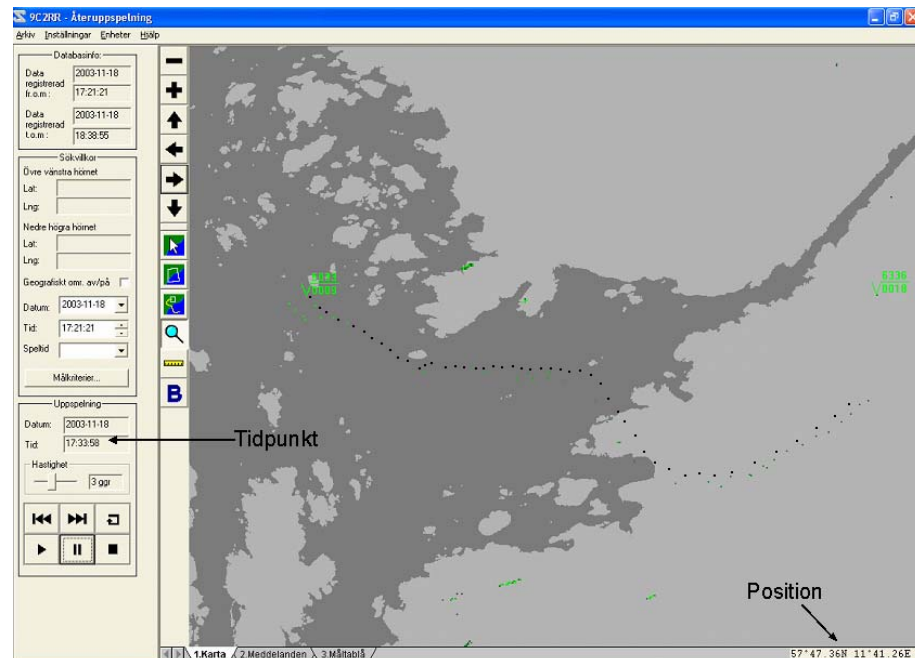
**Fig. 14:** The primary and secondary radar picture shows the position of H99 at 17:33:58 and the SSR response gives the flying altitude as approx. 90 m STD, i.e. approx. 10 m AMSL in the vicinity of Märta Collin's location south-west of Lilla Barlind island. The green radar responses indicate double returns.  
Illustration annotations: Time (Tidpunkt).

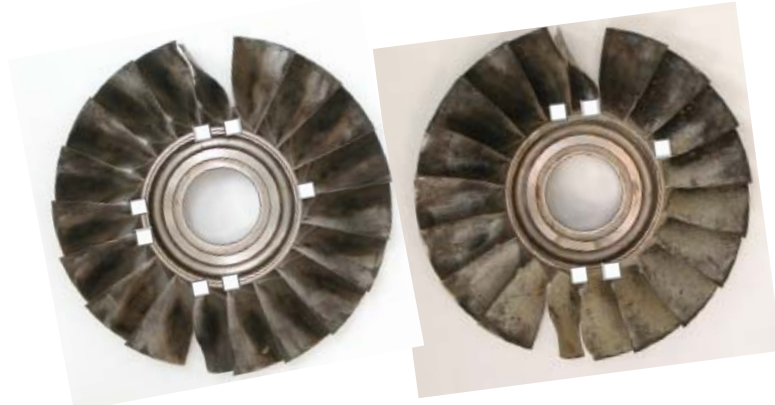
**Fig. 22:** The first compressor stages of the right engine (#2, left-hand picture) and left engine (#1, right-hand picture) photographed from the front. The symmetrical locations of the damage to the compressor blades can be seen in the pictures.

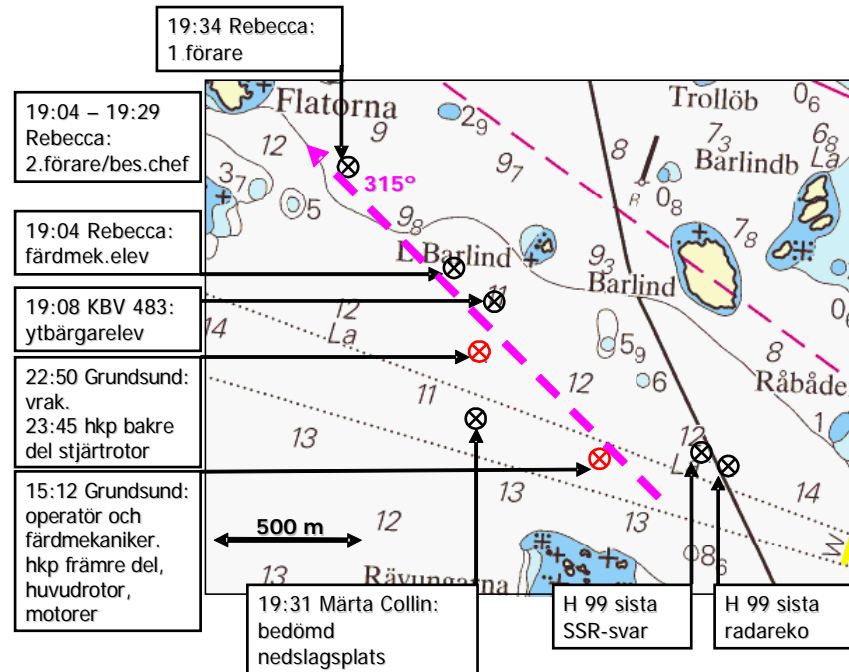
**Fig. 23:** Positions where the helicopter and its crew were found by the respective rescue units, with the actual times stated. The position where the body of the second pilot was found was not logged by the Rebecca.

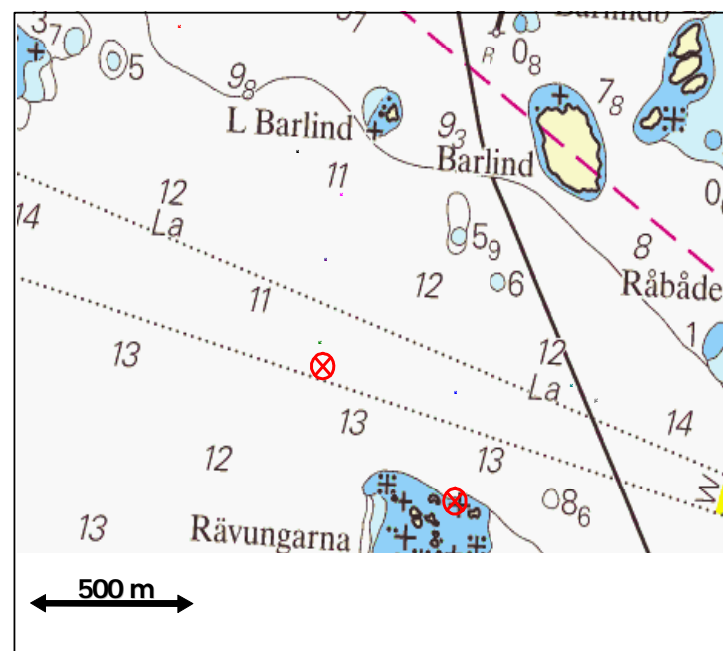
**Fig. 27:** The two locations where the helicopter wreckage was found. The south-eastern location was called *salvage site 1* ( $57^{\circ}47.14' N 11^{\circ}41.05' E$ ) and the north-west location was called *salvage site 2* ( $57^{\circ}47.33' N 11^{\circ}40.60' E$ ).

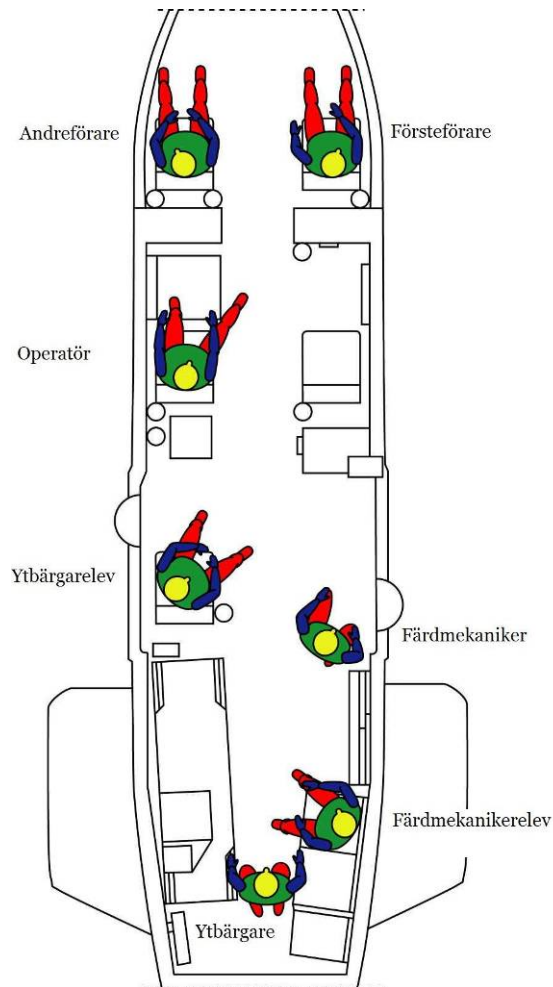
**Fig. 28:** The probable locations of the crew at the instant of impact. The flight engineer was wearing the winch operator's safety belt and could not therefore sit in his normal place, due to the length of the support line and it being secured to the roof. The rescue swimmer and student rescue swimmer were not secured in their seats by securing straps at the instant of collision.
